DARLINGTON CIVIC THEATRE

Historic Building Recording

planning application ref: 16/00065/LBC

August 2016

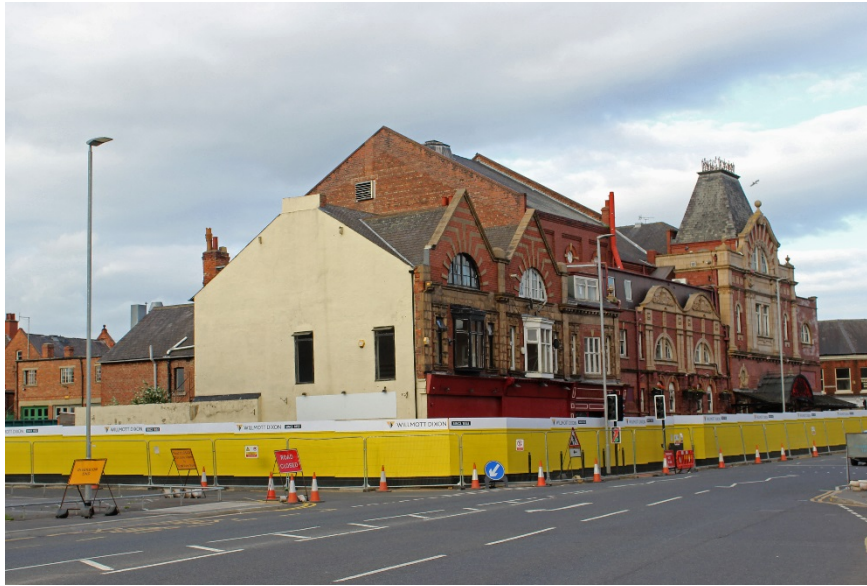
Illus 2 – General view of Darlington Civic Theatre from the south-west. The Parkgate shops can be seen in the foreground, with the box office between these and the main theatre building. The rear of the former fire station can be seen to the far left of the image.
