LAND 125 METRES SOUTHEAST OF LORD HOME HALL LORD HOME ROAD CURRIE HERIOT-WATT UNIVERSITY, EDINBURGH

ARCHAEOLOGICAL EVALUATION

16/00915/FUL

November 2016

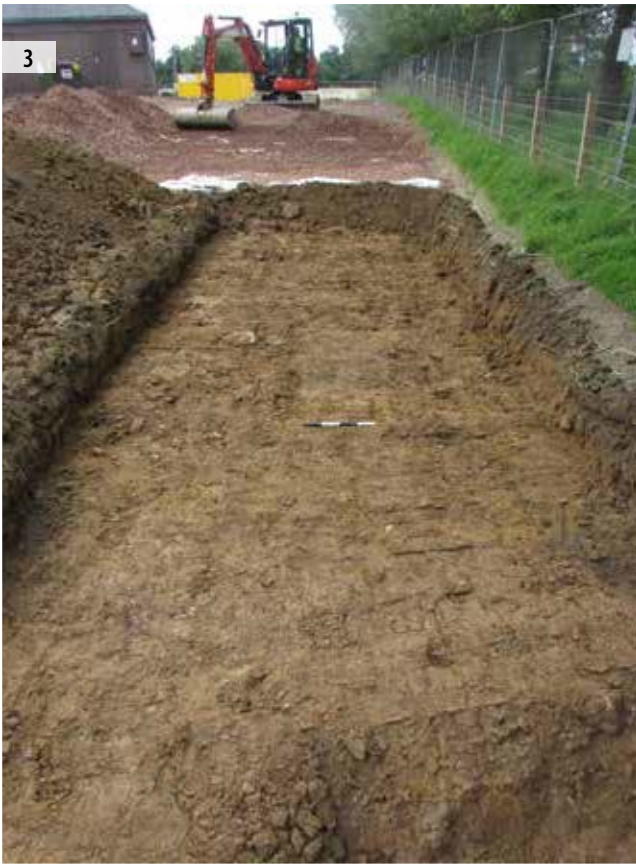
ILLUS 3 Record shot of TR001a, looking SW **ILLUS 4** Record shot of TR001b, looking SW **ILLUS 5** Record shot of TR001c, looking NE

Trench 001 (Illus 3, 4 and 5) was excavated along the northern border of the site, with an extension running south-east at the north-eastern end. Mid-orange-brown sandy silt subsoil up to 0.20m thick was encountered beneath the modern stone crush in the north-eastern corner of the trench. This was interpreted as hill-wash as it appeared to have accumulated at the foot of the gentle slope. Two distinct geological deposits were observed. Upslope to the south-west the superficial geology consisted of mottled

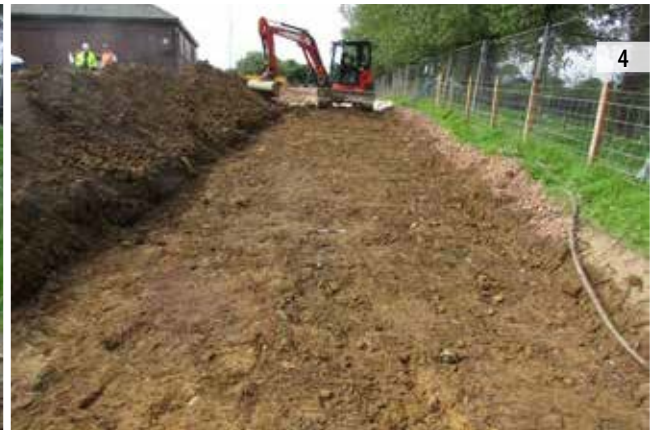
A single rubble constructed field drain was observed in the south-western end of the trench, cutting through the geological deposits. This measured 0.20m wide and 4.00m long and was aligned north-west to south-east. No features of archaeological interest were observed in Trench 001.

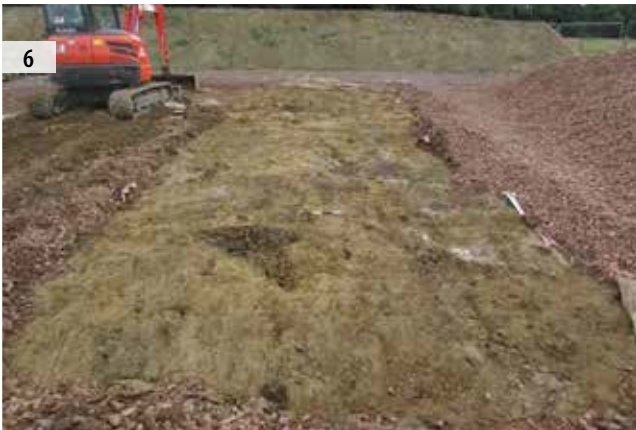
ILLUS 6 Record shot of TR002a, looking S **ILLUS 7** Record shot of TR002b, looking N
ILLUS 8 General shot of Road Trench
ILLUS 9 West facing section in Road Trench, showing rubble field drain
ILLUS 10 General shot of Water Main Trench

beneath and consisted of mottled orange-brown and grey silty clays with large sand stone inclusions (Illus 6 and 7).

Two modern field drains were observed running or north-west to south-east alignments. Both appeared to be of a rubble construction and matched the alignment observed in Trench 001.

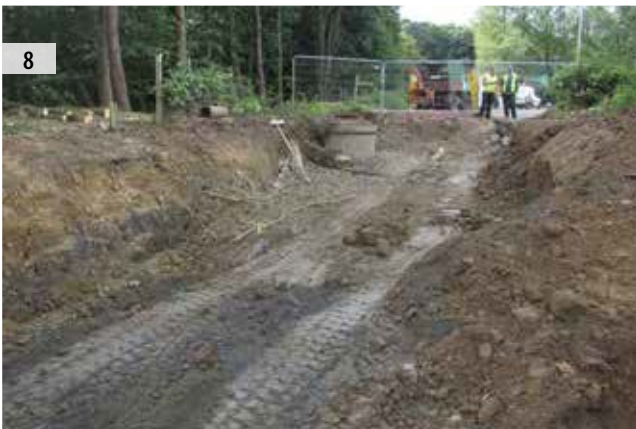
An area measuring approximately 10.00m x 4.00m was excavated to the north of the existing car-park for the purpose of linking up a new access road to the maintenance shed (Illus 08). This was excavated to a maximum depth of 1.00m. A mid-brown-grey loam topsoil up to 0.40m thick was observed overlying a mid-orange-brown sandy silt subsoil up to 0.30m thick. Geological deposits consisting of light-orange brown sandy silts with large sand-stone inclusions were observed at a depth of 0.70m. The southern end of the trench extended into the area of the existing car-park and was heavily disturbed by modern made ground. A modern drain and manhole were observed cutting across the trench on an east to west alignment. At the northern end of the trench a rubble field drain 0.20m wide and 0.40m deep was observed in the west-facing section (Illus 9).

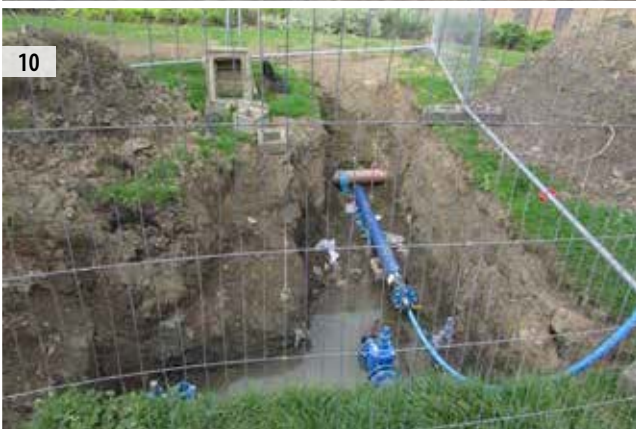
A small trench was also excavated to the north-west of the car-park to expose an existing water main (Illus 10). Turf and loam topsoil up to 0.20m thick was observed over a deposit of modern made ground up to 0.60m thick. This consisted of a mid-brown-grey sandy loam with angular stones and modern refuse inclusions.
