# A78, MAIN STREET, LARGS, NORTH AYRSHIRE

## ARCHAEOLOGICAL WATCHING BRIEF

commissioned by Scotland TranServ

January 2017

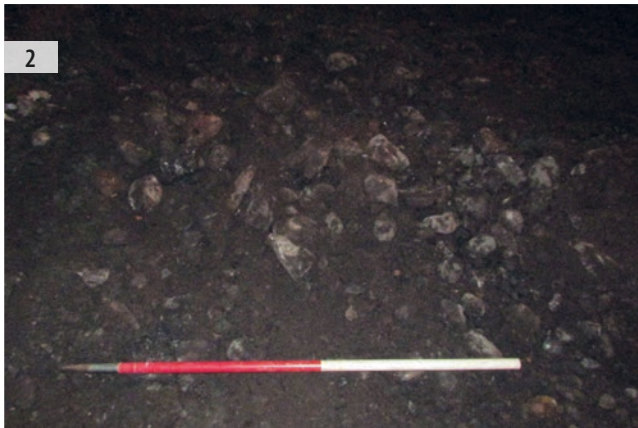
**ILLUS 2** SE facing view of disturbed cobbles (1005)    **ILLUS 3** NE facing section in deepened area of sub-base (1002) showing leveling layer below cobbled surface (1005)    **ILLUS 4** N facing view of flat ring of stones (1004) as possible foundation for market cross    **ILLUS 5** NE to SW running kerb or gutter (1007) of previous road layout    **ILLUS 6** North facing view of lime deposit (1003)

Patches of a possible cobbled surface (1005) were present across the extent of the site, but were mainly concentrated in the area of the roundabout. These measured approximately 1m<sup>2</sup> and were visible in areas where sub base had been removed or scraped away.

The cobbles were relatively small at approximately 50mm by 50mm and were roughly square in shape (Illus 2). In the areas where the excavation had deepened through the sub base, a levelling layer of silty sand (1009) was identified underlying the cobbles (Illus 3). The cobbles did not appear to be in situ and would have provided a relatively rudimentary surface when in use.
