# FORMER ODEON CINEMA, EDINBURGH

*Historic Building Recording*

*for G1 Group*

*October 2016*

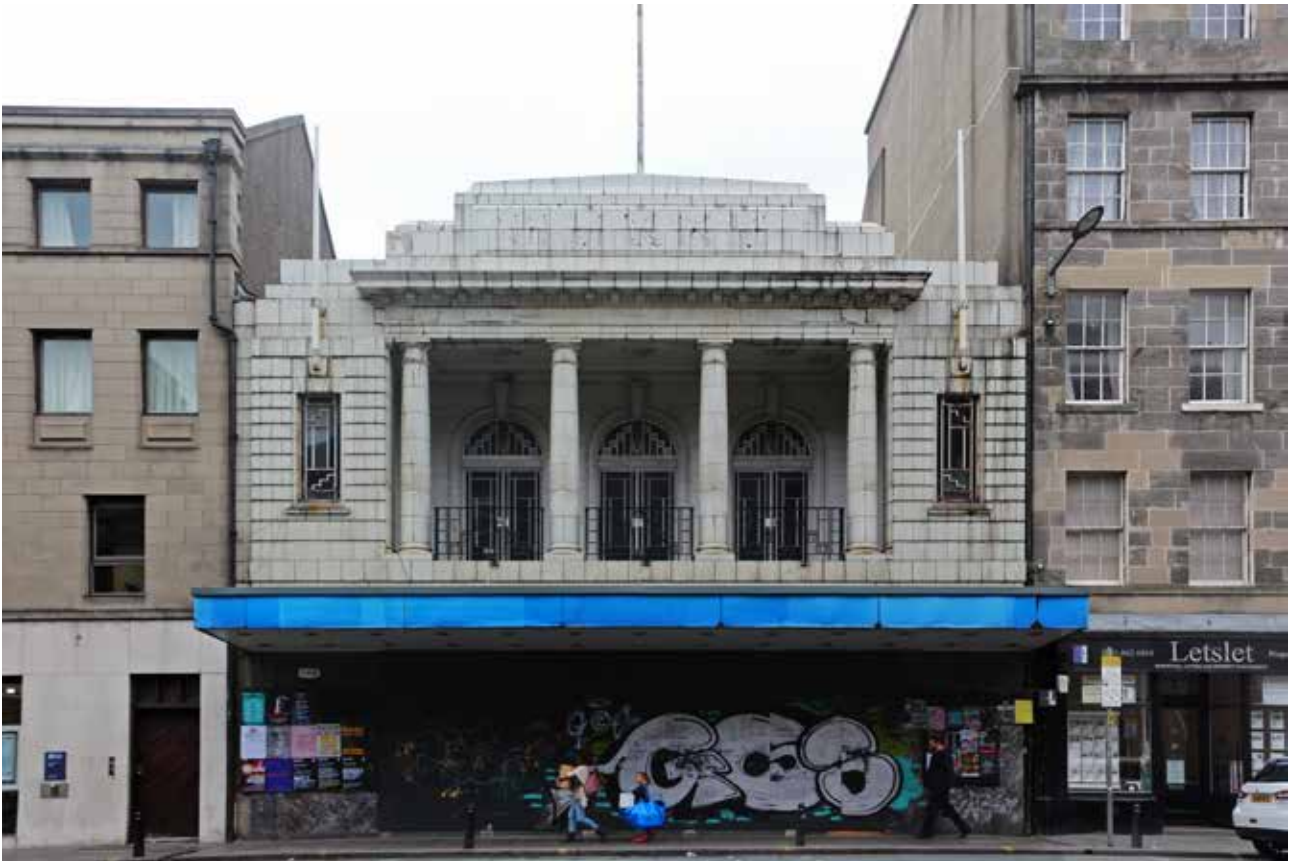
**ILLUS 2** Clerk Street façade, facing south-west. Some of the original lettering for the 'New Victoria' cinema is visible on the signage zone at the top of the elevation

Most of the exterior of the building is largely functional and unadorned, and indeed is only easily visible from the rear windows of the surrounding tenements. The notable exception to this is the two-storey Clerk Street façade (Illus 2). The choice of white Hathernware faience as cladding for this elevation was not unusual for this period. It appeared clean, was easy to install and cheaper than stone.

The central feature is a neat classical loggia, forming the first floor balcony. Four columns support a projecting cornice, above which the outline of the signage for 'New Victoria' are still visible. The loggia is flanked by narrow windows with art deco details, and two flagpoles. A central flagpole above has been a later addition.

The lower half of the elevation is obscured by 1950s dark red marble cladding at the sides, hoarding in front of the doors and an aluminium canopy. These will all be removed and restored to original – exposing the white faience, installing new replica doors with period geometric patterning and restoring the original canopy with 'readograph' show display board.

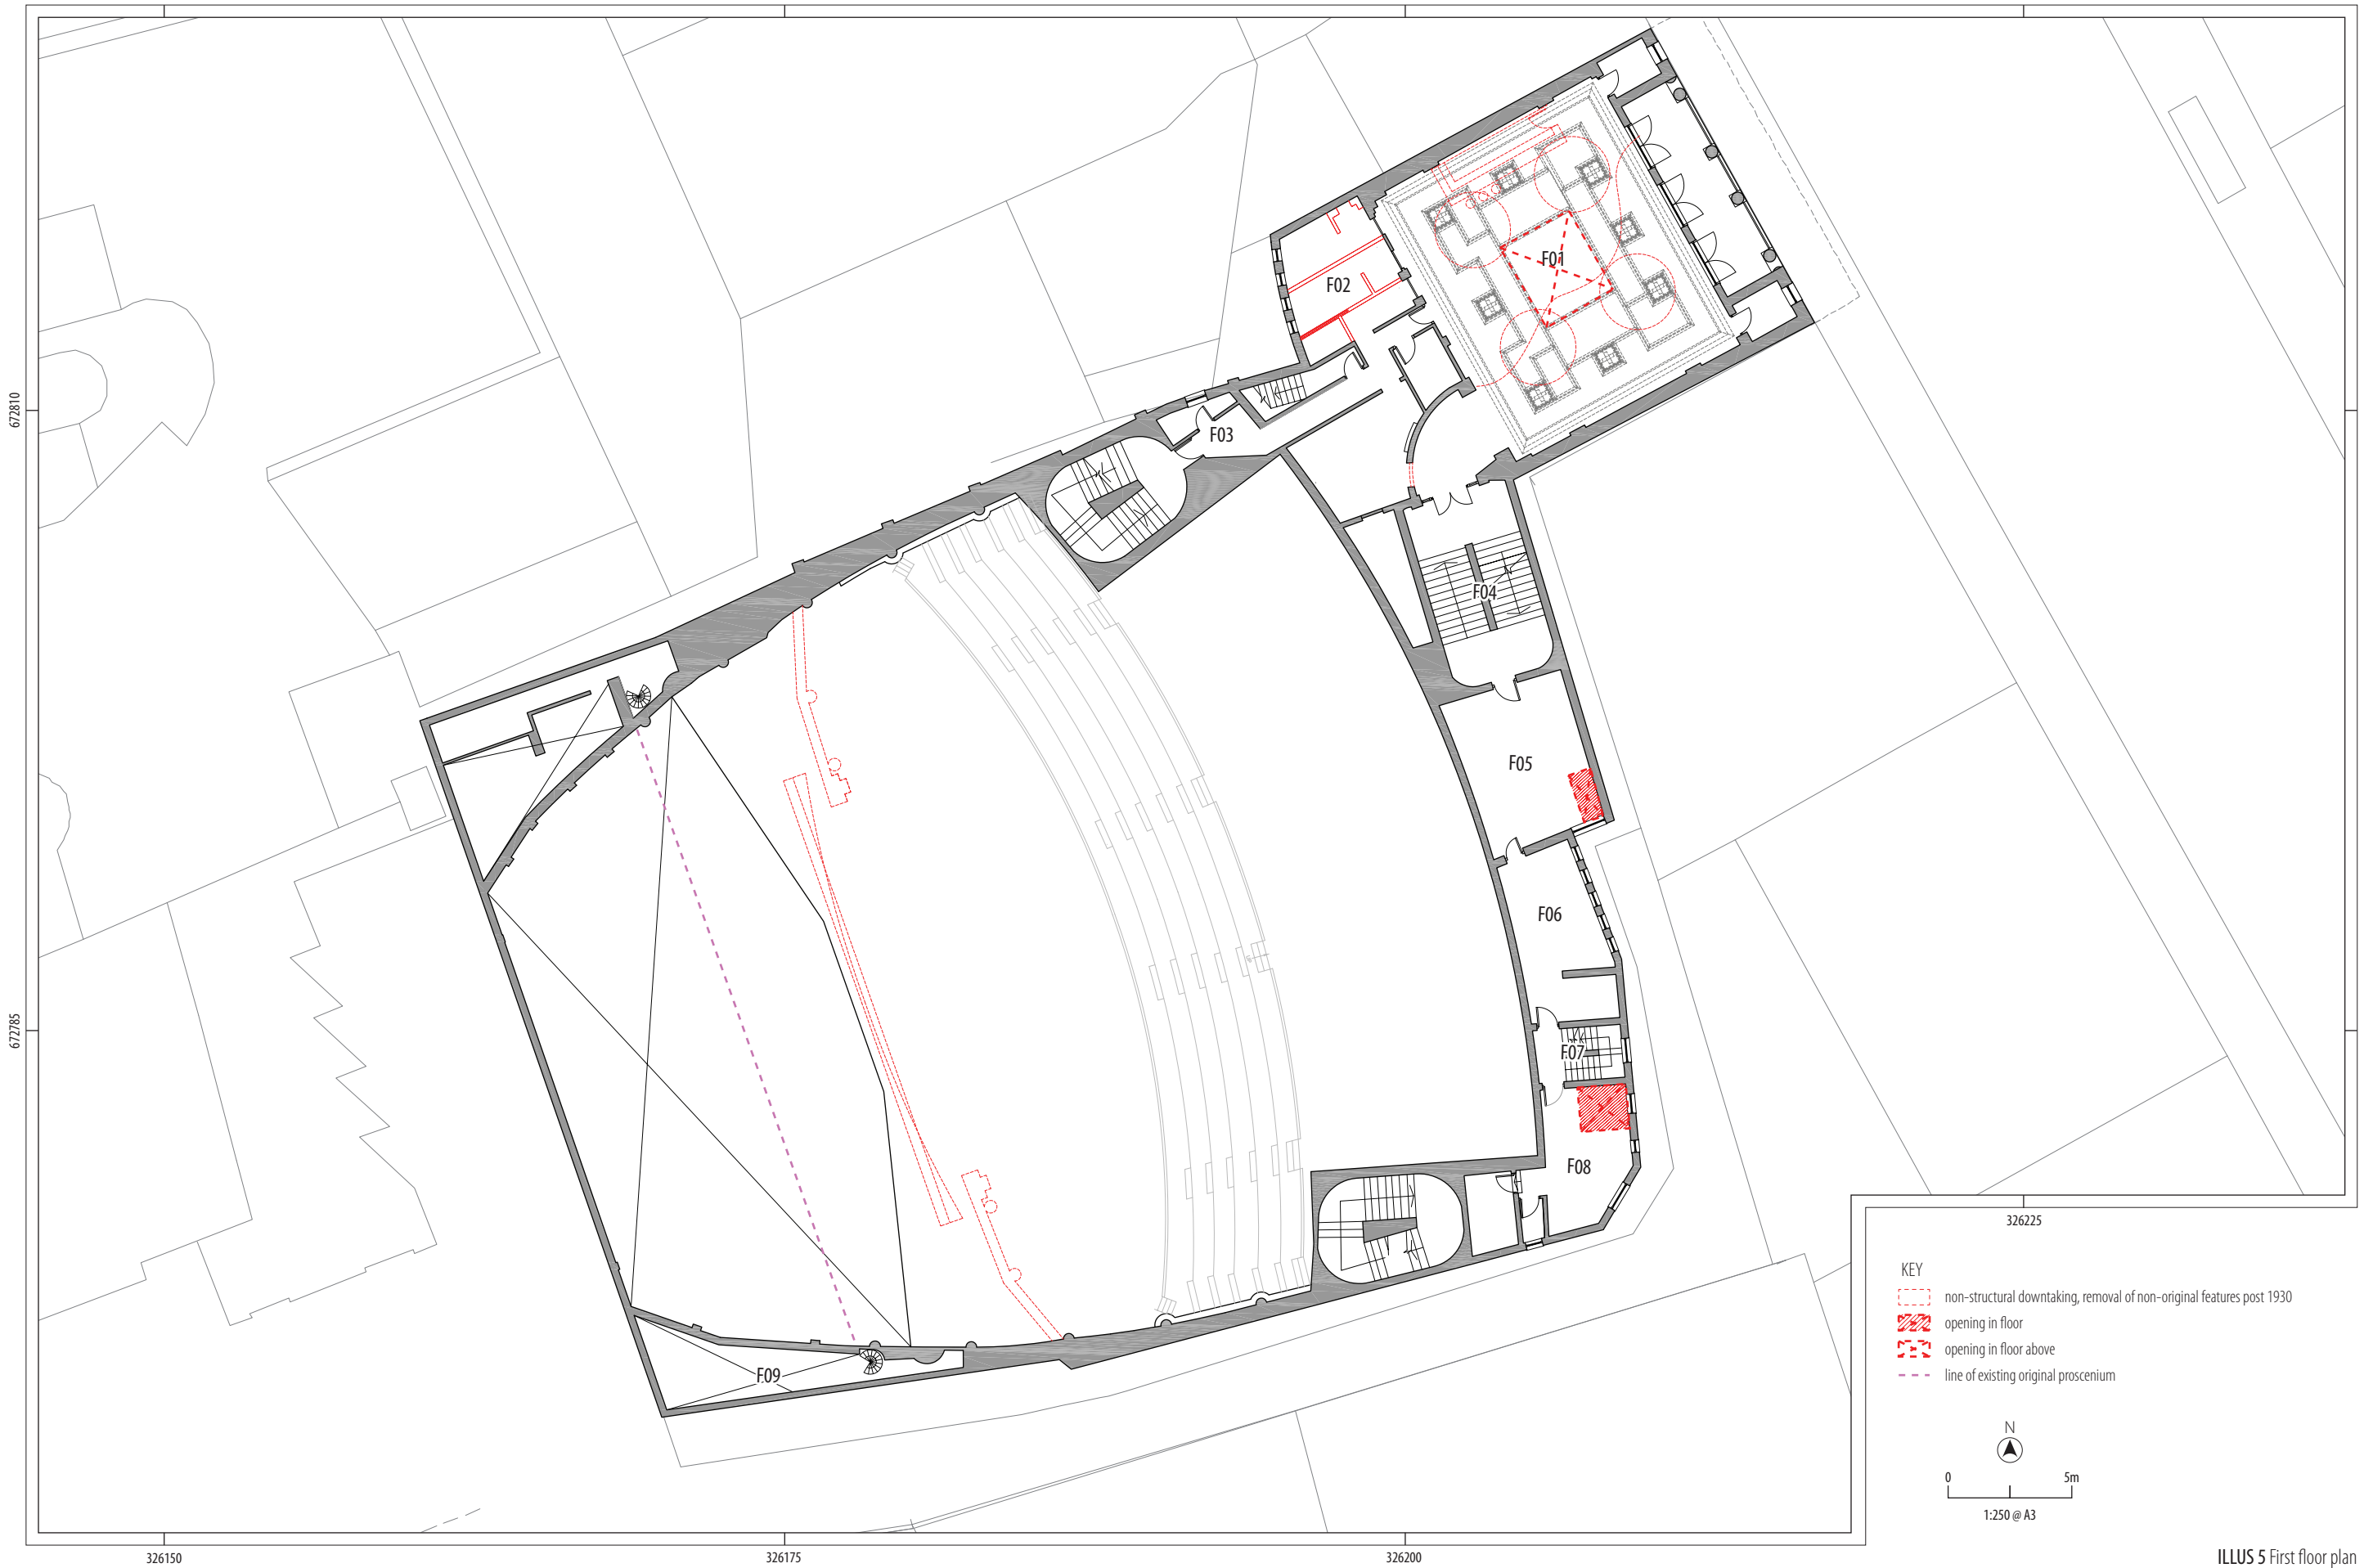
ILLUS 5 First floor plan

The first floor (Illus 5) broadly matches the footprint of the ground floor, albeit without the northern corridor (G09). The space above the foyer (G01) is occupied by a former café (F01) and associated toilets (F02). The level of this northern part of the first floor is around half a storey above the southern part, to allow additional height in the foyer (G01) below. This is most clearly evident in the north-east circulation, where an extra flight of steps takes the visitor from store (F05) up to the café (F01). The crush hall (F02) is also afforded extra ceiling height by its position under the higher section of the raked circle seating – the seats at this level are shown on the second-floor plan (Illus 6) and the circle seating generally is described as S07 below. Several stores were located east of the main auditorium (F05-08).

Since the cinema was divided into several smaller screens in the 1980s, the first floor level has been extended across the auditorium from the balcony forwards. This floor had been removed by the time of the survey, exposing the full scale of the original auditorium (Illus 9). This will only be a temporary situation, as this floor level will be reinstated during the present redevelopment work. The new upper screen will be positioned further back than the old one so more of the original decoration and the proscenium will be visible.

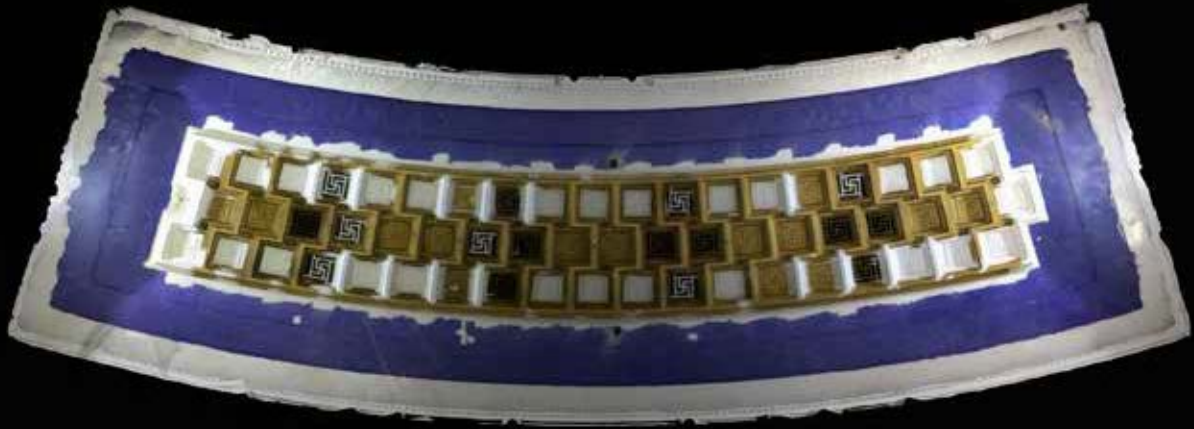
**ILLUS 8** Ortho-image of crush hall ceiling, clearly showing restored plasterwork in white. This gives a great idea of the scale of the space in the original cinema

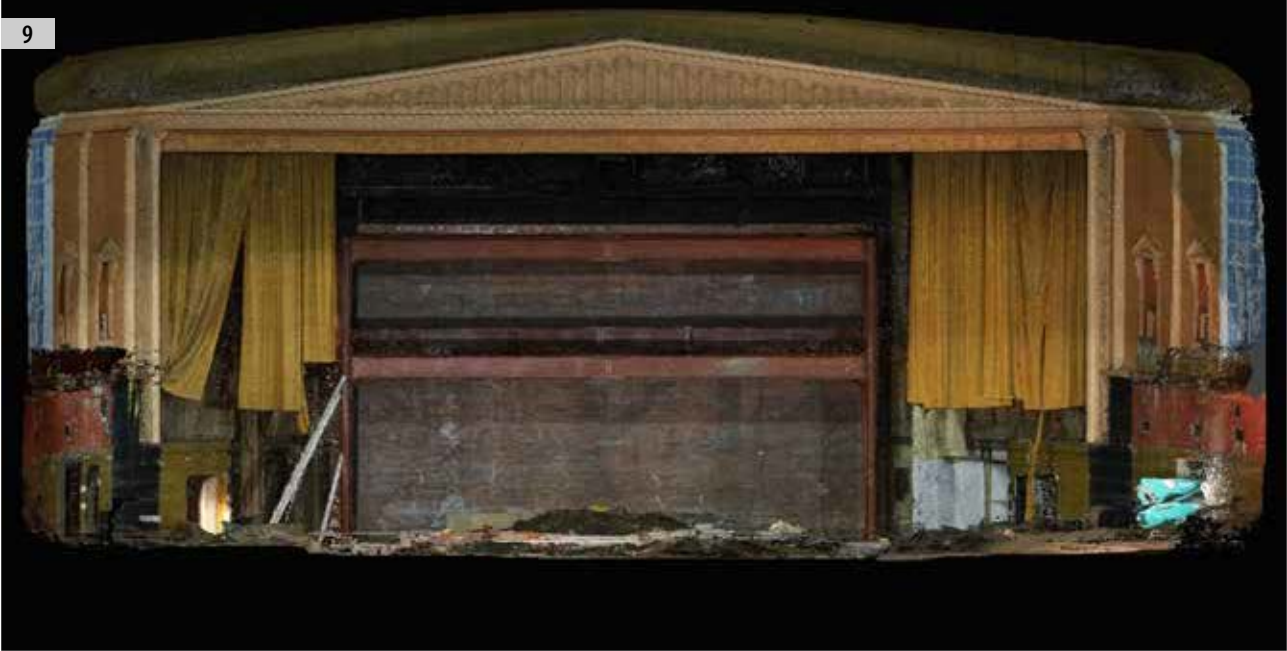
**ILLUS 9** View of photogrammetric 3D model of west elevation of auditorium.
