SHRUB HILL TRANSPORT DEPOT, EDINBURGH

Report on watching brief

for Places for People

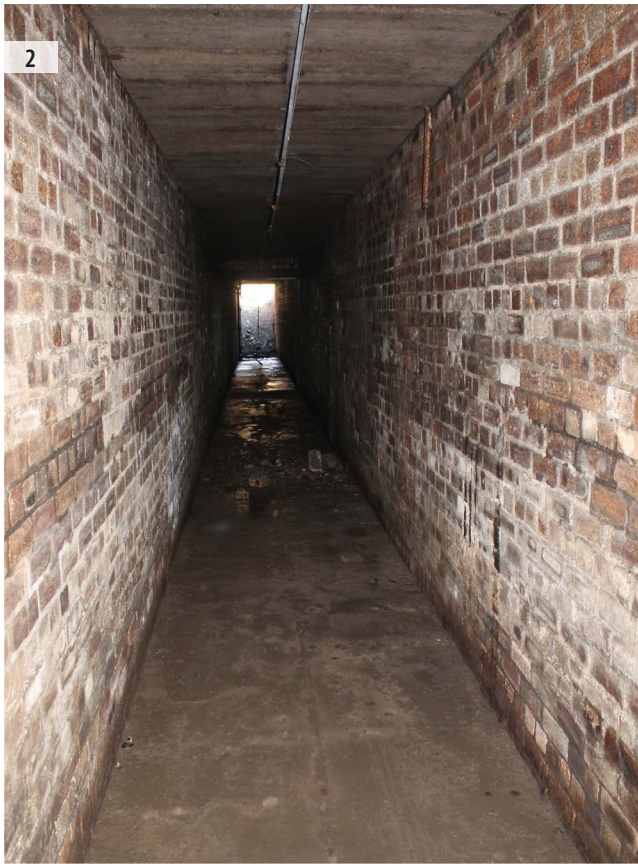
The 2015 watching brief monitored the excavations along the west end of the tunnel extending some 87m east from the power plant. This section of the tunnel was 1.56m wide and 2.9m high. The sides of the tunnel were built from bricks and it had a flat concrete roof (Illus 2).

ILLUS 2 W end of tunnel with flat concrete roof, facing NW

There was clear indication of this at the west end where the tunnel had a flat concrete roof that was clearly not part of the original feature.

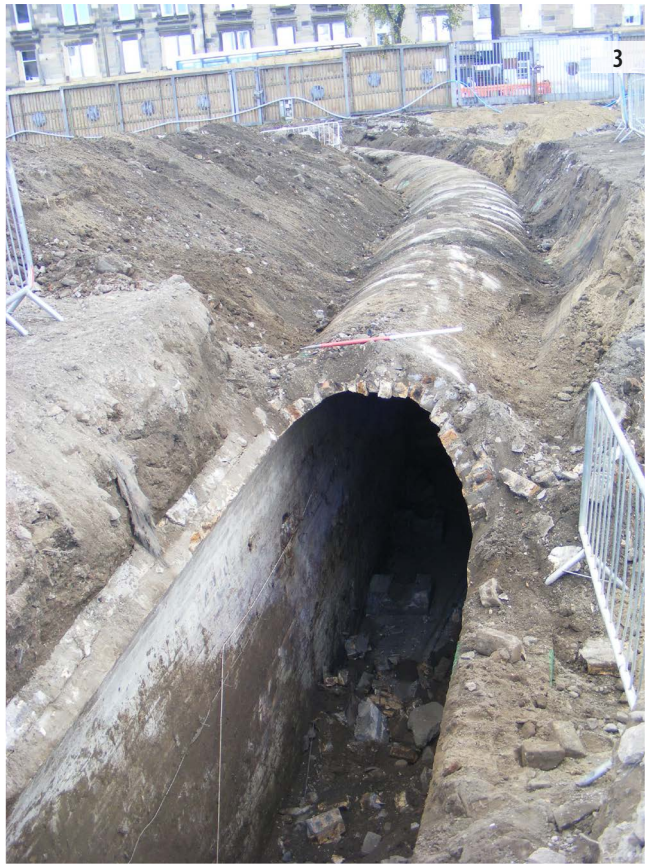
The east segment of the tunnel was also built from bricks. It was 1.56m wide at the west end and had a

brick-built vaulted roof making it some 3.6m high (Illus 3). It had a slight but clear bend in the alignment at the east end of the site (Illus 1, 3).

ILLUS 3 N segment of tunnel, facing ESE

In contrast the vaulted roof at the east end was built using similar bricks as in the walls and appeared at first to be part of the original design. However the partition walls and the blockage wall at the east end, built using similar bricks, indicated that the tunnel had been vaulted over at a later stage.

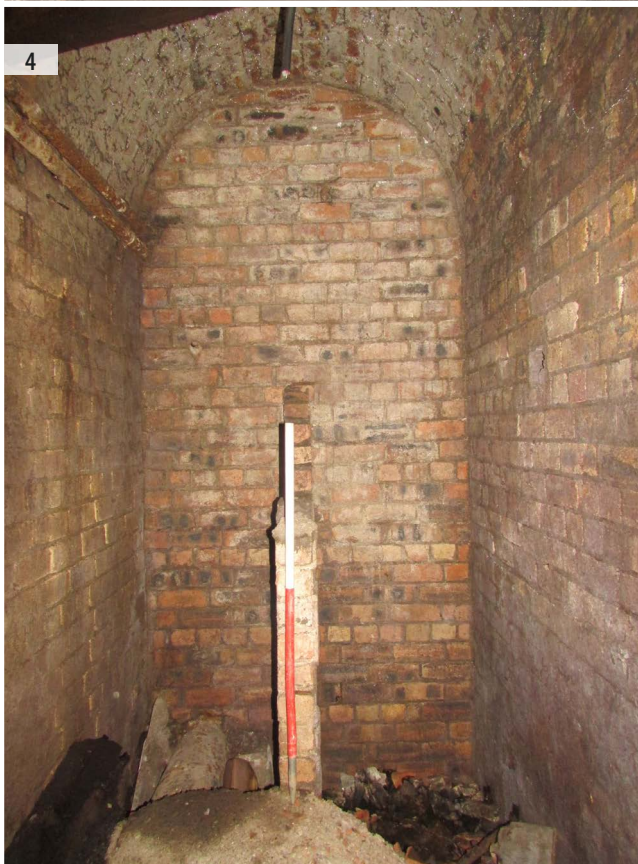
Most significantly, the tunnel was fully blocked by a brick wall located under the pavement of Leith Walk. A one brick wide wall was built up against the middle of the blocking wall. It was 1.85m high and extended 1.05m out from the wall (Illus 4).

ILLUS 4 Brick wall blocking tunnel at E end, facing SE

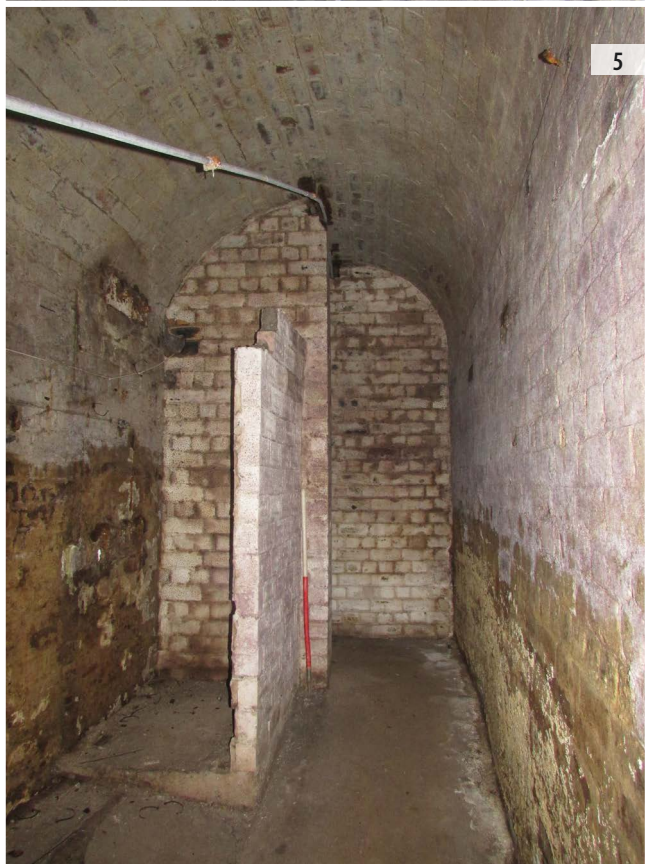
Located at the crown of the bend were two partition walls set 1m apart and extending over half way across the tunnel from opposite sides. Out from the end of these were single brick walls ranging 1m along the middle of the tunnel in opposite directions (Illus 5). The two partition walls were not keyed into the sides of the tunnel and must have been inserted at a later stage.

ILLUS 5 View towards partition walls near the middle of the tunnel, facing SE

The half partition wall within the tunnel suggests that could have been converted to be used as a bomb-shelter during the Second World War. The overlapping half walls recorded within the tunnel would deflect the force of a blast should a bomb penetrate either end of the tunnel.

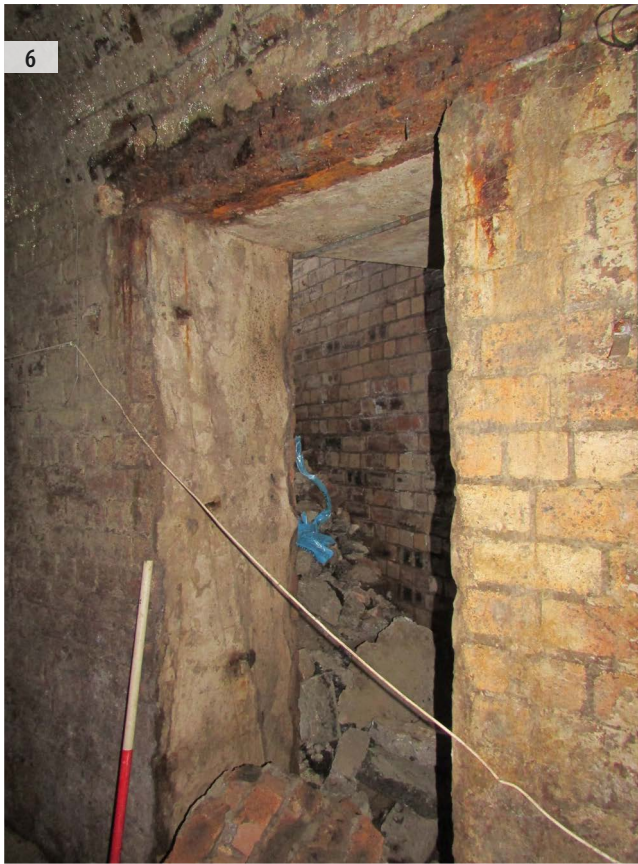
Some 5m to the east of the partition walls was a side access to the tunnel. It had a full sized door opening in the north wall leading into a short passage up towards the north-west out from the tunnel (Illus 6).

ILLUS 6 View into side entrance on the N side of the tunnel, facing NW **ILLUS 7** Iron lungs leading into square shaft providing access into the tunnel, facing SE **ILLUS 8** Graffiti revealed behind the partition wall against the north side of the tunnel, facing NNE **ILLUS 9** Wall anchors along the N wall, facing ESE

A small booklet titled 'A Guide to Edinburgh Air Raid Shelters' have been reproduced on the EdinPhoto web site. The booklet shows the location of the air raid shelters in Edinburgh including a shelter on the north-west side of Leith Walk within the area of the Shrubhill Tramway Depot. An arrow indicate the entrance on the north-east side corresponding to the one recorded during the watching brief.

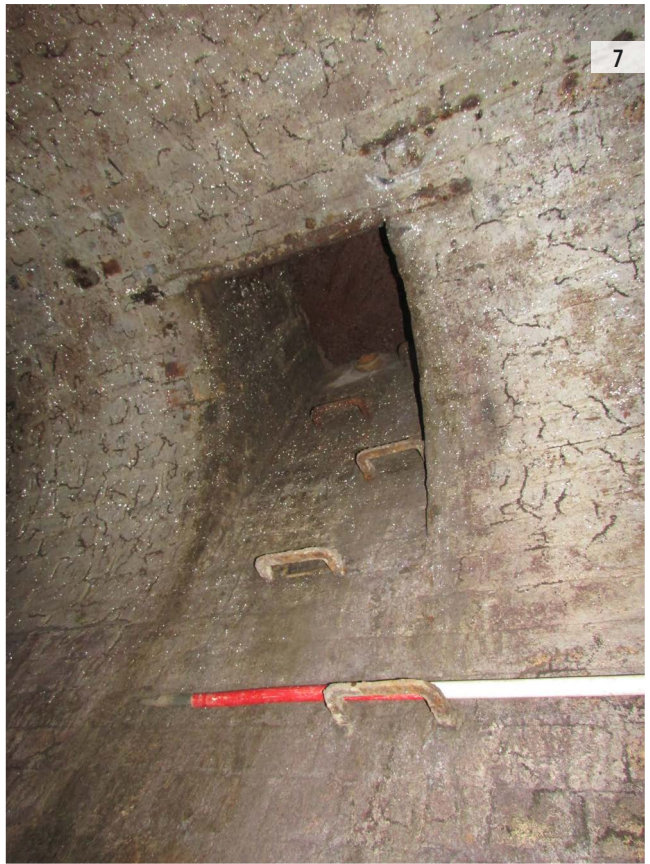
In the south wall towards the east end of the tunnel were a series of iron rungs providing access into a square man-hole built into the roof of the tunnel (Illus 7). The top of the opening was situated beneath the pavement and was not exposed.

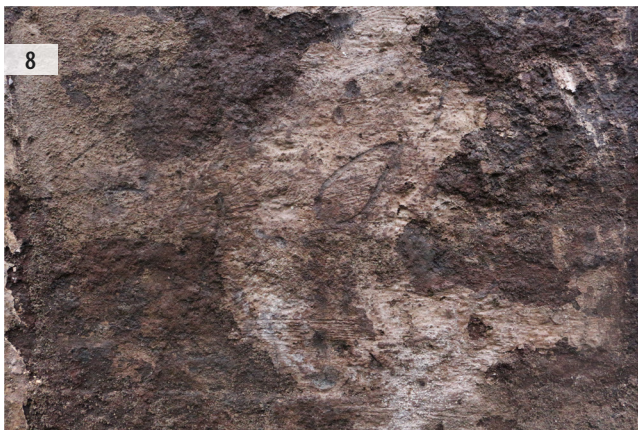
During the demolition it became clear that the partition walls were not fully keyed into the tunnel walls. A piece of graffiti was exposed cut into the whitewash of the tunnel wall that had been obscured by the partition wall against the north side of the tunnel (Illus 8).

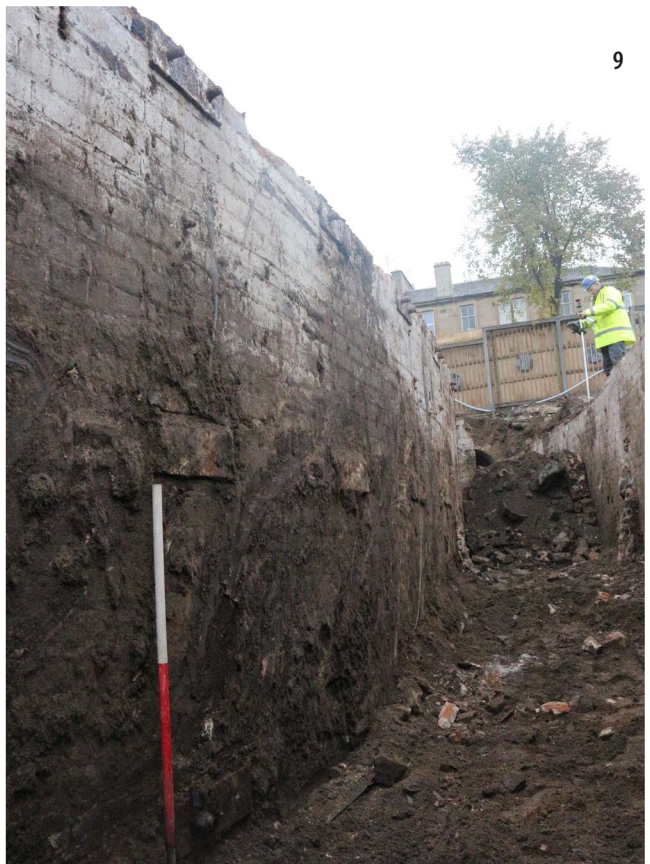
A series of wall anchors were located along the north wall of the tunnel. They were set in three tiers; at the top, in the middle and at the base of the wall. The comprised rectangular iron plates with two anchoring bolts (Illus 9).

Another indication that the structure originally had not been vaulted, was the wall anchors situated along the north wall to prevent the wall being pushed into the cavity of the tunnel. Such measures would be less important if the gap at the top was covered by a vault.
