LAND 50 METRES EAST OF 20 NEWHAVEN PLACE, EDINBURGH

ARCHAEOLOGICAL EVALUATION

15/02317/AMC

March 2017

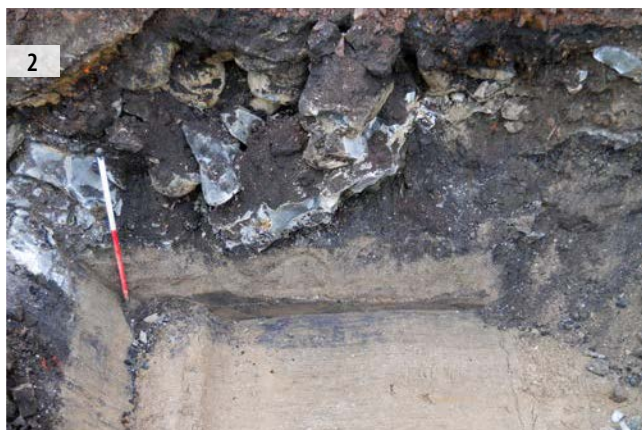
ILLUS 2 West facing section Trench 1, southern end showing boulders over marine sands material over sands **ILLUS 3** North east facing section Trench 2 showing loose made ground material over sands **ILLUS 4** SW facing section Trench 3 showing modern made ground layers

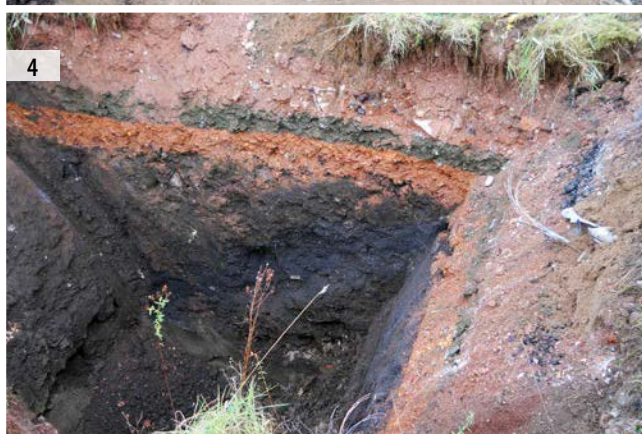
The made ground was also disturbed by concrete foundations and modern utility trenches in trenches Trench 2 (Illus 3), Trench 3 (Illus 4) and Trench 6 (Illus 7).

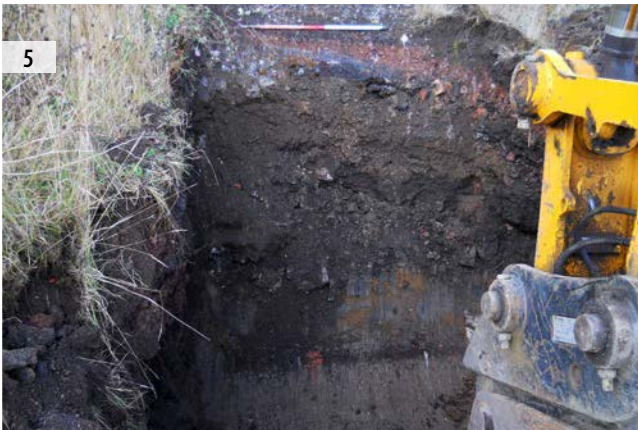
ILLUS 5 South east facing section Trench 4 **ILLUS 6** South east facing section Trench 5 **ILLUS 7** South west facing section Trench 6
