RAIT PARISH CHURCH, PERTH & KINROSS

*Archaeological Watching Brief
for Tay Landscape Partnership*

March 2017

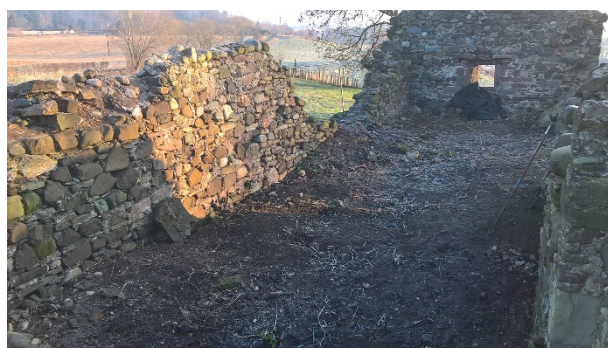
Illus 3 - Pre-excavation shot of the internal area of the church facing east

The work was undertaken on 23th January 2017 in clear and dry conditions. The groundworks required in order to level the ground surface within the church were undertaken by hand. Prior to the work commencing all trees and ivy had been removed from the walls and floor surface. The present ground surface was uneven comprising a mix of dark brown stone-rich silty sand and larger sub-rounded stones. Three areas in particular formed large mounds of earth and stone abutting the inner sides of the church walls. The two largest of these were located against the south-east corner and the eastern side of the north wall. A third mound was found in the south-west corner of the church (Illus 3).

The mounds were reduced by hand with all the larger stones being removed and the smaller stones and earth spread over lower areas of the existing surface. Material within the two larger mounds included a moderate assemblage of 19th/20th century pottery and glass fragments (this was left on site). A small number of disarticulated bones were also recovered from this material (collected).

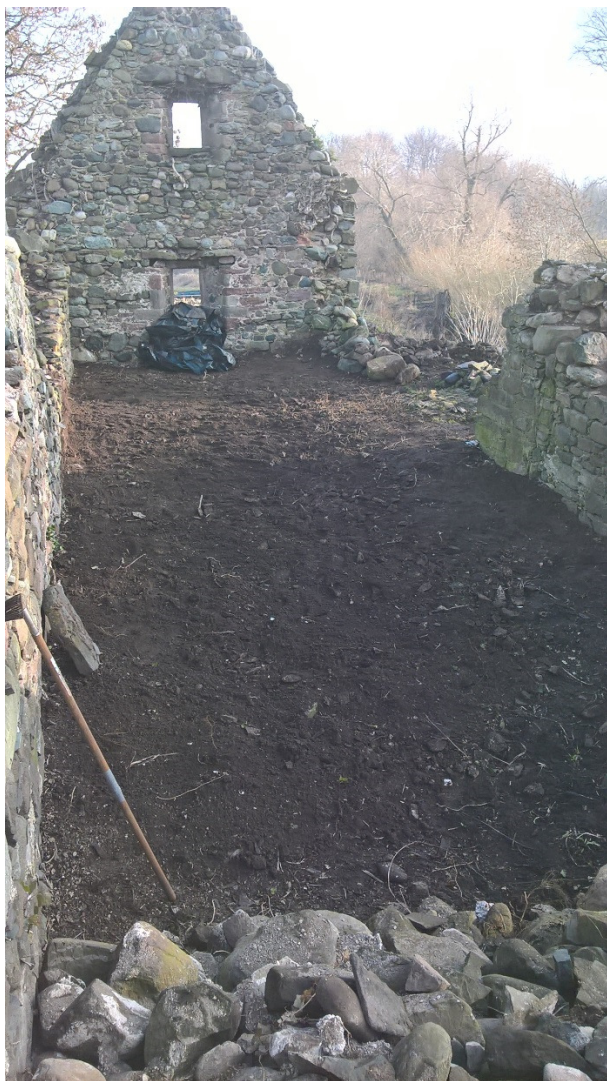
Illus 4 – Post-excavation shot of the church floor facing east.

No features or structures of archaeological significance were exposed during this work and no artefacts relating to the early history of the chapel were identified. In general the existing ground level was left undisturbed (Illus 4).
