# 60 PLEASANCE AND QUAKER BUILDING EDINBURGH

ARCHAEOLOGICAL WATCHING BRIEF

commissioned by University of Edinburgh

April 2017

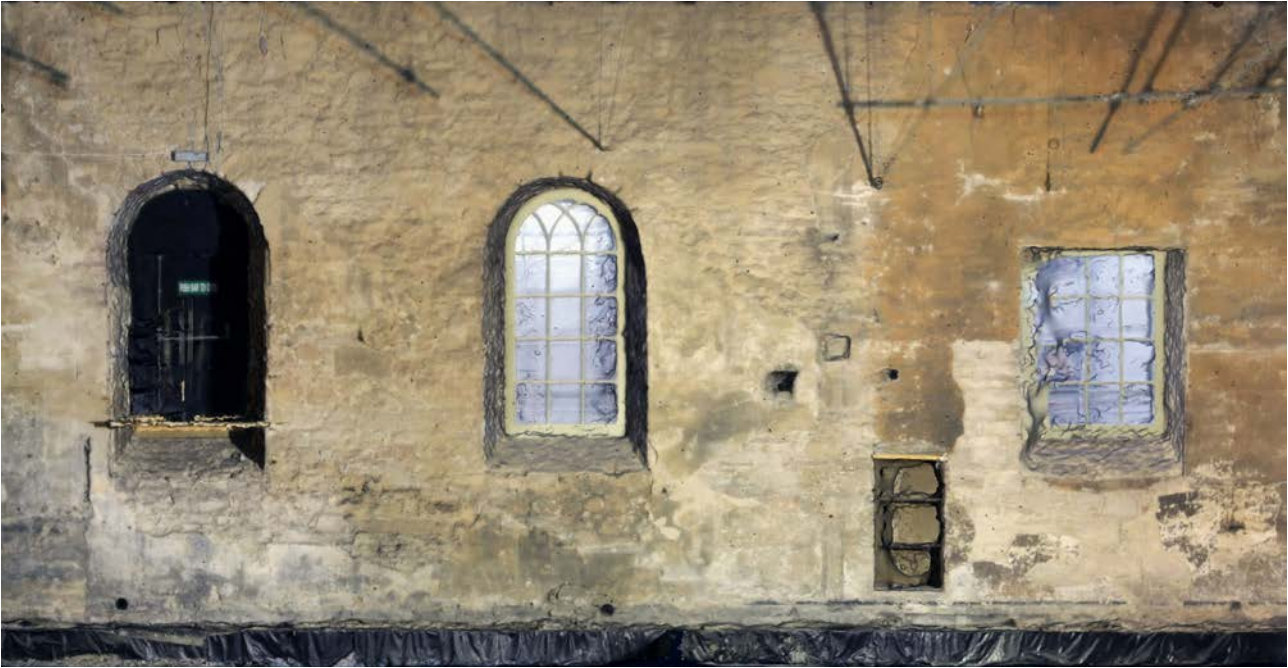
ILLUS 3 Quaker Meeting House – East elevation interior showing arched windows with blocked arch at south

Photographic survey was undertaken following the removal of a wooden or plywood floors. The structure consisted of a rectangular stone brick building with a roughcast exterior and plain interior room. The original layout of the structure appeared to have been a single large room, with 3 pairs of arched windows on the eastern and western elevations. A fireplace was located centrally on the southern wall, a small cupboard or niche on the eastern wall and the original entrance door in the western wall. Large fragments of render survived on the walls, although it is unclear if this was original or not.

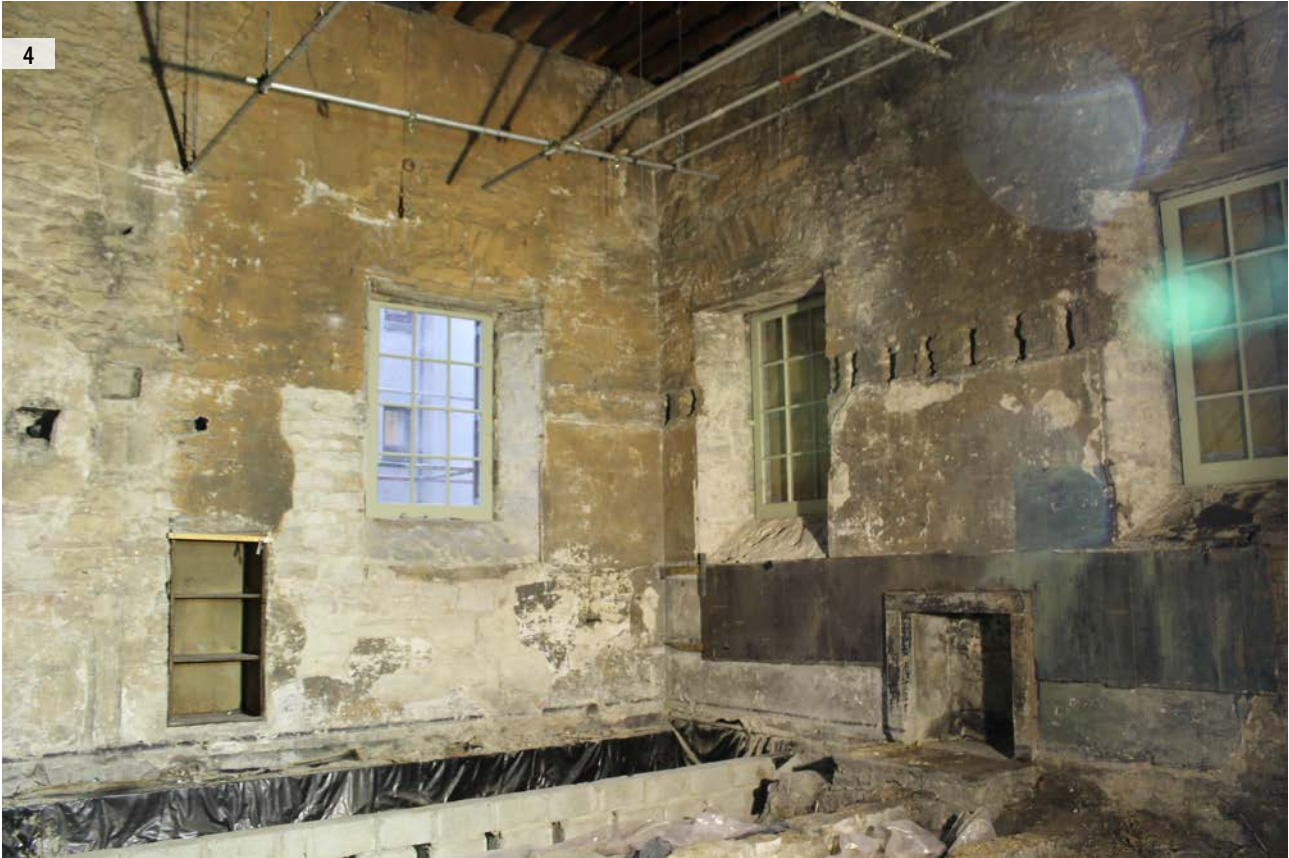
**ILLUS 4** Quaker Meeting House – Detail of blocked arch at south of east elevation (interior) **ILLUS 5** 60 Pleasance – View of lift shaft excavations from south

Extensive later alterations were evident; the arched tops of the southernmost window in the eastern wall and the two windows in

the southern wall, had been squared off, also with roughcast stone. A line of holes for a raised floor level could be seen cutting halfway across the windows, particularly in the southern half of the structure, possible the result of a later addition of a partial mezzanine floor. The southern window on the western wall had been bricked up at some stage, and two additional doors had been punched through the southern wall, one of which had then also been bricked up.

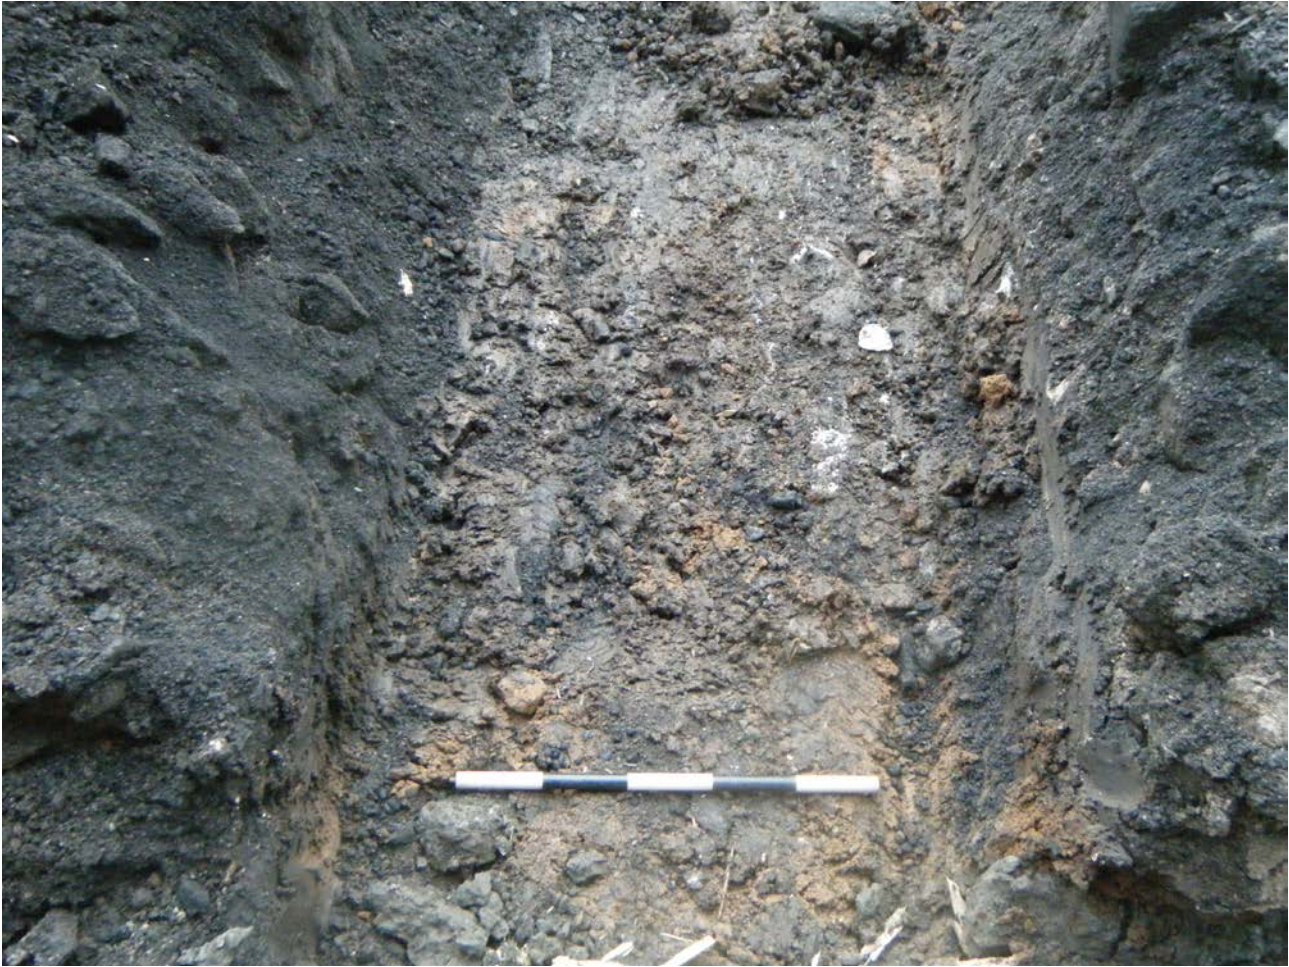
ILLUS 8 Theatre Building Access – Pre-ex shot of linear feature [1008], looking north

A small section of linear feature [1008] was located 4.9m east of the western limit of excavation and 0.9m north of the southern limit of excavation, running roughly east-west. It measured 0.83m wide, 0.35m deep with relatively steeply sloping sides and a curved base. It was visible for 0.74m, with the feature extending into unexcavated ground to the east and west. It was cut into the geological subsoil (1010) and was filled by a midden deposit (1009), containing bone, oyster shell and pottery fragments which consisted of a strap handle and body sherd of a post-medieval reduced ware dating to the 16th Century (Julie Franklin, pers comm).
