UNION CANAL BOROUGHMUIR, EDINBURGH

ARCHAEOLOGICAL WATCHING BRIEF

commissioned by Mackenzie Construction Ltd

February 2017

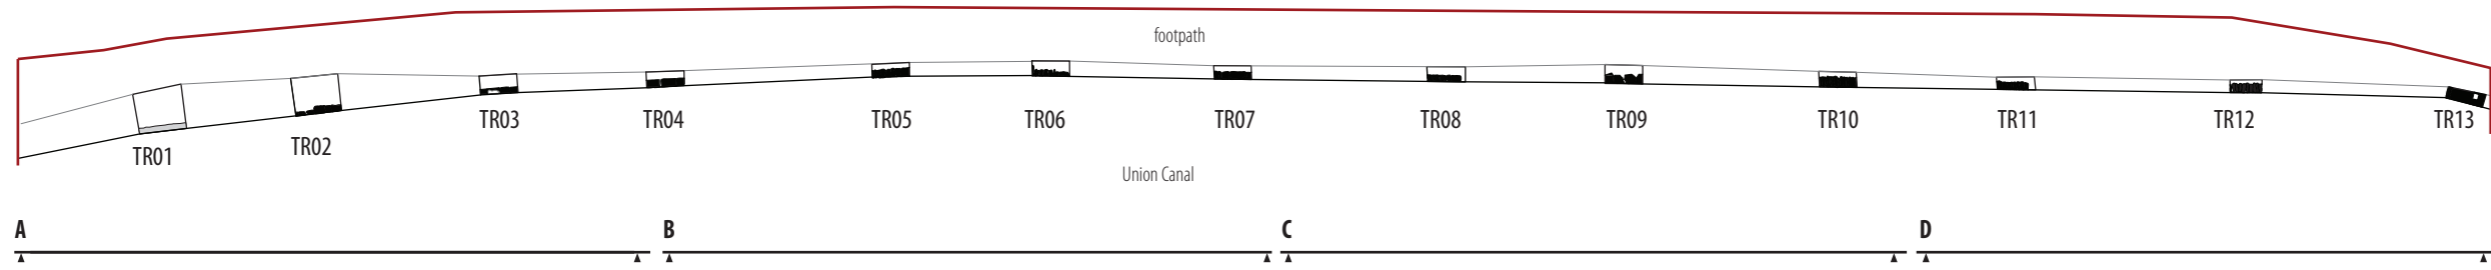
ILLUS 2 SE facing elevation of Union Canal wall

The archaeological monitoring of the vegetation removal was carried out on 14th February 2017 and was carried out from the canal to obtain an extensive photographic record to be used as data for the production of an elevation out of a photogrammetrical process. However, as the access was by boat and being this pulled from the footpath, the lack of stability made the photographs not suitable for a complete photogrammetry of the stretch as a whole. Different sections of the exposed wall were created serving as base for the production of an elevation (Illus 2)

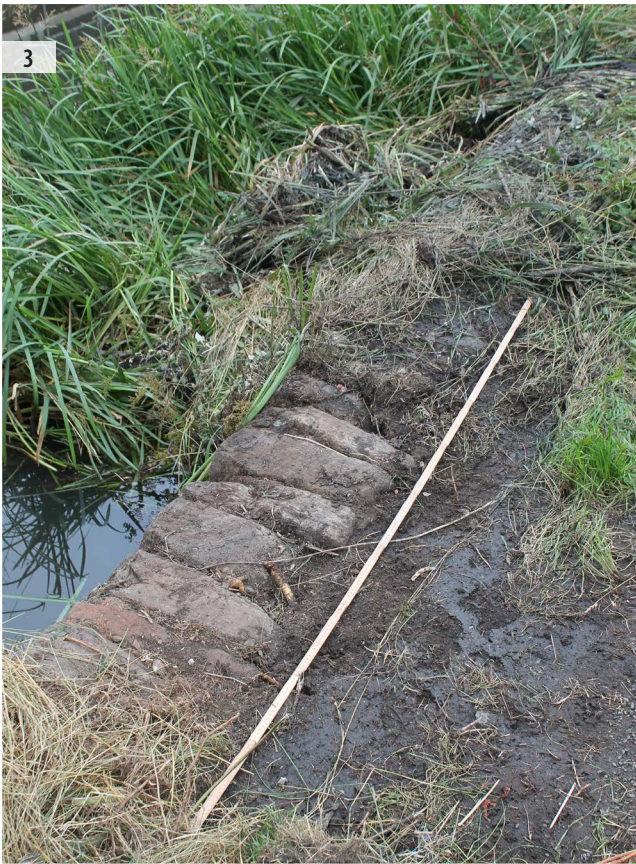
The 13 trenches monitored along the wall were approximately 2.00 x 2.00m each and just enough depth to expose the stone work of the canal wall removing around 0.10m of topsoil and vegetation [001] (Illus 3).

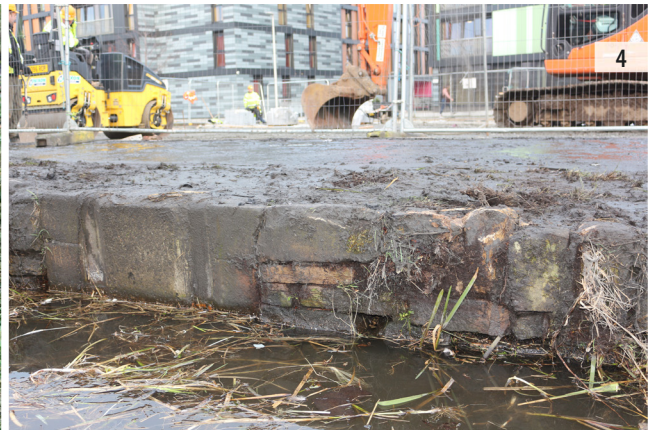
Although the wall seemed to be constructed following the same pattern of coursed rubble masonry. The wall head showed several differences in the way the stone blocks are arranged and some modern addenda. The latter consisted primarily of concrete poured on to consolidate the most worn out areas [002] and modern bricks to fill the gaps in the fabric [015] (Illus 4).

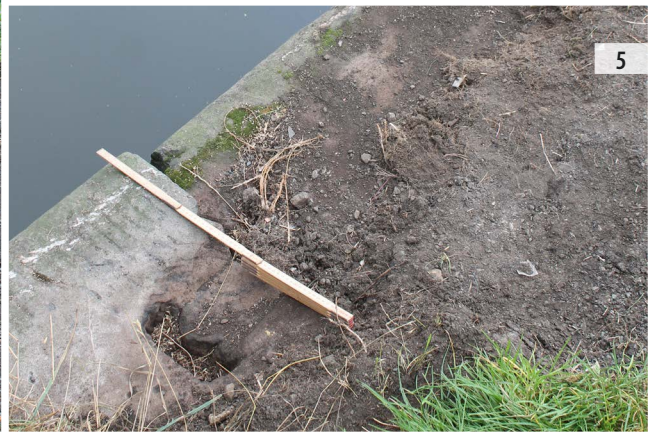
At the area closer to the Viewforth Masonry Arch Bridge the fabric is made of more rectangular sandstone blocks [014] with average dimensions of 0.80 x 0.40 x 0.40m (Illus 5).

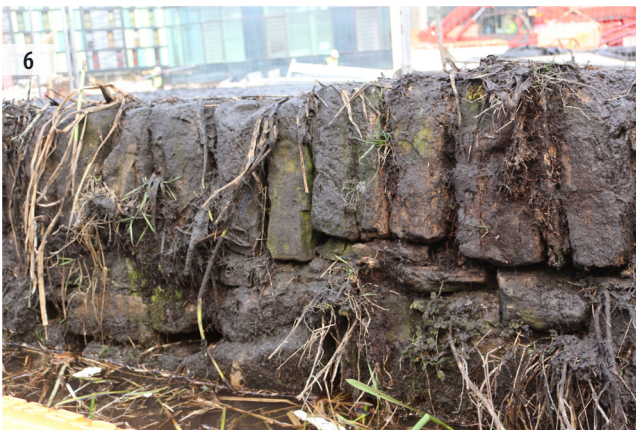
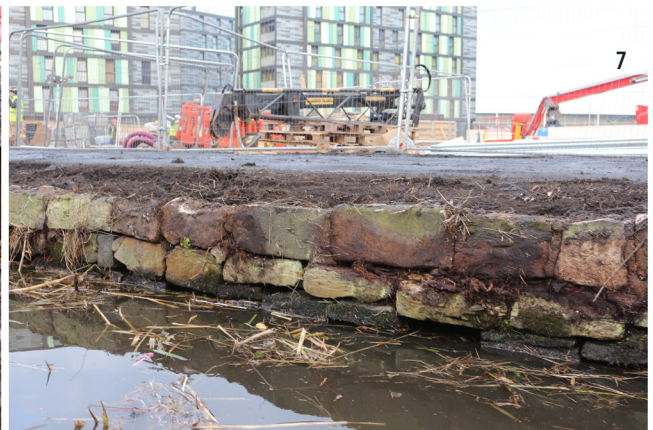
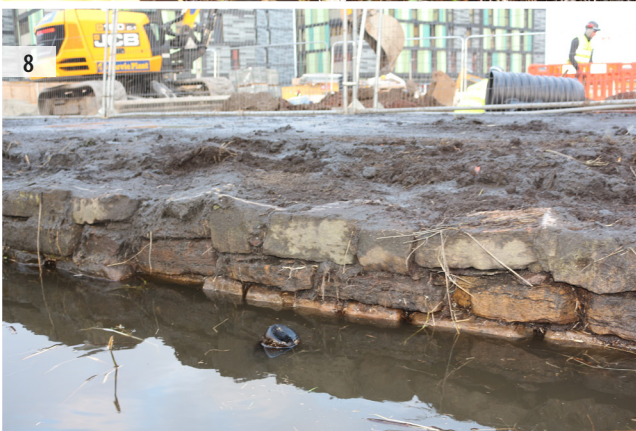
The rest of the wall head presents a disparity of rough shaped stone blocks with sizes ranging from 0.08 x 0.30 x 0.30m to 0.30 x 0.25 x 0.30m. The layout of blocks varied with stretches of irregular blocks alternating with more regularly shaped stone blocks (tending to the rectangular) sitting on headers (Illus 6) and well coursed on stretchers (Illus 7). It is in this area of the wall where the topsoil reaches the maximum thickness over the fabric as the wall head has been lost almost entirely.

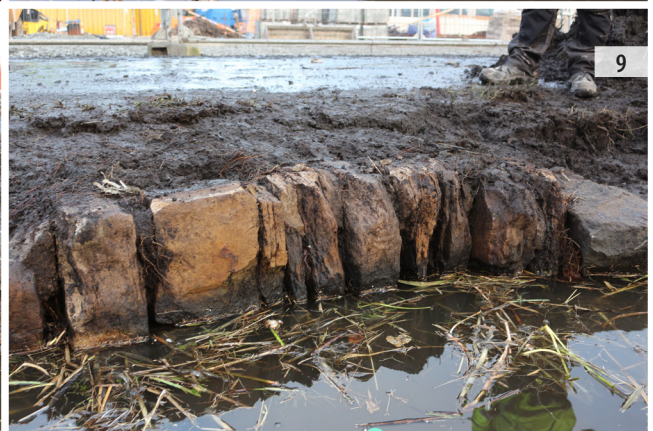
The wall head varies in height possibly due to the loss of stone blocks in several areas of the stretch and the degree of deterioration suffered by the fabric (Illus 9).

The wall head has been affected by the roots of vegetation. Vegetation which may have helped stabilised looser stone blocks whilst being covered by these plants and the top soil. In some parts of the monitored stretch the wall head seems to have lost sandstone blocks which has led to variations in the height of the wall along its exposed length.
