ALDI, KIRK STREET, PETERHEAD, ABERDEENSHIRE

HISTORIC BUILDING RECORDING (LEVEL 1)

commissioned by ALDI Stores Ltd

August 2017

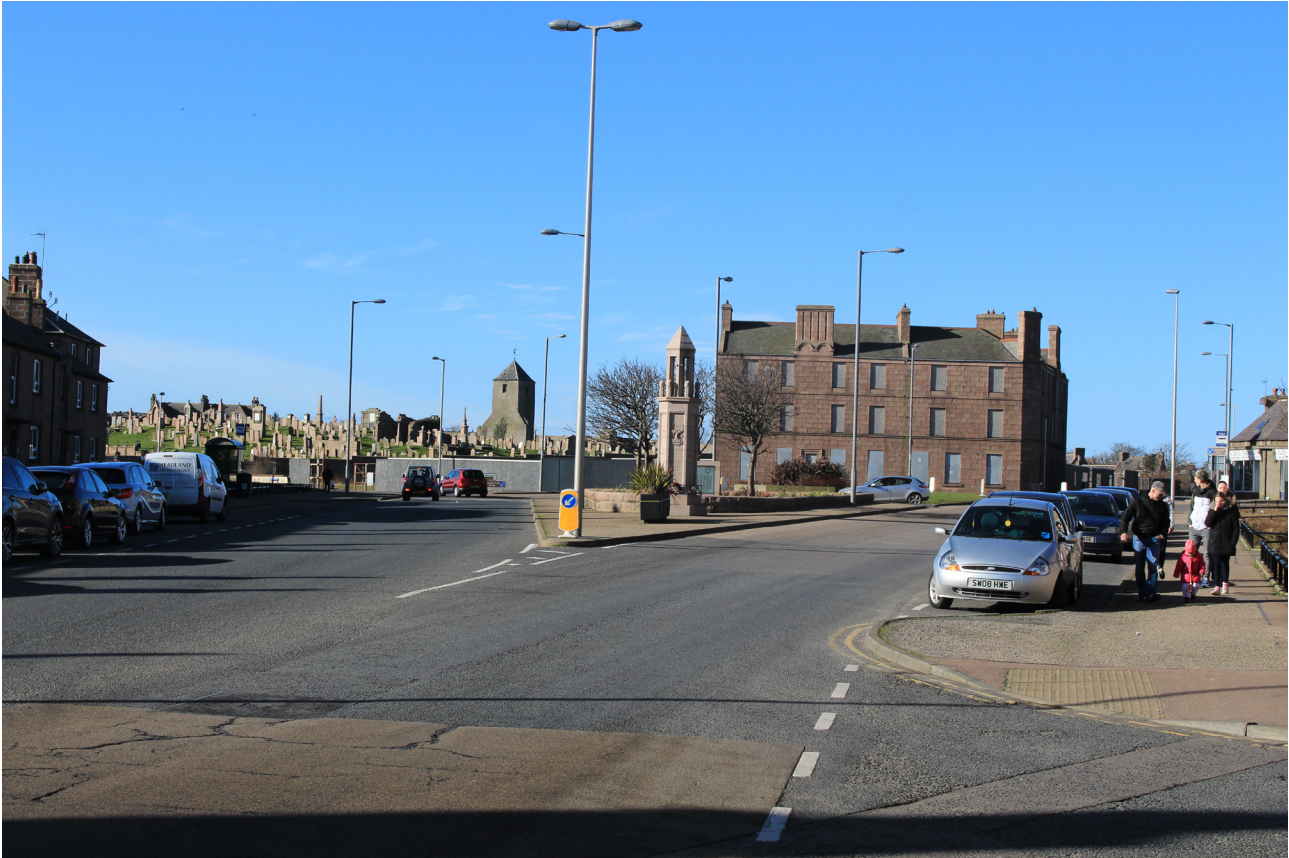
The remains of a standing building (55-69 Kirk Street) occupy the north-east corner of the development site (Illus 2 photo 78). This forms an L-shape building in plan facing north onto Kirk Street and east onto South Street. The land behind them is open having been cleared of buildings. The site lies at approximately 10m AOD.

ILLUS 2 View of the tenement from the east

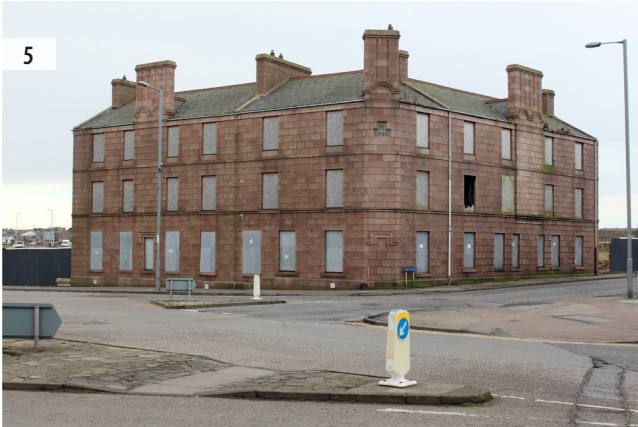
ILLUS 5 View of the front facing elevations **ILLUS 6** View of the mill site from the rear of the tenement **ILLUS 7** View of the rear facing elevations **ILLUS 8** Detail of the roof tile capping

The two front facing elevations of the three storey tenement were constructed of coursed pink granite masonry bonded with cement with projecting stone string courses dividing the floors presenting an impressive and grand façade to the building. These two elevations displayed rows of windows to all three floors with no doors present.

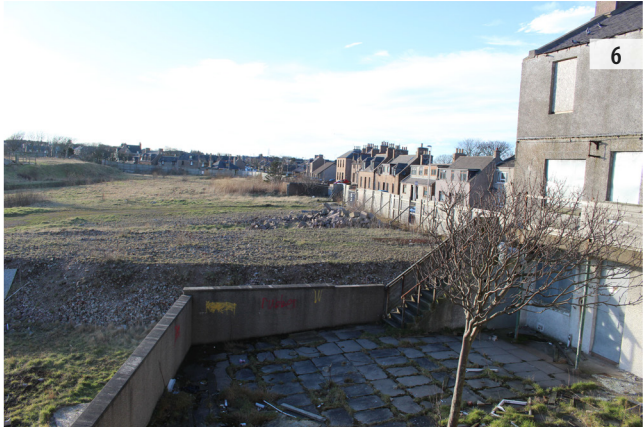
The building formed the only upstanding remains of what had previously been the site of Kirkburn Mills. The rest of the complex had been demolished and levelled. The only other remaining feature was the surviving bank and ditch of the Kirk Burn that had once powered the early woollen mill (Illus 6 photo 71).

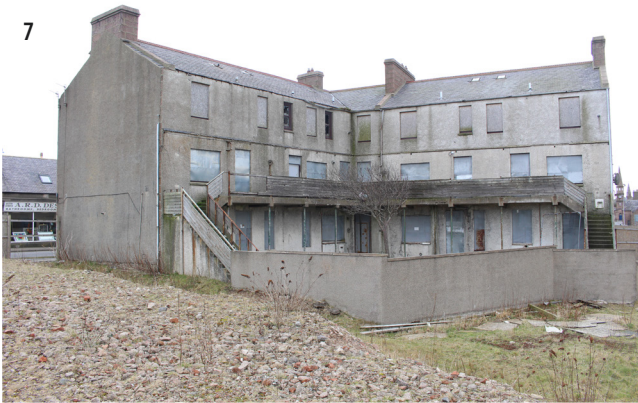
The rear elevations were more mundane having been covered in a grey painted harl (see Illus 7). The ground and first floors had been divided by a concrete walkway supported on steel poles and accessed by concrete steps located to the outer sides of the two rear facing elevations. The west facing elevation included two doors and three windows to the ground floor, two further doors and three windows to the 1st floor and five windows to the 2nd floor. The south elevation in comparison had a single door and four windows on the ground floor, three doors and two windows on the 1st floor and five windows on the 2nd floor. Due to the harl covering of these elevations it was not clear how many of these opening were original. It is likely that the doors on the 1st floor are not original as the walkway and stairs are thought to be a later addition to the building. Unlike the front elevation where the windows on the upper two floors were regular in size and position, the windows to the rear varied in size displaying little conformity or patterning.

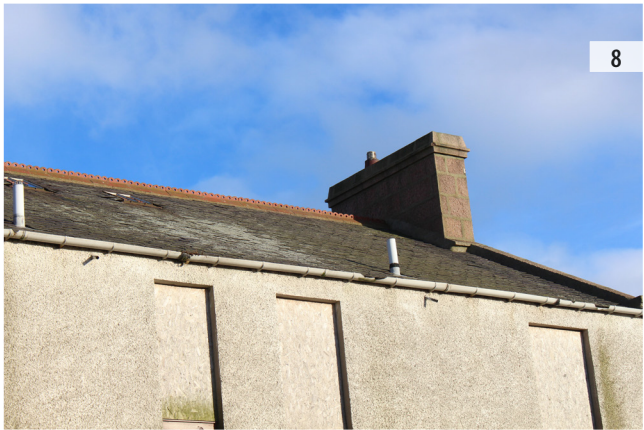
The construction materials of the gable ends and the rear facing elevations had been masked by a painted harl. No features were present on the gables while a series of doors and windows were recorded to the rear of the property along with two concrete staircases to each end of a concrete walkway situated along the first floor level of the building (Illus 7 photo 4). The slate roof included a decorated red tile capping (Illus 8 photo 65) and seven tall granite masonry chimneys.

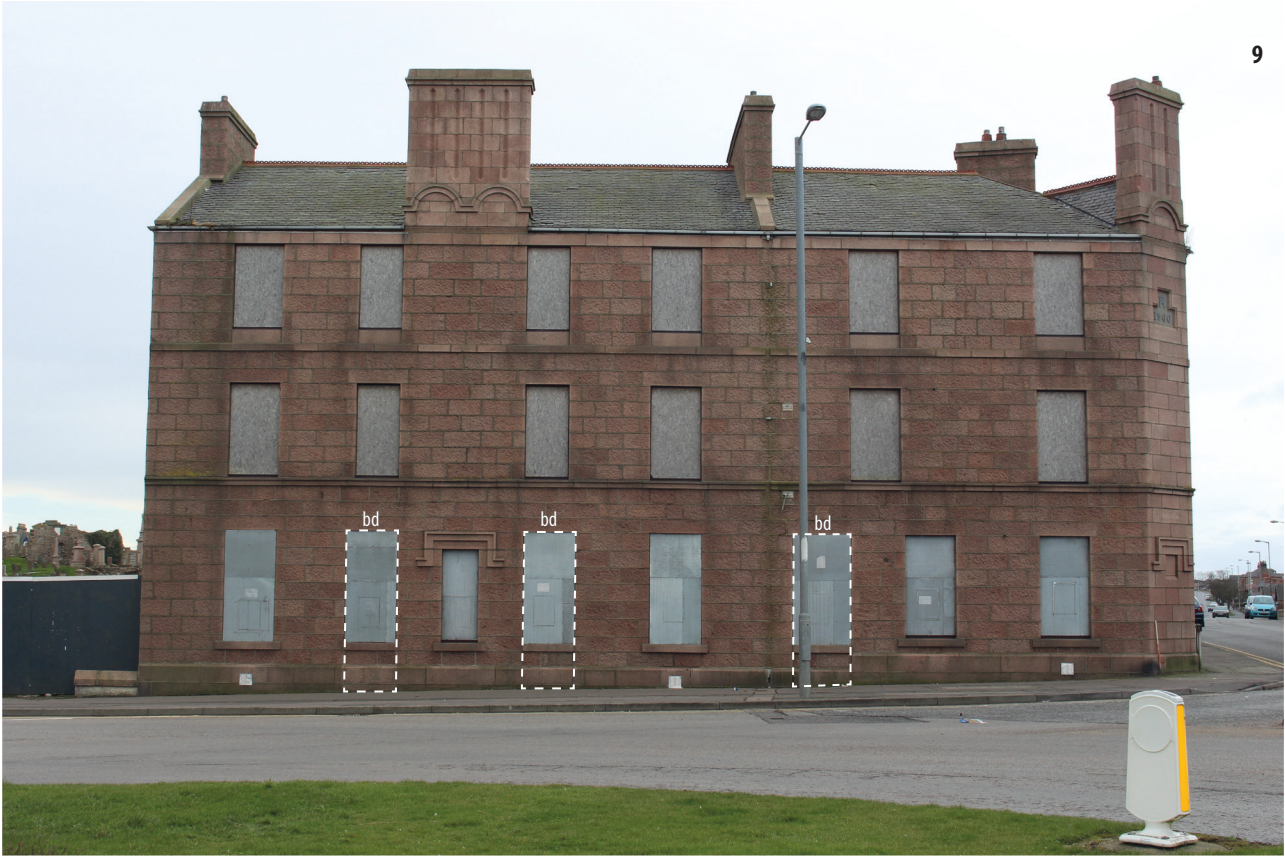
The front east facing elevation comprised eight windows to the ground floor and six to the 1st and 2nd floors (Illus 9 photo 14). The north facing elevation was slightly shorter with seven windows on the ground floor and five to the upper two floors (Illus 10 photo 24). All the ground floor windows on the two front elevations included projecting granite cills. The majority of these cills extended beyond the width of the window although in five cases they corresponded to the width of the window (Illus 11 photo 21). This anomaly suggested that the windows in these instances were not original features and that they had been partially blocked at the base. This indicated that their original purpose was as doors rather than windows. One of these windows in particular (on the east facing elevation) was situated on the same alignment as the pend shown on the 2nd edition Ordnance Survey, further suggesting an original use as a door.

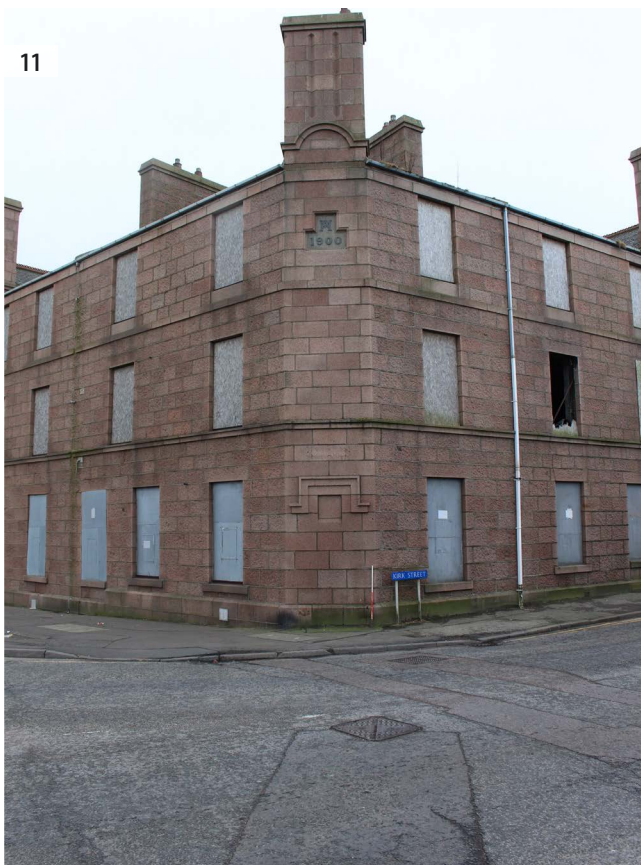
ILLUS 11 Detail of the original drip mould decoration and one of the later phase windows

Decoration on the front facing elevations was limited to a projecting drip mould over one of the windows on the east facing elevation, a similar feature over a slight recess on the angled corner elevation,

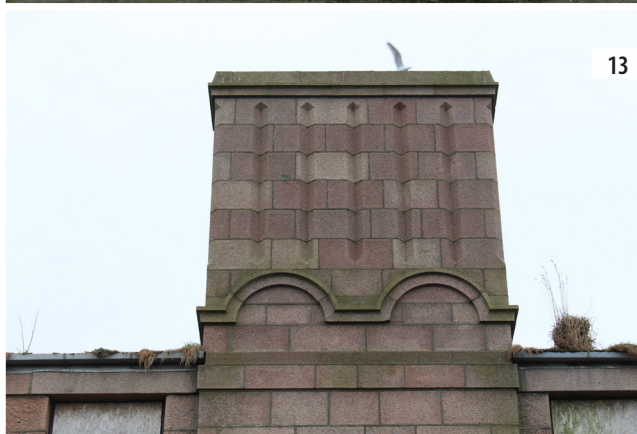
ILLUS 13 Detail of the chimney decoration

a date plaque on the same elevation (Illus 12 photo 22) (dating the construction of the building to 1900) and decoration on the three front facing chimneys. The decoration on these chimneys comprised arched drip moulds at the base and fluting of the stonework above (Illus 13 photo 26). The stonework of the chimney on the north facing elevation also projected slightly from the main wall to the base of the first floor.

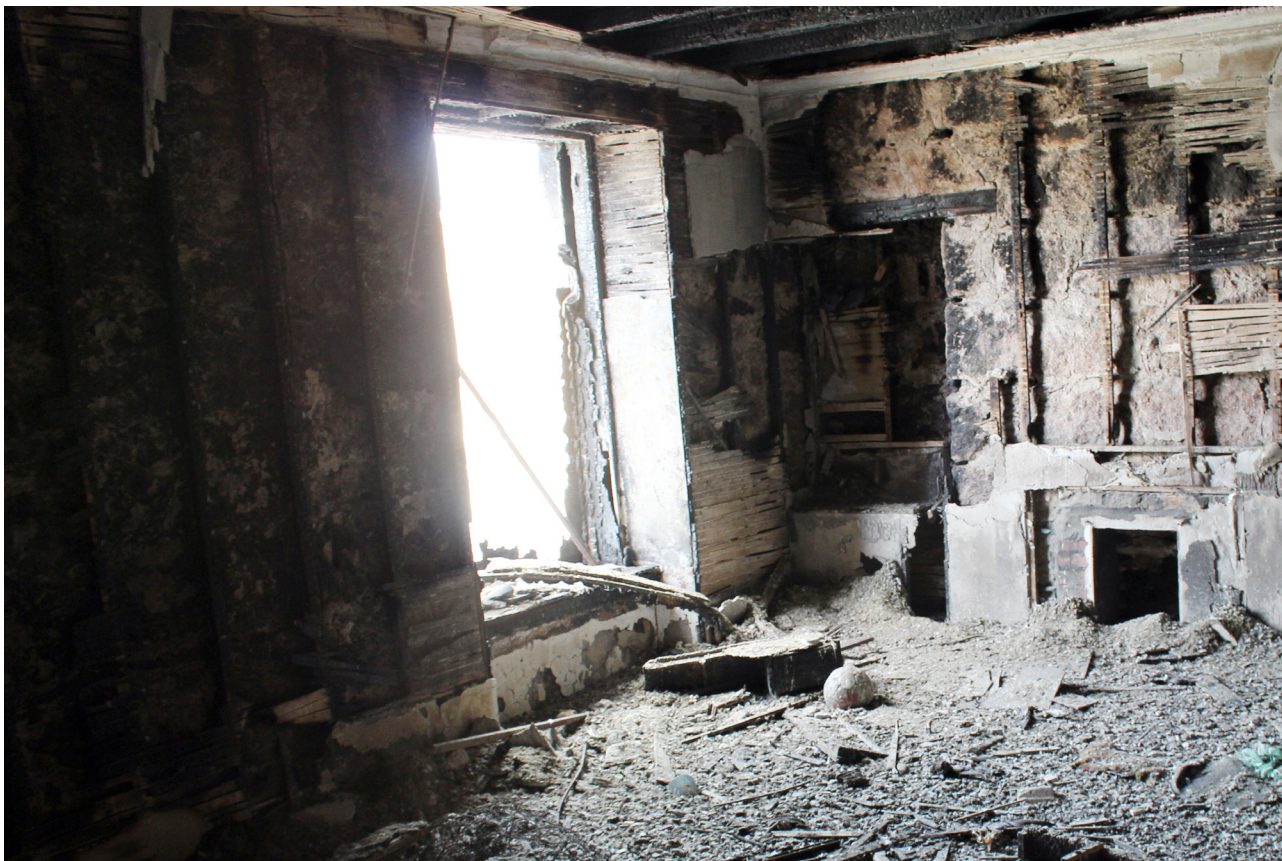
A second flat was accessed via a door on the 1st floor of the rear south facing elevation. This led to a two storey flat located over the 1st and 2nd floors. The 1st floor level (Illus 17 floor plan) comprised a hallway and timber staircase plus a kitchen, small bedroom/box room and a living room. The only detail of interest on this floor was the fireplace on the east wall of the living room (Illus 18 photo). Again all the rooms were in a poor state of repair. On the 2nd floor (Illus 19

ILLUS 18 View of the first floor living room and fireplace

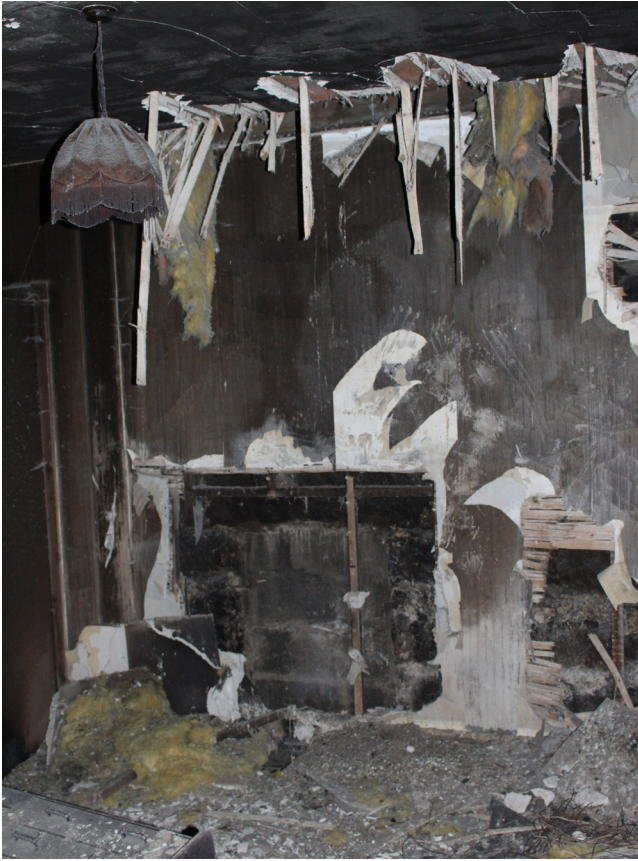
floor plan) two further bedrooms, a box room, a bathroom and a large cupboard space were located. A second fireplace was located on the east wall of the main bedroom (Illus 20 photo 56). Access to the upper floor was limited due to the poor condition of the flooring.

ILLUS 20 The fireplace in the second floor bedroom
