11KV POWER LINE REPLACEMENT, TRANENT, EAST
LOTHIAN

Watching Brief

For SPIE-ENS

February 2017

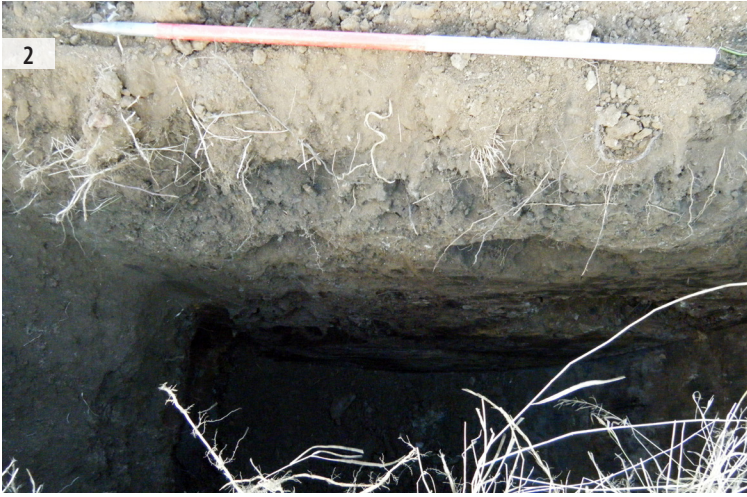
Of the seven trenches in Area 2 only Pole 31 required additional stabilisers. The pole was located close to the north-east corner of the field with all three stay trenches close to or within the hedge line. The excavation of Pole 31 (*Illus 2*) and the stay trenches generally revealed 0.45m of dark-brown sandy loam overlying geological subsoil comprising mid-brown sandy clay loam to a depth of 1.8m. No archaeology or artefacts were identified within these trenches. Similar results were recorded for the remaining six poles in this area with the topsoil varying in depth between 0.35m and 0.45m.

ILLUS 2 Detail of Area 2, Pole 1 trench section **ILLUS 3** Working shot of the excavation of Area 5, Pole 2 **ILLUS 4** View of the north side of Area 7

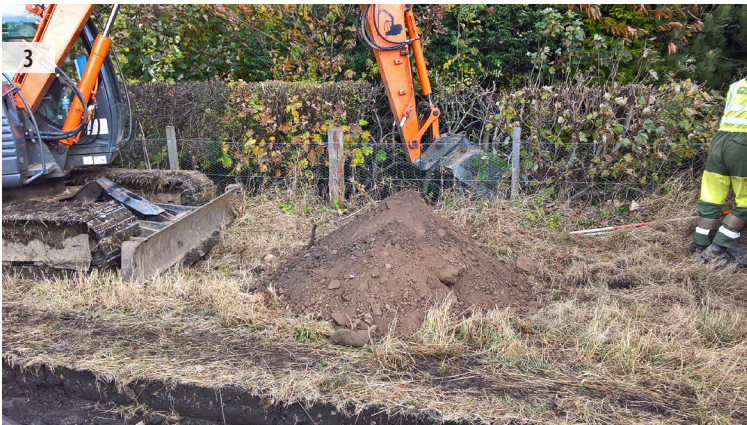
stabiliser trench. Poles 2 and 3 were located within the hedge line of the field boundary making visibility of the stratigraphy difficult (Illus 3). Both recorded heavy root bioturbation in the topsoil comprising dark brown stone rich loam 0.4m deep overlying a geological subsoil comprising light brown stone rich sand. Pole 1 at the north-west corner of the field produced similar results.

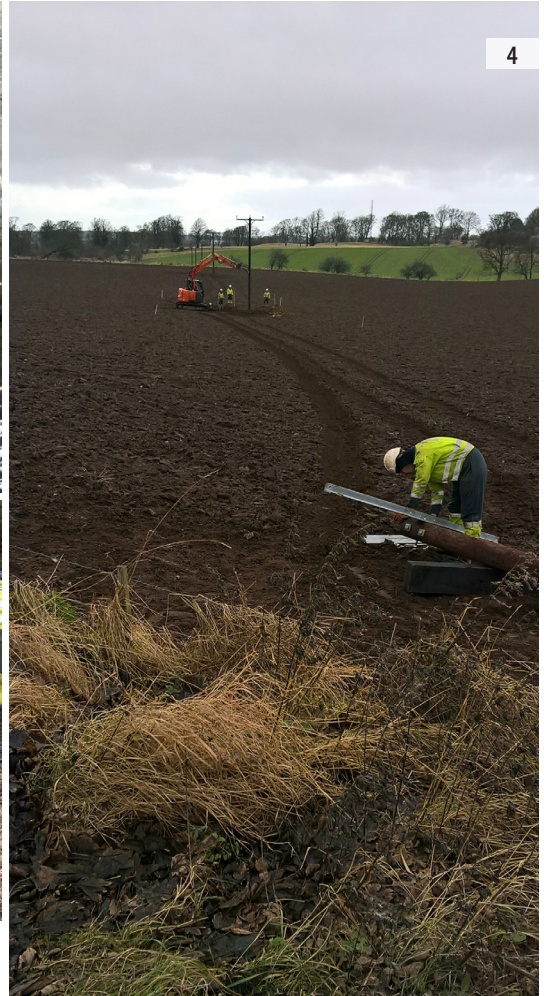
The four poles to the north side of Area 7 were excavated within a ploughed field (Illus 4). Pole 6 was the only one of these that required an additional stabiliser trench. This was located in the verge at the side of the road. The resulting two trenches recorded 0.5m of dark reddish brown loam topsoil overlying a boulder rich orange sand geological subsoil. The trenches for Poles 3 to 5 recorded 0.3m of topsoil overlying the subsoil.
