# MERCHISTON CAMPUS MAINTENANCE, EDINBURGH

*Results of an Archaeological Watching Brief  
for Edinburgh Napier University*

HA Job no.: MCME17/001  
NGR: NT 24245 71822  
Parish: >parish<  
Council: City of Edinburgh Council  
OASIS ref.: headland1-280937  
Archive will be deposited with: NMRS

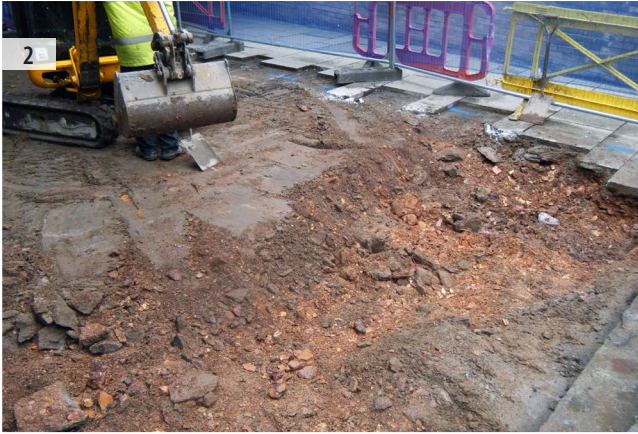
Upon removal of the concrete slabs that formed the existing steps a layer of light grey sands and concrete powder up to 0.2m thick was observed across the area (Illus 2). This deposit had been used form a level platform for the concrete steps.

**ILLUS 2** Working shot showing sand levelling layer beneath slabs

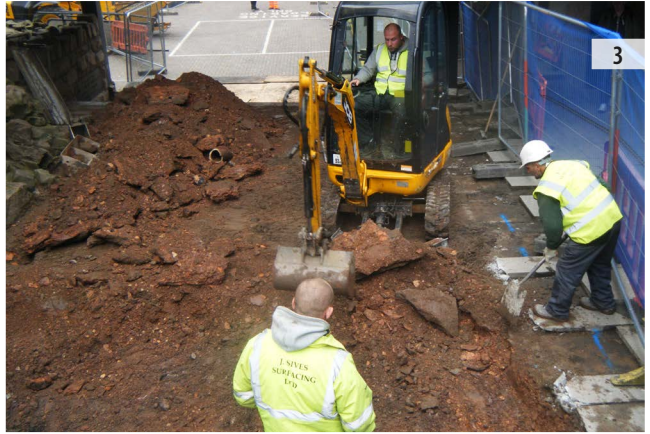
Beneath this a 0.3m thick layer of modern red blaes (inert waste deposits of colliery spoils that have been burnt or oxidised) was observed across the area (Illus 3).

**ILLUS 3** Working shot showing red blaes across whole area

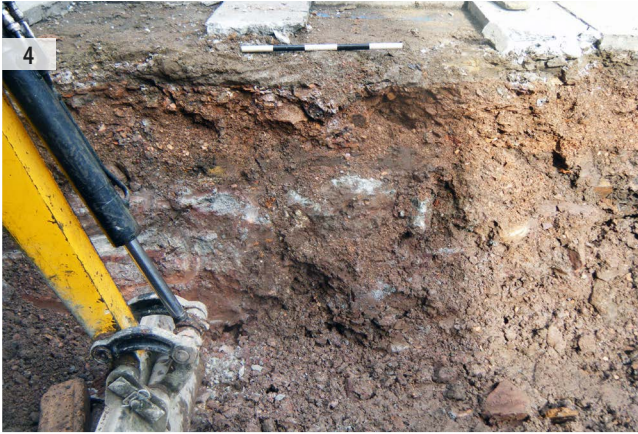
Beneath this and comprising the remaining 0.40m of removed deposits across the area was a made ground deposit consisting of bricks, broken sand stone, concrete and other modern debris in a mid-brown-grey sandy silt matrix (Illus 4). This deposit extended beneath the required depth of excavation across the area.

**ILLUS 4** SW facing section showing made ground to bottom of excavation    **ILLUS 5** N facing shot of interior of planter box excavated down to formation level    **ILLUS 6** SE facing shot of stairs and shelf to be re-surfaced. New wall built during Phase 1 to the right. Phase 2 area between heras fence and outer wall to the left

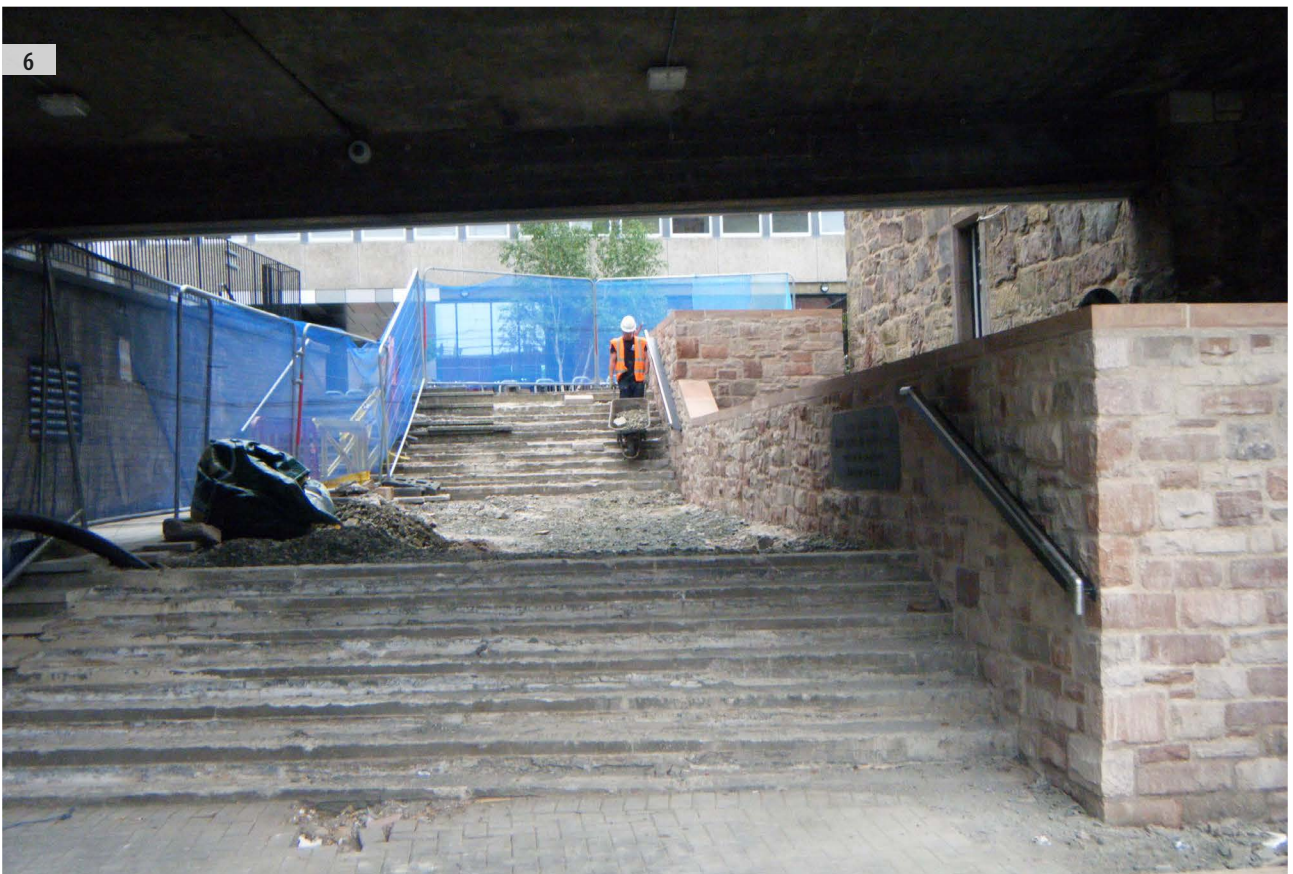
The remaining work within Phase 2 involved the replacement of slabs along a narrow corridor along the east side of the steps and a wide shelf in the middle of the steps (Illus 6). This work involved a minimum disturbance of the underlying ground and given the results from the adjacent work to the west during Phase 1 it would not disturb any significant archaeological deposits. It was therefore decided that no further archaeological monitoring was required.
