# A90/A96 HAUDAGAIN IMPROVEMENTS, ABERDEEN

## ASSESSMENT REPORT ON THE RESULTS OF TRIAL TRENCHING

commissioned by Jacobs (UK) Ltd  
on behalf of Transport Scotland

November 2017

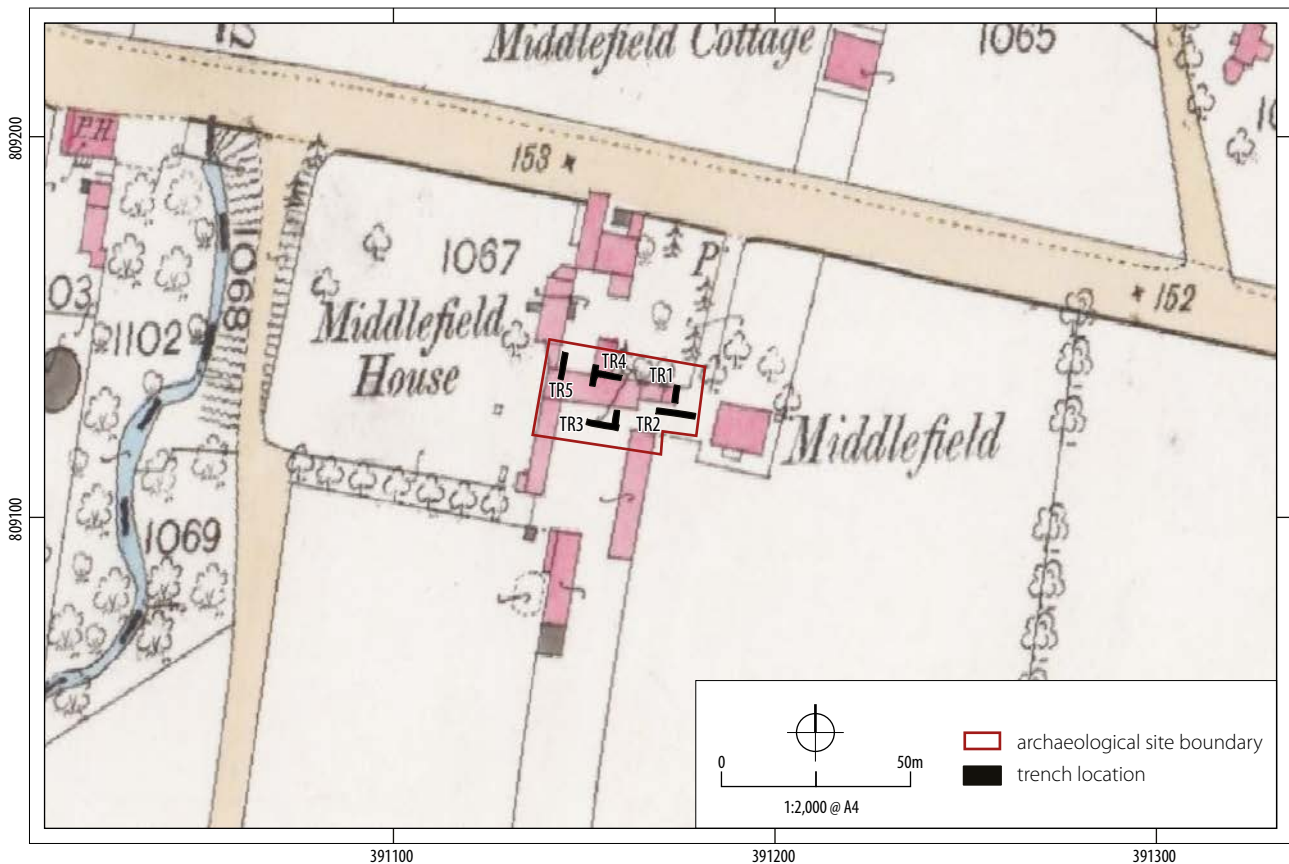
Of the assets identified in the ES, the evaluation was centred over the location of the Middlefield buildings (Nos 42–44). These buildings, as depicted on the 1st edition Ordnance Survey (Illus 3), comprised Middlefield House and a cottage named Middlefield. The house (ES Sites 42 and 43) seemed to comprise of a series of inter-connected buildings probably forming a main house with associated farm buildings, such as stables, workshops and out-buildings. The buildings probably all date to the 19th century although the place name 'Middletown' is depicted on Taylor and Skinner's 1776 road map in this location. Unfortunately the detail on this map is poor and it is not certain if it represents the area depicted on the later maps. The majority of the complex that formed Middlefield House is now occupied by the present tenements, although below ground remains relating to the Middlefield House may survive below the present ground surface to the south of these tenements. Sites 42 and 43 represent the location of two parts of the house that may have survived below the areas of lawn to the rear of the present buildings. At least one of the buildings marked on the 1st edition Ordnance Survey, Middlefield Cottage (Site 44), survives to the east of the evaluation area.

**ILLUS 3** Extract from 1869 Ordnance Survey Map 25 inch 1st edition, Aberdeen Sheet LXXV.2

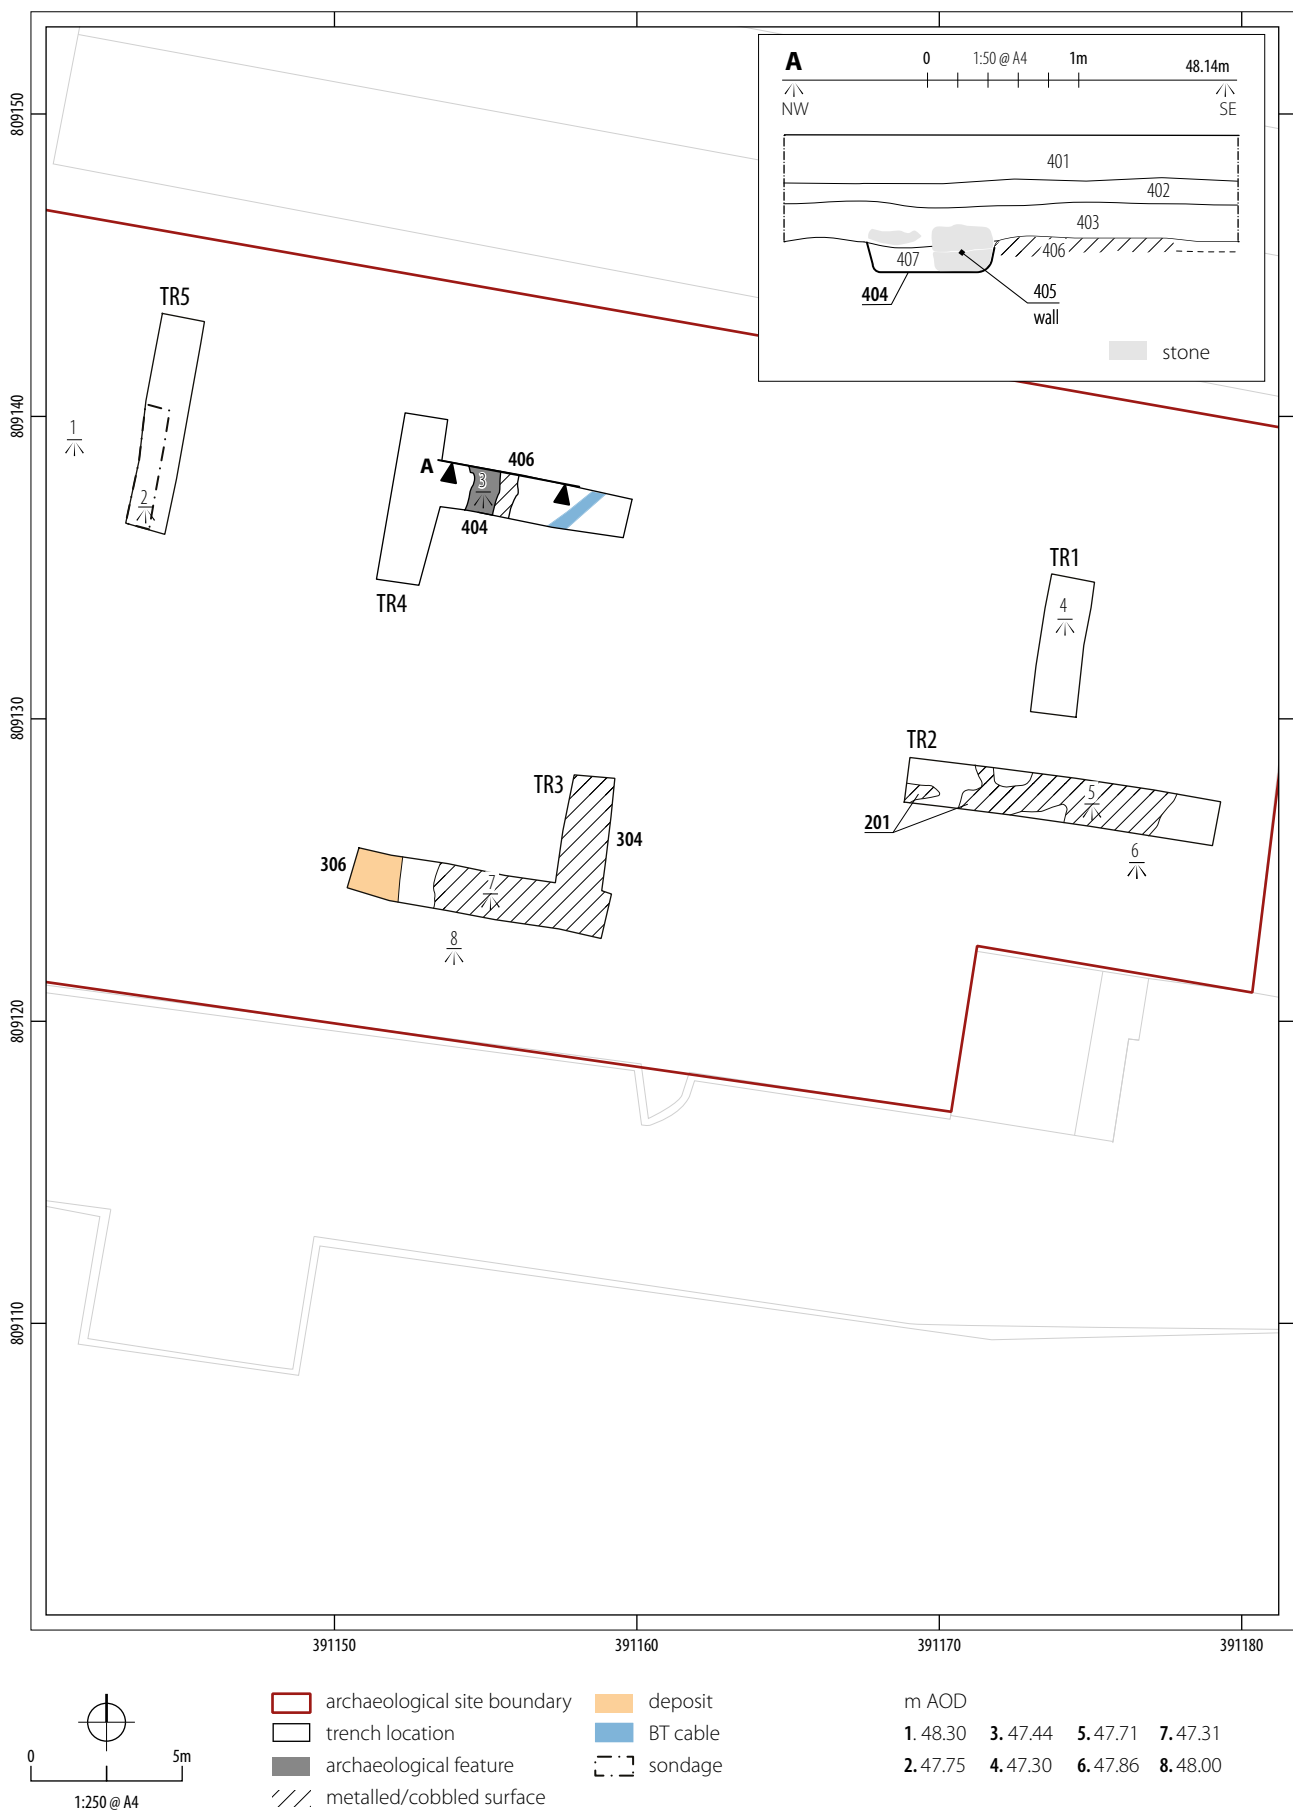
ILLUS 4 Trench and feature plan

A total of five trenches were excavated, each measuring 1.6m wide and between 4.5 and 10m long (Illus 4). They were primarily located to target the Middlefield House buildings (Sites 42 and 43) identified from historic mapping, and to avoid any identified services. Full trench details are tabulated in Appendix 1.

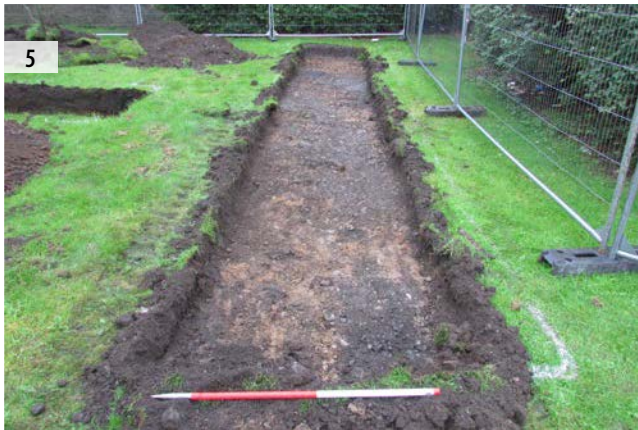
**ILLUS 5** View east of metallised surface (202) in Trench 2     **ILLUS 6** View south of cobbled surface (304) in Trench 3

This trench was aligned east to west and located immediately south of Trench 1. In comparison to the other four trenches Trench 2 was much shallower, with a maximum depth of 0.20m. A layer of small pebble stones (202) 0.1m thick, forming the remains of a possible metallised surface, was recorded below 0.2m of topsoil (201) throughout this trench. The surface was patchy in nature and in places the geological subsoil (203) was exposed (Illus 5). The stones appear to have been pressed into the natural below and formed a flat but uneven surface.

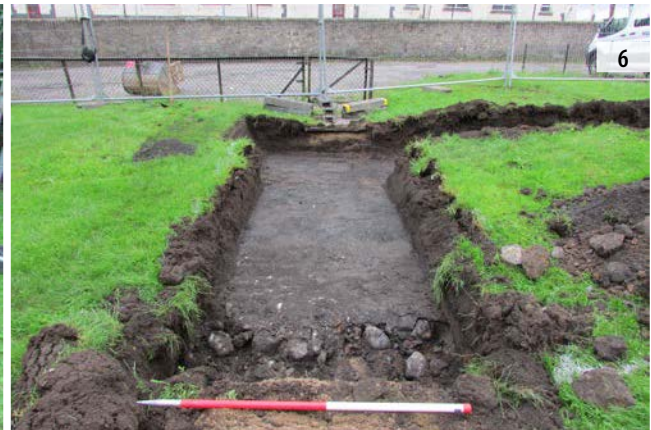
Trench 3 was L-shaped and located to the south side of the evaluation area, to the west of Trenches 1 and 2. It was excavated to a maximum depth of 0.95m (at the north end only). A layer of large rounded cobbles (304) (Illus 6) overlying the natural geology (305) was recorded within this trench. These were 0.75m below the surface extending beyond the trench boundaries to the north, south and east. Towards the west end of the trench an uneven break was recorded in the cobble surface (304) and the geological subsoil was exposed. The cobble surface did not continue to the west of this break. Instead a thin layer of ash rich loam (306) was located at the west end of the trench at the same level as the cobbles. The 1m wide area of exposed geological subsoil between the cobbles to the east and layer of loam to the west was initially interpreted as the potential location of a wall that had subsequently been removed, the cobbles to the east representing either an internal or external floor surface. No evidence of a cut was identified either in plan or in section and no stones forming the remains of a wall were observed. It was therefore unlikely that the break in the cobbles represented an extant wall line. The cobbles were overlain by a compact thin layer of cinders and pea gravel (303). In turn this was overlain by a 0.35m layer of made ground (302) comprising dark grey silty sand

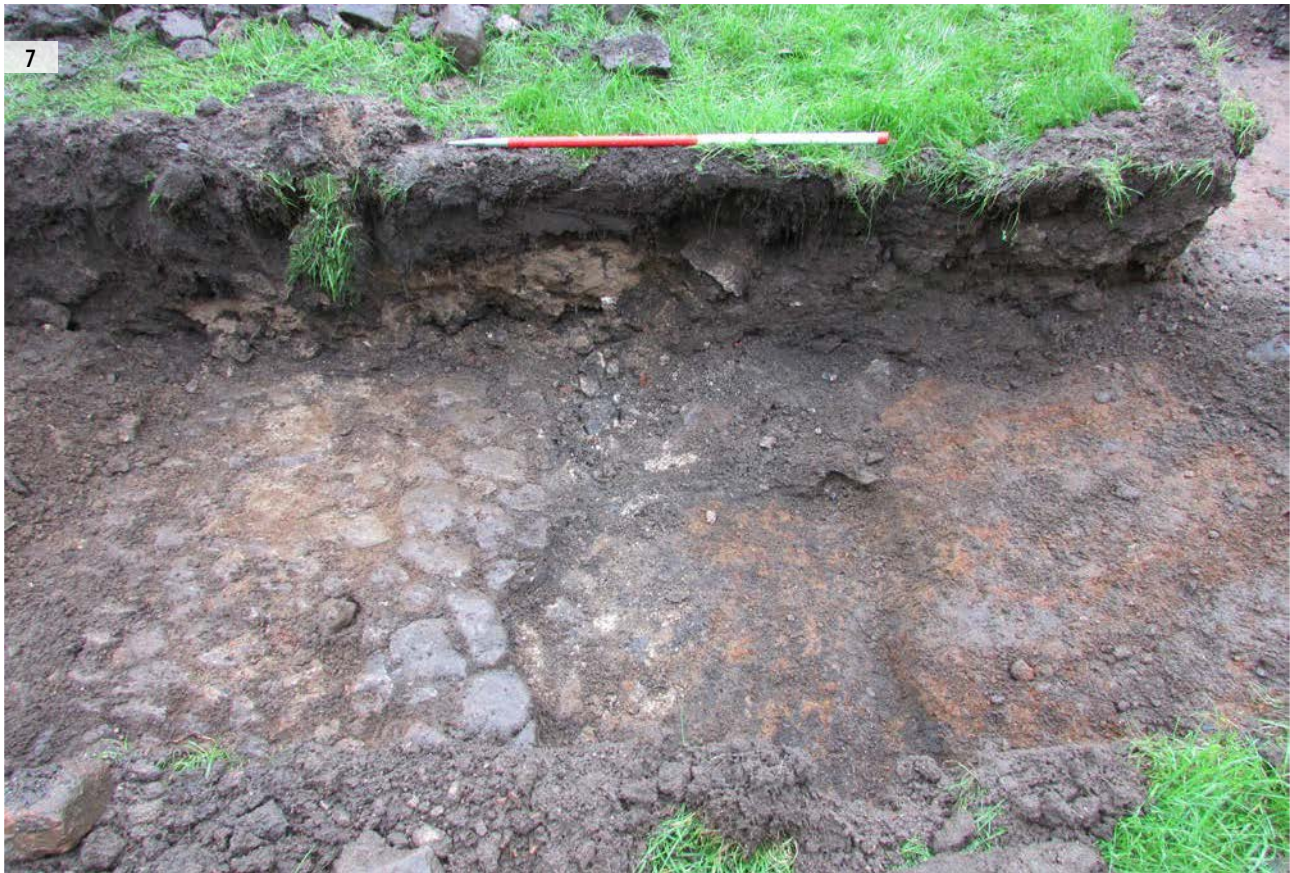
Trench 4 was T-shaped in plan and located to the north side of the evaluation area. It was excavated to a maximum depth of 0.7m, through 0.35m of topsoil (401) and two further layers of made ground (402) and (403). At the centre of Trench 4, at a depth of 0.5m below the surface, a shallow 1m wide wall foundation cut [404] 0.2m deep was recorded cutting the geological subsoil (408). In the south-facing section of the cut two large stones (405) 0.5m wide were recorded, although the remainder of the cut was filled with a deposit of mixed loam, small poorly sorted stones, brick fragments and tile (407). Immediately east of the cut, a layer of cobbles (406) was recorded (Illus 7) forming an edge at the top of the cut. The cobbles were exposed for a further 2.5m to the east and potentially continued beyond this. The cut and cobbles were overlain by a 0.3m thick dark brown loam deposit (403) containing fragments of modern pottery, glass, brick and stone. This in turn was overlain by a thin layer of light yellow sand (402) forming a levelling layer, which was overlain by topsoil (401).

**ILLUS 7** View south of cobbled surface (406) and foundation cut [404] in Trench 4

Although a number of features were recorded across the area their purpose was not always clear. The alignment of the wall cut in Trench 4 mirrored the alignment of the break in the cobbles recorded in Trench 3 to the south. Initially this was interpreted as representing the same feature, specifically a north/south aligned wall foundation. When the trenches are placed over the 1st edition Ordnance Survey map of the Middlefield buildings (See Illus 3) no buildings are present in Trench 3 and the potential wall cut in Trench 4 is not in alignment with any outer walls. This would imply that neither of these features were structural wall foundations. In the case of Trench 4 given the shallow depth of the cut the feature may represent the remains of an internal wall or even a curb. The break in the cobbles in Trench 3 is more difficult to explain and may just be the result of later disturbance. Certainly no wall or kerb stones were present.

From the evidence of the 1st edition Ordnance Survey map the cobble floor in Trench 3 is likely to represent the remains of an external ground surface, whilst the cobble floor in Trench 4 seems to represent an internal surface. The large cobbles forming this internal floor surface may indicate that the building had been a workshop or stable block, as it would have been unusual to have such a floor surface in a domestic building. The metallised surface in Trench 2 has been interpreted as the remains of an external road linking the surviving Middlefield cottage (871 Great Northern Road) and the demolished buildings. The presence of modern pottery in the made-ground layers above these surfaces represent deposits associated with the construction of the housing development in the 1950s.
