# MUIRHOUSE SILVERLEA, EDINBURGH

## ARCHAEOLOGICAL EVALUATION

commissioned by City of Edinburgh Council

June 2018

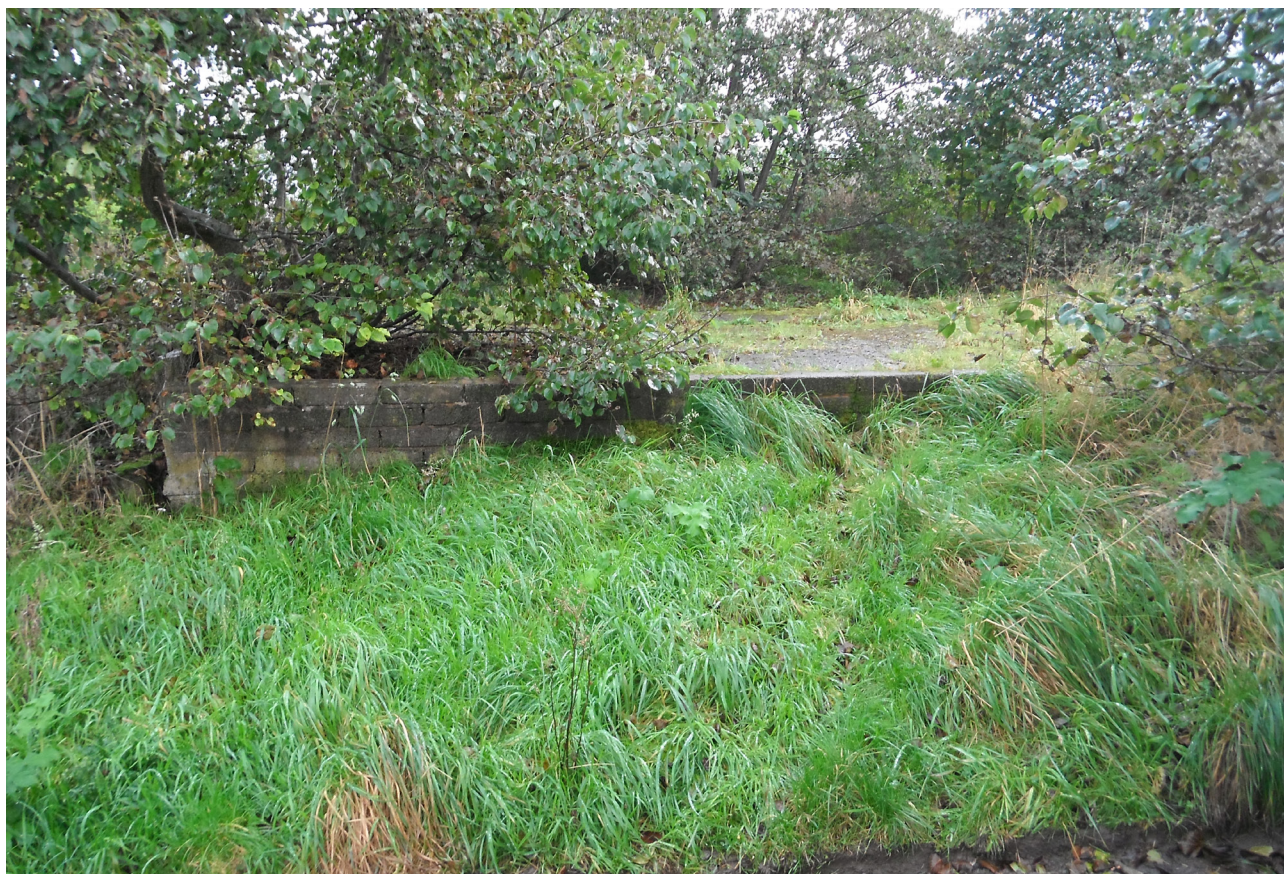
**ILLUS 4** View of the remains of the riding school with the tree cover

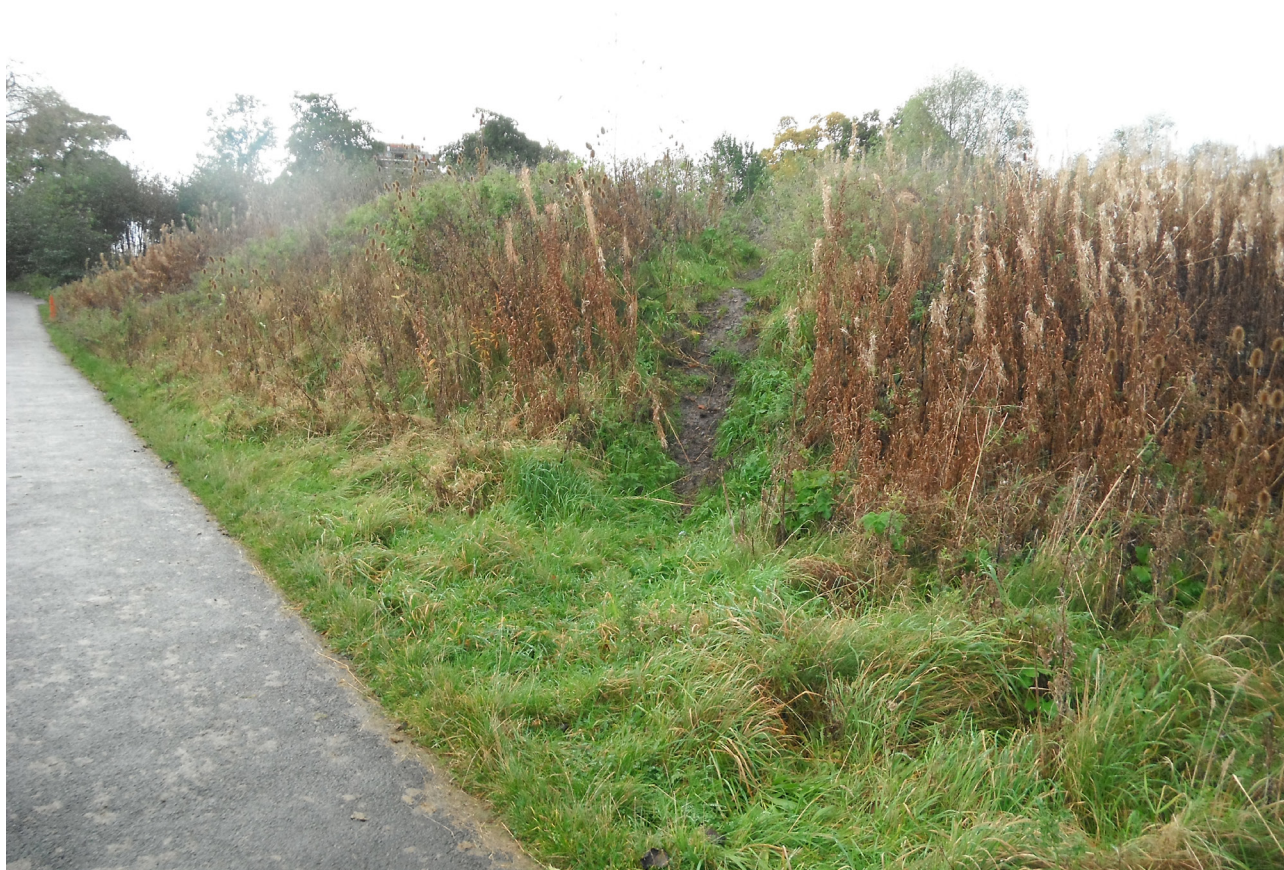
Trenches 1 and 2 were located over the manège. This was a large parcel of land that had been raised to over 2m above ground level at the northern end (Illus 6) in order to form a level surface for the training of horses. The two trenches were excavated to the clay geological subsoil at a maximum depth of 2.9m revealing several layers of made ground (Illus 7). In trench 2 this included a layer of stone and timber demolition material, possibly remains associated with the home farm.

**ILLUS 6** View of the raised bank of the manège facing south

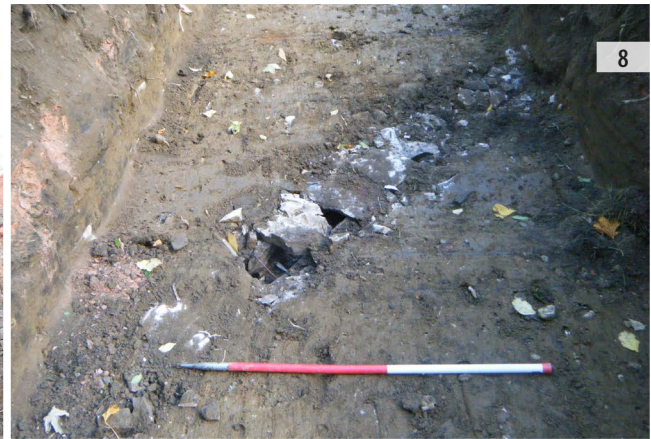
east/west aligned stone-lined culvert 0.6m [028] wide was recorded in Trench 3 (Illus 8), 0.8m below the surface. The culvert had a stone capping and sides plus an earthen base forming a channel 0.13m wide and 0.16m deep. A rubble stone drain [033] on a similar alignment was also recorded in Trench 4. This was 0.7m wide and recorded at a depth of 0.75m cutting the clay geological subsoil. Oyster shell was noted within the topsoil that may represent midden material in the general area.

**ILLUS 7** Trench 1 from the south    **ILLUS 8** The stone-lined drain in Trench 3    **ILLUS 9** The road surface in Trench 5, facing west    **ILLUS 10** The linear cut and stone fill in Trench 5    **ILLUS 11** East facing section of the pond cut in Trench 9

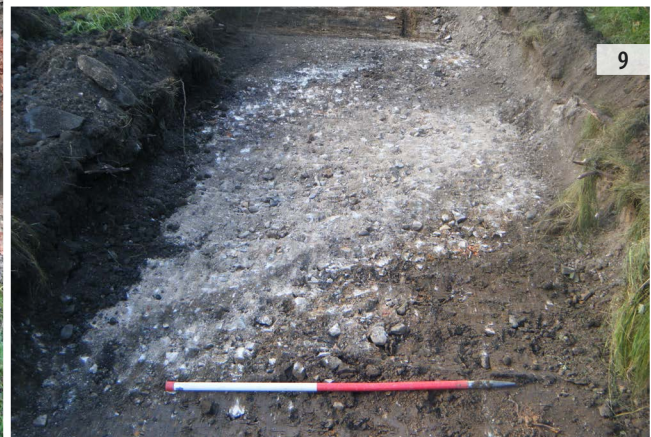
At the east end of Trench 5 two features of interest were recorded. The most prominent was a 2.1m wide compact stone surface [039] 0.4m below the topsoil (Illus 9). This was aligned north-west/south-east and presented the remains of the track depicted on the 1st edition ordnance survey leading to the new house to the north. To the eastern side of the road surface was a shallow gully [037] 0.62m wide and 0.1m deep, filled with small stone and lime mortar fragments. As it reached the east side of the track a row of five larger sub-rectangular stones [038] were present within the cut (Illus 10). It was unclear what these larger stones represented although they may signify the remains of a boundary wall, the cut probably representing the base of this wall. Within the deposits to the west side of the trench a 0.25m layer of discarded and broken garden pottery was recorded presenting one of a number of re-deposited layers of material found at this end of the trench. This also included frequent large stones to the base of the cut. These were loose and did not form the remains of a structure.

The track located in Trench 5 is clearly the remains of the roadway shown on the 1st Edition OS map. The origins of the road are unknown though it may relate to a 19th century re-configuration of the site once Muirhouse House had been demolished. There was slight ambiguity as to the nature of the wall foundation to the east of the track, although given the narrow width of the cut in which it was placed it is unlikely to have been a foundation for a major building. Therefore, it was more likely to be the remains of a boundary wall of unknown date.

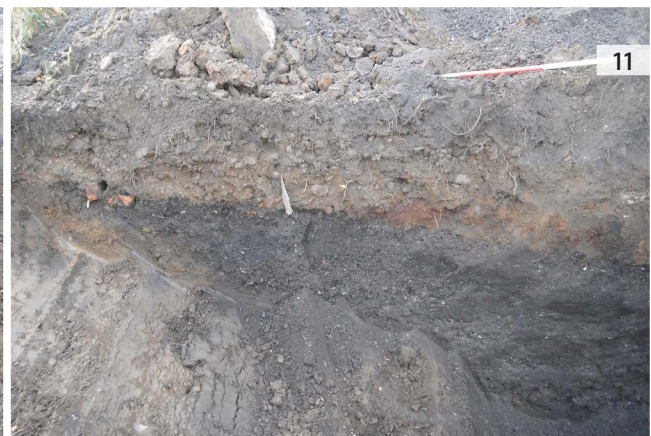
Trenches 7 and 8 revealed bands of bedrock at a maximum depth of 0.7m overlain by subsoil and topsoil. Trench 9 was positioned to target the pond depicted on the 1st edition ordnance survey. Only a short length of the trench could be excavated due to tree cover but this exposed the southern edge of the pond 0.8m below the surface level. The pond cut was steep (Illus 11) although the base was not encountered as the trench excavation could not continue beyond a depth of 2.9m. The pond cut was filled with a deposit of ash and cinder with a moderate amount of 20th century pottery and glass bottles recorded throughout (not collected). Evidence from the 1912 ordnance survey indicates the pond was still in use in the early 20th century therefore it could not have been backfilled before this date.

The historic pond depicted in the 1st Edition OS map to the east of the farmstead had been backfilled in the early 20th century and contained midden material of this date. The Pond was not bottomed out and therefore its origins and function are as yet unknown. As such it may date back to the post-medieval operations of the
