EDINBURGH CASTLE RAILWAY FENCING

ARCHAEOLOGICAL WATCHING BRIEF

commissioned by Network Rail

January 2018

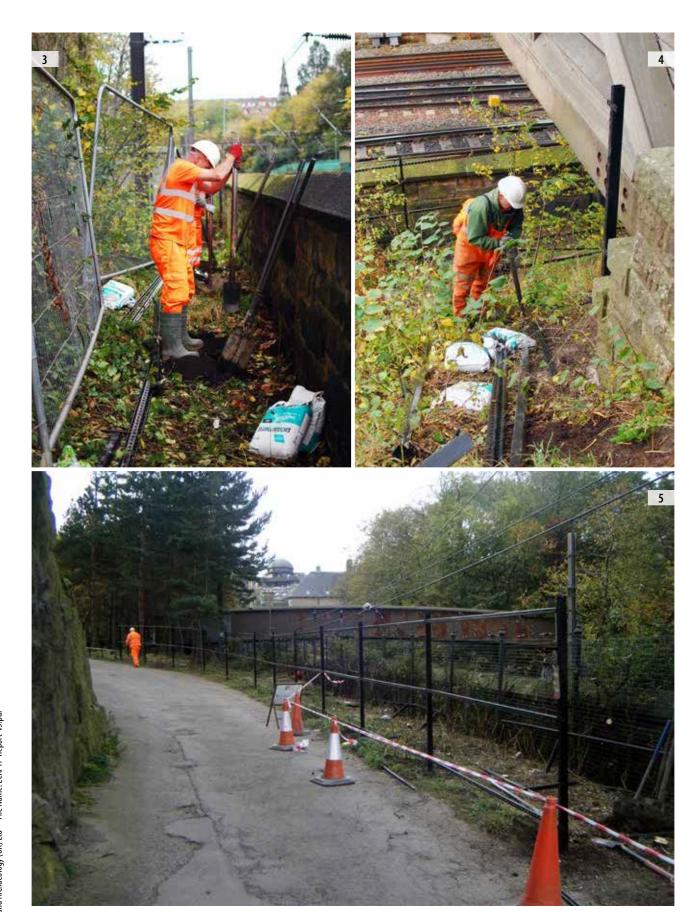
ILLUS 3 Manual excavation of the holes ILLUS 4 Excavation of hole under the Middle Footbridge ILLUS 5 General view of the fencing line east of West Footbridge, facing west

ILLUS 6 Detail showing concrete layer between topsoil and subsoil ILLUS 7 Detail of hole for railway access gate

The work was undertaken as specified in the WSI with monitoring of the excavation of around 120 holes, each measuring approximately $0.30 \times 0.30 \times 0.60$ m, to accommodate the posts for the new fence (Illus 3 and 4).

The development area lies within the boundaries of the railway line built in 1845 by the Edinburgh-Glasgow Railway Company linking Haymarket Station with Waverley Station. These works affected the existing gardens' southern edge so it was likely that the existing soil would be made ground. As the proposed new fence line was erected to replace the existing, adjacent to the stone wall along the railway tracks, this was even more distinct (Illus 5).

The holes were each approximately 0.60m deep and comprised a subsoil (002), at least 0.30m thick which was identical in colour and composition to the overlying topsoil (001), only differentiated by its firmness. The overlying topsoil (001) was 0.30m thick and comprised dark grey silty sand with organic material and ocassionally either concrete or cobble small fragments (Illus 6).

Near the rail-track access gate, concrete and stones from the railway works (006) were also recorded beneath the topsoil (Illus 7).

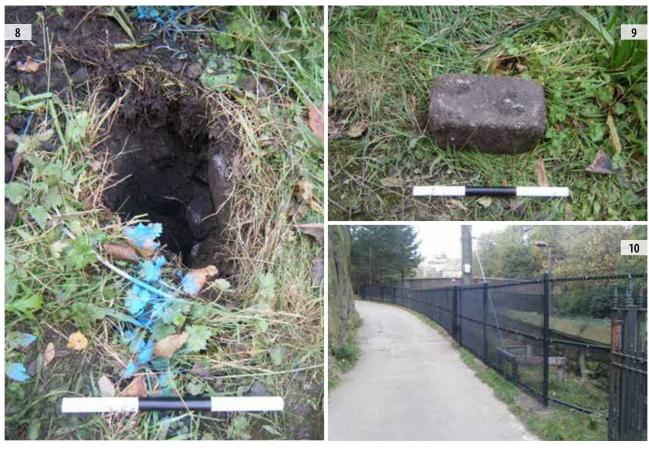
ILLUS 8 Detail of hole with cobbled surface (004) ILLUS 9 Cobble recovered from the excavations ILLUS 10 General view of the completed new fence line, facing west

In the holes excavated between the rail track access gate and the Castlehill pathway entrance, a layer consisting of loose cobbles was identified (004) whilst in those adjacent to the road tarmac (003) was present.(Illus 8 and 9)

No archaeological features were identified during the works and the panels for the fence were installed according to the proposed schedule (Illus 10).
