LAKELAND LEISURE PARK, MOOR LANE, FLOOKBURGH, CUMBRIA

HISTORIC BUILDINGS RECORDING (LEVEL 2)
PLANNING REF. SL/2016/0940

commissioned by Bourne Leisure Ltd

January 2018

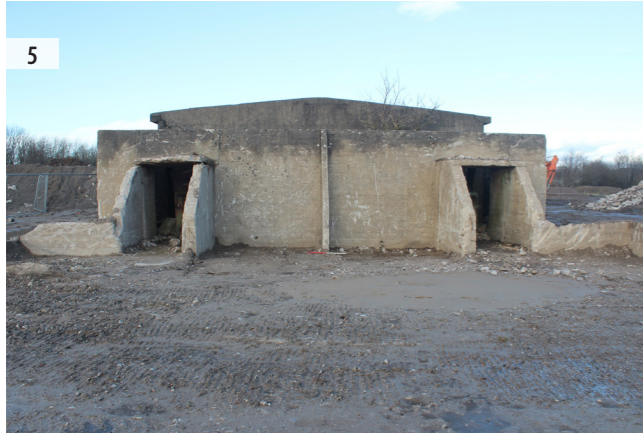
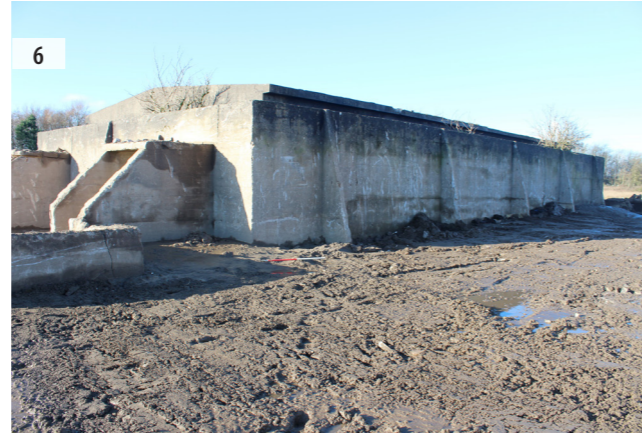
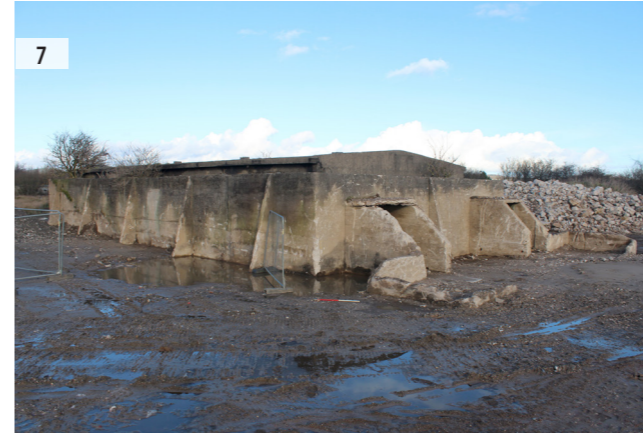
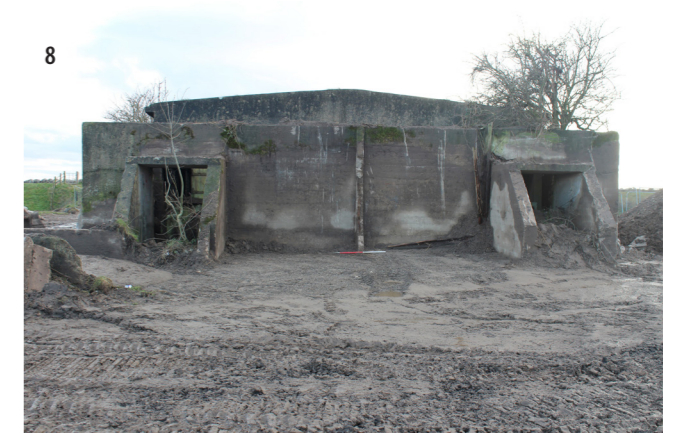
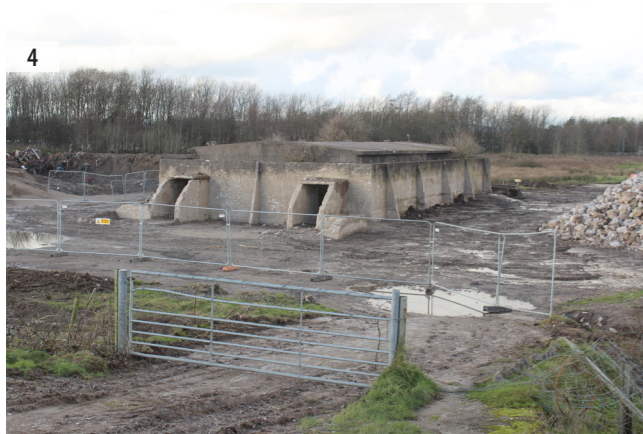
The concrete blast wall measured 3.2m high and 0.3m thick and on its longest sides was supported by five external concrete buttresses (Illus 4 to 8). The buttresses were spaced between 4.5m and 4.8m apart, were 0.15m thick and extended 0.8m from the wall. The two entrances on each end measured 1.3m wide and 2.06m high and included a porch extending 2.9m from the wall with a roof 0.15m thick. The presence of a door in each porch was indicated by a hinge and mortice recorded on the side jamb. A single buttress was recorded between the porches. In front of each porch entrance was the remains of a small annex (Illus 9). This comprised a wall 0.2m thick extending off the outer wall of the porch enclosing a 7.5m² space. The walls enclosing the space in the north-east corner of the building were the only ones that survived to their original height (0.8m) as all the other walls had been partially demolished. From the surviving annex in the north-east corner, it was seen that these spaces had always been unroofed.

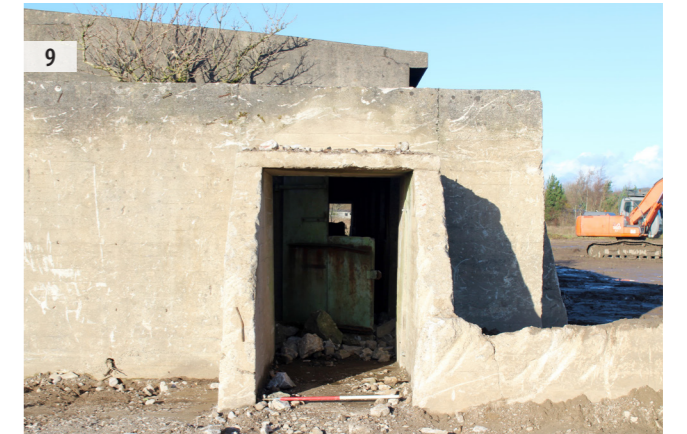
ILLUS 2 Site plan
ILLUS 4 South facing general shot of bunker
ILLUS 5 South-west facing shot of north-eastern entrances
ILLUS 6 South facing shot of north-eastern and north-western external walls
ILLUS 7 West facing shot of north-eastern and south-eastern external walls
ILLUS 8 North-east facing shot of south-western entrances
ILLUS 9 South-west facing shot of north-eastern entrance
ILLUS 10 South-west facing shot of entrance door detail
ILLUS 11 Shot of internal wall damage
ILLUS 12 Shot of internal corridor
ILLUS 13 Shot of windows

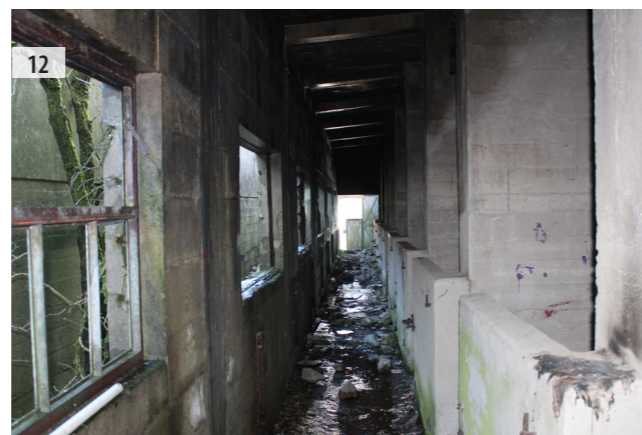
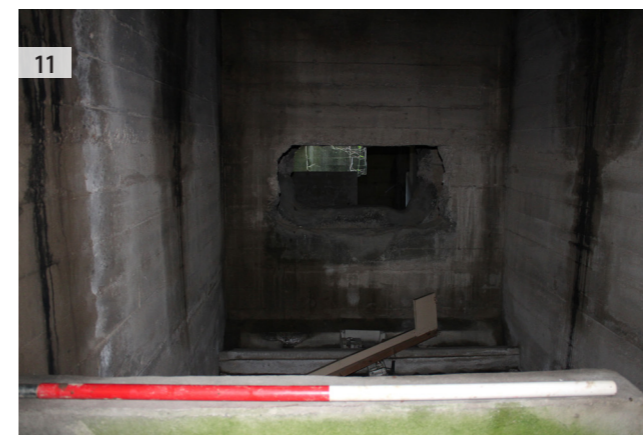
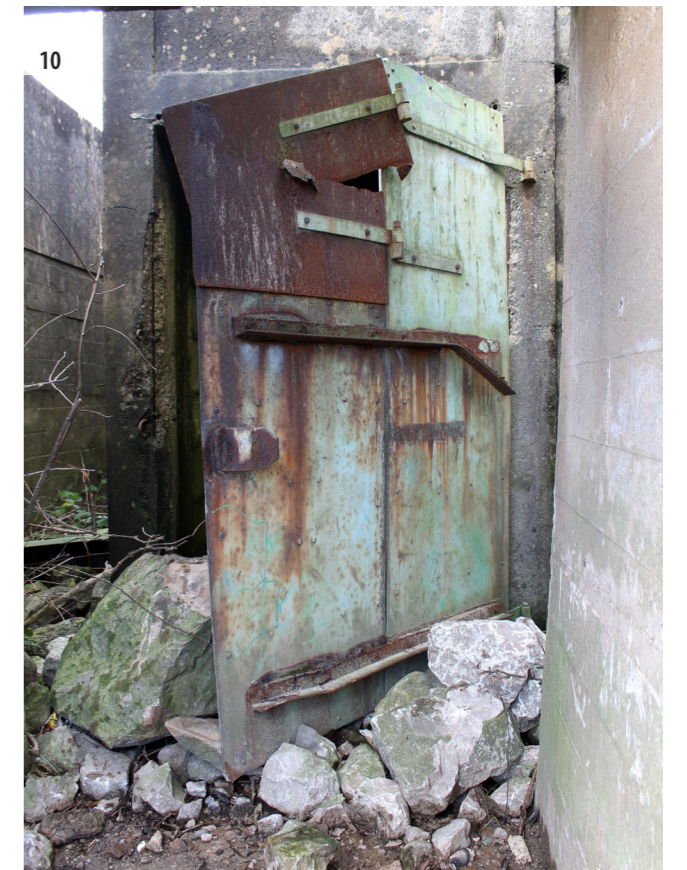
The main structure within the buttressed concrete wall comprised a building constructed of seven concrete ribs/arches which supported a gently sloping roof. The walls were constructed of a double skin of concrete blocks with a 0.05m gap between them, with an external concrete render. Six windows were located along each side of the structure (12 in total). Only one of these still contained the window frame comprising a steel multi-pane casement with no glass panes extant (Illus 13). There were four entrances to the structure all of which aligned with the four entrances of the buttressed wall. The entrances were 1.3m wide and 2m high, and each had a thick metal sheet door (Illus 10). The doors lead to passageways on each side of the building that continued to the entrances at the opposite end of the building (Illus 12).

The area between the passageways was subdivided into 15 cubicles each measuring 2.7m by 2m. The walls of the cubicles were constructed from poured reinforced concrete and would originally have been open to the passageways. 1m high walls had been added later to enclose the cubicles (Illus 11). The cubicles were organised either side of a central passageway 0.9m wide. A sixteenth cubicle in the north-west corner lacked a back wall presumably to allow access to the central passageway, however, there appeared to be no way to access the cubicles themselves from this central passageway. Holes appeared to have been crudely cut in the back walls of the cubicles at a later date.
