# INDIA BUILDINGS, VICTORIA STREET, EDINBURGH

HISTORIC BUILDING RECORDING  
PLANNING REF. 15/04445/FUL

commissioned by India Buildings Ltd

March 2018

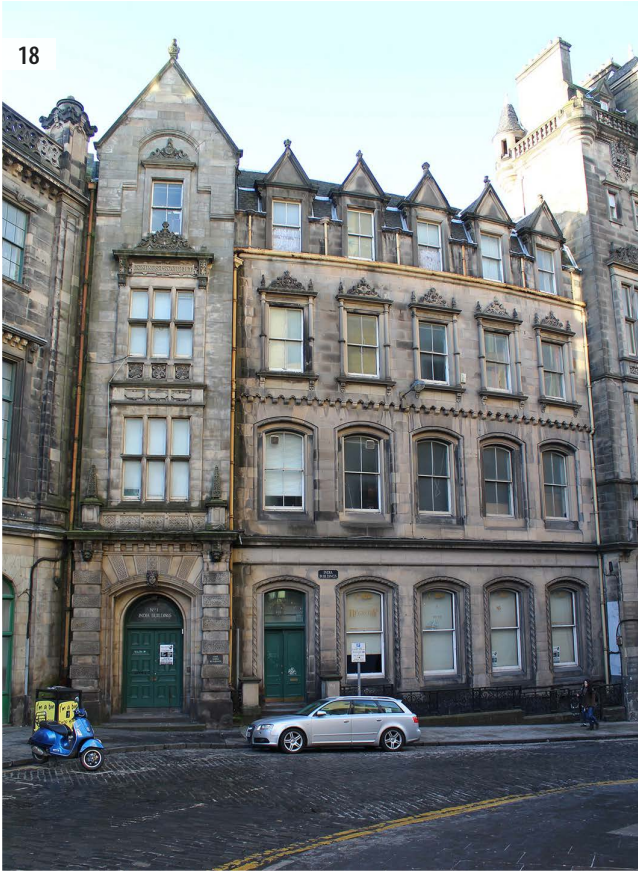
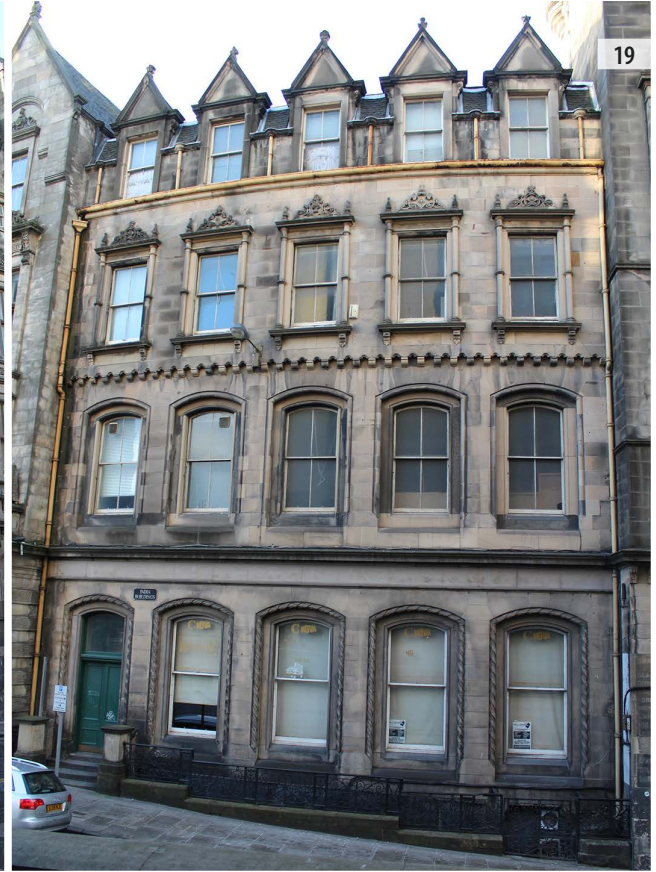
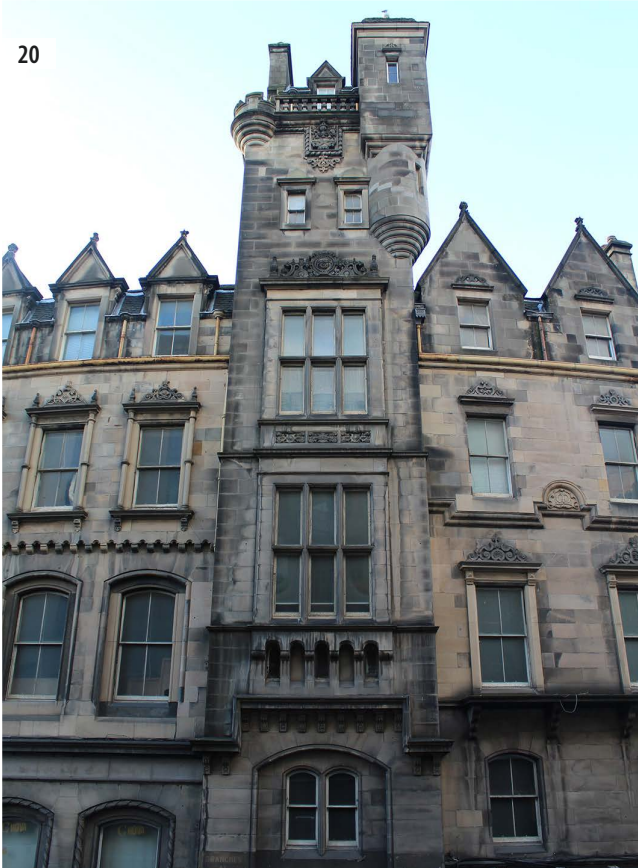
**ILLUS 18** 1-3 India Buildings north facing elevation    **ILLUS 19** 1-3 India Buildings north facing elevation    **ILLUS 20** 1-3 India Buildings north facing elevation    **ILLUS 21** India Buildings tower

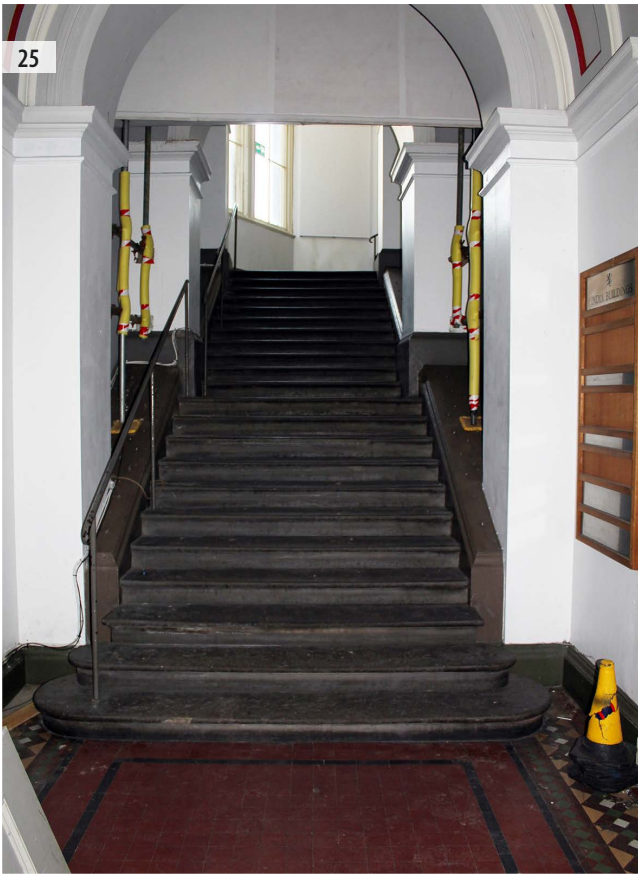
**ILLUS 25** India Buildings main staircase to first floor (IG,15)    **ILLUS 26** Victorian tile flooring in ground floor hallways (IG,1)    **ILLUS 27** Victorian tile flooring in ground floor hallways (IG,1)    **ILLUS 28** Hallway cornicing and archway to main hallway (IG, 2)    **ILLUS 29** Wood panelled room with decorative ceiling (IG,3)

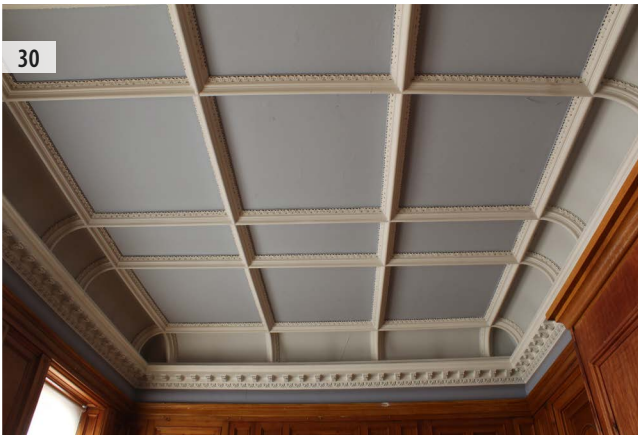
**ILLUS 30** Decorative ceiling (IG,3)    **ILLUS 31** Wood panelling, wood panelled bar covering stone fireplace (IG, 3)    **ILLUS 32** Marble fireplace surround covered by bar structure (IG, 3)    **ILLUS 33** Decorative ceiling with chandelier fittings (IG,12)    **ILLUS 34** Cornicing within IG, 12    **ILLUS 35** Cornicing in Corridor (IG,9)    **ILLUS 36** Mezzanine floor room with two recessed sash windows and original ceiling (IM,5)    **ILLUS 37** Decorative ceiling and cornicing (I1, 7)

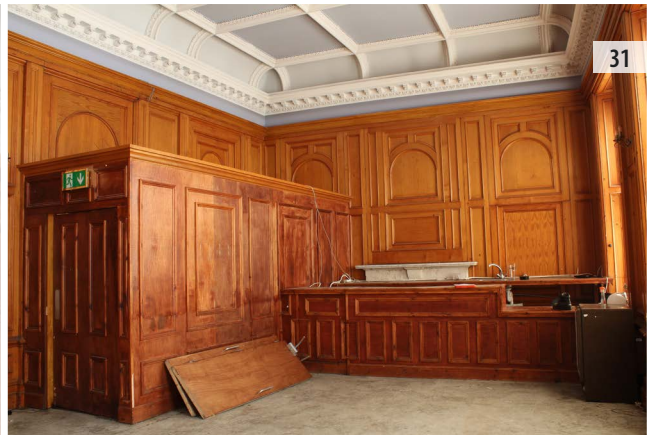
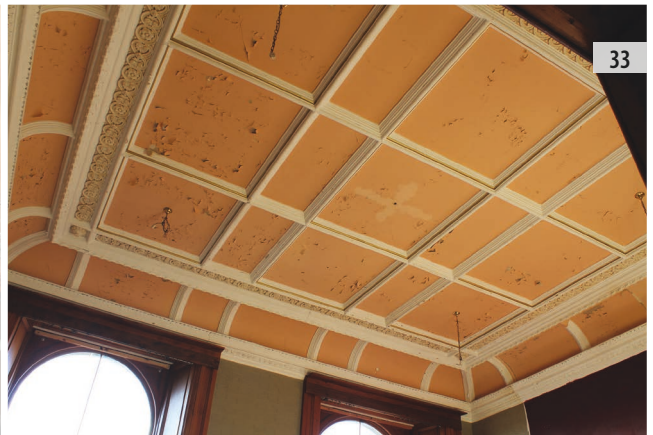
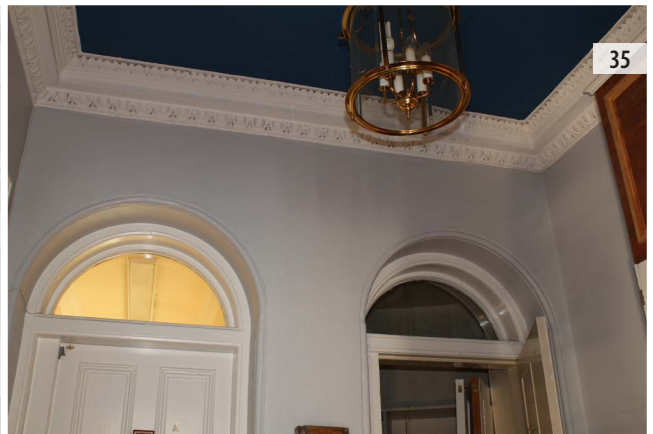
Additions were made to this panelling more recently at the western end of the room, along with a corridor to the south-west. The panelling continued into IG,4. A bar/kitchen area has been built in IG,3 with matching panelling, blocking off the fireplace (which itself is a replacement of an original fireplace), which is likely much more recent (Illus 32). The wood panelling is to be retained in Room IG,3 after conversion.

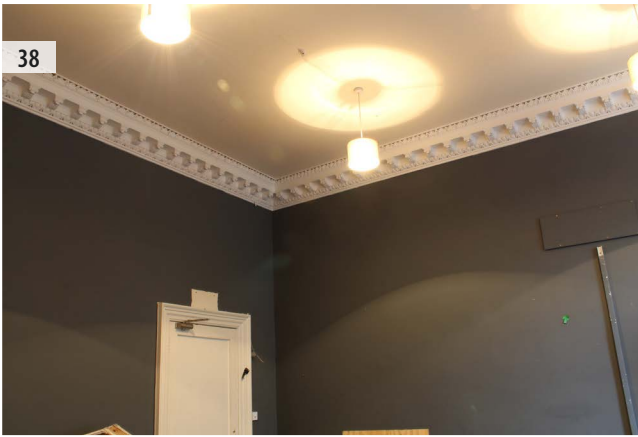
**ILLUS 38** Elaborate corning (I1, 3)    **ILLUS 39** Domed roof and balconies within atrium (I1,10)    **ILLUS 40** Rounded room wall shared with atrium (I1,12)  
**ILLUS 41** Victorian tile flooring of the atrium    **ILLUS 42** Victorian tile flooring from first floor atrium into hallways (I1,13)    **ILLUS 43** Corning with later dividing wall (I1, 1)  
**ILLUS 44** Bay windows facing onto Victoria Street (I1,19)

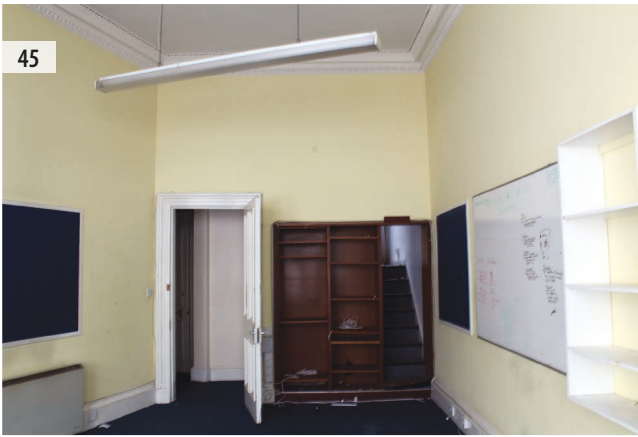
**ILLUS 45** Hidden access to room 11,20 (11,19)    **ILLUS 46** Blocked up chimney breast with vent (11,15)    **ILLUS 47** Recessed sash windows and corning typical of India Buildings 2nd floor (12,4)    **ILLUS 48** Doorways leading from atrium: modern and original (12,14)    **ILLUS 49** Detail of decorative iron work within atrium (12)    **ILLUS 50** Main room of third floor with six sash windows along northern wall (13,14)    **ILLUS 51** View of the atrium from above (13,2)

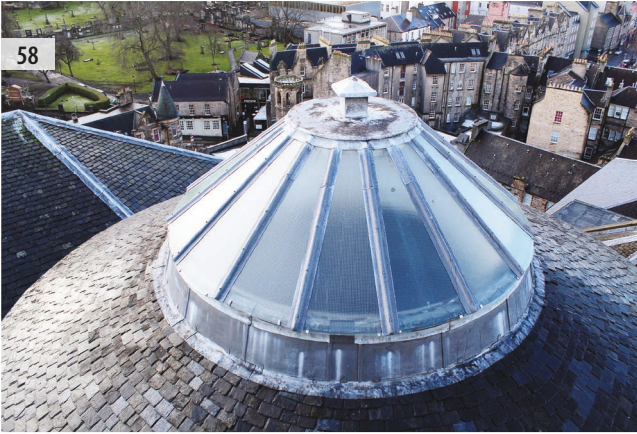
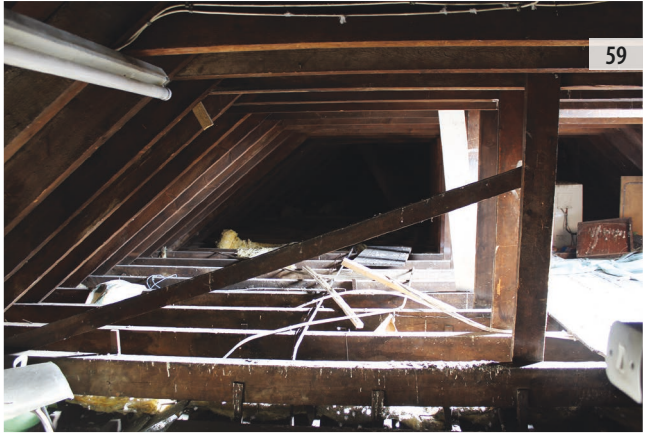
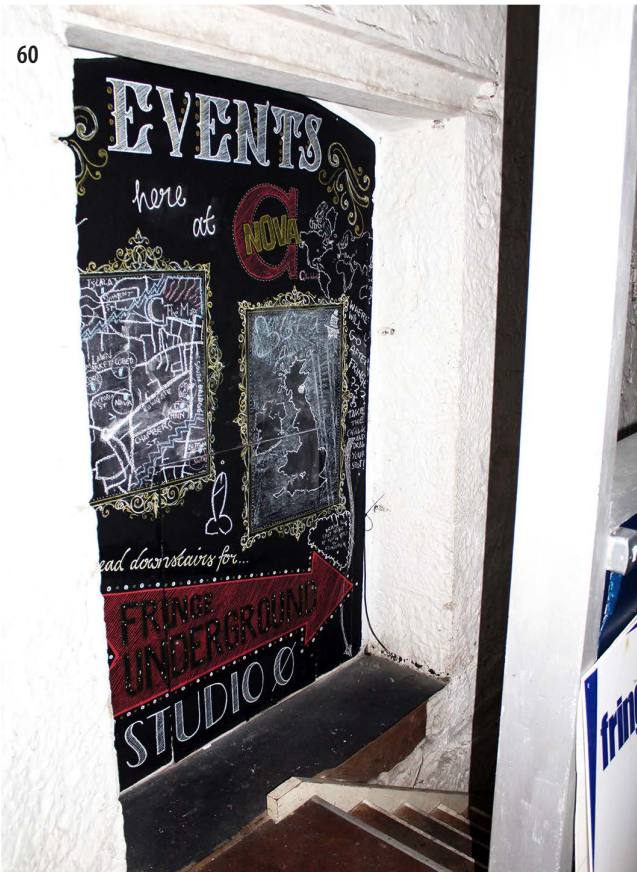
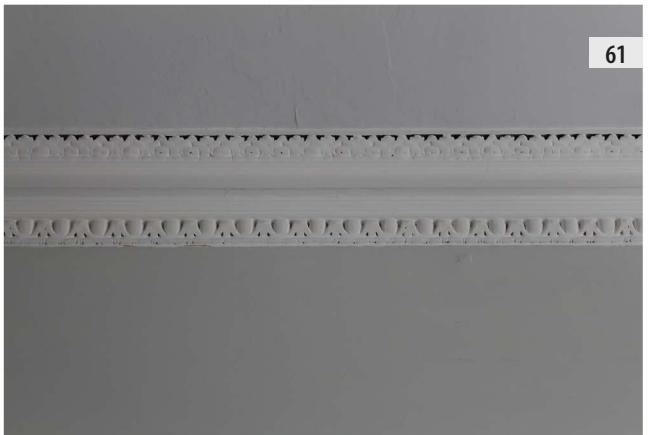
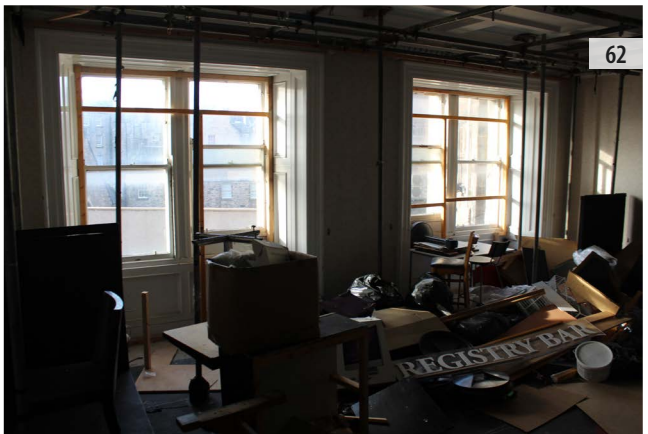
**ILLUS 52** Original atrium stairwell (I3,1)    **ILLUS 53** Roof room over western end of India Buildings (I2,20)    **ILLUS 54** Lower tower room with original fireplace (IT,1)  
**ILLUS 55** Detail of fireplace (IT, 1)    **ILLUS 56** Spiral staircase to upper tower room IT, 2    **ILLUS 57** Upper tower room with original fireplace (IT,2)

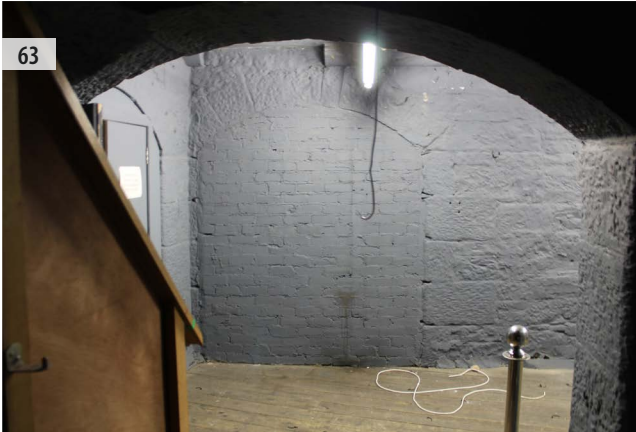
ILLUS 58 Top of atrium dome, external view    ILLUS 59 Roof space above room 13,14 (I1,3)    ILLUS 60 Re-use of blocked-up archway, staircase to I-2 (I-1,5)  
ILLUS 61 Detailing of cornice (I-1)    ILLUS 62 Double sash windows (I-1,7)    ILLUS 63 Bricked-up arch separating 4 India Buildings from 1-3 (I-2,1)

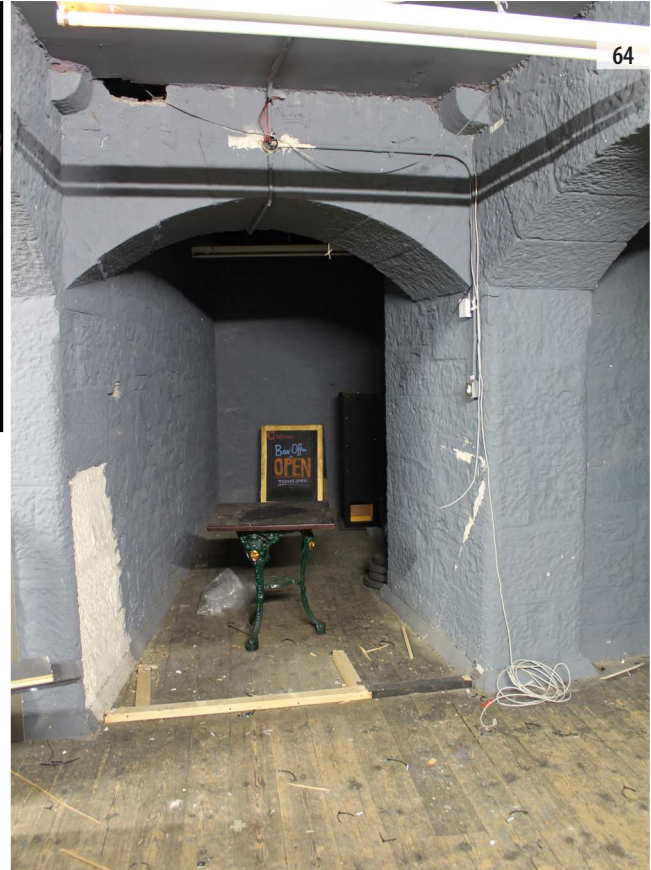
**ILLUS 63** Bricked-up arch separating 4 India Buildings from 1-3 (I-2,1)

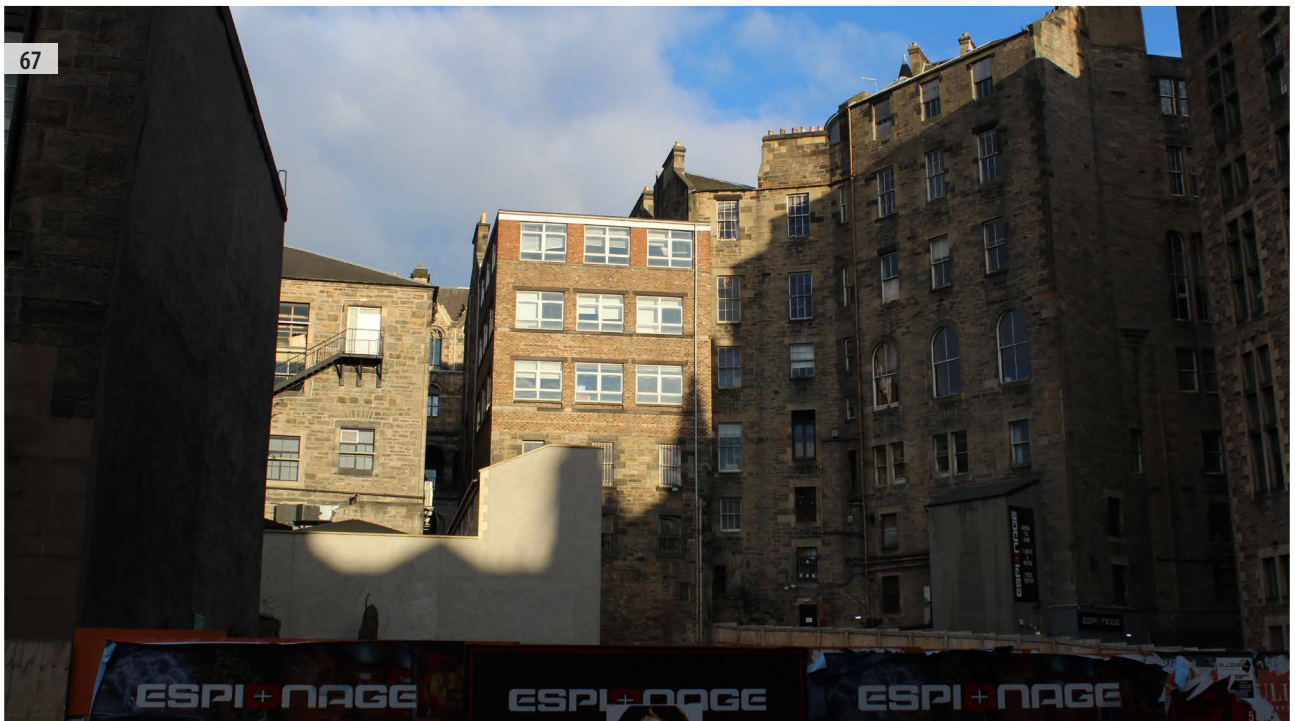
ILLUS 65 11-15 Victoria Street north facing elevation

The southern half of this floor is visibly different in construction, as seen from the external elevation with upper brick construction (Illus 67). This indicates the start of the 1898 renovation in which two extra stories were added to the rear of the building. Room V1,5 shows this divide clearly, as this room spans both sections of the building. Illus 70 shows the divide between the two construction phases through the difference of the earlier window style compared to the later (which have subsequently been replaced).

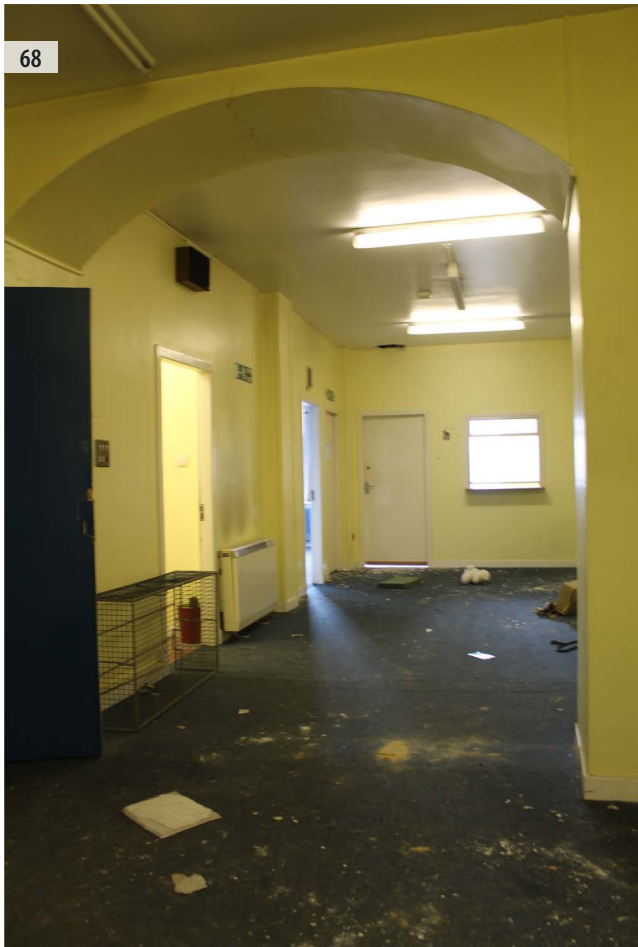
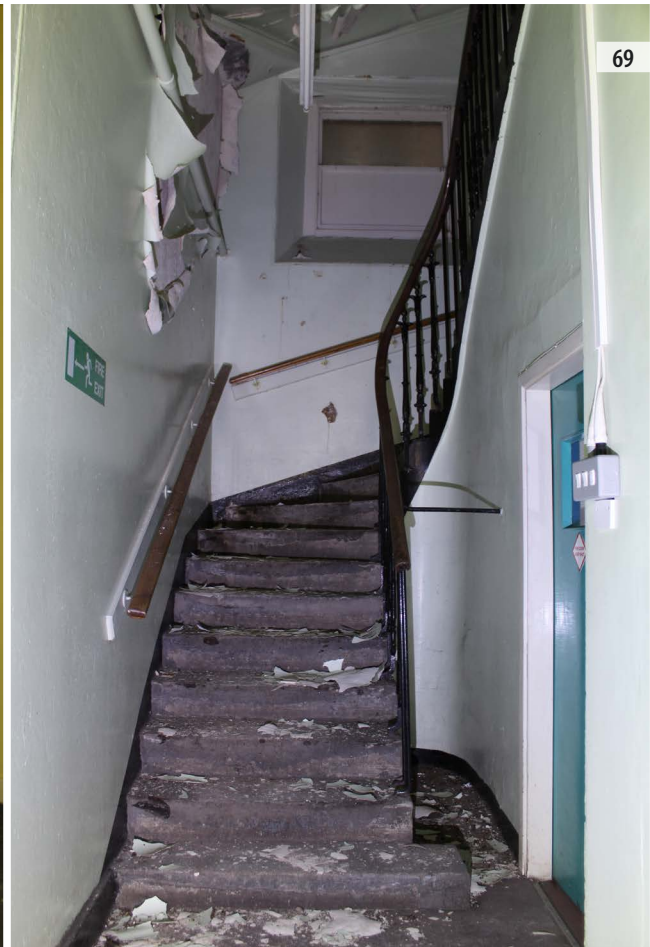
A stone staircase runs from the ground floor up to the third floor (Illus 69), with a decorative iron banister topped with a continuous wooden handrail. This is likely an original feature as it was located

**ILLUS 68** Ground floor hallway with original arch (VG,8) **ILLUS 69** Main stairwell up from ground floor (VG,15)

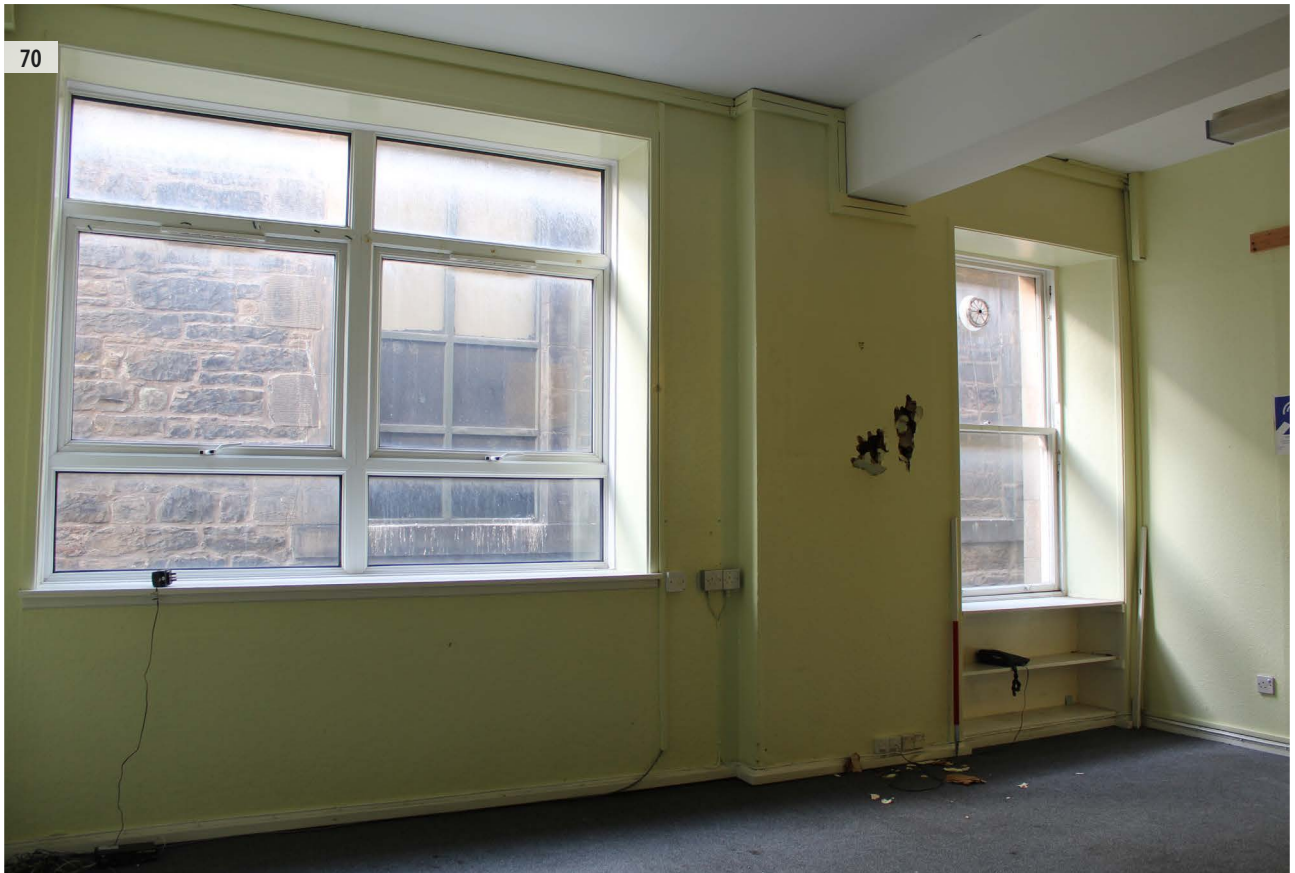
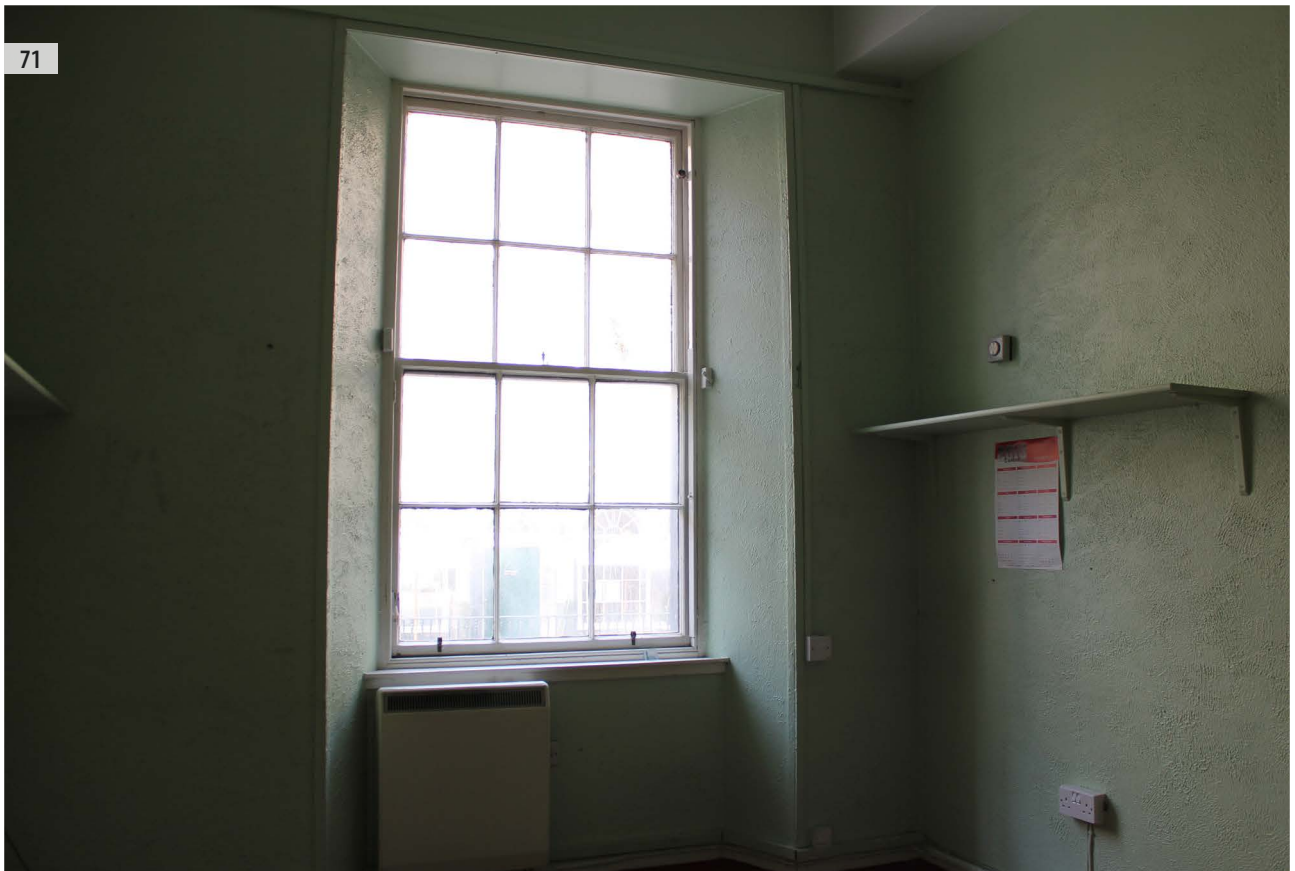
This level is subdivided into 16 rooms: V2,1 to V2,16 (Illus 7). There are slight internal differences to this floor plan compared with Floor V1. Original recessed sash windows could be seen in Rooms V2,1, V2,3 (Illus 71), V2,4, V2,5, V2,7 and V2,8, with modern replacement windows in the southern rooms. The southern extension again dates from 1898 with the four original support pillars still present. The light shaft is visible from Bathroom V2,15 and the main stairwell.

ILLUS 70 Windows in (V1,5) ILLUS 71 Room with original window (V2,3)

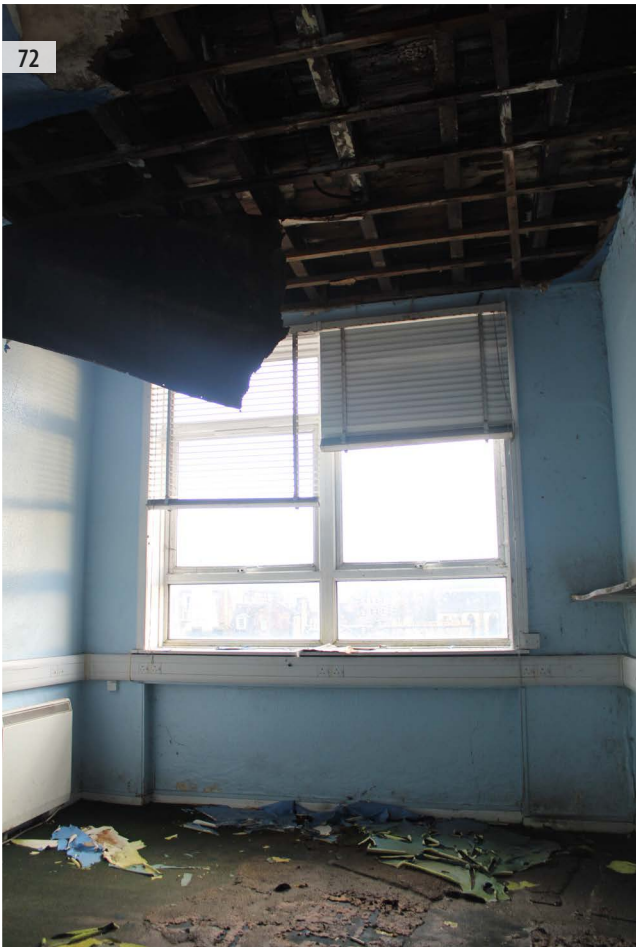
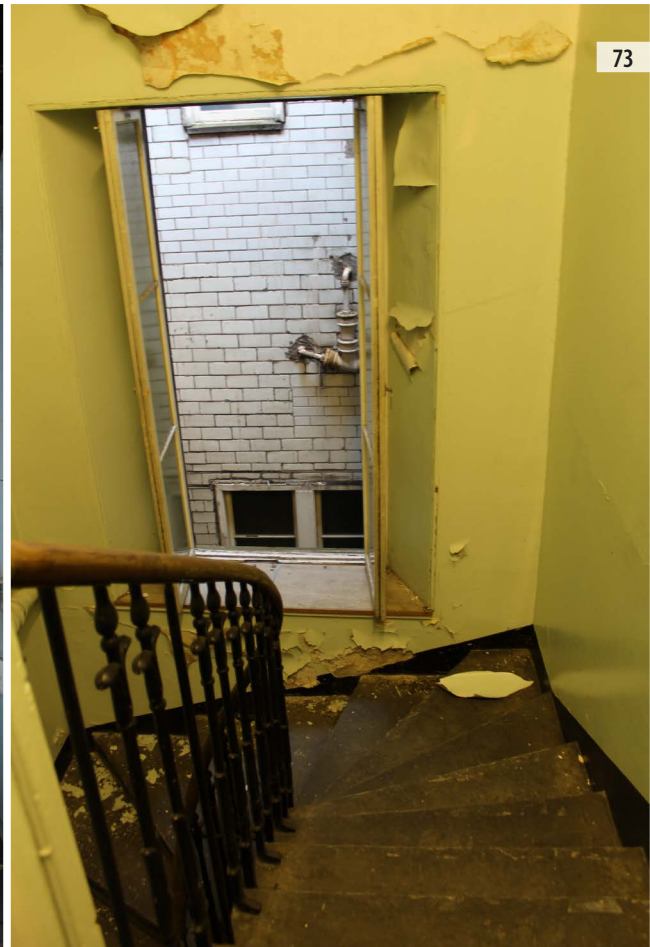
**ILLUS 72** Water damage to room (V3,11) **ILLUS 73** Shot of stairwell showing structural void through window (V3)

present (Illus 73) and provides ample light to the upper section of the staircase.

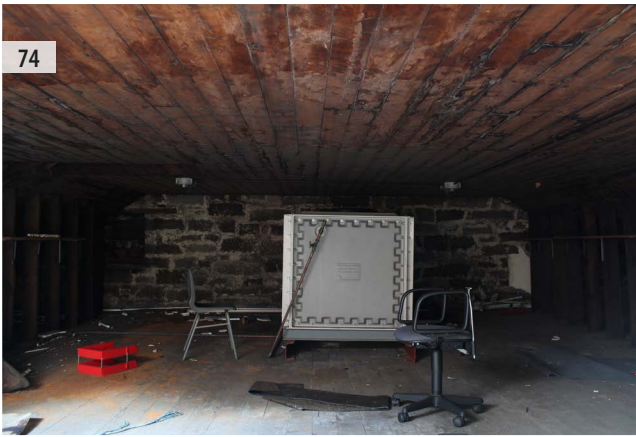
**ILLUS 74** Shot of original roof space with water tank (VR)    **ILLUS 75** Main room with original floorboards and south facing windows (V-1,5)    **ILLUS 76** Original arches with exposed beams above (V-1,3)    **ILLUS 77** Shot of bricked-up arches forming room V-1,4    **ILLUS 78** Main room of lower basement (V-2,1)

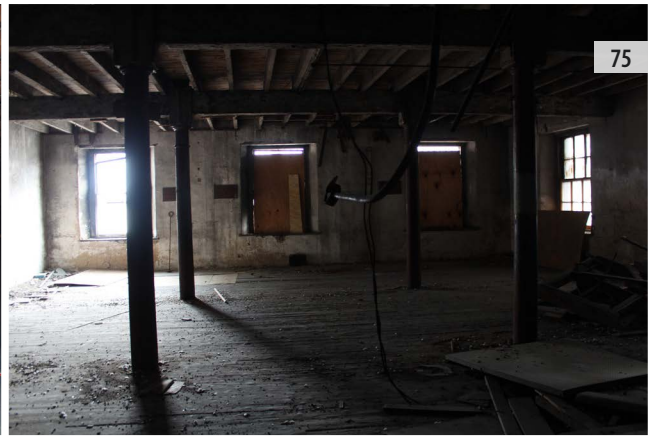
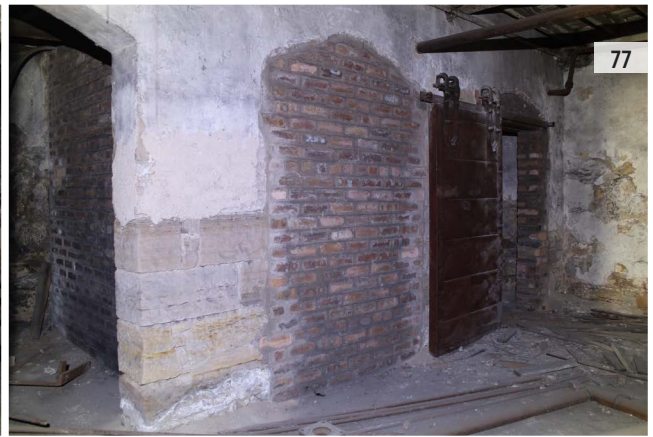
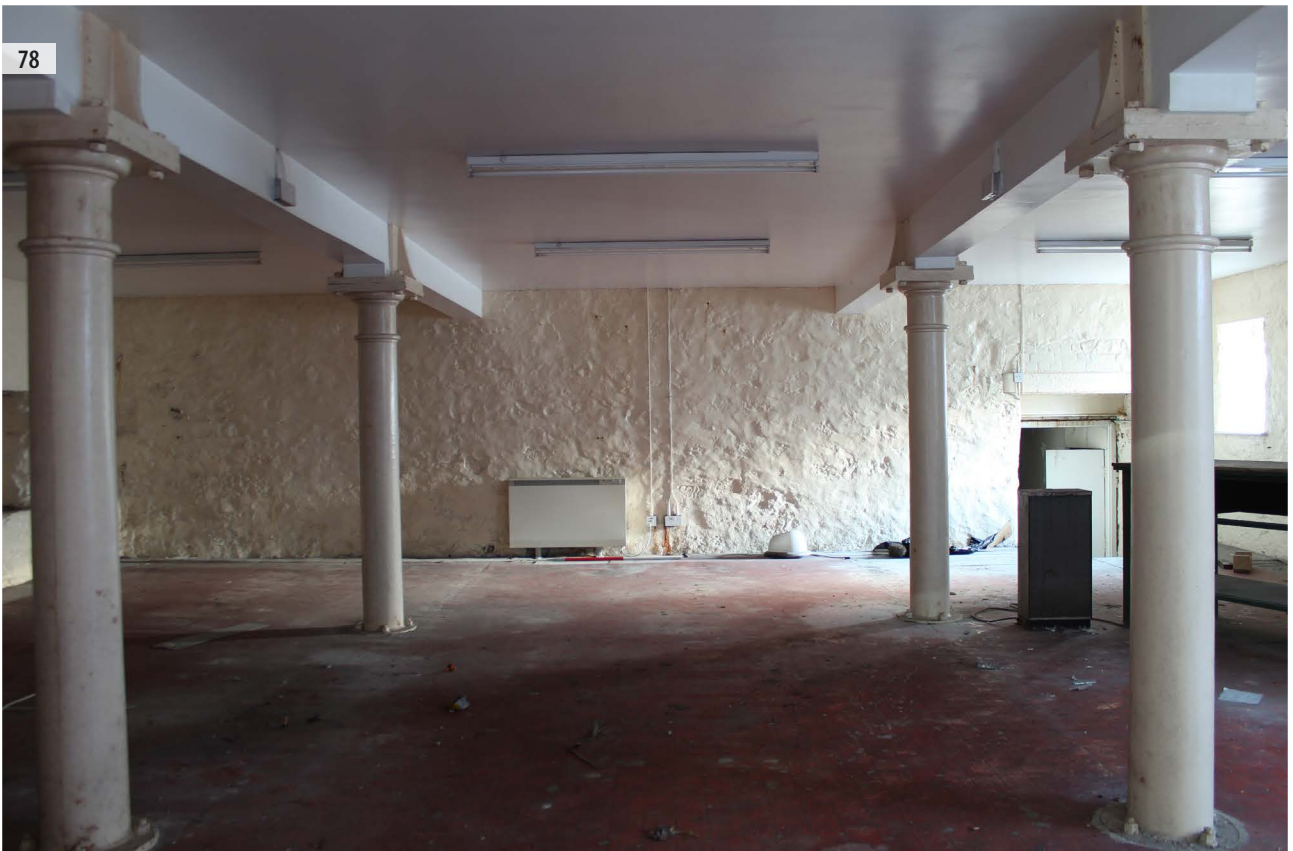
in V-1,1 and V-1,2 show significant warping and have bulges where the nails have affected the wear of the boards and are likely original. No ceiling covering is present, with exposed beams being visible throughout the level (Illus 75).

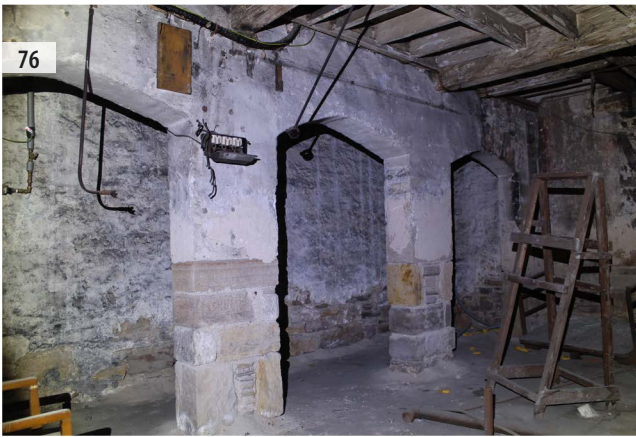
V-1,3 has undertaken alterations since 1898, with a new door and doorway being fitted in the southern wall, evidenced by brickwork around the doorway, set into the original stone walling. Two series of three arches run north-south dividing this room into three sections (Illus 76). Two arches have been bricked off in the north-eastern corner of the room to form a smaller chamber V-1, 4 (Illus 77). This chamber has a metal sliding door attached externally, and has a bricked-off exit within, leading away from the building to the west – possibly an early access into the basement.

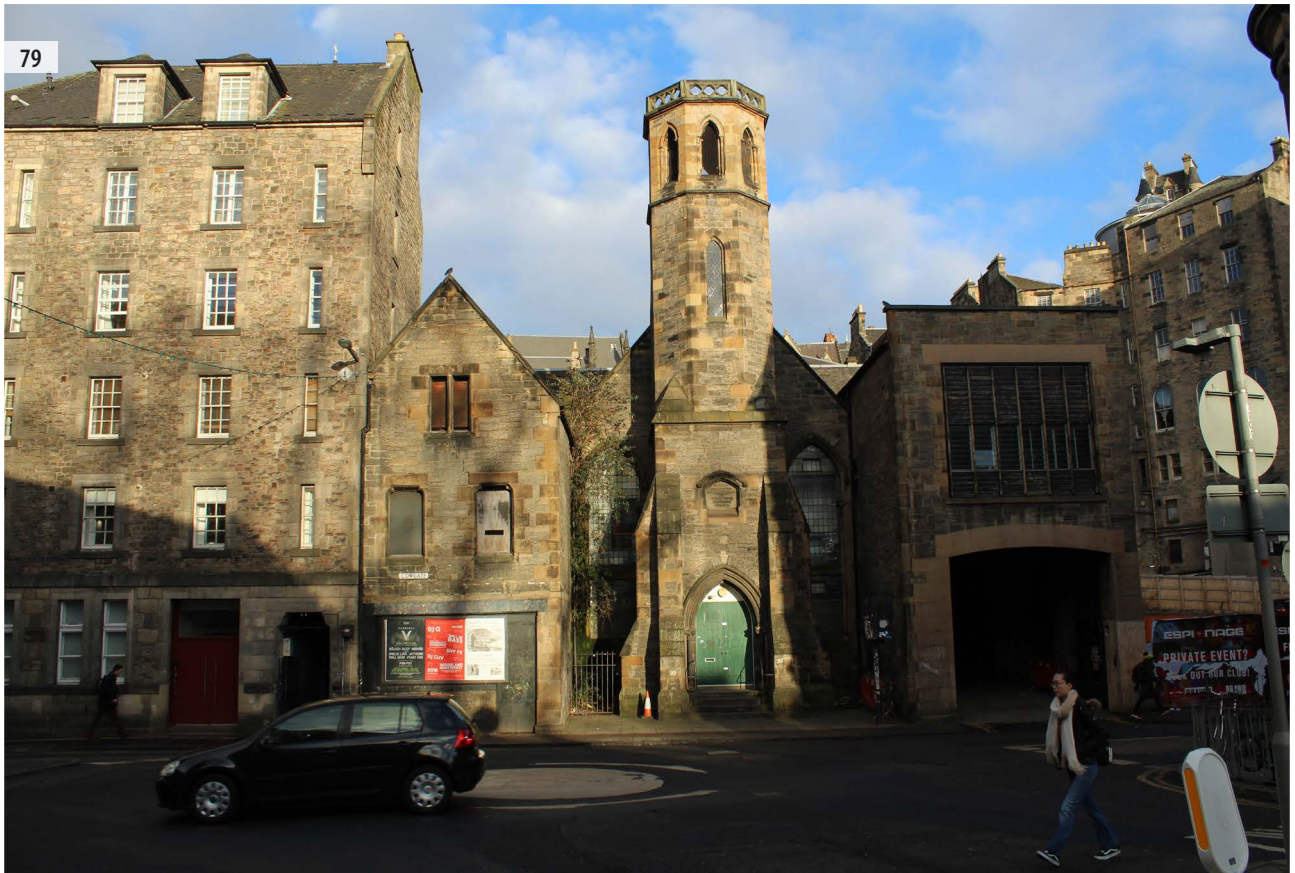
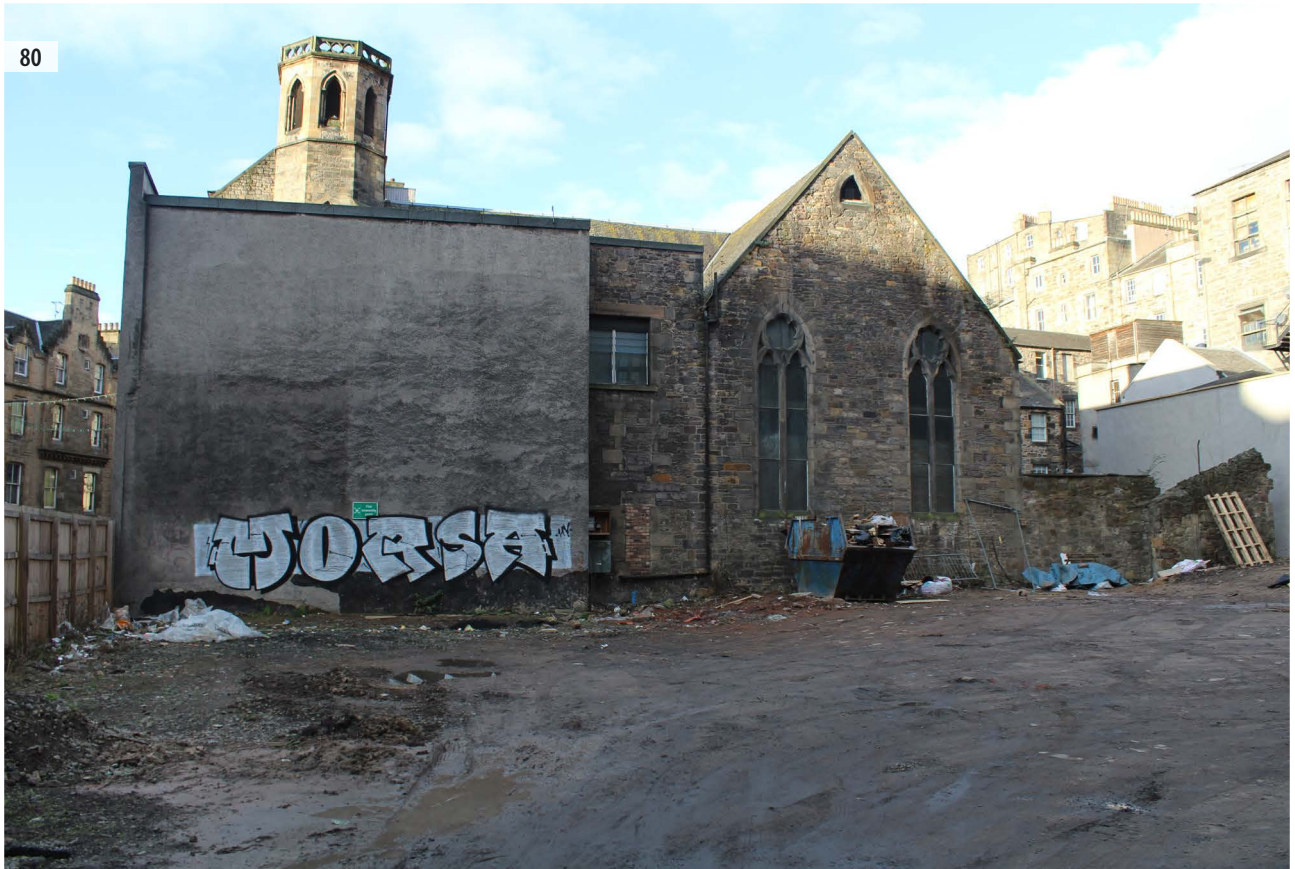
ILLUS 79 South facing elevation of Cowgatehead Church ILLUS 80 East facing elevation of Cowgatehead Church

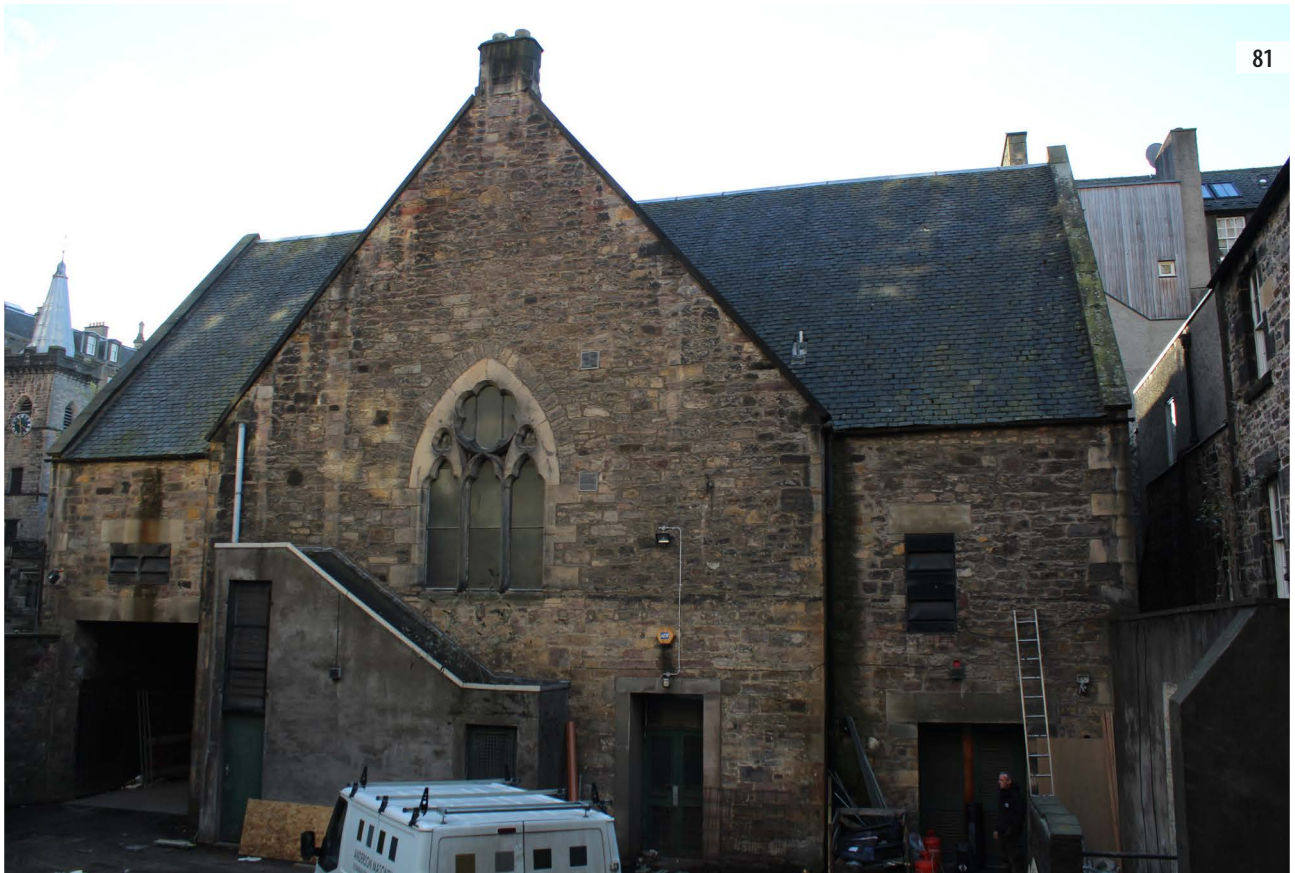
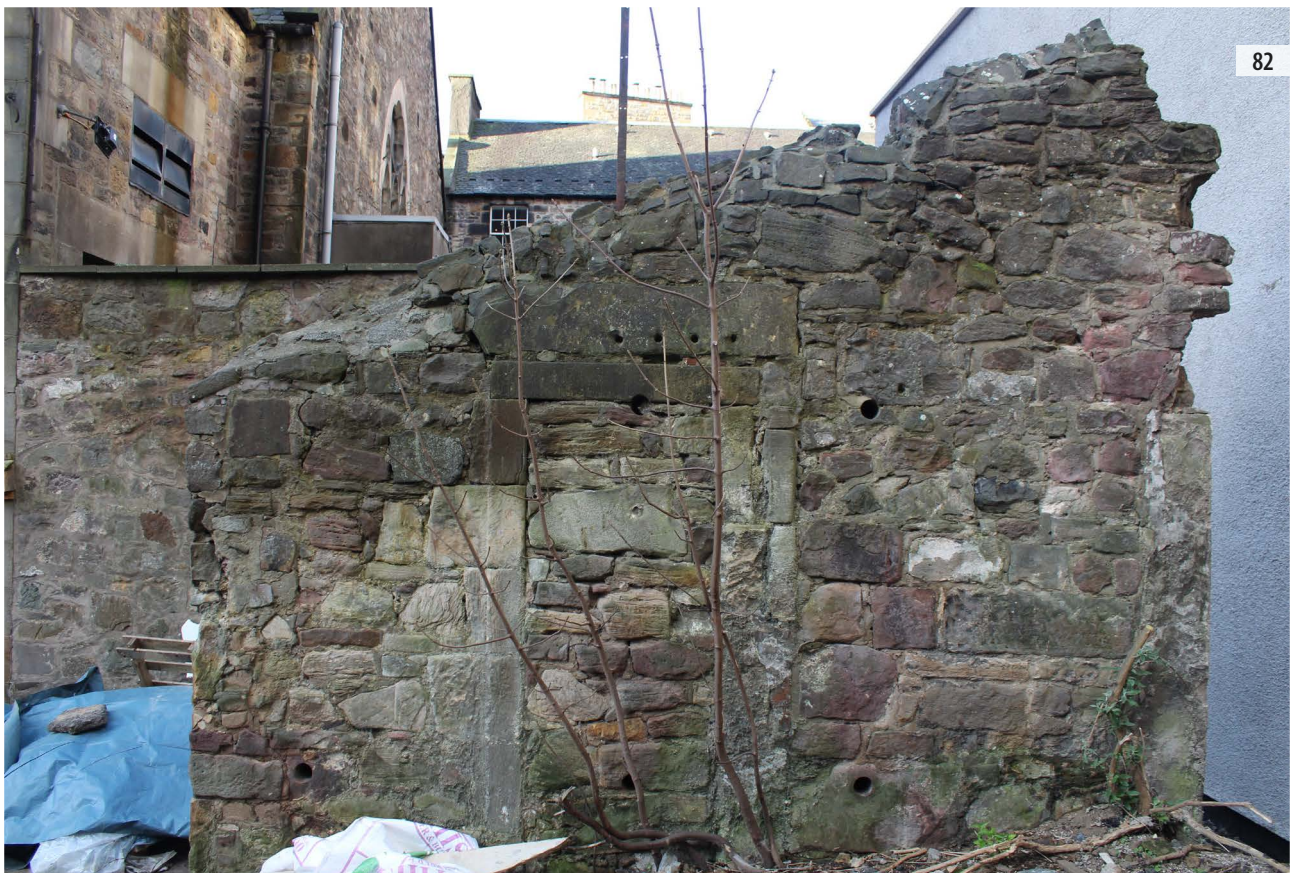
ILLUS 81 North facing elevation of Cowgatehead Church    ILLUS 82 Shot of remnant wall segment relating to Pollock's Close

The rear elevation (Illus 81) shows several modern additions to the main church building including a modern fire escape, and replaced chimney top. The original gothic windows with multifoil tracery designs are still extant with lead-framed glass panels on each of the eastern, northern and western external walls.

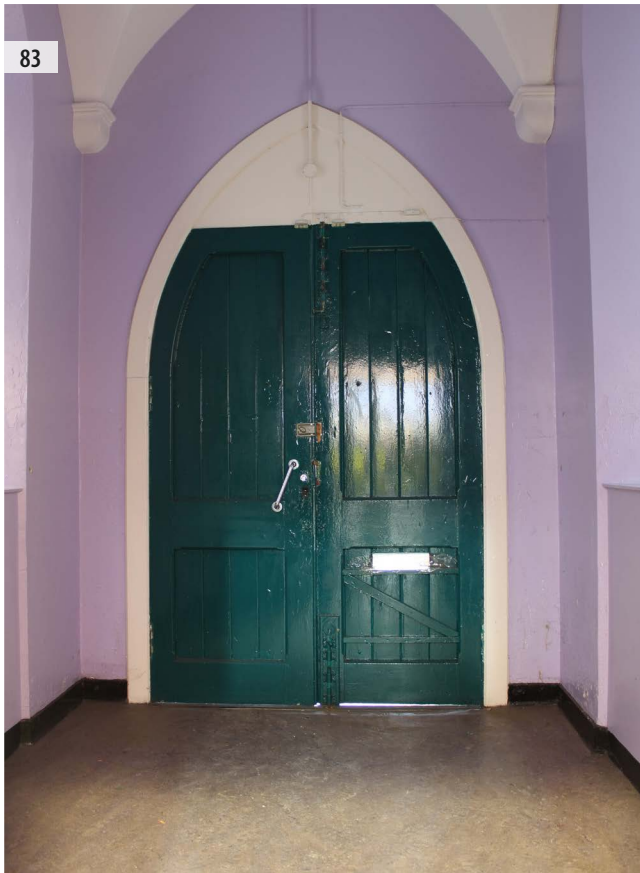
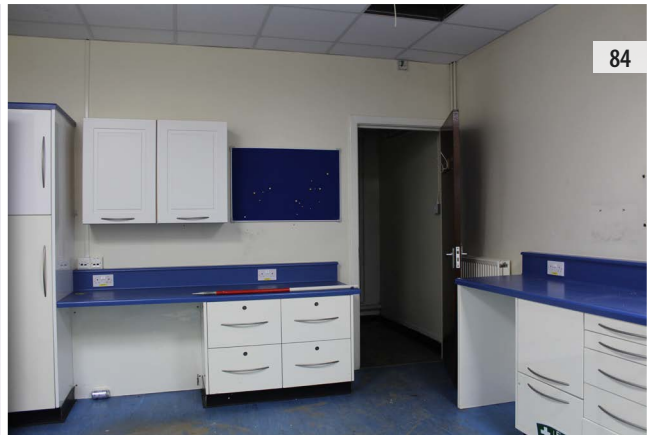
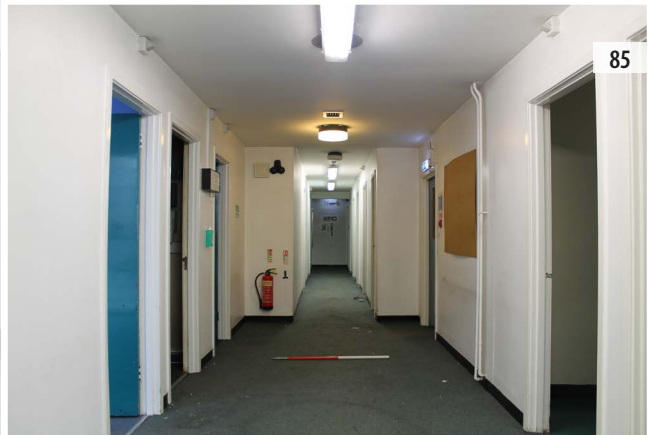
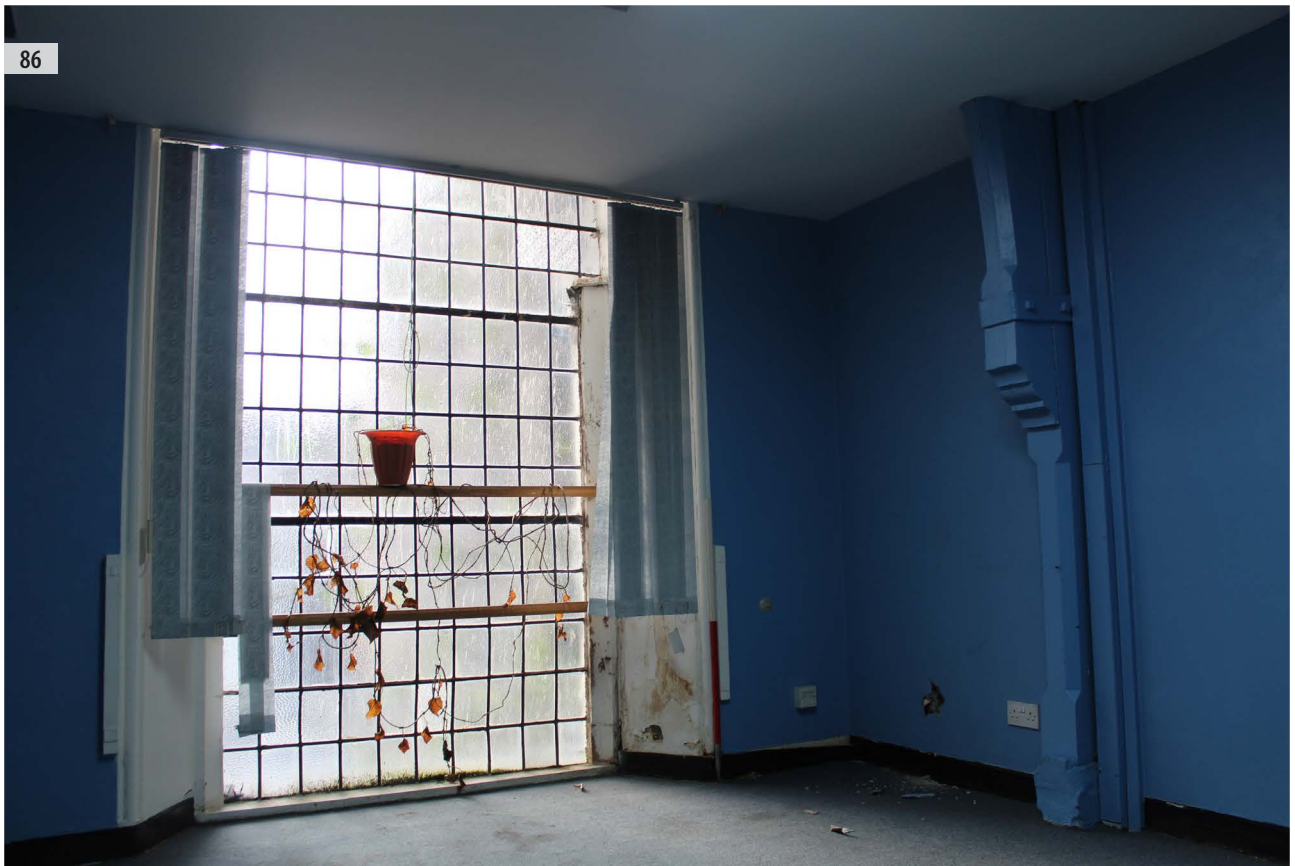
**ILLUS 83** Original narthex (CG,1)    **ILLUS 84** Modern renovations throughout including rooms for medical services (CG,18)    **ILLUS 85** Main hallway of first floor - modern partitions (C1,1)    **ILLUS 86** Original lead-frame window and roof beam within room (C1,2)
