# INDIA BUILDINGS, VICTORIA STREET, EDINBURGH

HISTORIC BUILDING RECORDING  
PLANNING REF. 15/04445/FUL

commissioned by India Buildings Ltd

March 2018

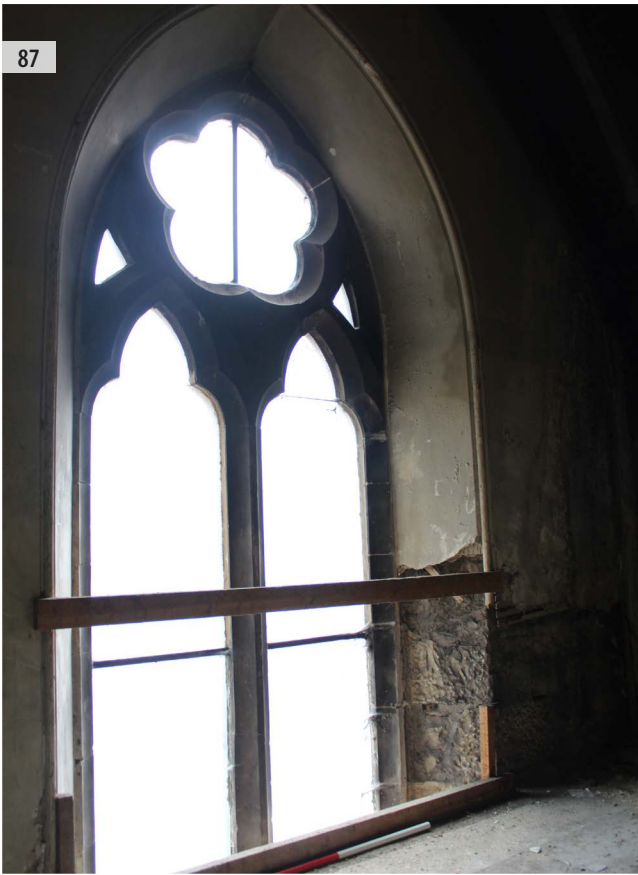
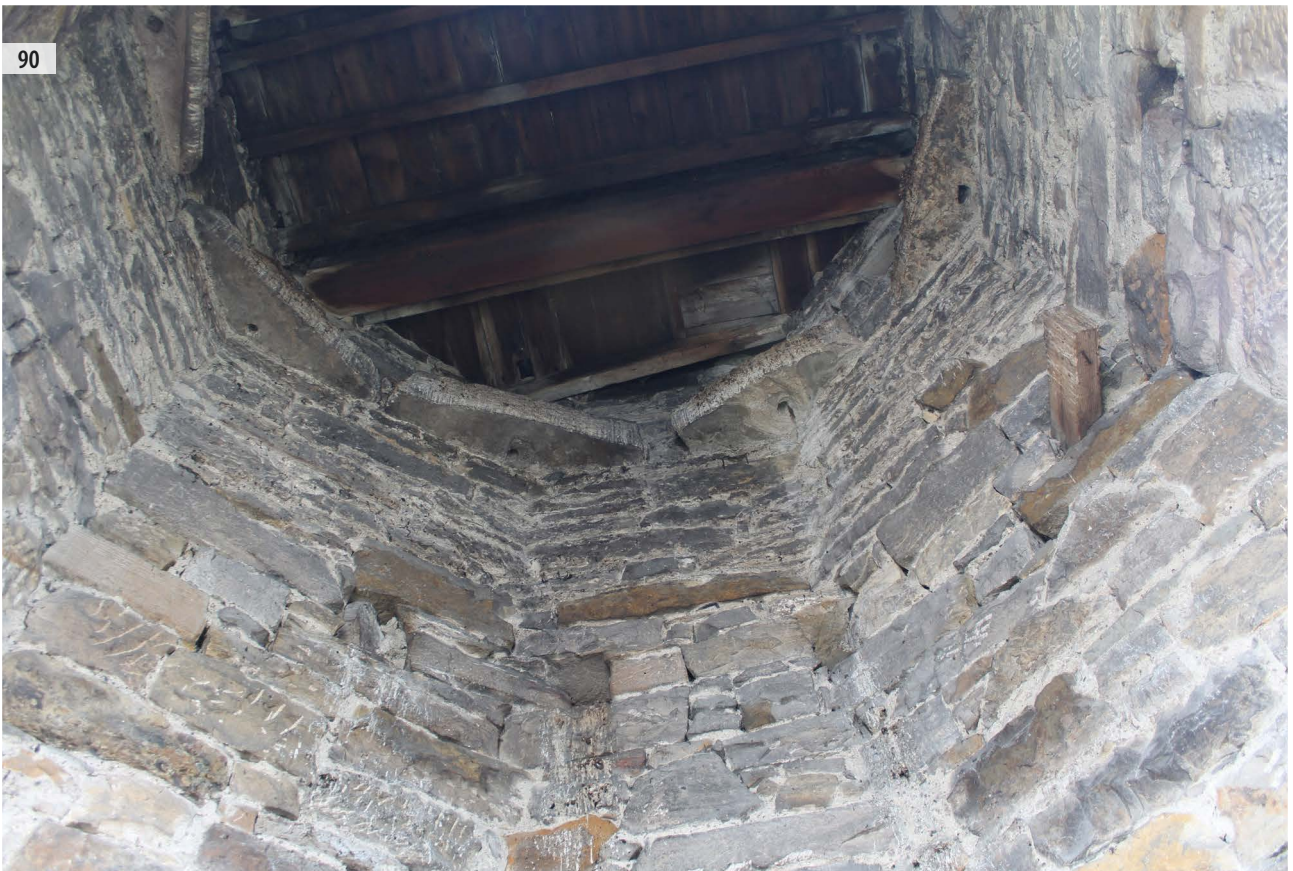
The original high arched windows with multifoil tracery and twin lancet panes remain in situ, located in the western, northern, eastern walls. These follow a typical (yet relatively simple) gothic style. The window surrounds and walls retain some of the original plaster (Illus

**ILLUS 87** East-facing original window with exposed wall fabric (CR,1)  
**ILLUS 90** Interior of the tower (CR,3)

A wooden ladder provides access to the upper floor of the tower, CR,3. Three lancet windows are located in the eastern, western and southern walls in CR,3, with access into the roof space through a small doorway to the north. The southern window contains its original diamond patterned lead-framed window, whilst the eastern and western windows had been replaced with modern safety glass. Above CR,3 heavy beams form the lower platform of the tower top. A small hatch is visible to the north (Illus 90), however no access was available at the time of the survey. An internal octagonal stone support structure is visible within the upper tower which appears to have no obvious function. It is possible that it relates to the original design of the church which included a spire atop the tower. The construction of the spire was abandoned during construction due to cost (Cross, 2015).
