25 CASTLE TERRACE, BERWICK UPON TWEED

*Archaeological Watching Brief  
for Nash Partnership*

# 25 CASTLE TERRACE, BERWICK UPON TWEED

## *Archaeological Monitoring*

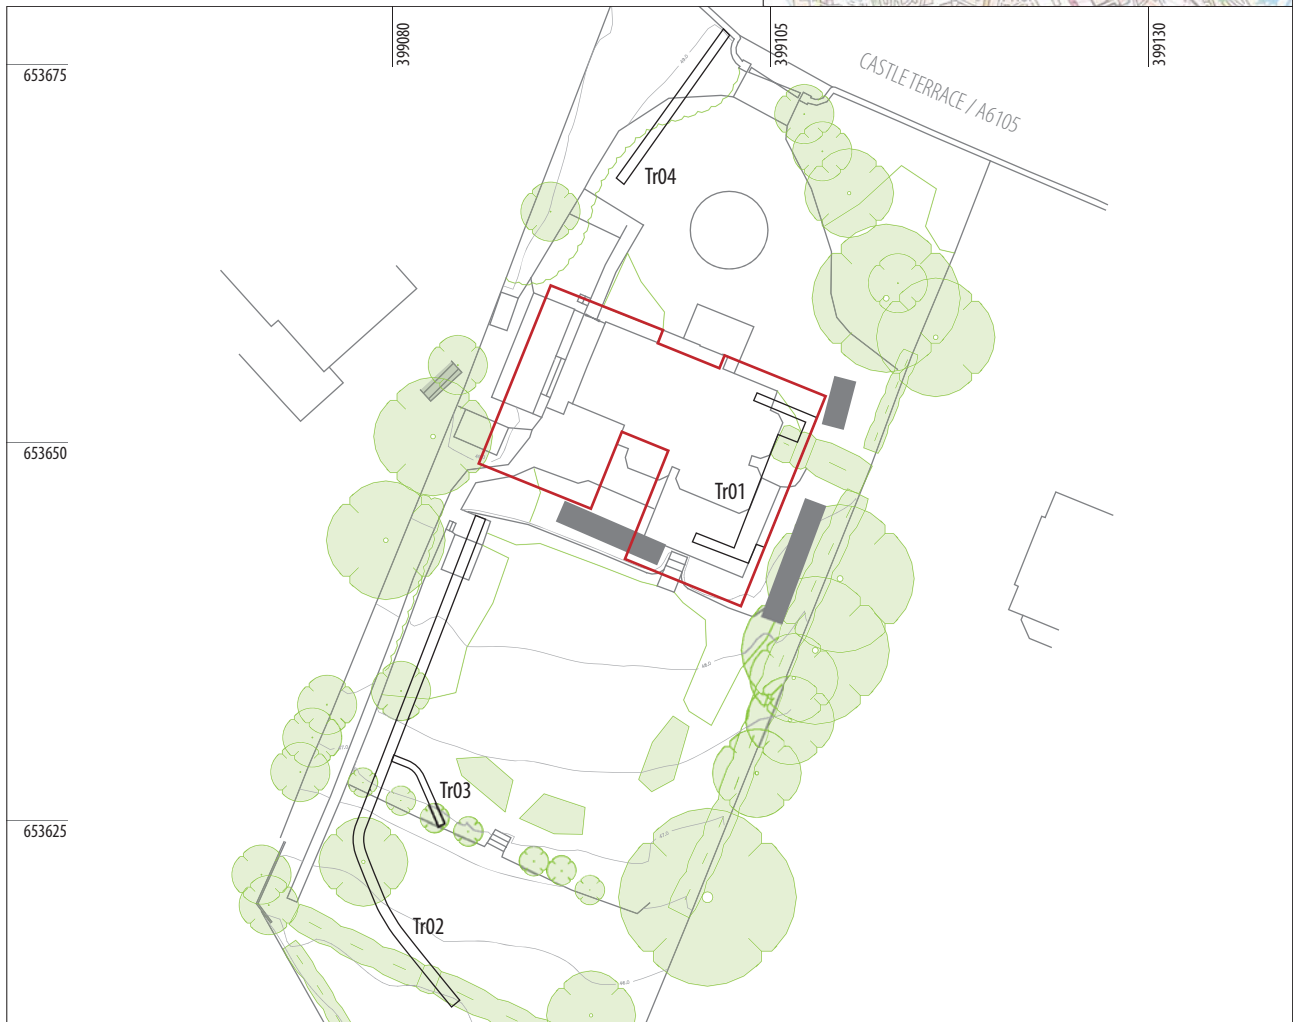
ILLUS 1  
Site location

The principle groundwork excavations comprised trenches for foundations and services within the development area. A total of four trenches were excavated (Illus. 1) comprising approximately 62.5m<sup>2</sup>. Trench one was excavated for the foundations of the new dwelling, while the remaining trenches were dug to contain services.

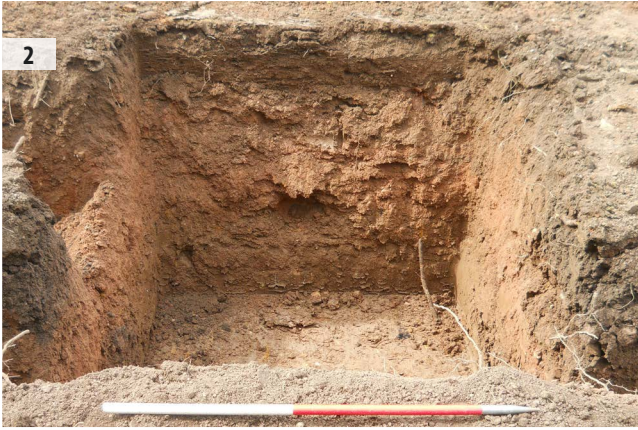
**ILLUS 2**

Trench 1 was excavated for new foundations at the eastern edge of the site to a depth of 1.7m below present ground level. It revealed sterile geological subsoil (003) of brownish grey silty clay, exposed at 1.3m depth. It was sealed by orange sandy clay (002), up to 0.75m thickness. Deposit (002) also appeared sterile and was interpreted as a redeposited layer similar to that identified in an adjacent trench during the previous evaluation phase (Wilson 2014). Overlying this was a mixed deposit (001) containing topsoil and rubble that derived from construction and demolition of the previous building. Monitoring of the remaining building footprint during grubbing out works identified a similar soil profile with no archaeological remains identified.

View of eastern facing soil profile in Trench 1

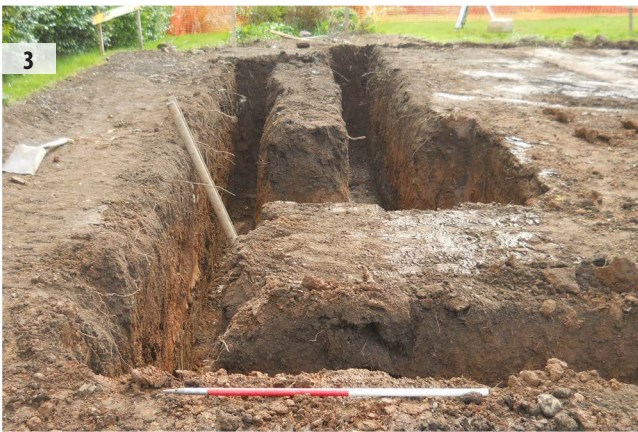
**ILLUS 3**

View of foundation trenches in eastern half of building footprint (Trench 1), from NE

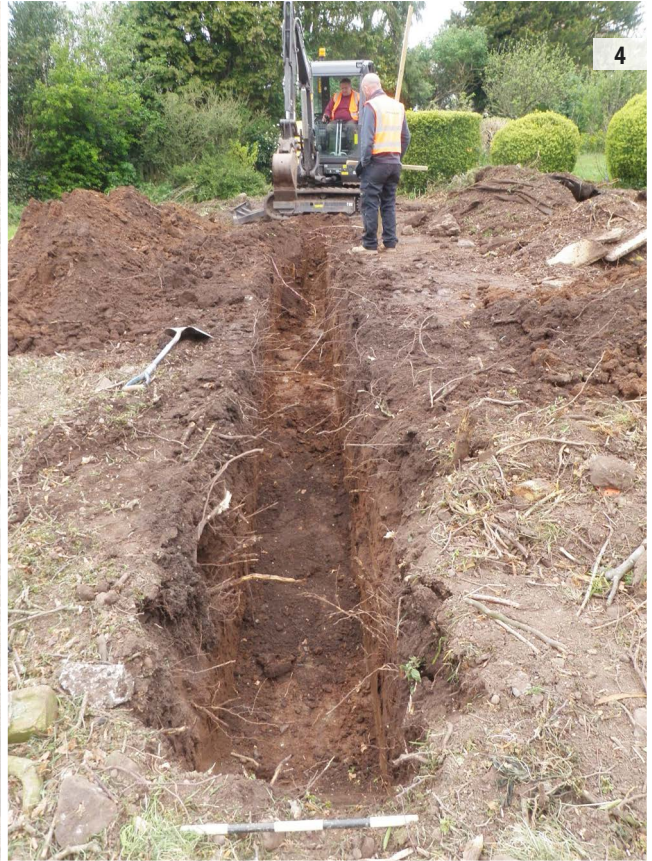
**ILLUS 4**

Trenches 2 (Illus. 4 and 5) and 3 (Illus. 6 and 7), excavated in the western half of the rear gardens for services, reached a maximum depth of 1 m. They revealed sterile, silty clay deposits of geological subsoil (006) and (005) under 0.2m of topsoil (004). No features of archaeological significance were identified.

View of south-eastern part of Trench 2, from SE

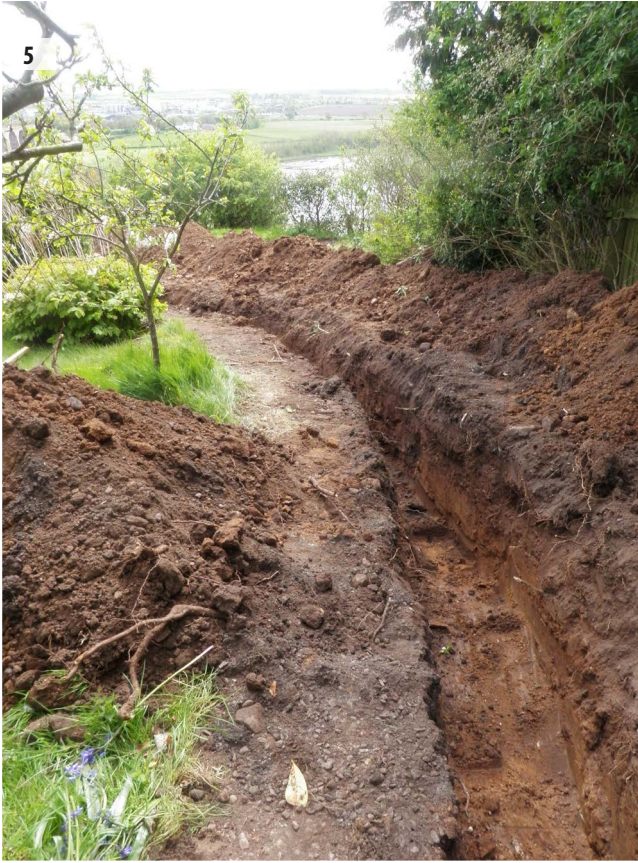
ILLUS 5

View of Trench 2 curvature, from N

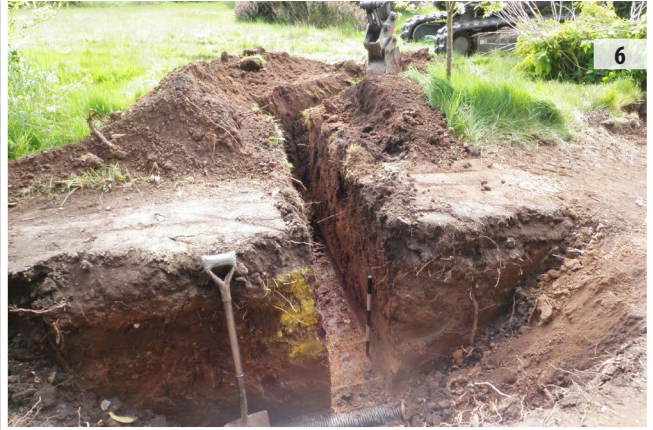
ILLUS 6

View of junction between Trenches 2 and 3, from W

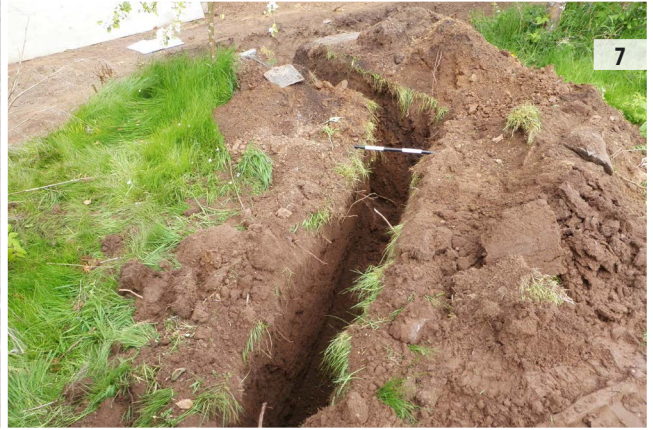
ILLUS 7

View of Trench 3, from SE

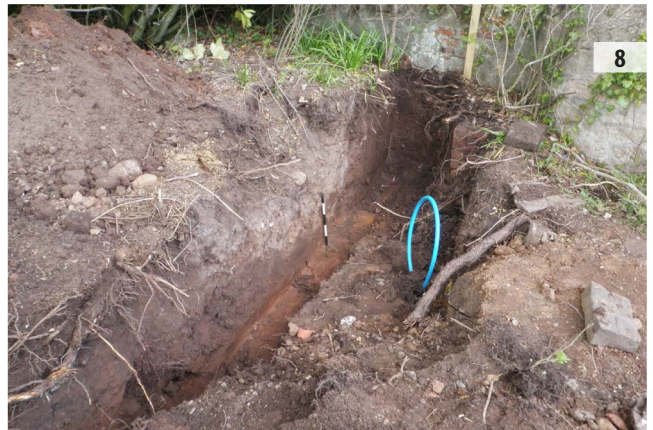
ILLUS 8

Trench 4 (Illus. 8) to the north-eastern edge of the site was excavated to a maximum depth of 1.2m. It revealed geological subsoil of compact orangey brown silty clay (006) underlying a mixed levelling deposit (007) of silty clay with fragments of modern brick, pottery and general debris; 0.6m-1m deep.

View of north limit of Trench 4, from S
