63 CALTON ROAD, EDINBURGH

*Archaeological Watching Brief and evaluation
for CSD (Calton Road) Ltd*

October 2018

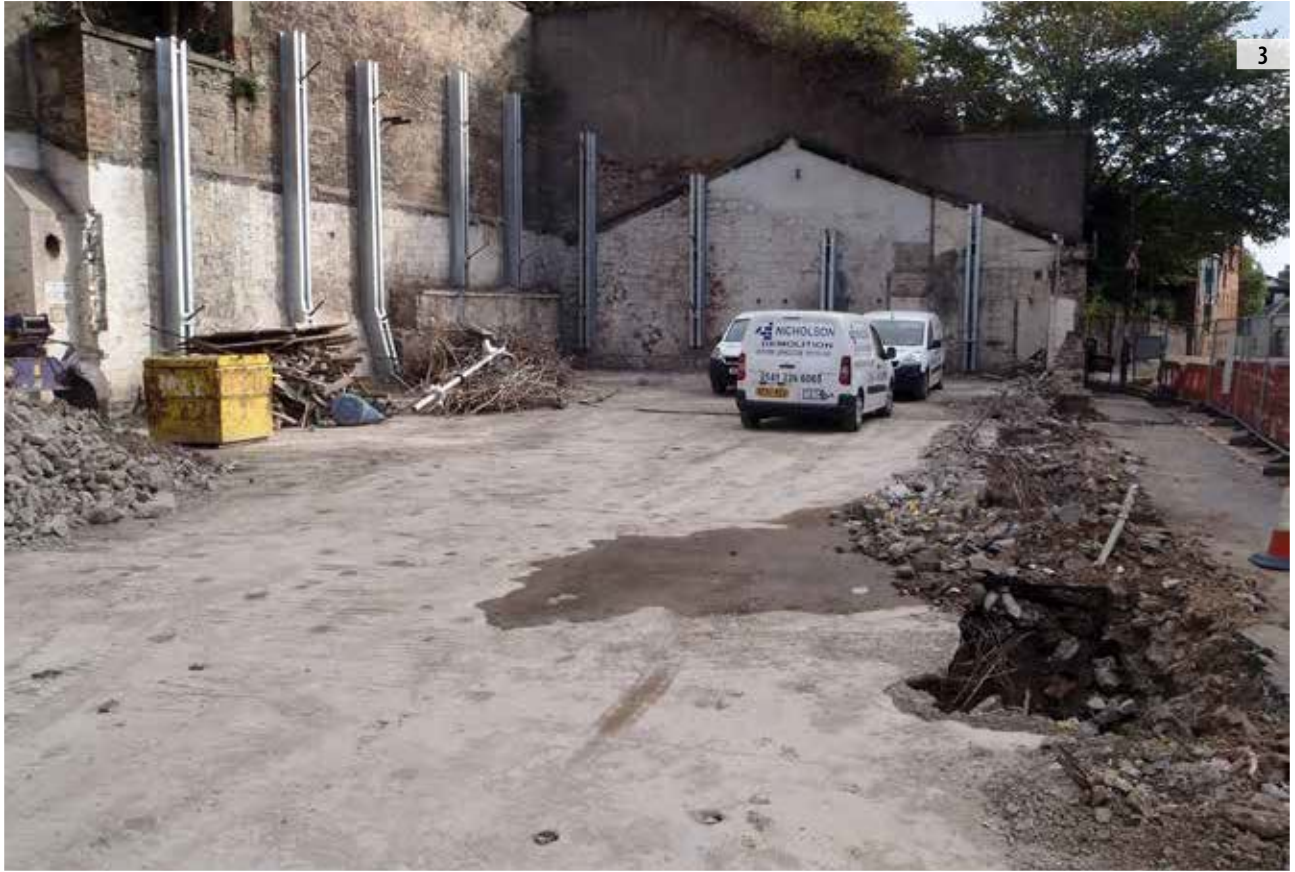
ILLUS 3 General pre-excitation view of the site

Prior to attendance the garage building had been demolished to ground floor level with the front (south) wall removed to foundation level (Illus 3). The only remaining walls were the back (north) wall and the two (east and west) gable walls. The watching brief was carried out during the removal of the concrete floor slab and all modern (20th/21st century) sub-surface features. These included three large metal fuel tanks, several brick manholes and associated piping, numerous concrete foundations and a large brick inspection pit. The depth of these features below the surface varied between 1m and 1.8m with the manholes and pipes generally being the deepest.

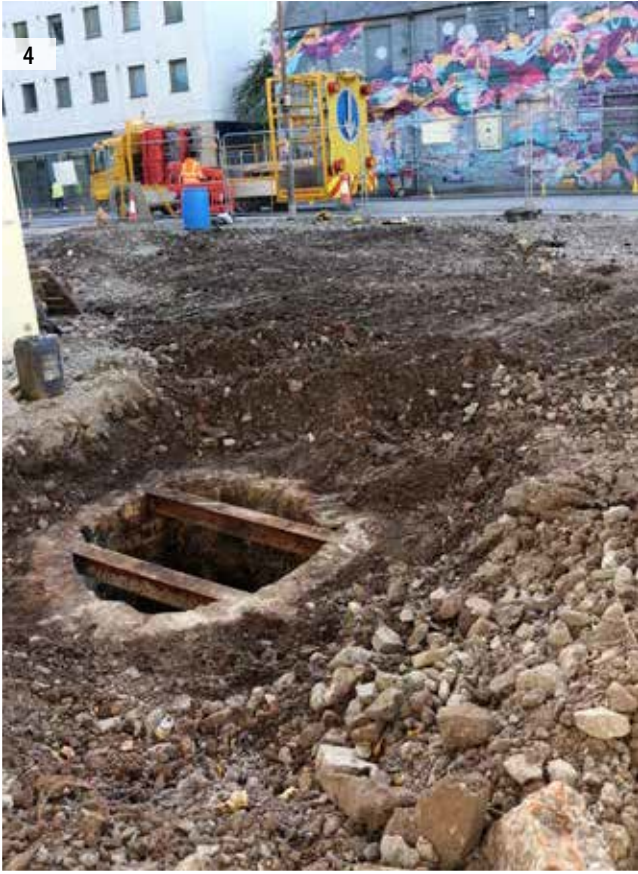
Three potentially earlier features were encountered during the watching brief. These comprised a stone-lined well cut into the bedrock to the north-west corner of the site, a small stone-lined culvert and the foundations of a stone wall both located closer to the site's southern extent. The well (c2001) had a diameter of 1.5m and was at

least 7m deep (Illus 4). The upper part of the wall of the well was constructed of squared stone to a depth of 1.1m (Illus 5), below which the bedrock was exposed (Illus 6). This was roughly cut leaving voids in the wall. A single course of brick work at the top of the well (at a height of 41m OD) supported two horizontal iron beams that had probably been placed across the top of the well to support the concrete cap that had covered the feature. The well was likely associated with the brewery and therefore 19th century in date although it is not marked on any of the historic or Ordnance Survey maps.

ILLUS 4 View of the stone-lined well **ILLUS 5** Detail of the wall of the well **ILLUS 6** Detail of the lower half of the well walls

The well was left in-situ during the demolition works and is due to be capped prior to the re-development of the site.

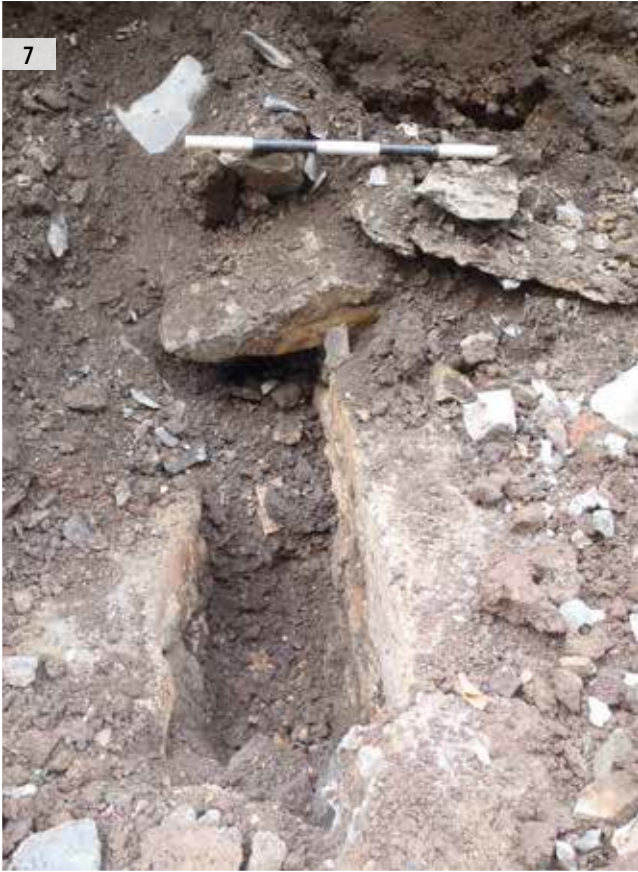
The culvert was only seen in section on the southern side of the site. This was stone-lined bonded with a course grey cement 0.25m wide and 0.5m deep and lying 1.2m below the surface (Illus 7). This seemed to be capped with stone although the disturbance in this area made this difficult to confirm. The stone wall foundation was recorded in two lengths, although its exact location was not recorded as it was disturbed by the demolition works. The first length was aligned east/west and the second, located to the east, was aligned north/south. Both walls survived to only two courses high of roughly squared stone bonded with a course grey cement indicating they probably represented two parts of the same wall. They both sat over the orange/brown geological subsoil at a depth of 0.6m below the surface. The cement bonding of these walls suggest they were of 19th/20th century origin and probably relate to the brewery phase of the site. The north/south aligned wall was located close to a further length of wall recorded during the evaluation (Tr 1, c1001) and was likely to represent part of the same structure.

ILLUS 7 View of stone-lined culvert **ILLUS 8** Detail of stone foundation with cut profile **ILLUS 9** View of the fuel tank excavations **ILLUS 10** Trench 1 facing east

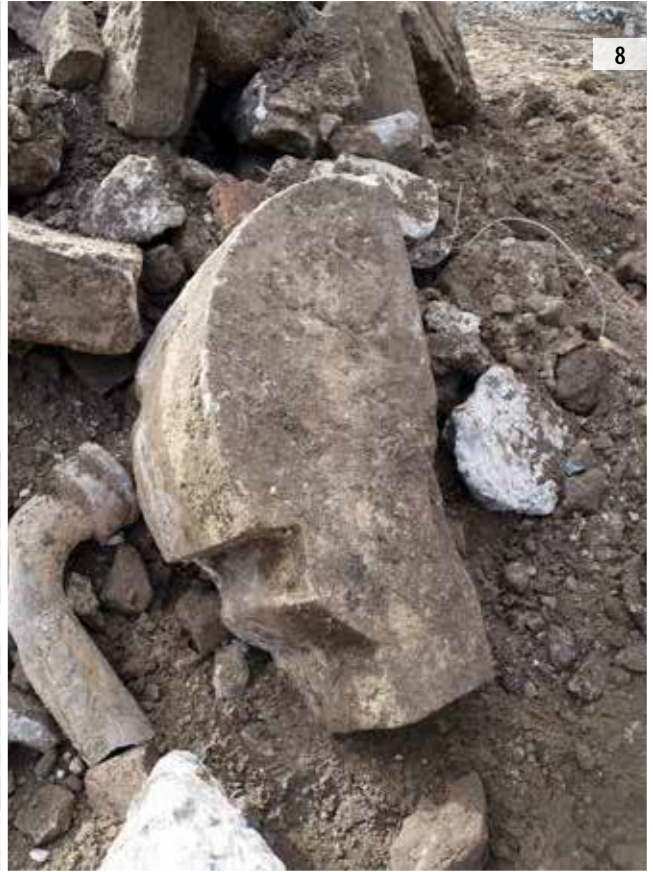
The demolition works also exposed the foundations to the south wall of the garage building. This revealed that they were placed upon a series of semi-circular stone blocks. These were likely to have been re-used stone probably from the demolition of an earlier building as one of the stones included an unusual profile (Illus 8). These may have originally been sections of stone columns.

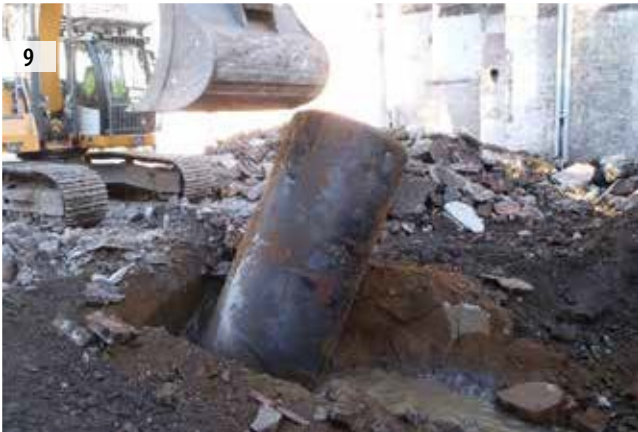
Three large fuel tanks were removed during the demolition works (Illus 9). These were each sat over concrete foundations and were likely to be associated with the 20th century garage. The size of these tanks inevitably disturbed much of the surrounding area as they had been placed below ground floor level.

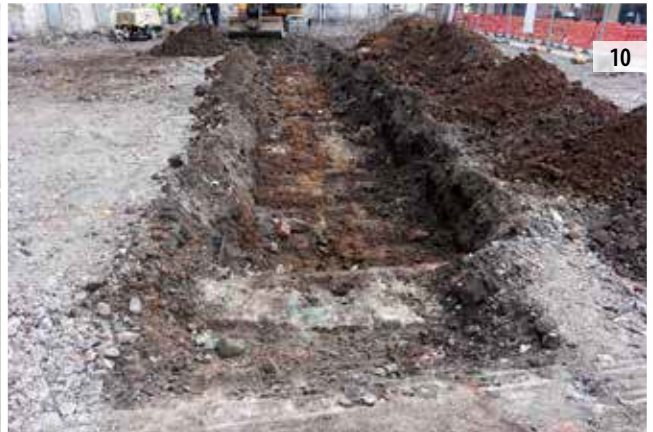
Trench 1 (Illus 10) was aligned east/west and excavated to a maximum depth of 0.8m. This exposed a further length of the stone wall (c1001) initially exposed during the watching brief. The wall was aligned north/south constructed of roughly squared stone bonded with a course grey cement. It was 0.45m wide and 0.25m below the surface standing 0.6m high. The wall abutted the orange brown subsoil to the east and had made ground to the west. The remainder of the trench was excavated to the geological subsoil although areas of modern disturbance cutting this were recorded.
