Project Code: HWL07  
Date: 27<sup>th</sup> August 2007  
Client: WRE Thomson's Children's Trust

## **Halmyre Mains, West Linton, Scottish Borders Historic Building Recording**

Planning References: 06/01950/FUL

## Project Summary Sheet

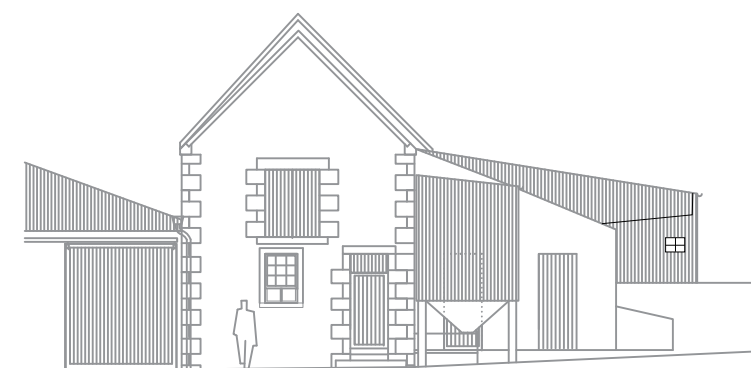
Figure 7: HWL07, Halmyre Mains Farm - Building 4

Summary Description: Two storey long range aligned SE-NW. Random rubble with dressed margins. It is built on sloping ground. Higher SE block has 1892 date stone. Lower NW block was raised and had 2 upper floors at one stage (now removed). The lean-to on the SW side is later 19<sup>th</sup> century. A later lean-to was attached in the 20<sup>th</sup> century.

Interior: The SE block contains 2 rooms flanking a central cross passage. The north room is now used as a garage, the loft is now removed. The other room has trevies and saddle racks and was used as a stable (accessed from the NE courtyard). The lean-to currently houses an electric power plant from the 1930s and line shafting powering a workshop and providing power into the barn (probably to power a thresher). The upper storey of the lean-to houses grain elevators and a hopper down to a grain bruiser on the basement level. The higher SE lean-to building is used as general storage and as a garage.

The large NW block houses a grain silo with grain elevators running up to the SW lean-to. The first and second floors have been removed – only a small area of loft (supported on corbelling) survives at the NW end. A full-height internal wall has been removed. The openings in the SW wall at first floor height are inserted or altered. This block has probably been raised. The NW elevation has an original window with glazing and shutters.

The basement of the lean-to houses a 1936 35hp electric motor built by Brooks of Huddersfield. The motor is belt-drive and powered line shafting suspended on metal brackets and running into the other basement room (probably a workshop with a belt driven saw bench). A large fuse board (probably of the same date) has fuses for the manager's house, the calf shed, hammer mill, small byre, turnip shed and garage. A hammer mill was used on farms to mill grain into course flour for feeding to livestock.

Assessment: Rubble built barn, probably used for threshing and other pre-production. Multiple phases including significant alteration in the 1890s. Interesting and complete electric powered belt drives from the 1930s.

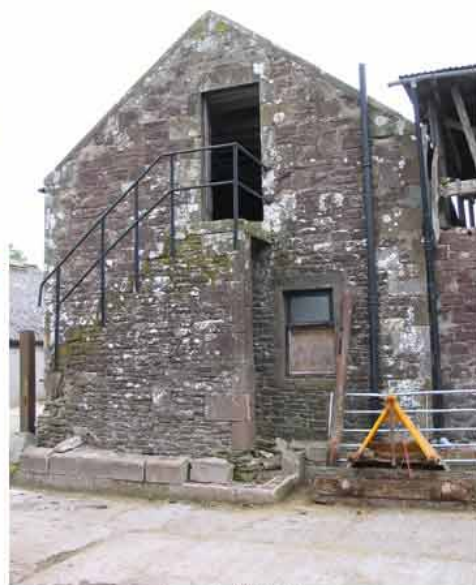
hwl07-3-21.jpg

- Building 1 – SW group including 5-bay cartshed with hay loft (3-21)
- Building 2 – NE range, stables (1-17)
- Building 3 – SE range, byre and cottage (3-04)
- Building 4 – SW range, barns (4-21)
- Building 5 and Building 6 - modern sheds (4-07, 4-18)
