CLYDE WATERFRONT AND RENFREWSHIRE RIVERSIDE

HISTORIC BUILDING RECORDING

PLANNING REF. 17/0486/PP

May 2019

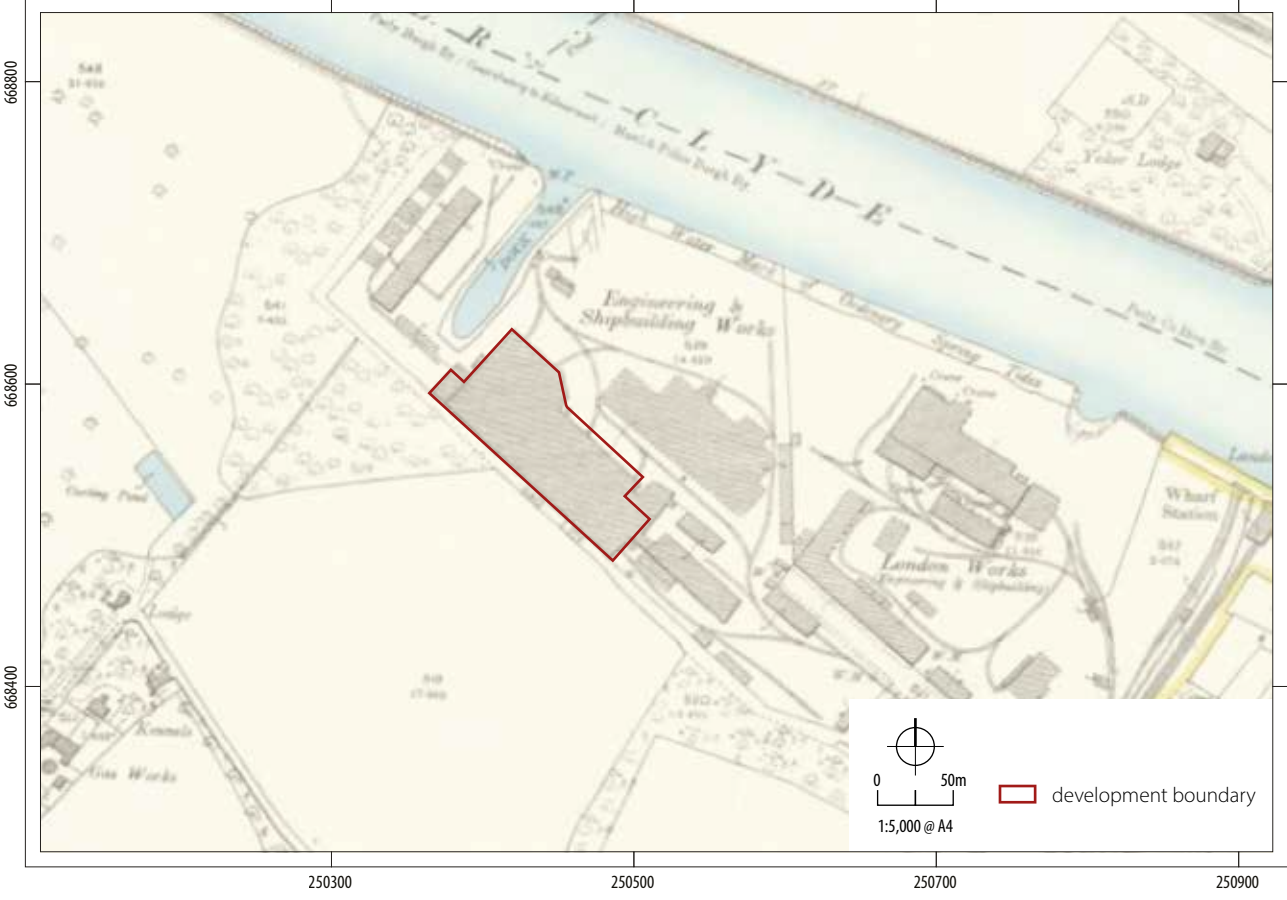
ILLUS 2 Extract from 1857 OS ILLUS 3 Extract from 1897 OS

The 1897 Ordnance Survey (Illus 3) seems to depict the two yards as a single entity with several large buildings, trackways and associated buildings spread across the site. This included the infilling of part of the wet dock and removing the slipway. This may have been a result of a change in construction techniques or a change in the styles of ships being built here by the turn of the century. At this time the two companies of Simons (east yard) and Lobnitz (west yard) were still separate entities. This map also shows that a further shipbuilding yard belonging to J and G Thompson had been established (1871) to the north side of the Clyde at this time. It was not apparent from this map if the original shed to the south of the site, as depicted on the 1857 Ordnance Survey, had been demolished or incorporated into the larger shed now depicted as occupying the area. Over the

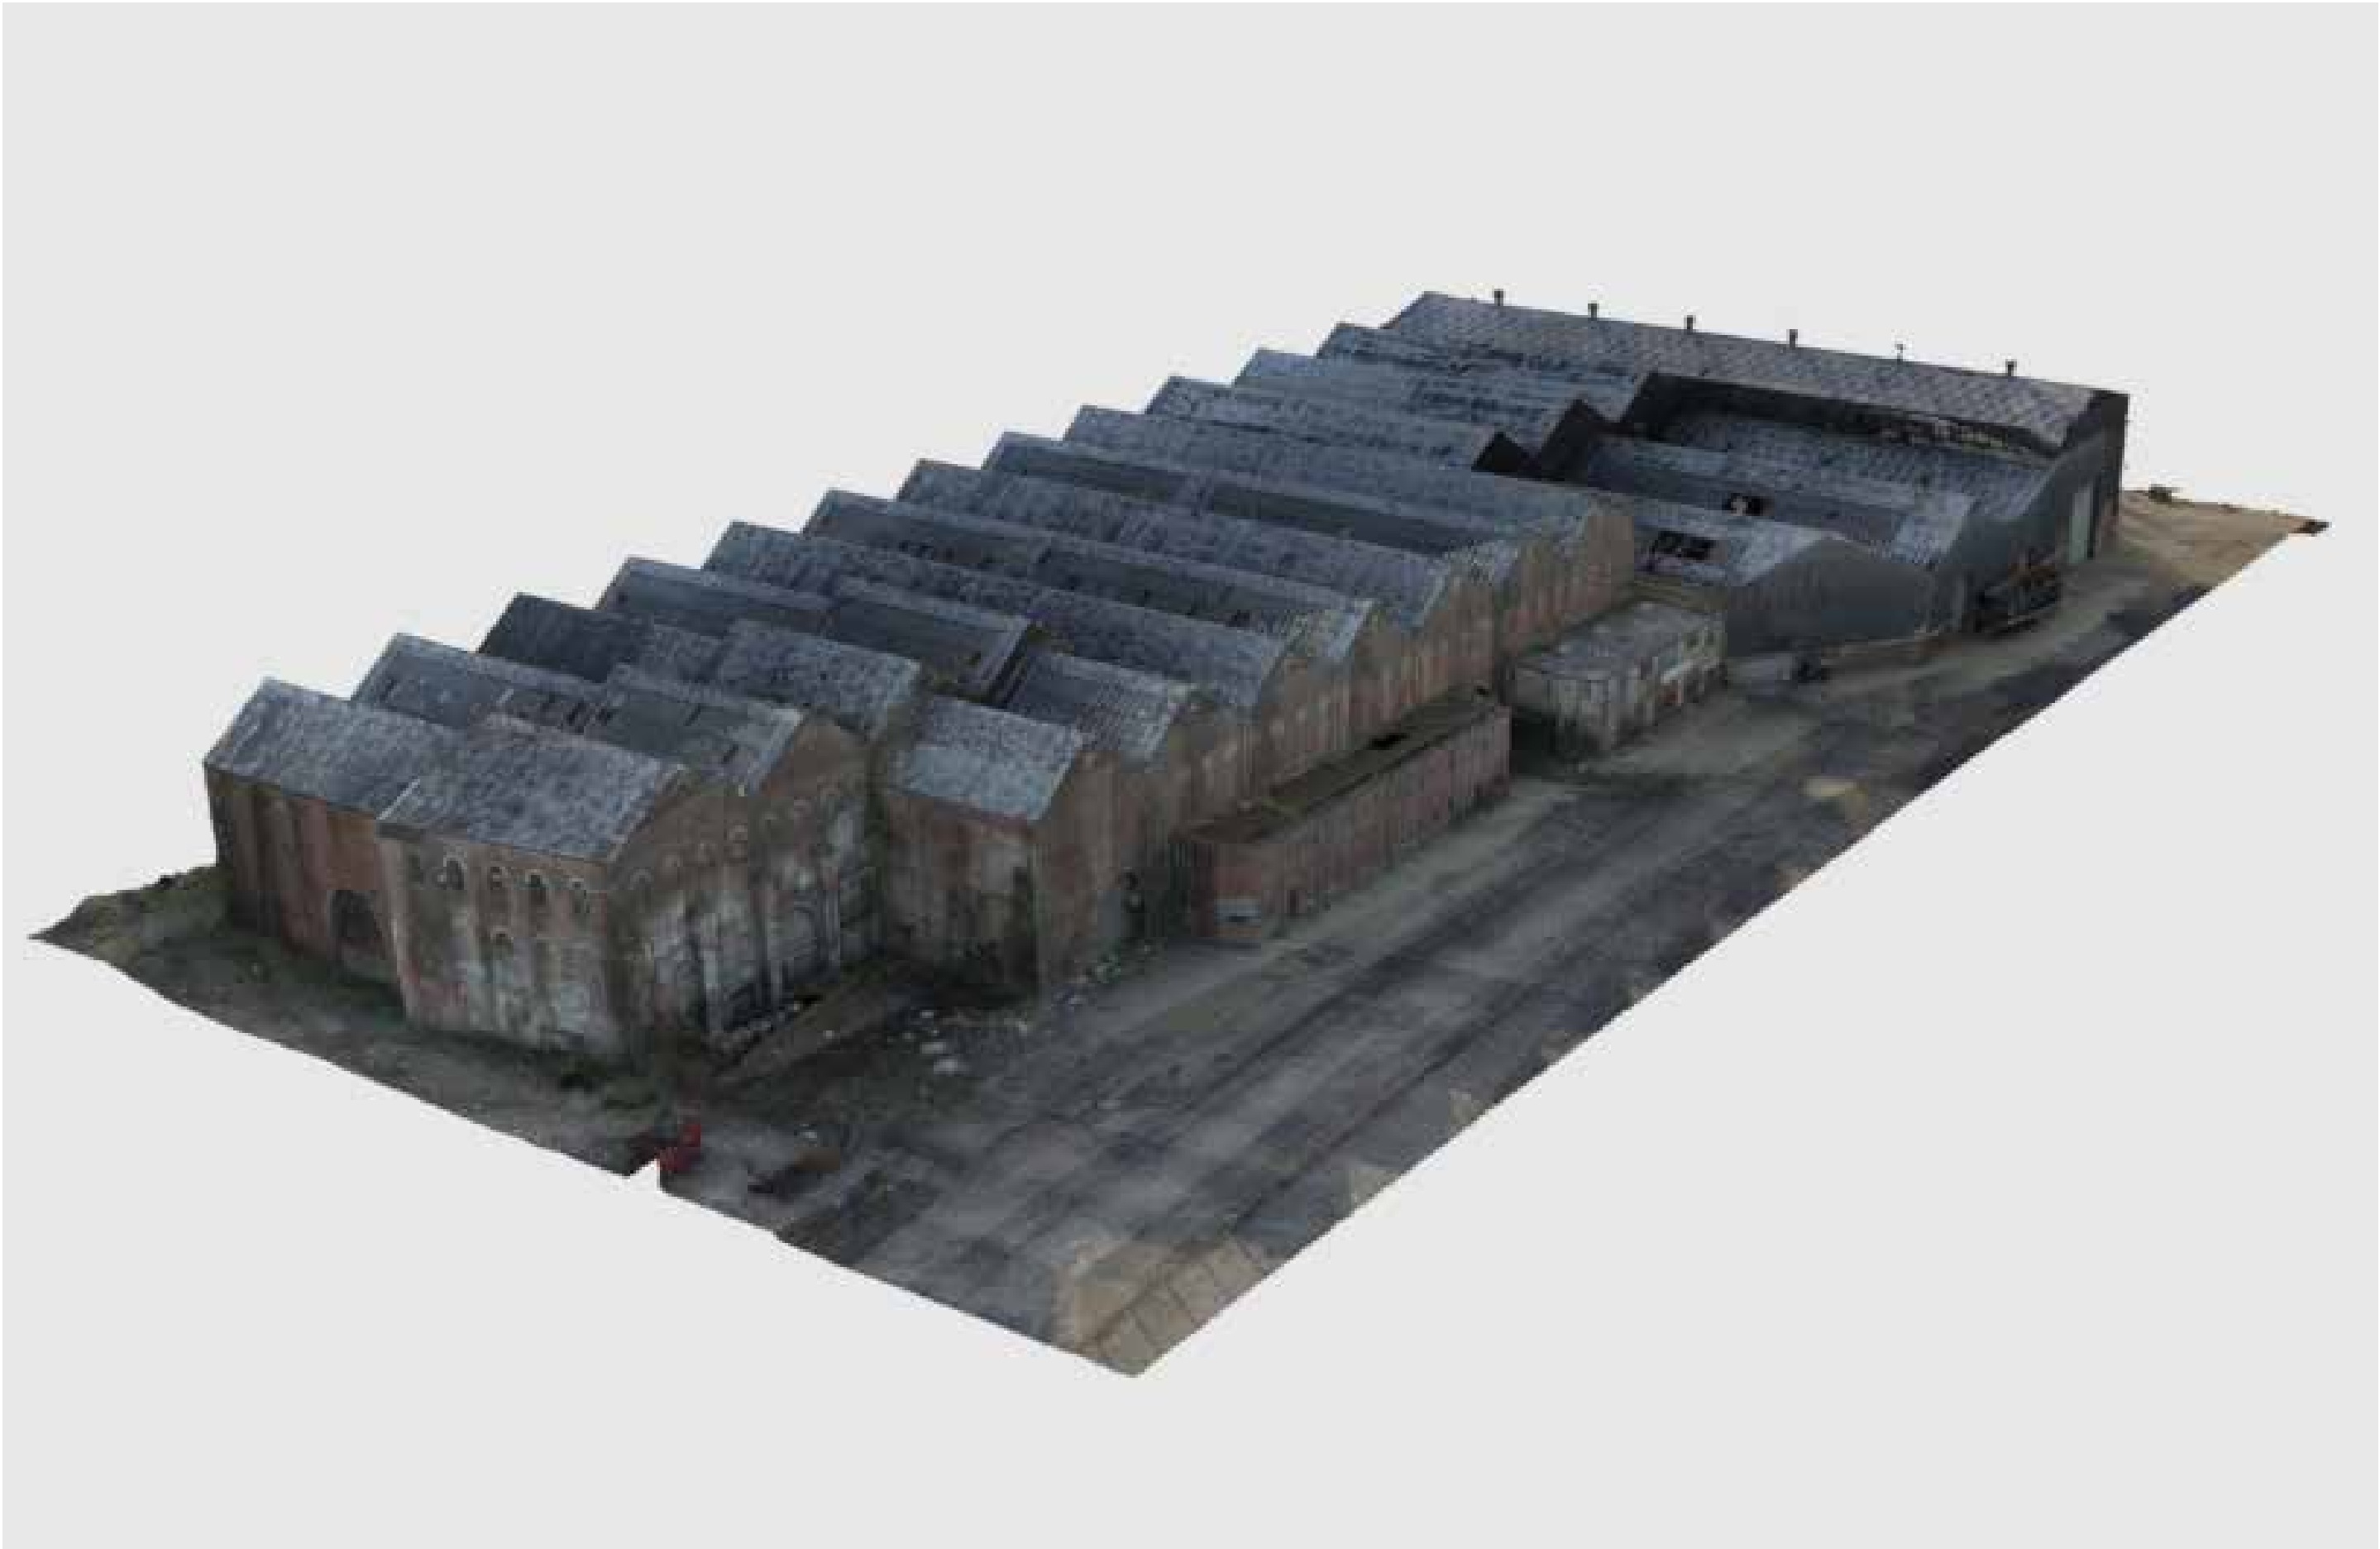
ILLUS 5 Photogrammetric plan of the building facing south-west

Much of the building presented a series of repetitive architectural features, typical of 19th century design, making it appear as if most of the building presented a single phase of construction. In fact, the building had been added to several times with multiple phases of construction recorded. This was most clearly represented by extensions to the north and west and varying roof heights as seen

on Illus 5. The building also included several 20th century additions including two extensions to the north side of the building.

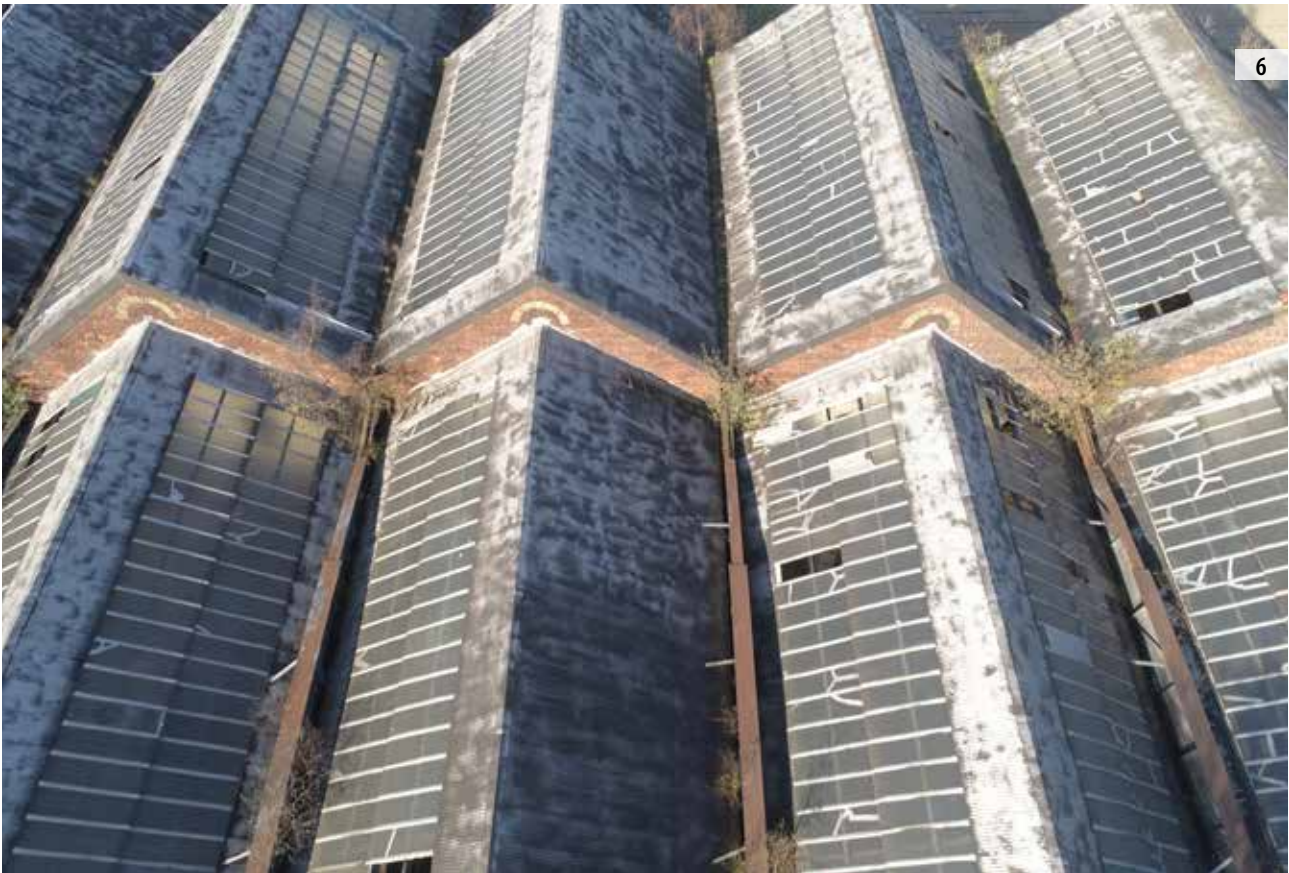
ILLUS 6 View of the changes in height of the roof **ILLUS 7** Detail of the design of the arched openings

The north elevation included the elevations of Shed 1 (elevation F and H) and Shed 2 (elevation J and K) plus two later extensions (elevations G and I) to the front of Shed 1. The elevation of Shed 1 (Illus 14) comprised seven bays, each with an identical gable end incorporating a small round-headed window and brick voussoir. Below the gables four of the bays included sets of four round-headed windows. The bay at the east end had no windows and the following bay along with the bay at the west end of the elevation included three windows. The two extensions masked much of the lower half of the remainder of the elevation. Where the full extent of the elevation was visible it exposed two of the tall round-headed entrances. The entrance close to the west end included a cobble floor and rail tracks leading into the building (see Illus 6).

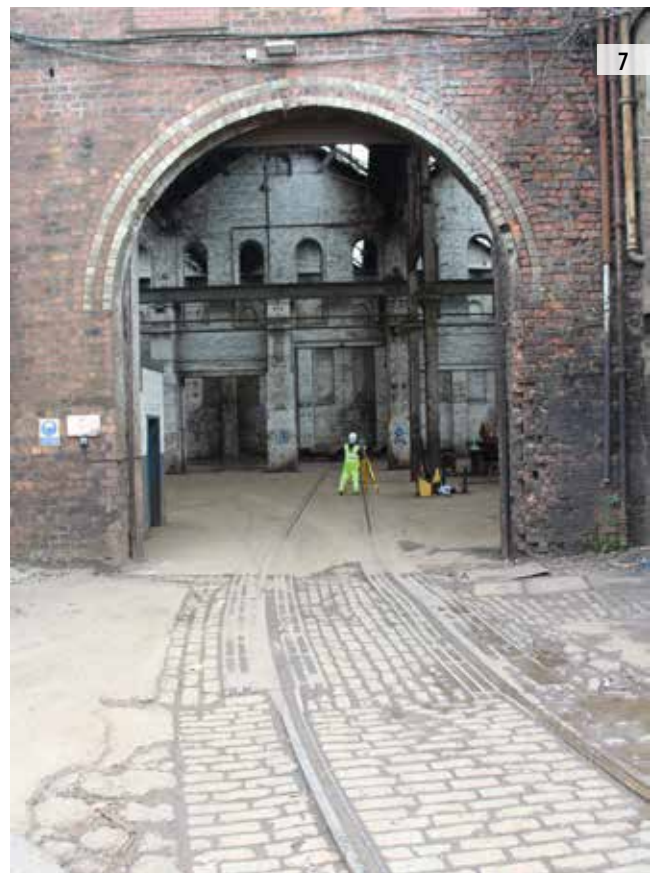
In general, the 19th century constructed elements of the building were of red brick in an English Garden Bond with a cement render. All the original window and door openings were round-headed with pale yellow brick voussoirs making the upper part of the openings more prominent. The large round-headed entrances included four rows of brick work across the arches with two bands of pale yellow bricks and two bands of red brick (Illus 7).

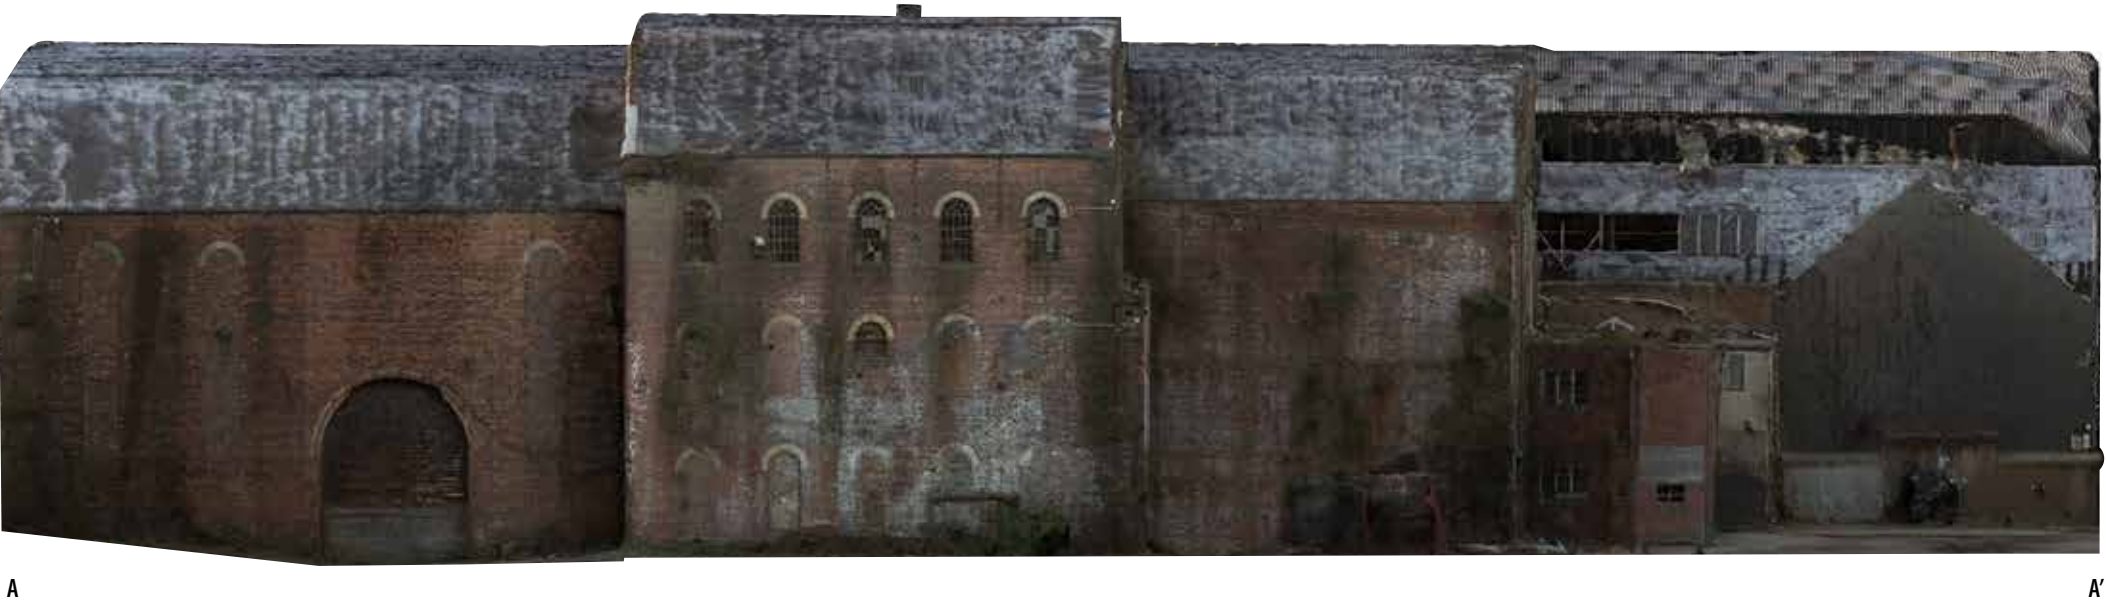
ILLUS 8 Plan of east elevation

7.2 EXTERNAL EAST END (ILLUS 8)

The east end of the building presented the most interesting face of the structure due to the projection of the central part of the wall and the recessed wall to the north side which altogether offered three separate bays to the elevation. The stepped plan of the elevation required the recording of five separate faces of wall (Elevation A – E). To the south side was Elevation A which included a large round-headed entrance and three long round-headed windows (Illus 9). The door included a modern steel roller door and the three windows had been brick-blocked. The north side of this wall abutted the south-facing elevation (Elevation B) of the central bay. Only a narrow width of this elevation was visible with no features identified although the roof line was higher than the north and south bays and a small round-headed window was just visible in the south facing gable.

- ① elevation
- proposed phasing**
- 1st phase (OS1859)
 - 2nd phase (OS1897)
 - 3rd phase mid 20th century
 - 4th phase late 20th century

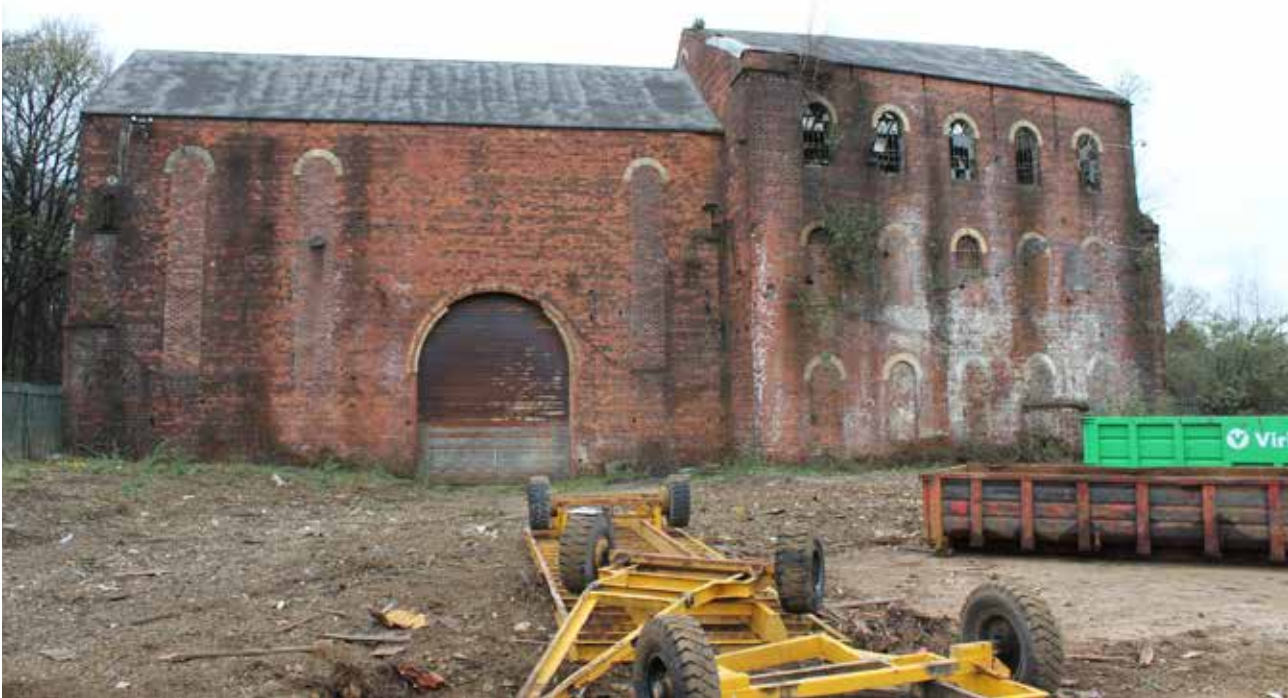
ILLUS 9 View of the east elevation ILLUS 10 Detail of the east elevation of the central bay

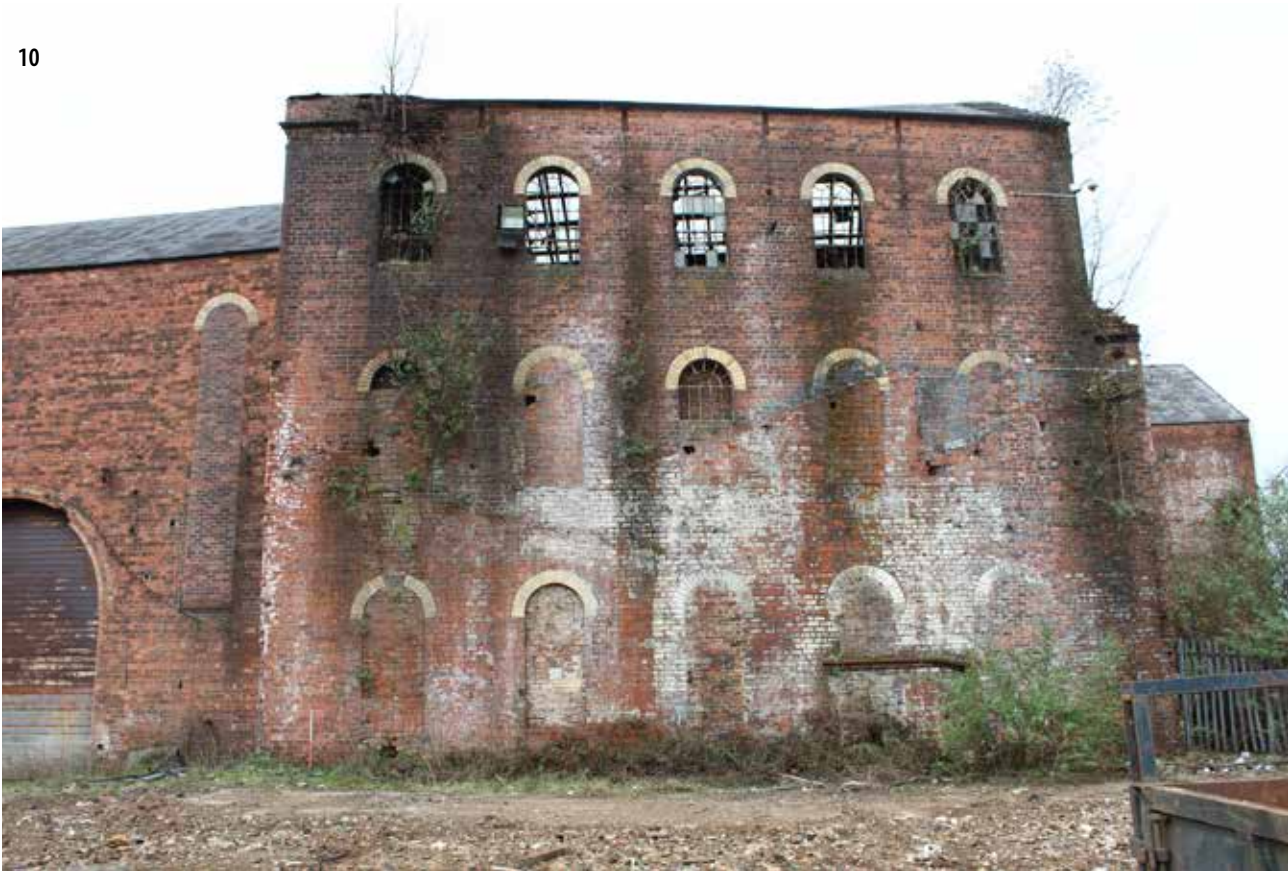
The central bay (Elevation C) was symmetrical displaying three identical rows of five round-headed windows. The lower two rows had all been brick-blocked with only the upper row of windows still incorporating their casement frames (Illus 10).

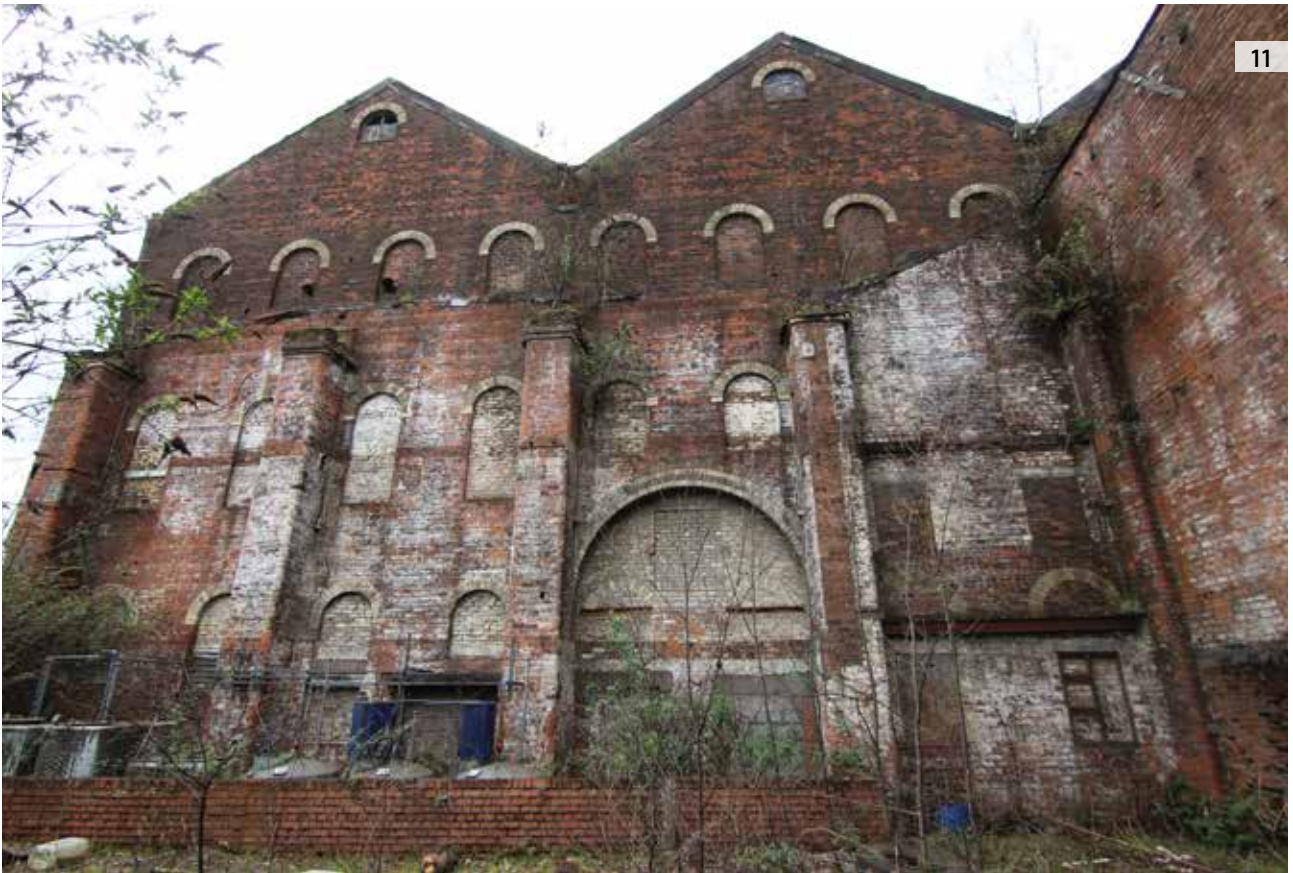
The north side of the central bay (Elevation D) presented the most complicated elevation of the whole building due to the insertion and subsequent blocking of several openings within the original blocked openings (Illus 11). This was also the only external elevation to include brick buttresses, with five visible. The elevation included two gable ends each with a small round-headed window inserted. Below this were two rows of eight windows to the top and middle of the wall and six at the base along with a large round-headed entrance. All the openings had been brick-blocked with later square windows inserted into the middle and lower blocked windows to the west side of the elevation and two round-headed windows and a square window inserted into the entrance. These had also all been brick-blocked. A construction line high up on this elevation indicated that the external area to the north of this elevation had once been roofed although this would not have been part of the original construction.

ILLUS 11 View of the north side of the central bay **ILLUS 12** The east elevation of the north bay

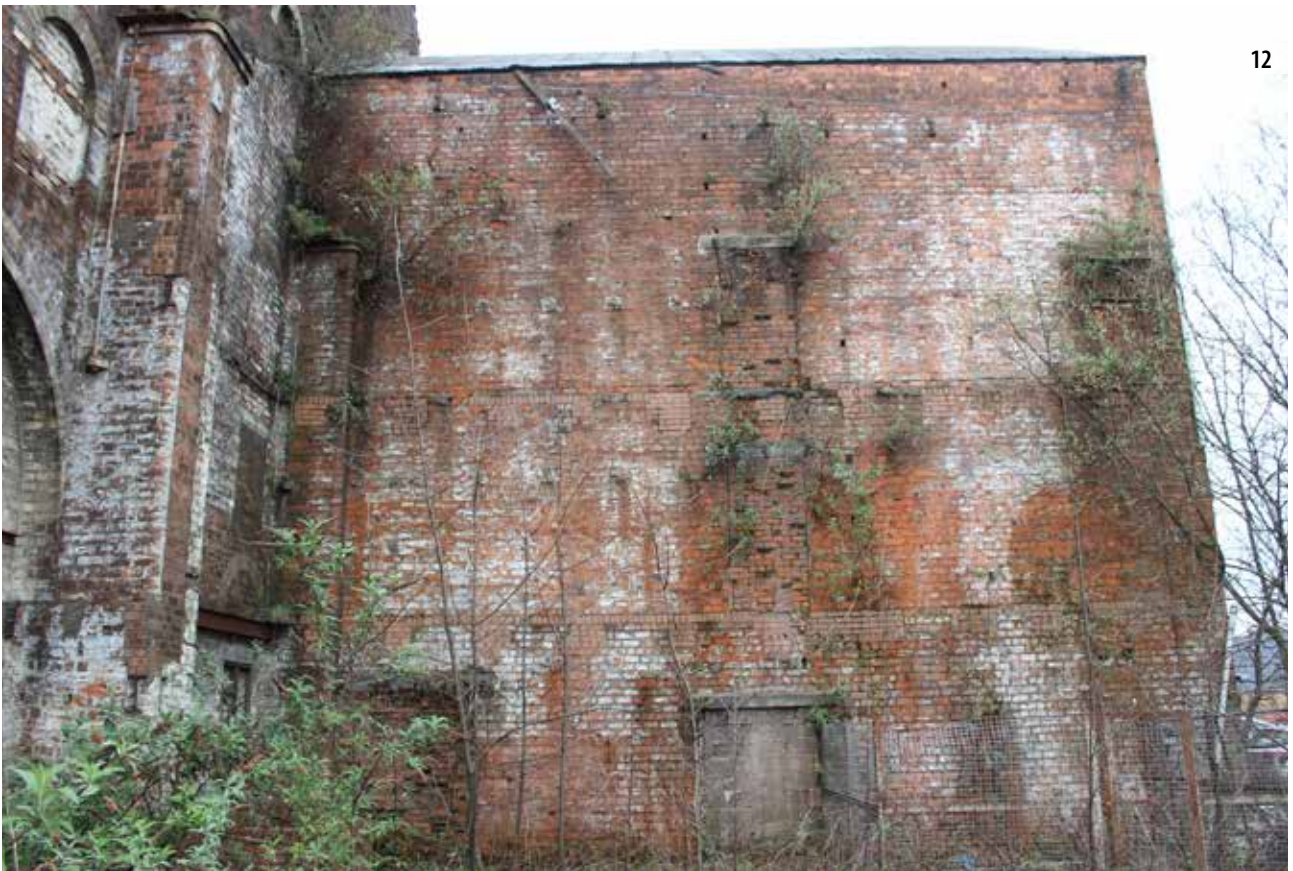
The final bay to the north side of the east elevation (Elevation E) Included two brick-blocked doors at ground floor level and a single square opening higher on the wall (Illus 12). The size of the opening may suggest it was a door (possible leading to an external staircase or extant floor). The wall also included two rows of small brick-blocked recesses (one set being just below the upper window/door). These are likely to have been inserted when internal flooring was inserted (see below).

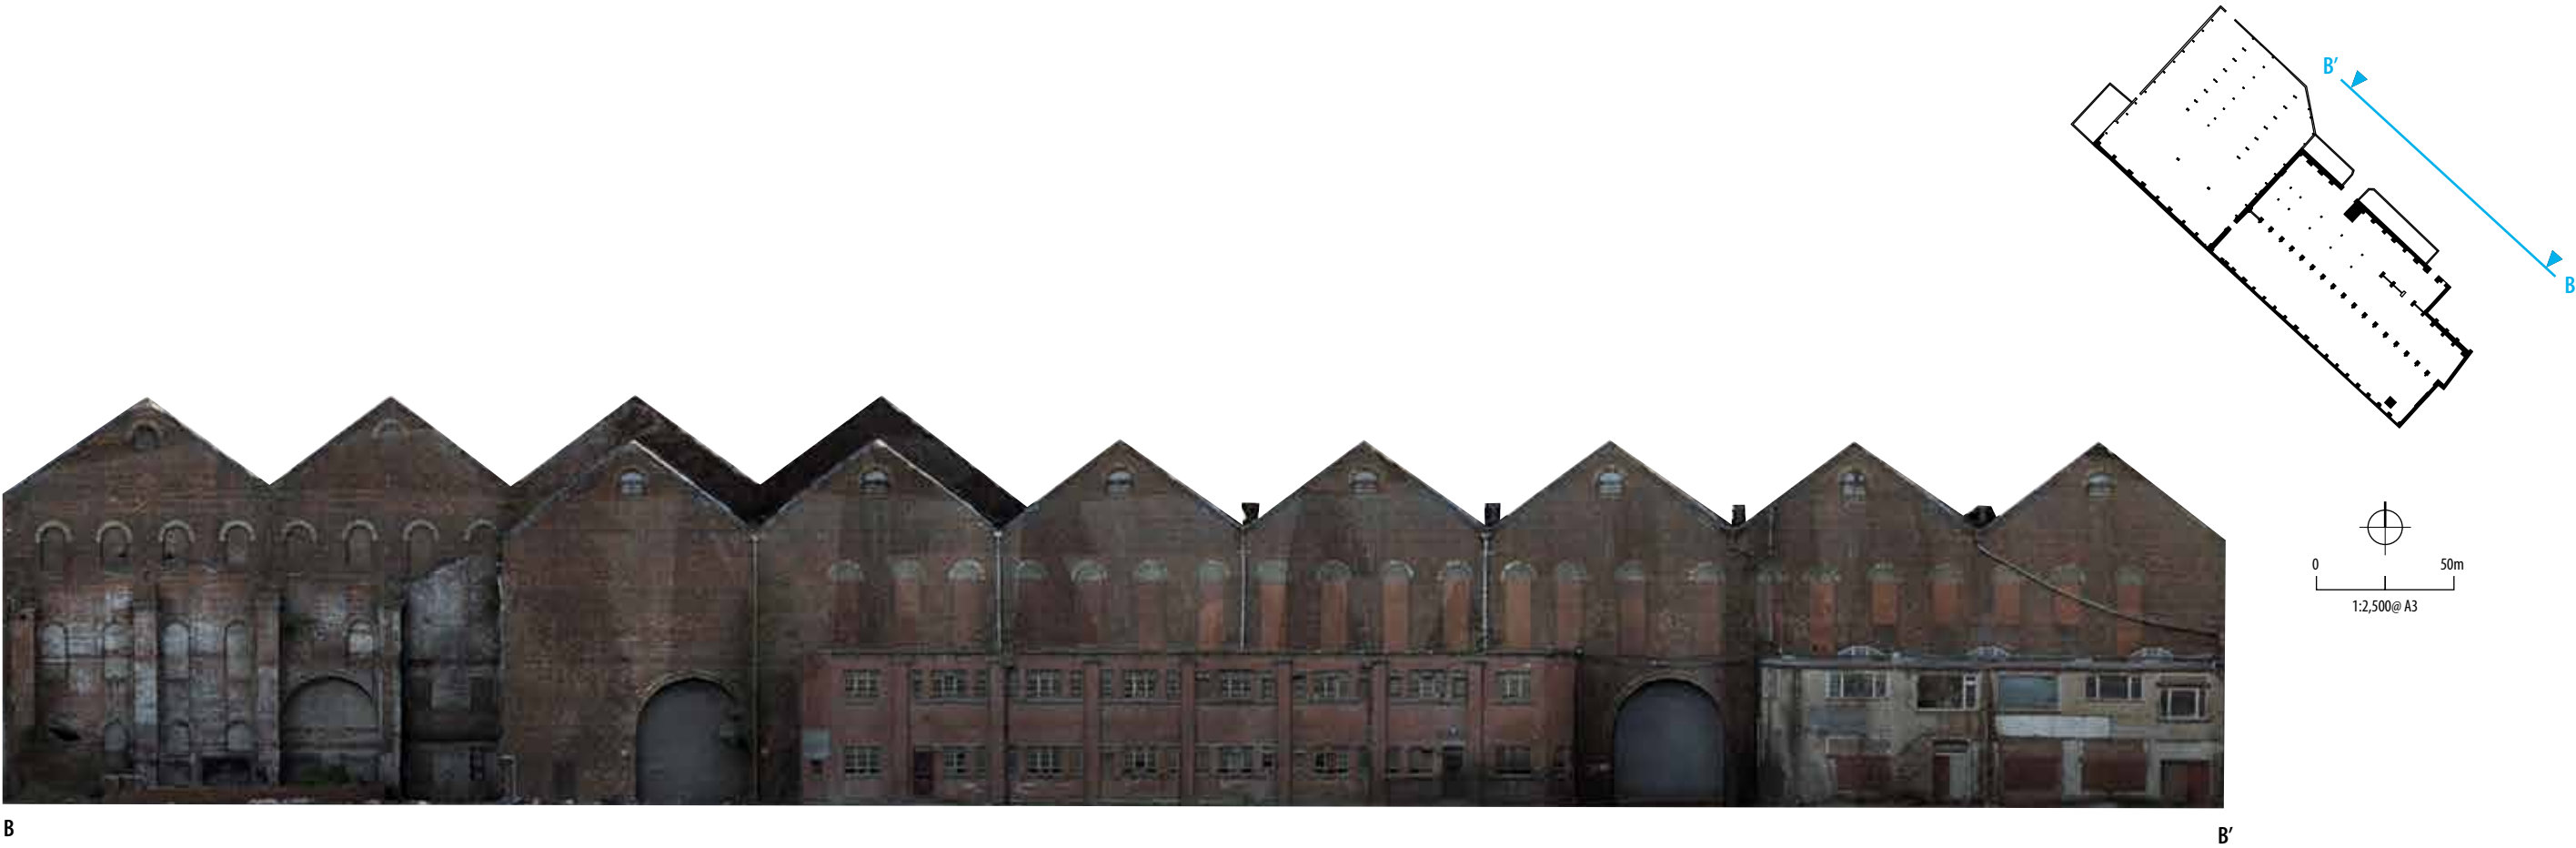
ILLUS 13 Plan of North elevation

7.3 EXTERNAL NORTH ELEVATION (ILLUS 13)

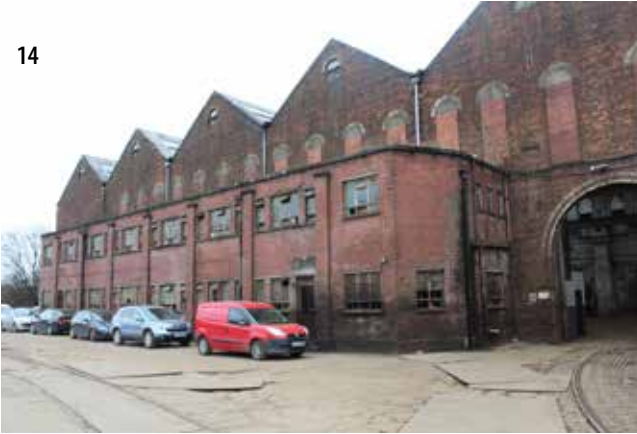
Both extensions to the north side of the elevation were constructed of brick over two floors and represent 20th century additions to the fabrication shed. Extension 1 to the east masked 3 ½ bays of the earlier building. It included casement windows to ground and first floor levels with small entrances at both ends and a flat roof. The corners at each end of the extension were angled and it included a series of slightly projecting brick buttresses.

ILLUS 14 General view of the north elevation of Shed 1 showing Extension 1 **ILLUS 15** Detail of Extension 2 **ILLUS 16** View of the north facing elevation of Shed 2 **ILLUS 17** General view of the west elevation **ILLUS 18** Detail of Extension 3

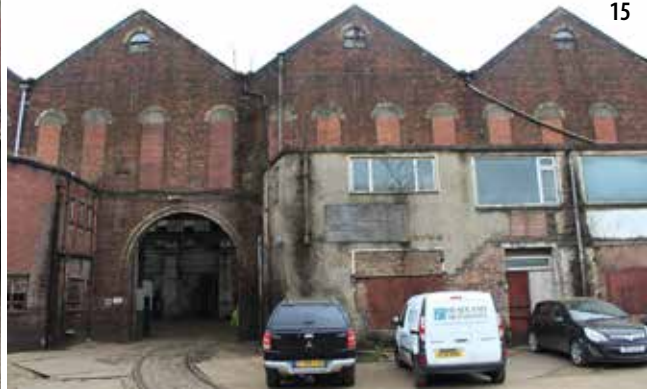
Extension 2 to the west masked the final two bays of the main elevation. This extension had been altered and partially covered in a cement render (Illus 15). Again, it was over two floors and had a flat roof. Markings on the north-facing wall indicated that it originally included an outer staircase. This led to a door on the upper floor that had been brick-blocked and subsequently partly turned into a large window. Three large entrances on the ground floor had also been brick-blocked.

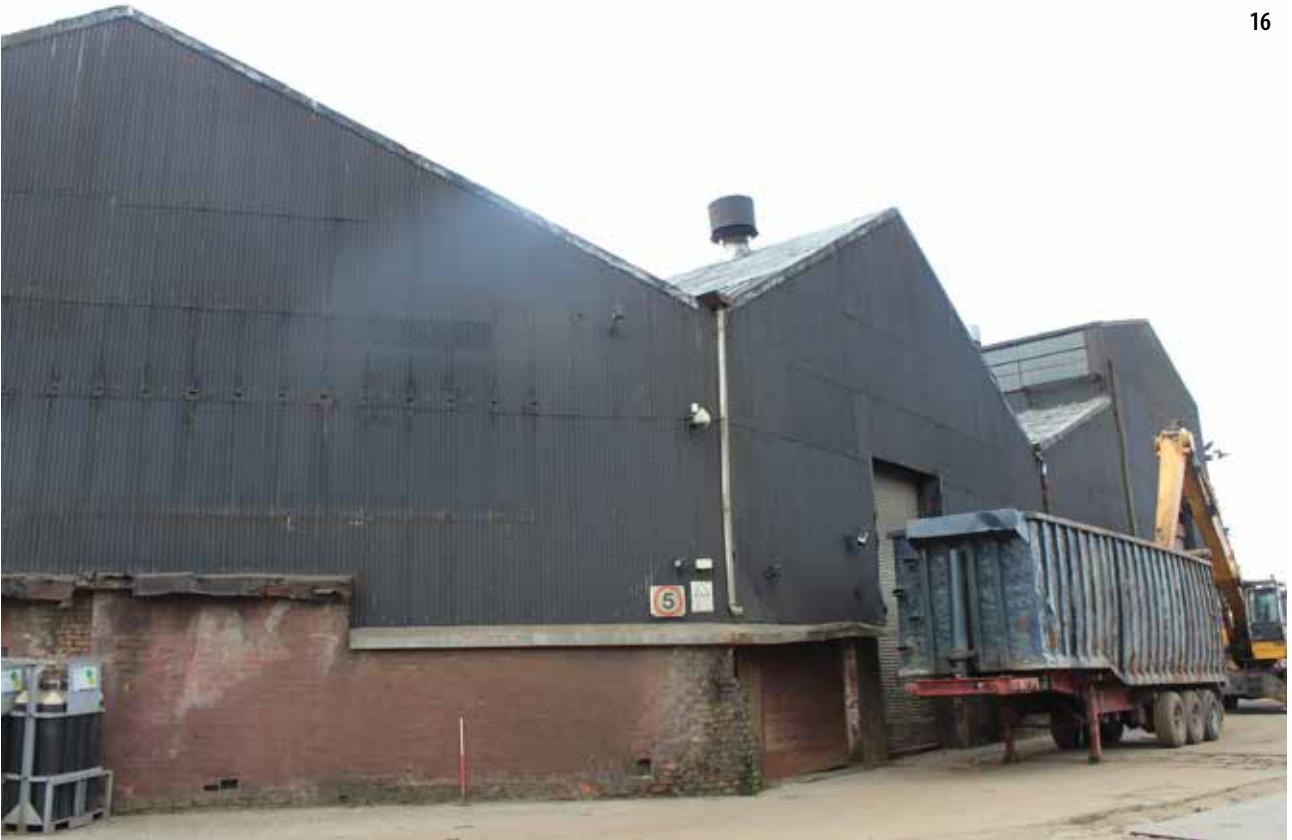
The north elevation of Shed 2 comprised of two components (elevation J and K) with the eastern half (J) set at an angle facing north-east and the remainder facing north, although they were constructed of the same materials which also continued across the west elevation (Illus 16). The elevation comprised a brick wall base (2.5m high) with a corrugated steel upper wall. The brick wall included three large doors and three windows. This elevation along with the west elevation (L) were the most recently constructed and date to the 20th century.

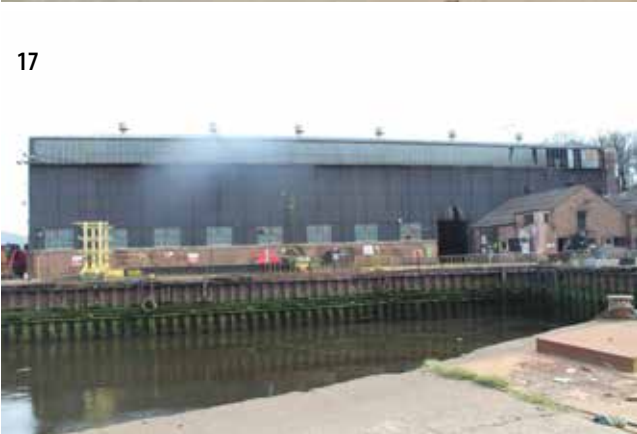
The west elevation of Shed 2 was constructed in the same materials as the north elevation of Shed 2 with a brick wall base and corrugated steel upper wall (Illus 17). A series of casement windows were positioned at the top of the brick wall with a further continuous long window at the top of the corrugated wall. A single large entrance was located close to the south side. At the south end of the elevation was the third extension. This was a small two storey brick-built office (Illus 18) with a double gable end facing west (Elevation N). The building had been altered with a brick-blocked double door on the north face, new windows inserted and an upper floor office added to the north-west corner. This building was probably originally part of the shipbuilding yard but had been modified for use as offices for the scrap yard.

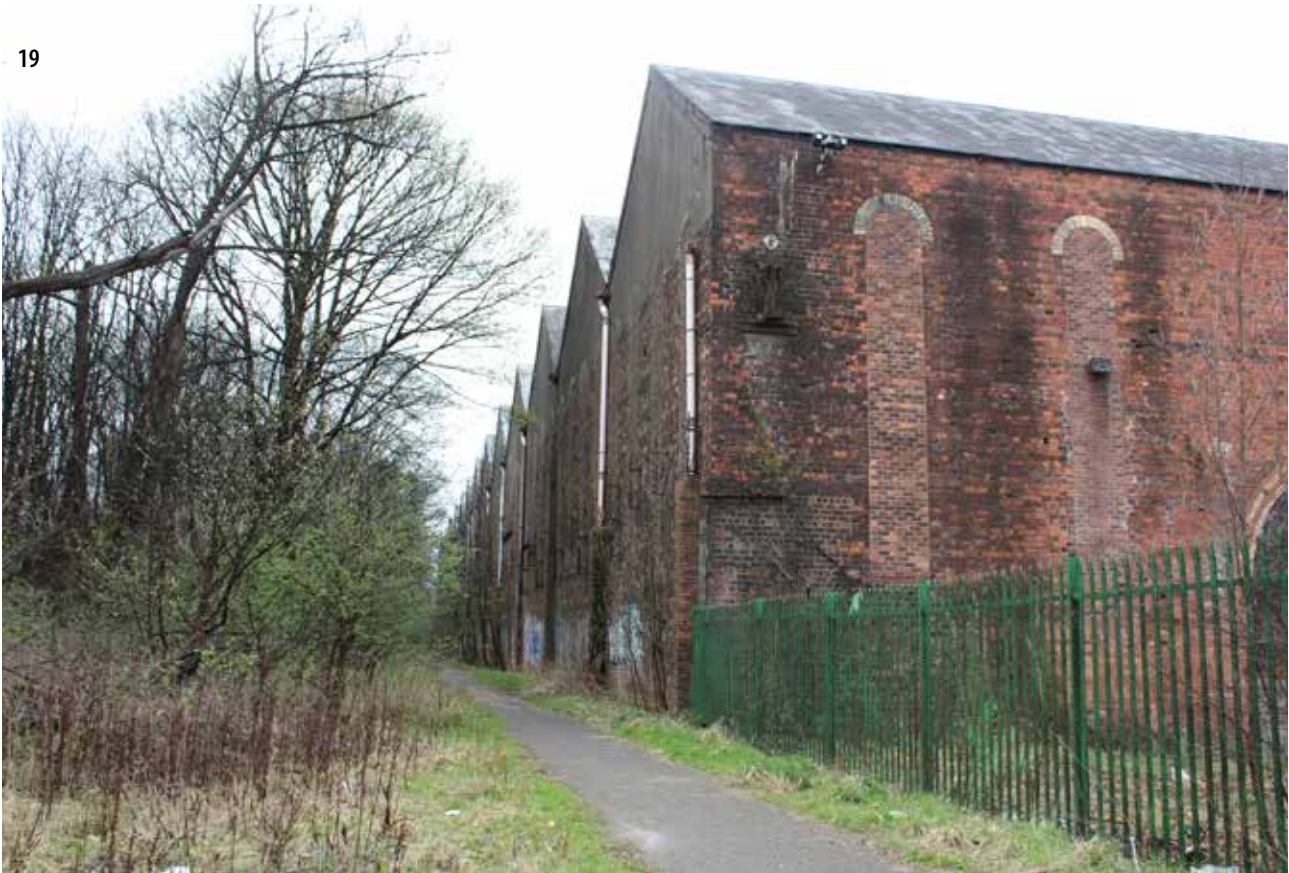
Access to the rear of the building (Elevation N) was limited due to the proximity of the woodland to this side of the building. A public track runs between the building and the woodland, although the trees limited the position from which a photographic record could be made (Illus 19). The elevation comprised 13 tall gabled bays. Each bay included four tall round-headed windows that had been brock-blocked (Illus 20). These bays were identical apart from the final bay at the west end. This was wider and taller with flat squared ends at the base of the gable. The similarity of the windows across all 13 bays indicate that this elevation was part of a single phase of construction. The only additional features were several tie-bar ends that had been inserted to support the wall.

ILLUS 19 Oblique view of the south elevation **ILLUS 20** Detail of the south elevation bay

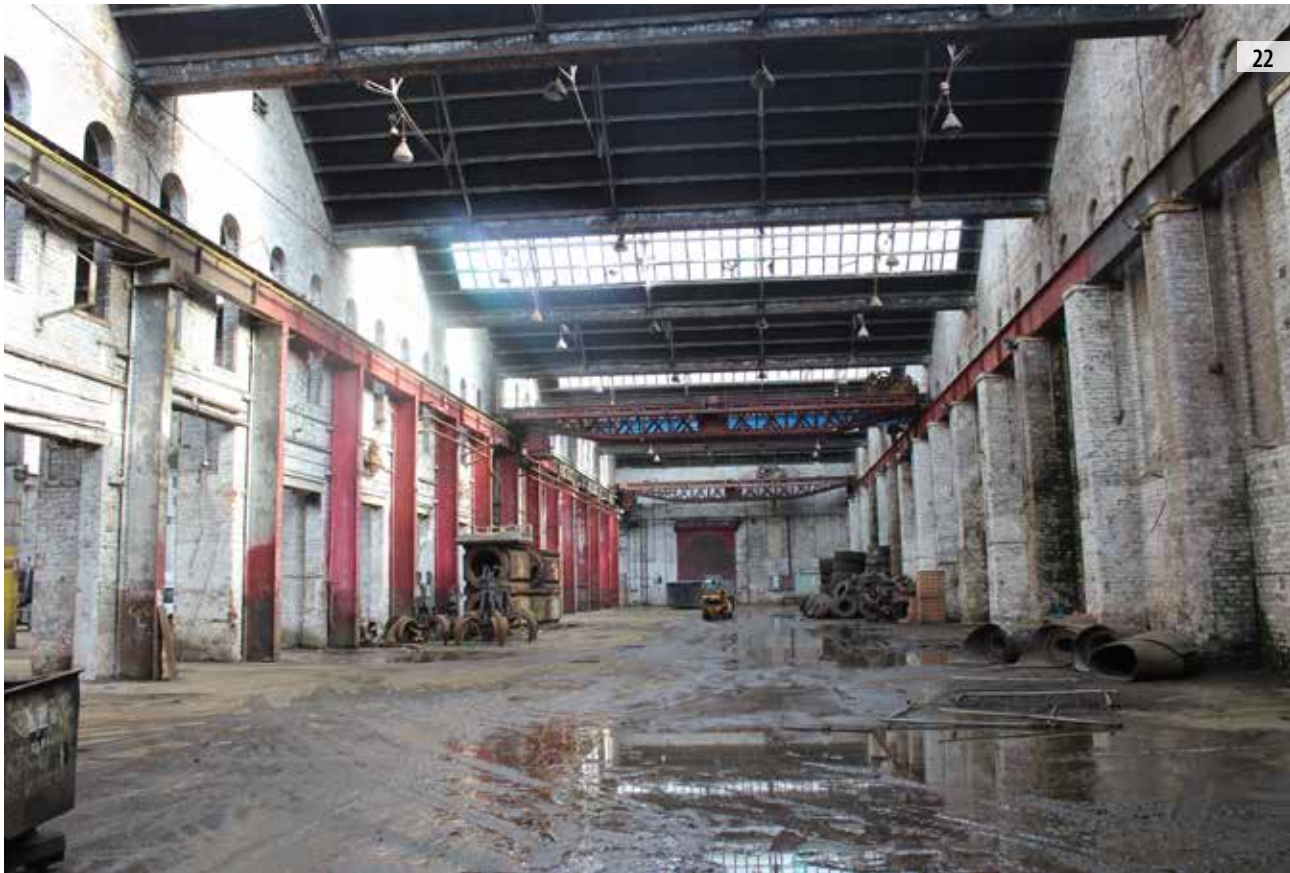
The south bay (Illus 22) was formed of the south and east external walls of the building along with a series of 17 brick pillars supporting an upper wall to the north side and a brick partition wall to the west. The south wall included 17 internal buttresses 10.5m high that supported a long steel beam. The beam was mirrored on the north internal wall although on this side it was supported on a series of steel columns. This indicated that the two walls were not contemporary. The beams carried an overhead crane that was still present. This crane had a name plate indicating it had been supplied by 'Royce Ltd of Manchester' and was capable of holding '25 tons' (Illus 23). The north wall was a continuous wall along the whole length of the shed (Illus 24). It comprised nine gabled bays which, although very similar in design, displayed several differences. The first four bays at the east end included two large openings at the base with steel lintels. Above the openings were two rows of four round-headed windows and within each gable was a further small round-headed window. The remaining five bays to the west were lower and only included a single set of four windows. In addition to this the lintels of three of the openings at the base of the wall were raised higher. Two of these raised openings aligned with entrances on the north side of the building. The west wall formed the partition wall between buildings 1 and 2. It was brick built with a single large brick-blocked door. The east wall mirrored what was recorded on the east external elevation.

ILLUS 22 General view of the south bay of Shed 1 **ILLUS 23** Detail of the overhead crane in the south bay **ILLUS 24** The north wall of the south bay

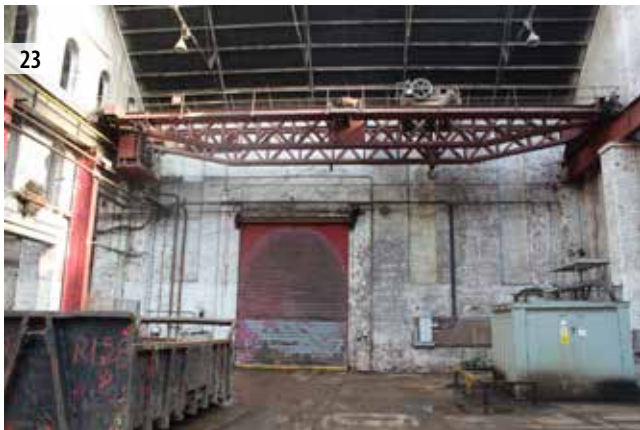
No dating evidence was identified for the overhead cranes that were present although they were probably installed as part of the expansion of the yard in the late 19th century. The design of the buttresses on these buildings imply they were purposely
