CLYDE WATERFRONT AND RENFREWSHIRE RIVERSIDE

HISTORIC BUILDING RECORDING

PLANNING REF. 17/0486/PP

May 2019

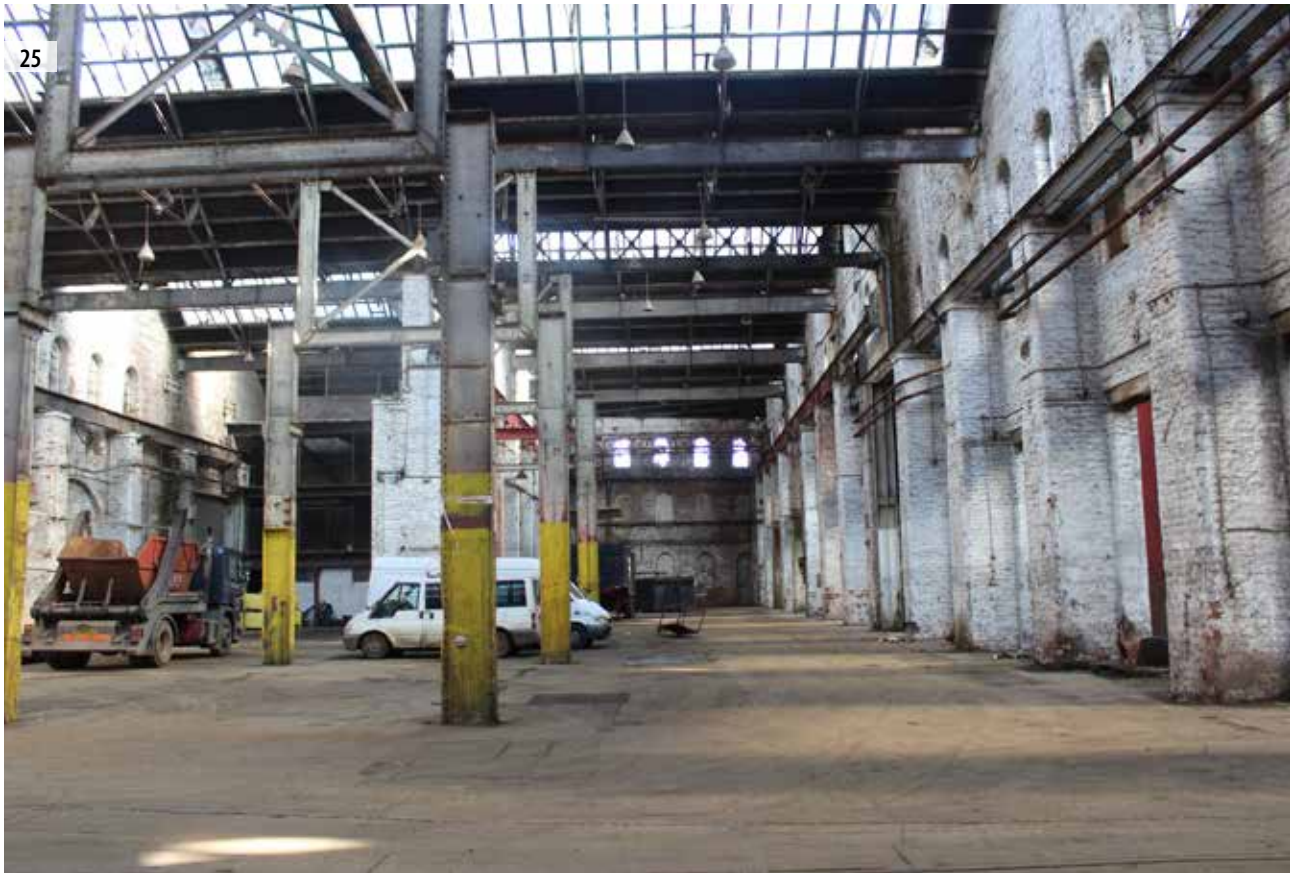
and corresponded to the change in height of the wall. A steel beam was placed on the top of the buttresses with a lower beam set on the western group (Illus 25).

ILLUS 25 East facing view of the central bay of Shed 1 **ILLUS 26** South wall of the central bay **ILLUS 27** General view of the east wall of the central bay **ILLUS 28** View of the steel columns at the west end of the central bay **ILLUS 29** Detail of the steel platform at the west end of the central bay

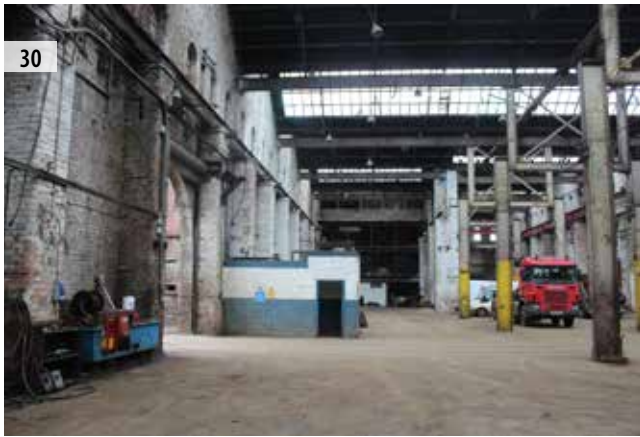
The north bay of Shed 1 was shorter than the other two bays and was formed of the gabled north external wall of the building and two gabled bays of the south wall (Illus 30). At the east end the back wall was masked by a series of three mezzanine floors supported on steel cross beams. At ground floor level below the mezzanine floors was a breeze-block constructed store room. The north wall included projecting brick buttresses and three round-headed entrances, one of which had been brick-blocked due to the addition of the extension to the outside of the building. The west wall included a blocked fireplace which was identified more clearly from Shed 2. Along with the rail tracks and the cranes, a series of markings and brick outlines on the floor of the north bay provided evidence of machinery associated with the shipbuilding works in this building.

ILLUS 30 East facing view of the north bay of Shed 1 **ILLUS 31** General internal view of Shed 2 **ILLUS 32** View of the south wall of Shed 2
ILLUS 33 Detail of the overhead crane in Shed 2 **ILLUS 34** Detail of the fireplace on the east wall of Shed 2

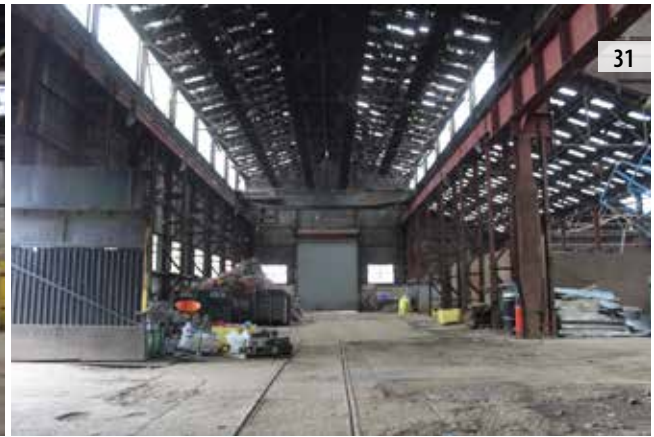
Shed 2 was still in use for sorting metal waste at the time of the site visit and this restricted access to some areas of the space. The shed was one large room (Illus 31) with rows of steel pillars supporting the roof. The north and west walls were relatively modern and only the south and east wall represented earlier 19th century parts of the building. The south wall formed the external south wall of the building and comprised four gabled bays each with four long brick-blocked round-headed windows (Illus 32). A series of projecting buttresses again supported a long steel beam for carrying an overhead crane (Illus 33). The steel beam carrying the other side of the crane was supported on steel columns. A steel double sliding door was recorded on the east wall leading to Shed 1. A faint outline of a brick-blocked round-headed entrance was visible under the painted wall. A small round-headed fireplace or flue was also recorded to the north side of the east wall (Illus 34).
