BROOMIEKNOWE GOLF COURSE HISTORIC BUILDING RECORDING

Data Structure Report

MAY 2019

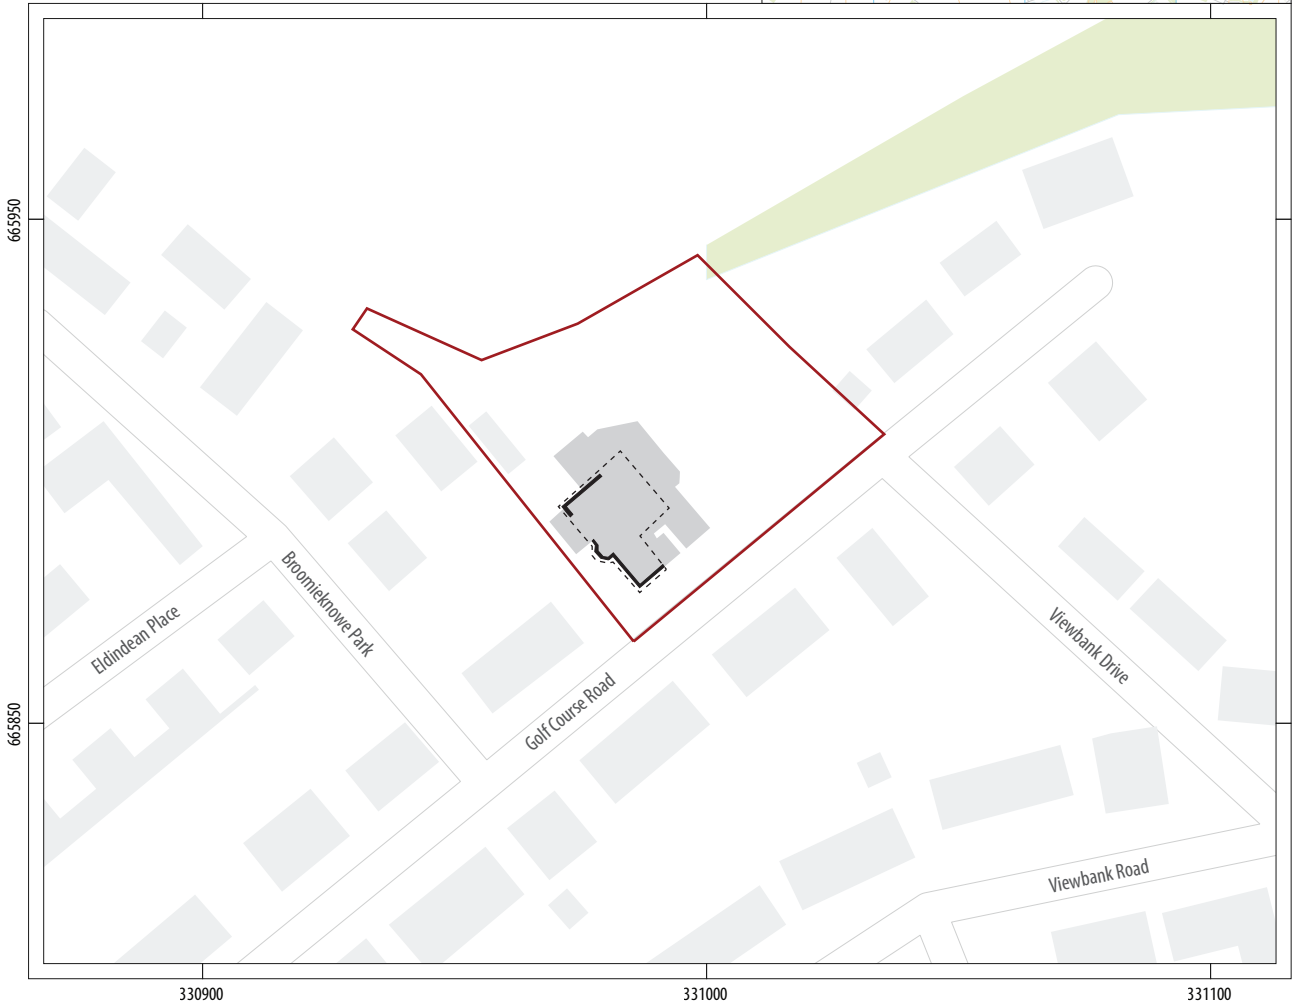
ILLUS 1 Site location

It was clear from the initial inspection of the building that it comprised several phases of construction. Most of these phases were formed of extensions to the original building and dated to between the 1950's and the 1970's. The ad-hoc construction of these extensions led to the building having an irregular shape with an uneven roofline. The modern extensions now formed the bulk of the building's footprint although parts of the original 1906 clubhouse were still present within this footprint.

The modern extensions of the clubhouse were mainly flat-roofed with a large two storey extension to the east corner and a large single storey glass-fronted lounge to the north corner. Two smaller rooms had been added to the south-west and east sides of the building. These extensions had been constructed onto or over the original clubhouse building. Although the extensions were comprehensive, parts of the original 1906 clubhouse did survive. The original clubhouse building was most evident along the roofline where the gabled slate roof of the original building was clearly visible above the flat roofs of the extensions. The partial remains of three of the elevations of the original clubhouse were also still visible.

- application boundary
- recorded remains of original clubhouse
- footprint of original clubhouse

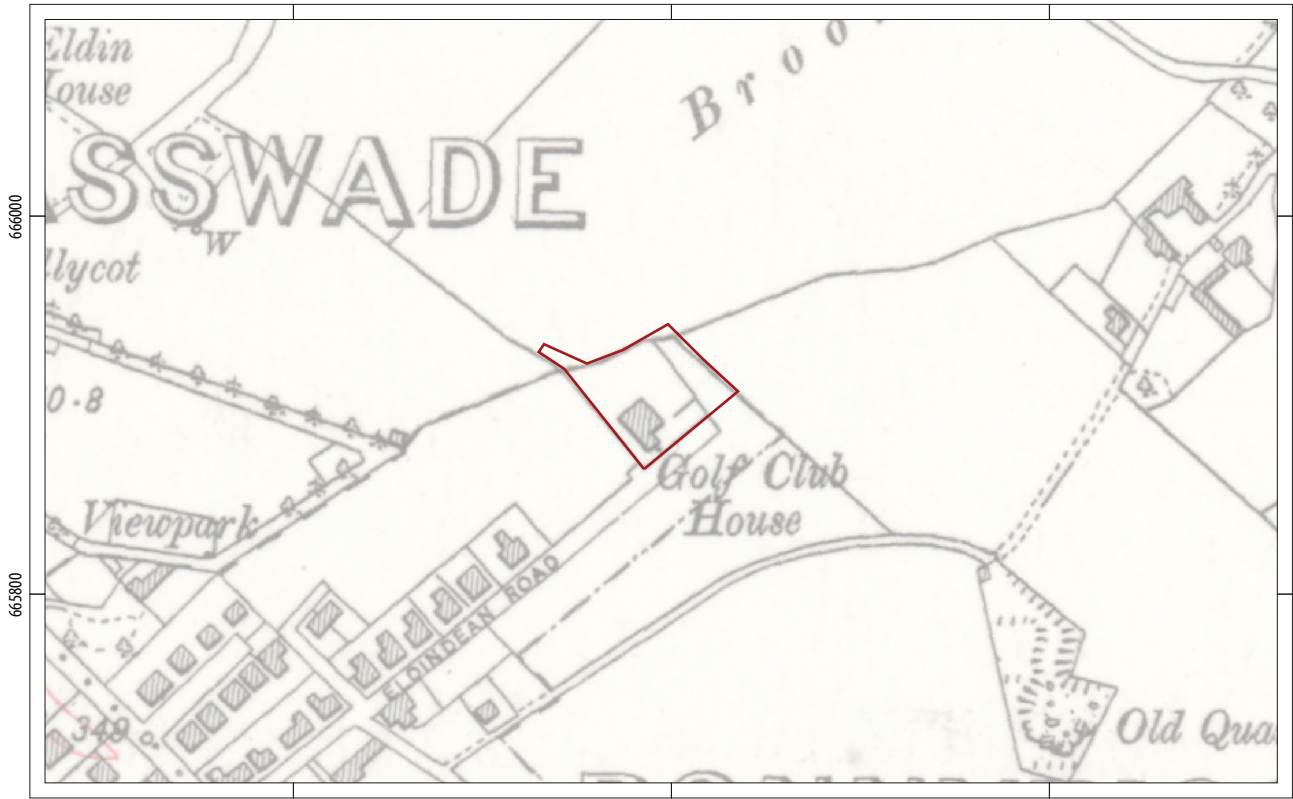
ILLUS 2 Extract from the 1915 Ordnance Survey

Survey (Revised 1913). Here it is shown as a small square building with an extension to the south-east side (Illus 2).

The building survey identified that more of the original clubhouse survived than had been anticipated. The 1915 Ordnance Survey depicted the building as a square building with an extension to the south-east. The remains of the original building recorded as part of the present survey seem to correspond to the plan depicted on this map. A photograph within Knowles (2005) history of the club (a copy was not available) shows the building originally included a bay window to the opposite side of the building to the one recorded. The photograph shows the bay window included a castellated upper parapet wall above the window and a flat roof to the rear of the building. It also shows that the front of the building included two verandas flanking a central gabled bay. Although the detail is not good on the photograph it looks as if the decorated art-deco window panels were present on the front bay and the north-east bay.

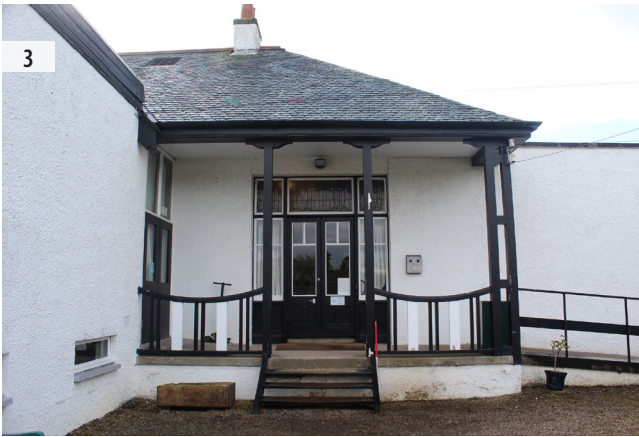
Approximately a third of the original front (north-west facing) elevation of the clubhouse survived (Illus 3). The details of the elevation included a raised veranda with painted timber railings and timber roof supports. A central short timber staircase led to a double door with timber surround and glass side lights. Above the door was a series of leaded glass panels displaying decorative art nouveau design (Illus 4). This was a typical design that was prevalent in many buildings of the time. The walls of the clubhouse had been covered in a rough painted harling and the slate roof was hipped and included a red tile cover at its apex.

ILLUS 3 North-west facing elevation of the original clubhouse **ILLUS 4** Detail of the art-deco window panes on the north-west elevation **ILLUS 5** Detail of the gabled central roof **ILLUS 6** South-west and south-east elevations of the original clubhouse

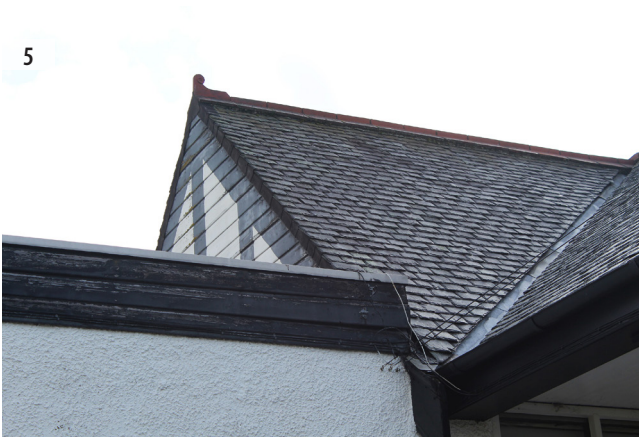
The rest of the original front elevation had been masked by a later extension although the upper part of a dormer gable was visible above the roofline of the later structure. This was constructed of timber slats painted to represent roof support beams (Illus 5). The tile covers on the apex of the gable here included a decorated end-piece.

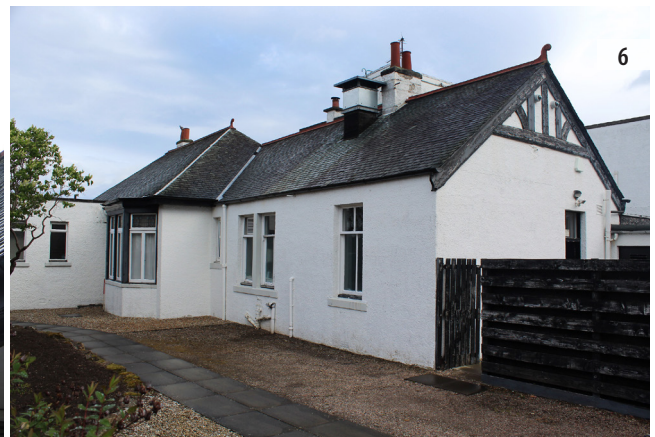
The eastern half of the south-west facing elevation and the south-east gable end of the original building were also still visible (Illus 6). The south-west elevation comprised a three-bay single storey building with harled walls and a slate roof. The bay to the north-west projected further forward than the other two bays and included a large bay window with sash-and-case windows. The upper panes of this window included the same decorative design as seen on the door of the front elevation (Illus 7). To the north-west side of the bay window was a small ox-eye window high up on the elevation (see Illus 7). This had subsequently been utilised as an extractor fan opening. The slate roof at the end of the bay was hipped and the gabled roof of the remaining bays was attached to the sloping roof. The two window bays to the south-east comprised a double window with a stone mullion and raised stone sill and a single window with a raised sill.

The south-east facing gable end was also covered in a painted harling and included a door and a series of attached faux-timber beams presenting a similar design to those painted on the dormer gable at the front of the building (see Illus 6). The design of the door suggested it had been inserted at a later date although this was not certain, and it is possible the original door had been replaced. A modern dormer window had also been inserted into the north-east side of the roof at this end of the building. Although the two end bays of this building are set back from the alignment of the remainder of the south-western elevation the tile copes at the apex of the roof and the decorated end-piece suggest that this was all part of the original clubhouse.
