# GLENBOIG, NORTH LANARKSHIRE – PODS 3 AND 4

ARCHAEOLOGICAL EVALUATION

PLANNING REF. 14/01594/PPP

commissioned by Taylor Wimpey West Scotland

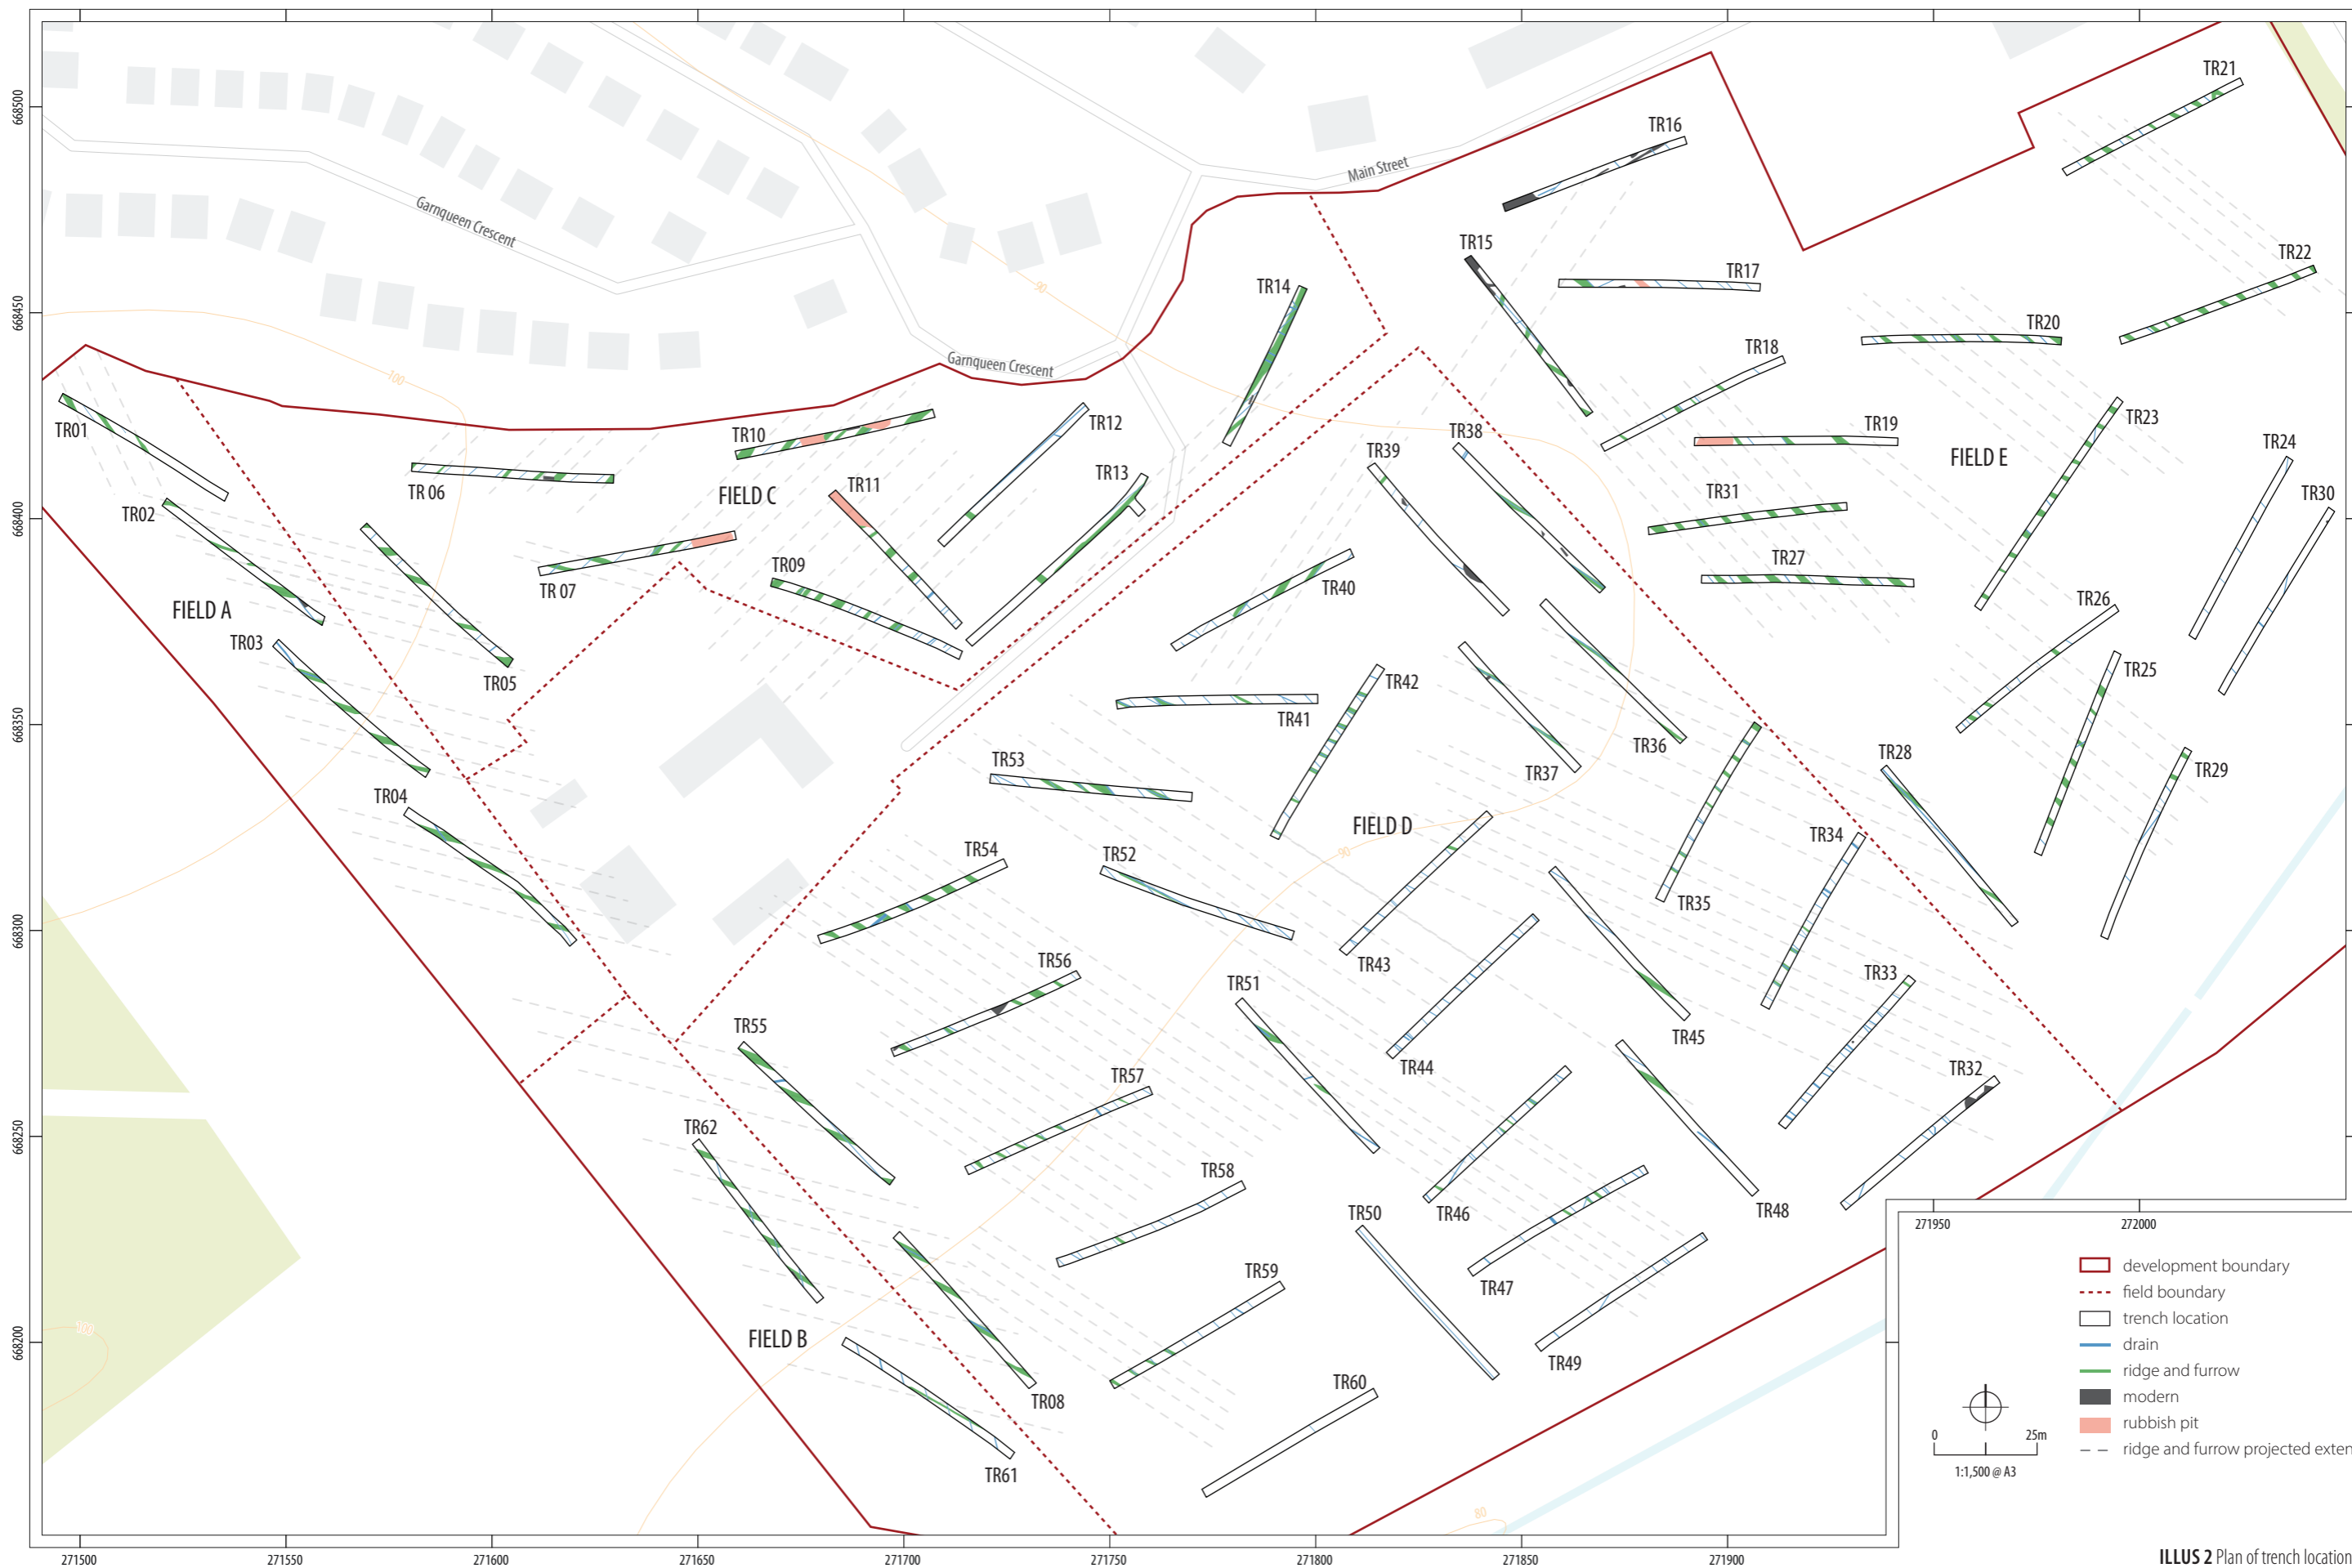
ILLUS 2 Plan of trench locations

Full trench descriptions, including orientation, length and depth are presented in Appendix 1. A total of 62 trenches were excavated (Illus 2). The majority of these were 50m long by 2.1m wide. Seventeen trenches at the east end of the area (Tr15–31) were excavated with a smaller machine and were only 1.8m wide. The total area of the excavated trenches amounted to 6234m<sup>2</sup>. The field boundaries divided the site into five areas (Fields A–E Illus 2).

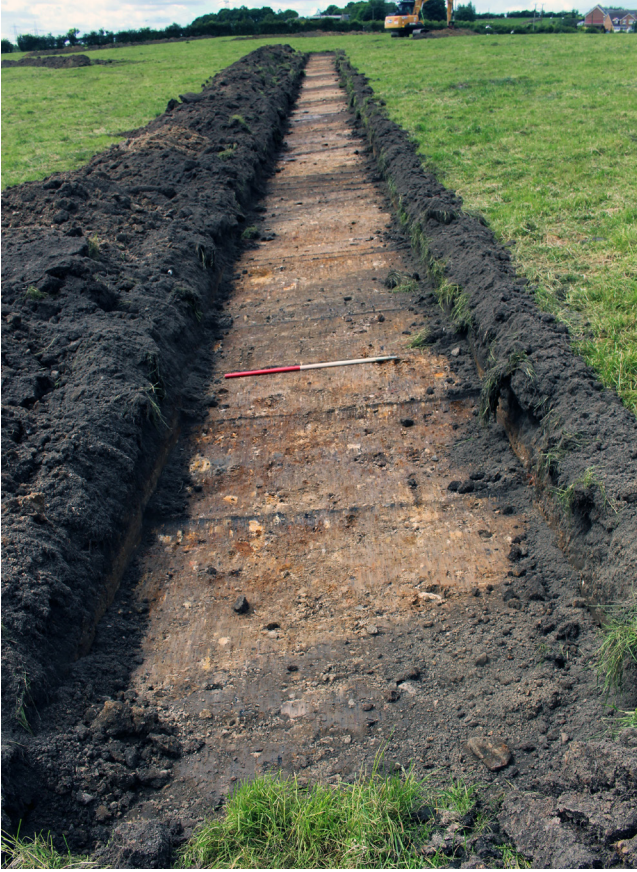
ILLUS 3 Furrows exposed in Trench 22. Facing south-west

Most trenches contained furrows associated with rig and furrow cultivation (Illus 3). Due to different orientations it was possible to

identify at least six separate sets of cultivation. The majority of the furrows were aligned north-west to south-east, reflecting the slope of the terrain. In Field C to the north of the farmstead the terrain sloped towards the east and the furrows in this area were on a north-east to south-west alignment. The furrows were on average 5m apart.

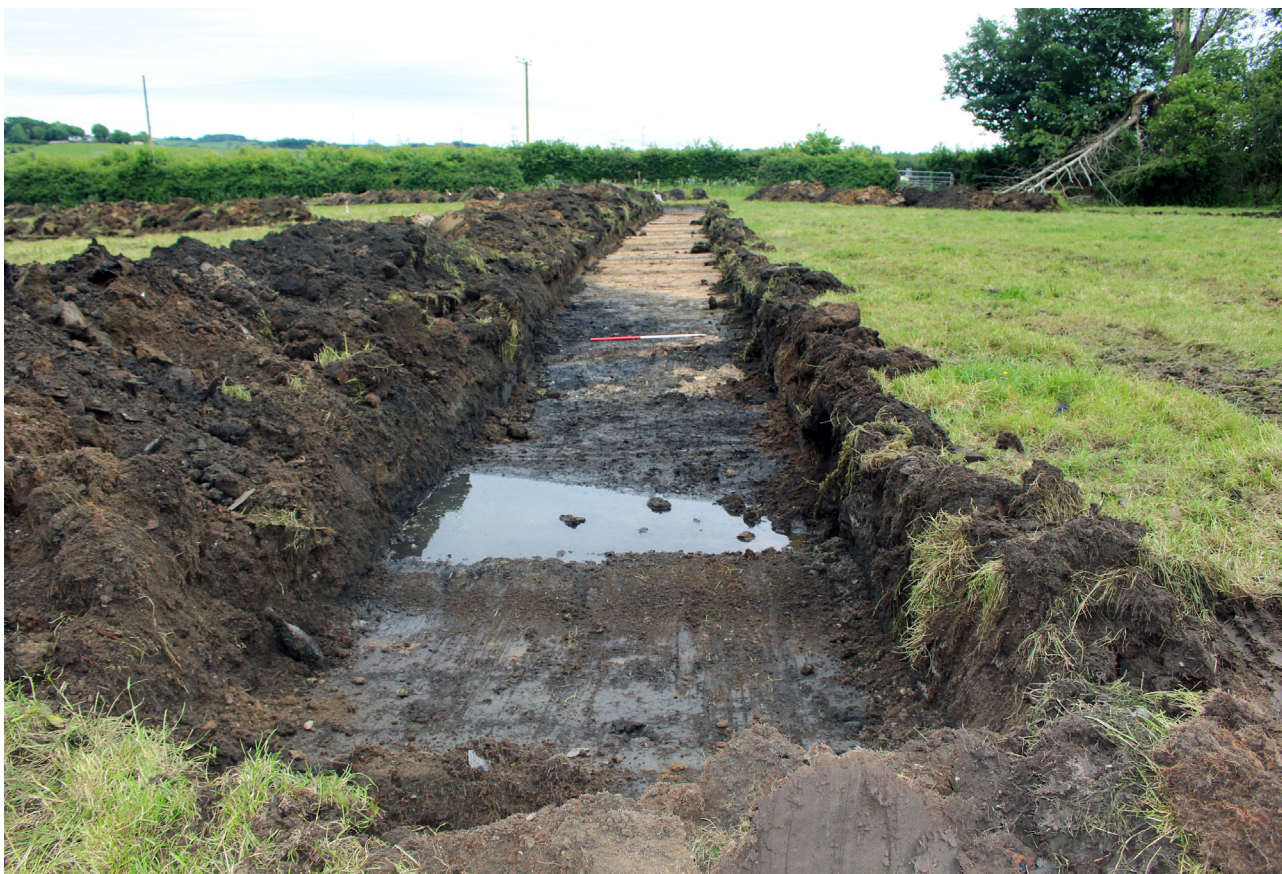
Some quarry pits filled with 20th century waste were recorded in Field C to the north-east of the farmstead. A pit at the east end of Trench 07 measured 10m across. A second pit was exposed at the north-west end of Trench 11 (Illus 4). It was at least 13m wide and extended beyond the end of the trench. A further two pits, 6m and 7m across were uncovered in Trench 10 to the north. All four pits were located within a radius of 30m. A fifth pit was uncovered at the west end of Trench 19 in Field E some 200m to the east. It was filled with cinder and measured 9m across (Illus 5).

ILLUS 4 Clay quarry pit filled with farm waste exposed at NW end of Trench 11. Facing south-east

The five larger pits uncovered in Fields C and E are likely to be small clay quarry pits or possibly clay prospecting pits associated with the Glenboig Fire Clay works located some 250m to the north of the site on the east side of Garnqueen Loch. The brick works started up in the 1840s and specialised in making bricks for furnaces utilising high quality local clays. At its peak it exported bricks all over the world. The brick works closed down in 1958.

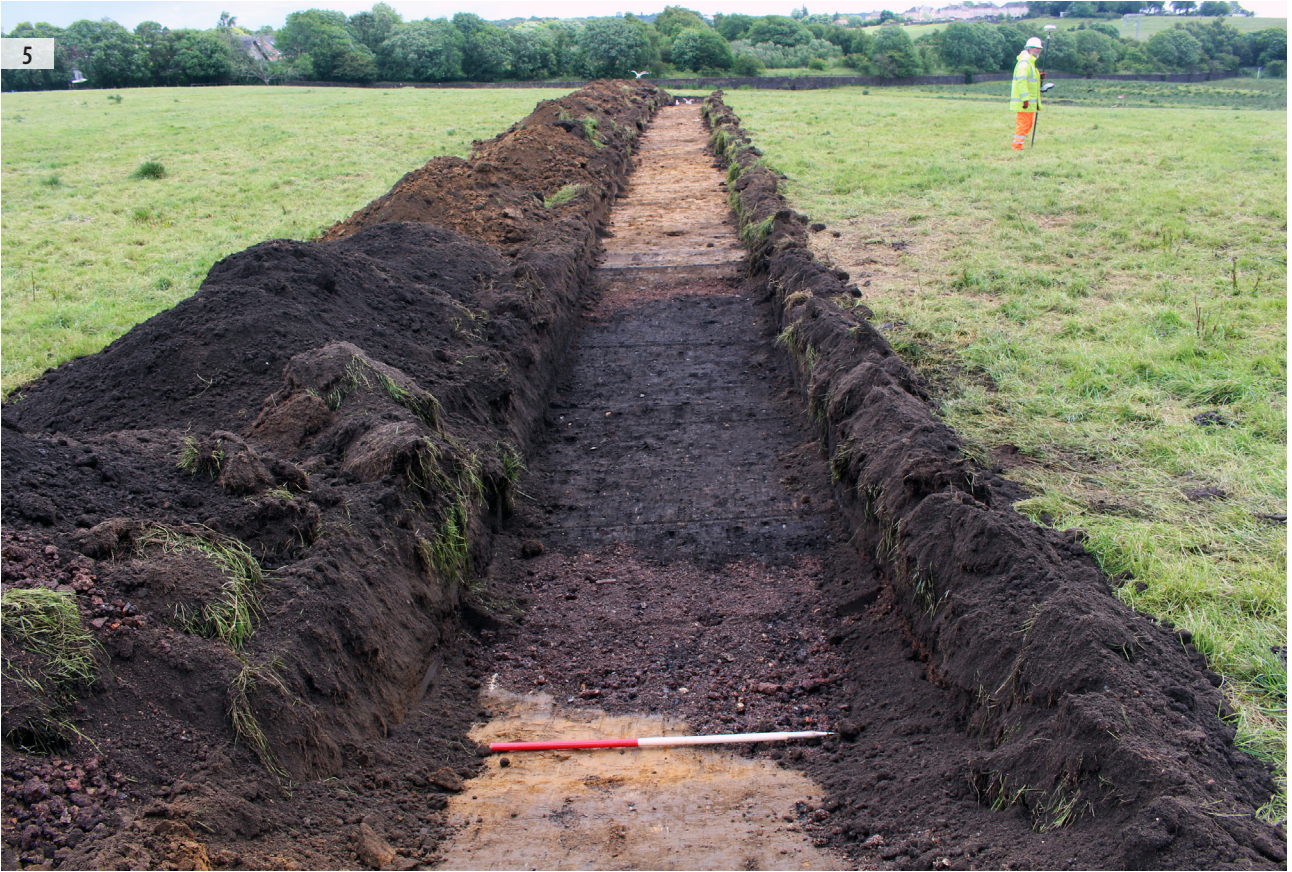
**ILLUS 5** Clay quarry pit filled with cinder exposed at W end of Trench 19. Facing east

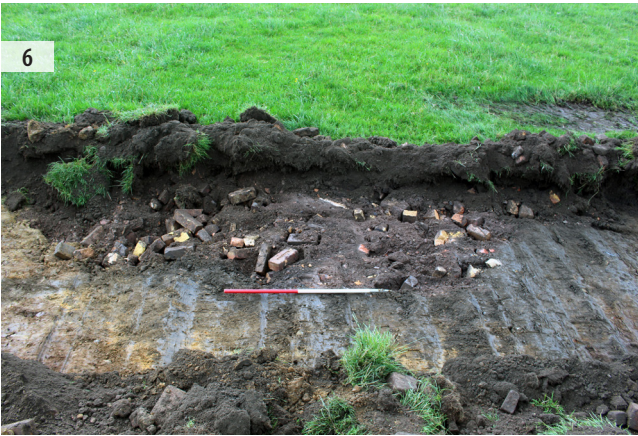
A modern pit was exposed along the side of Trench 39 in Field D (Illus 6). In addition to stone rubble the pit contained several bricks marked 'GLENBOIG' (Illus 7).

**ILLUS 6** Modern cut filled with brick rubble exposed in Trench 39. Facing north-east

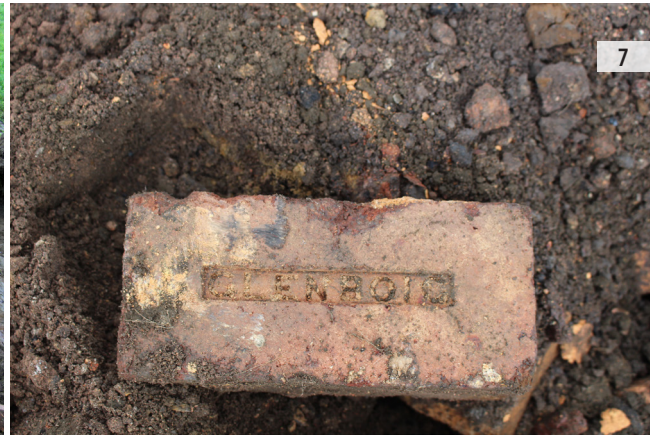
**ILLUS 7** Brick stamped 'GLENBOIG' from Trench 39
