Project Code: ESGW07
Date: January 2008
Client: Cooper Cromar for Steven Shear

138 Elliot Street, Glasgow: An Archaeological Evaluation

Planning Reference: 07/02128/DC

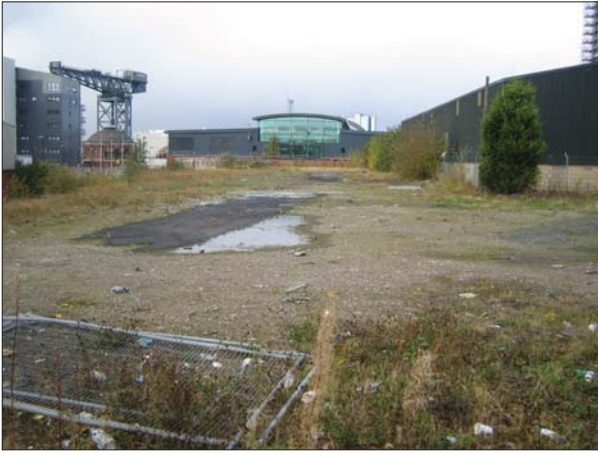
The site proposed for development is a 3098 m² plot of derelict ground on the west side of Elliot Street (Figure 1, Plates 1-3). The site is enclosed on three sides by modern buildings, and fronts directly on to Elliot Street in the east. The site was thoroughly cleared and levelled after demolition of the previous building. There is an approximate 2m change in level on the site, a feature that does not represent the natural topography but rather the substantial build up of material on the north side. The northern part of the site is higher, separated from the lower level by a steep drop.

Plate 1 - Site, facing east

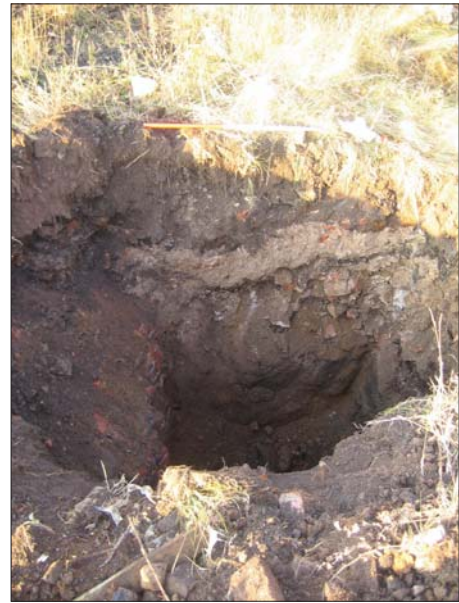
Compacted soil and mixed rubble [001] formed the surface material and extended to 1.4m below the modern ground surface. A brick foundation [009] was exposed in the southern side of the test pit (Plate 4). The bricks were machine rather than hand made, indicating that the structure was relatively modern, and most likely dates to the 20th century. A mixed, sandy

Plate 4 - Test Pit 1, with brick foundation 009.

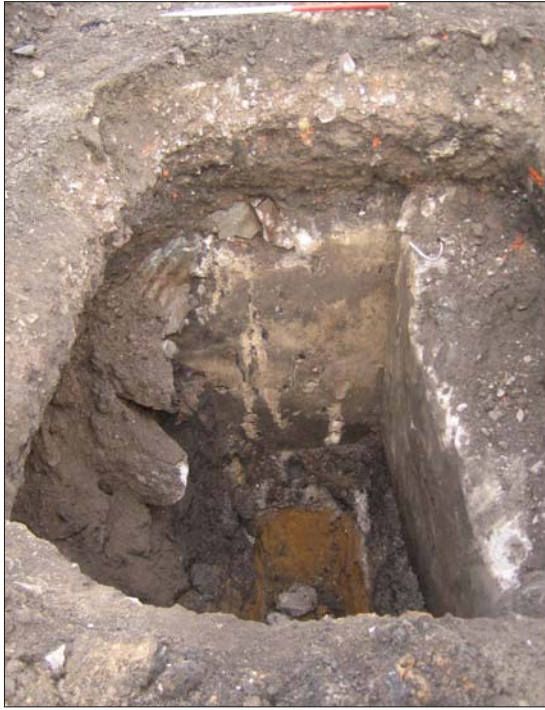
The same compacted rubble deposit [001] as seen in the previous test pit formed the surface material and extended to 1m in depth below the modern ground surface. Directly beneath this rubble layer a concrete tank [003] constructed from pre-cast slabs with steel reinforcement was identified (Plate 5). The overall thickness of the tank was 2.2m from top to base. The north, east and south walls of the tank were identified in the section faces of the test pit, giving the tank a north-south width of 2m. Backfilled rubble inside the tank extended to the west (Plate 6). Using the concrete breaker it was possible to determine that the base of this tank sat directly on natural sand.

Plate 5 - Tank 003 in Test Pit 2

No further deposits of archaeological significance were identified within the test pits. The concrete tank [003] identified in Test Pit 2 was constructed from pre-cast slabs reinforced with steel. This method of construction suggests it does not pre-date the 20th century. In March 2002 Headland Archaeology Ltd identified a concrete tank of similar construction in the western half of the site (Headland Archaeology Ltd 2002). This tank was also deemed to be modern.

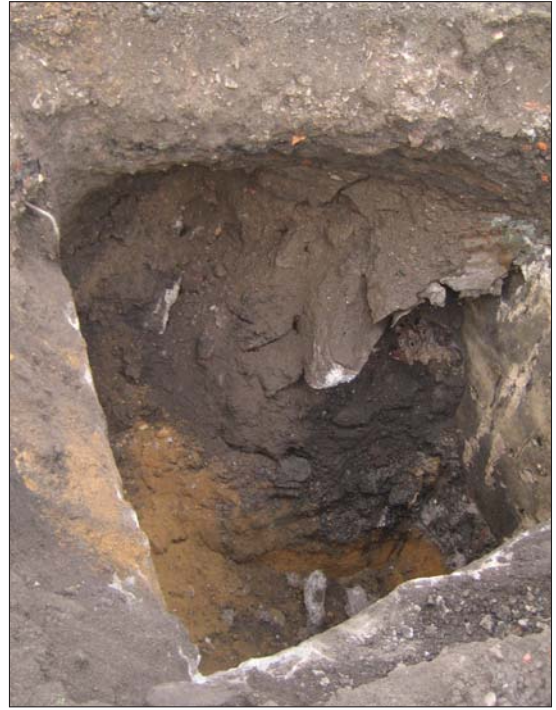
Plate 6 - Backfill in tank 003 in Test pit 2

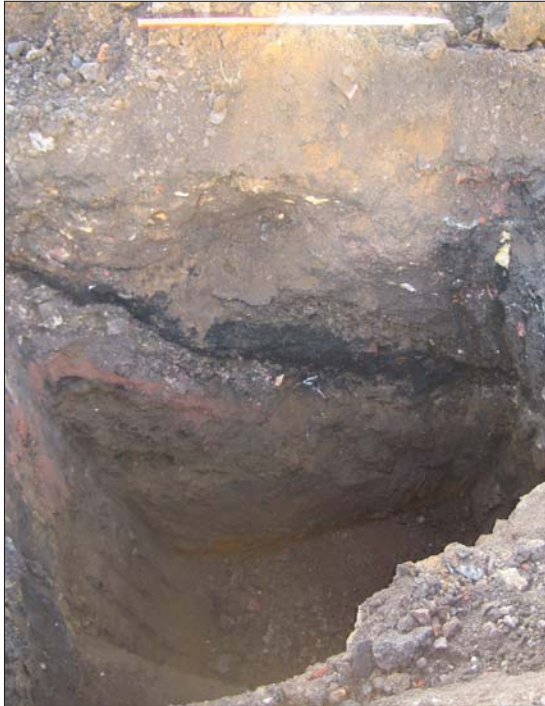
Plate 7: Test Pit 3

As in test pit 1 compacted loam and mixed rubble [001] formed the surface material and extended to 1.5m in depth below the modern ground surface. A mixed, sandy loam with less frequent rubble [002] up to 1.3m thick lay beneath [001] and above the natural sand and alluvial gravels (Plate 7).

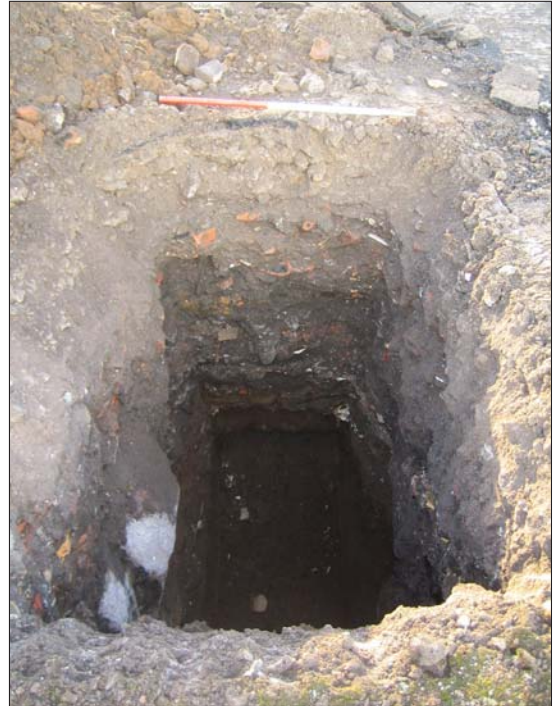
Plate 8: Test Pit 4

A very thick deposit of rubble and made up ground [001] up to 1.9m in depth lay over clean sand [004]. The sand was 0.4m thick and beneath this deposit lay a lens of material rich in ceramic fragments and kiln material [005] up to a maximum of 0.2m thick. A further loamy sand deposit [006] 0.5m thick lay beneath this pottery-rich lens and above the natural sand (Plate 8).

The lens of pottery and kiln material [005] identified in Test Pit 4 most likely represents dumped material relating to the adjacent Verreville Pottery. The deposit appears to be thin and localized. Pottery waste from Glasgow's many factories is a common find in the city. It has been shown to have a wide distribution, with material sometimes found some distance from the kiln (Haggarty pers com). Though some of the pottery patterns appear to be slightly different to those found at the Finnieston Street site (Headland Archaeology 2007), all are fragmentary, with no near complete vessels. It is certainly not part of a well stratified deliberate area of dumping by the factory, but rather some kiln waste which has become mixed with other material in the make up in this area.

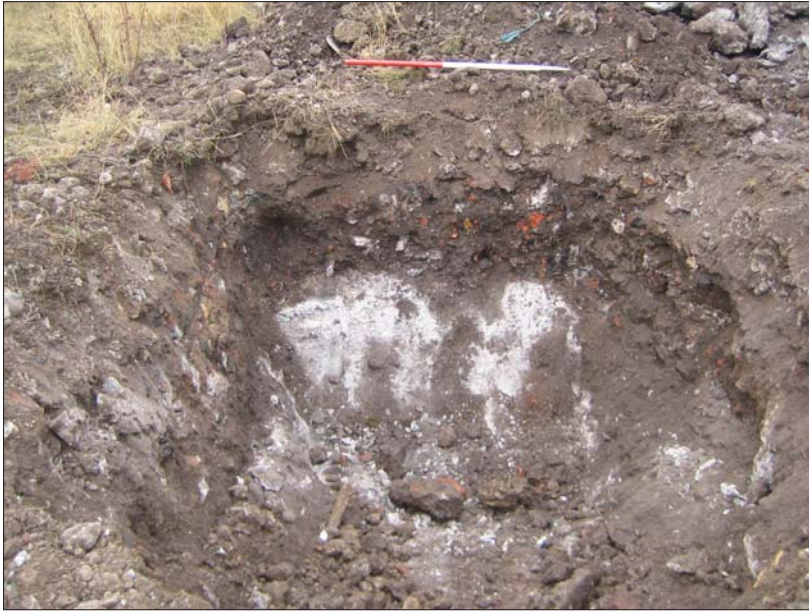
The made up ground deposit [001] extended to 0.9m thick and lay directly over a concrete pad or pile foundation [007] (Plate 9). An attempt to break through this foundation with the concrete breaker was abandoned after 0.7m of concrete was removed without signs of breaking through to underlying deposits.

Plate 9 - Concrete pile 007 in Test Pit 5

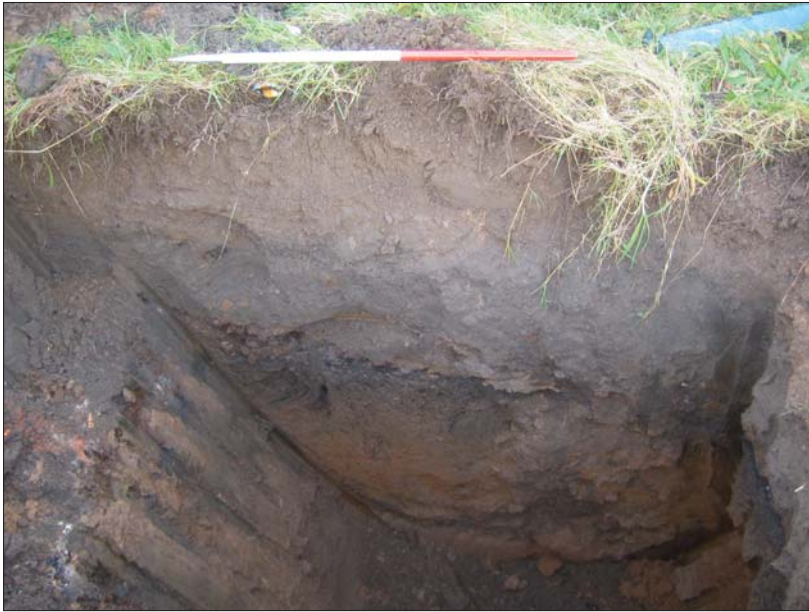
Plate 10 - Test Pit 6

Test pit 6 was located in the southern part of the site where the modern ground surface was approximately 2m lower than that of the other test pits. The surface material comprised compacted loam and rubble to a depth of 0.3m. Mixed loam with occasional fragments of rubble [002] formed a deposit up to 0.9m thick beneath [001]. A band of dark brown sandy loam [008] up to 0.1m thick was identified at the base of [002]. This deposit may relate to earlier dumping on the site. Beneath [008] lay natural sand (Plate 10).
