REPLACEMENT CASTLEBRAE HIGH SCHOOL, EDINBURGH

ARCHAEOLOGICAL EVALUATION

PLANNING REF. 19/01771/FUL

November 2019

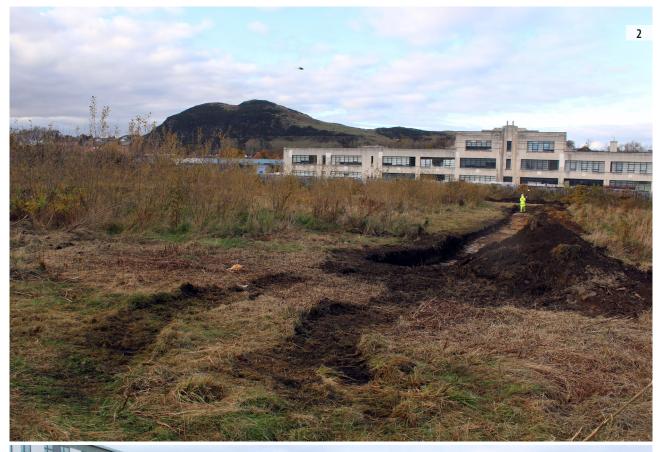
ILLUS 2 General view of the site showing the heavy scrub cover **ILLUS 3** View of the banking at the south end of the site

The evaluation was carried out between the 30th and 31st October 2019 in dry and bright conditions. At the time of the evaluation the land could best be described as wasteland. Much of the area was covered in small trees and scrub and was uneven throughout (Illus 2). The area also included several earthen banks forming rough terracing across parts of the site. The most pronounced bank was to the south end of the site. Here it formed a steep slope up to the rear of recently constructed CEC Neighbourhood Centre (Illus 3). Additional banks were recorded across the centre of the site and a small area to the north end of the site. This undulating ground and areas of scrub affected the positioning of the proposed trenches, although a reasonably even spread was achieved.
