VIKING WIND FARM MAIN COMPOUND, SHETLAND, PRE-CONSTRUCTION TRIAL TRENCHING

ARCHAEOLOGICAL EVALUATION

commissioned by Viking Energy Wind Farm LLP

December 2019

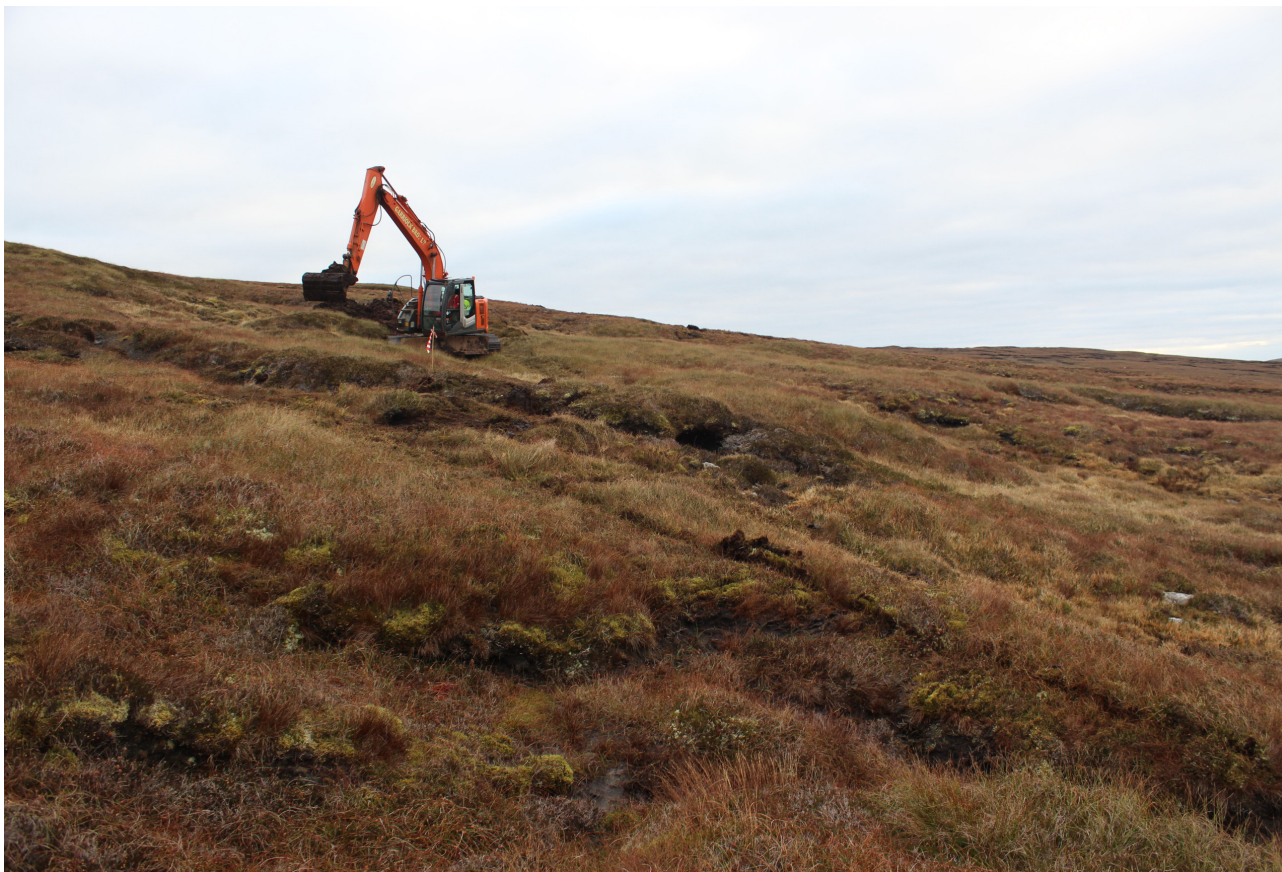
ILLUS 2 View east of the development area

The proposed development area was used as grazing for sheep at the time of the works. The topography was characterised by a gradual to steep incline to the east with undulating depressions and hillocks (Illus 2). Height above sea level ranged between 38m AOD and 75m AOD. The geology comprised superficial deposits of peat overlying Whiteness Limestone Member bedrock (NERC 2019).

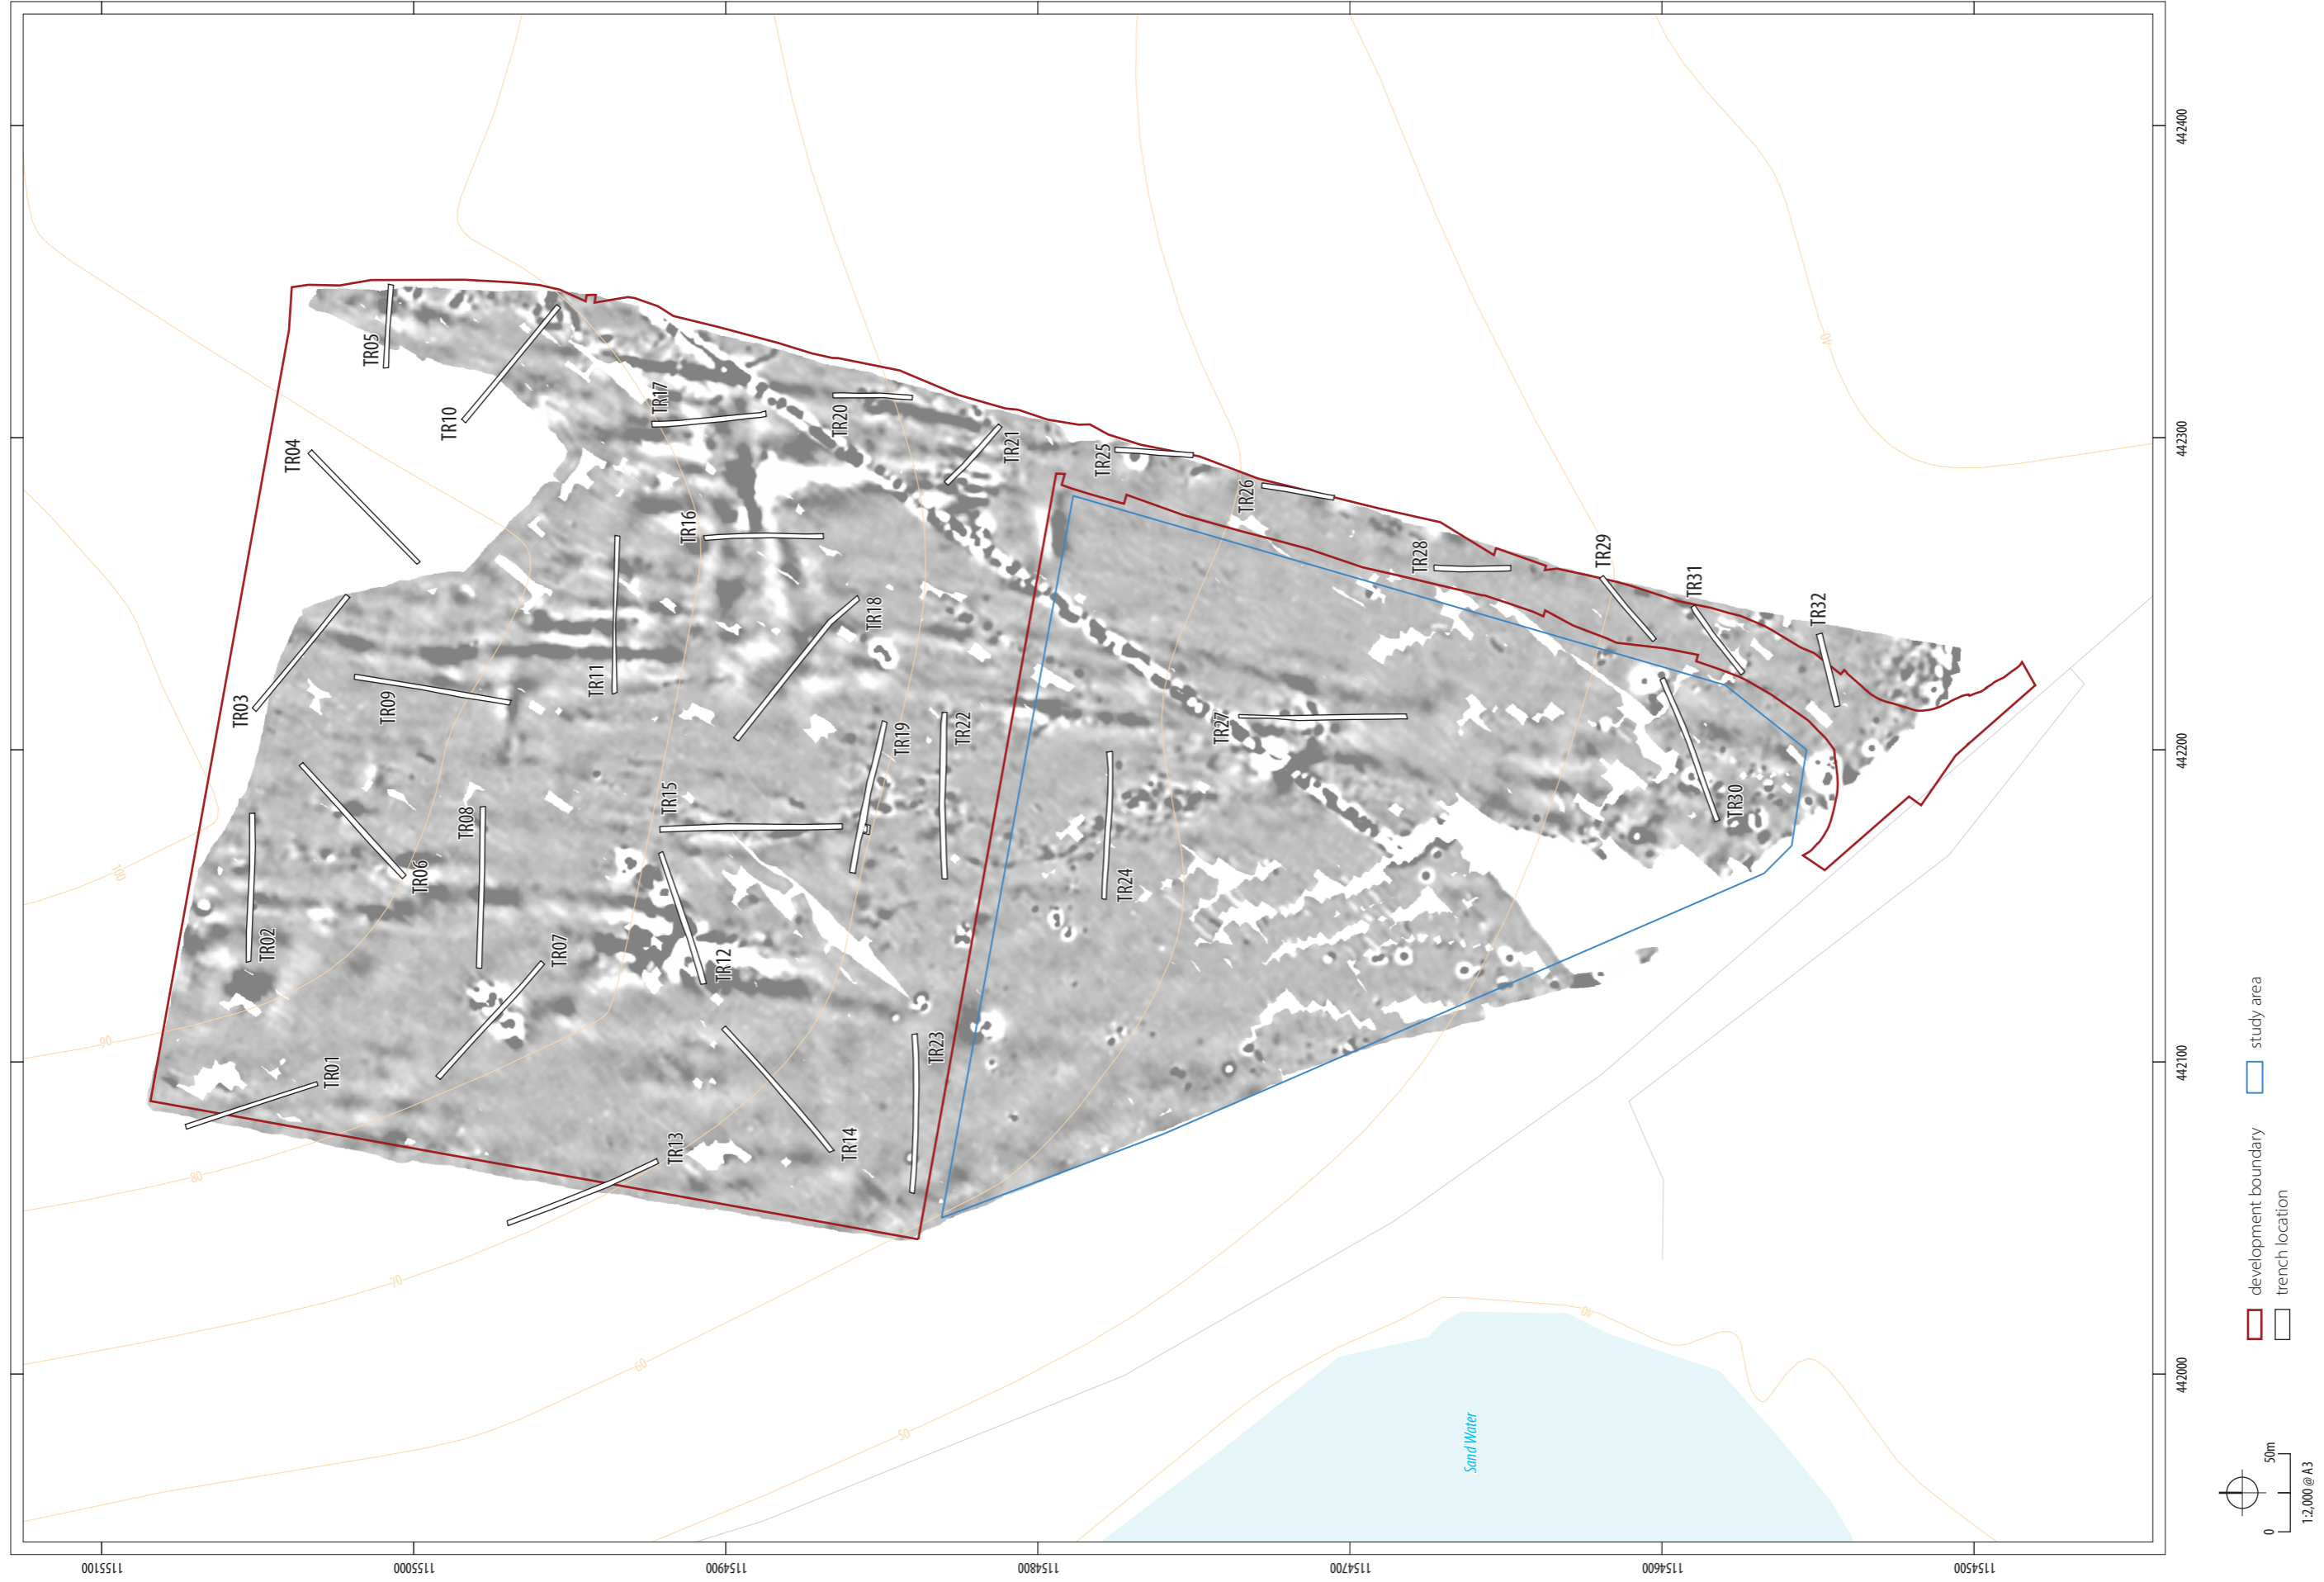
ILLUS 3 Trench location plan with geophysical survey results

Full trench descriptions, including orientation, length, width and depth are present in Appendix 1. A total of 32 trenches were excavated with the location of the trenches spread evenly across the development area to provide appropriate coverage (Illus 3). Of the excavated trenches, 33 were 50m long and five were 25m long. Trench 01, 05, 12, 16 and 24 were shortened due to conditions such as soft, boggy ground, steep inclines or peat banks which would impede the machine. The meterage shortfall was accounted for by the extension of Trench 14, 15, 17, 18, 20 and 22. The peat depth was deeper than 1m in Trench 09, 26, 28, 29 and 31, therefore the archaeological potential of these trenches could not be fully determined (Illus 4).

Trench 05, 06, 10, 15, 19, 20, 22, 24 and 27 were targeted to test possible anomalies identified by geophysical survey. Trenches 24, 27 and 30 were outside the proposed footprint of the compound and access track but were excavated in order to test geophysical anomalies identified at those locations. The anomalies in Trench 05, 06 and 15 were explained by bedrock or boulders set into the geological

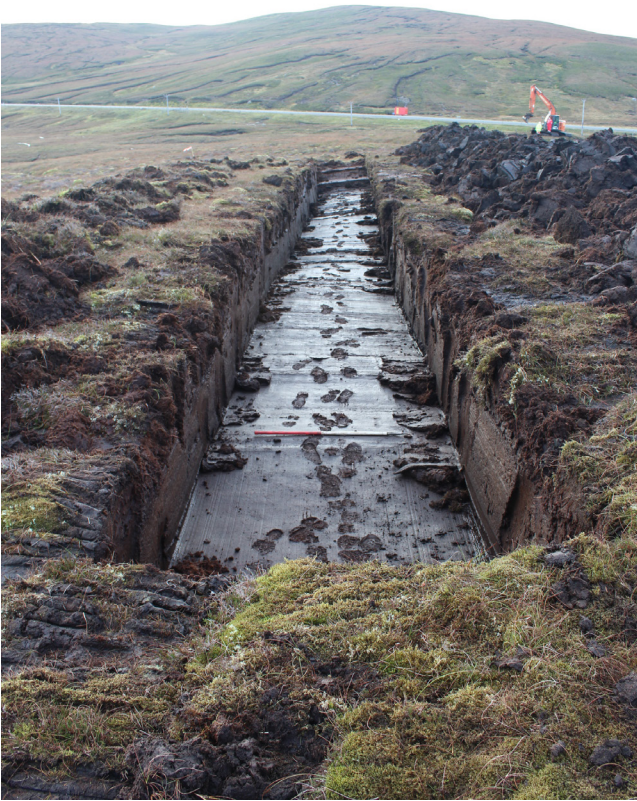
ILLUS 4 Trench 26 with no underlying geology exposed due to peat depth
ILLUS 5 Boulders in Trench 19 identified as geological

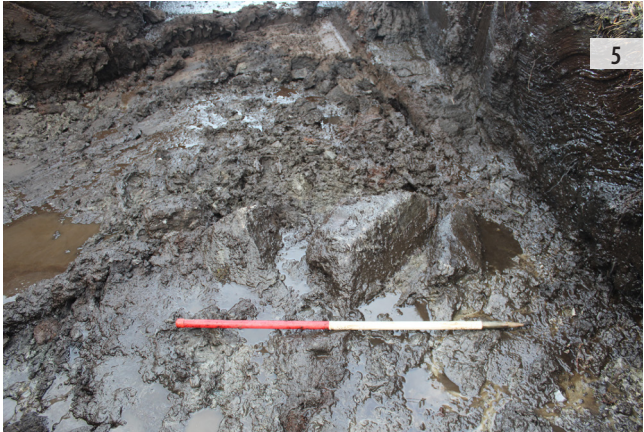
subsoil. A row of large boulders in Trench 19 were investigated further by extending the trench to the south and further excavating the peat. This revealed that the boulders were set into the underlying geology and therefore not archaeological. Causes for anomalies in Trench 10, 20, 22, 24 and 27 were not identified during the works.
