# DALMENY CONTRACTORS VILLAGE, SOUTH QUEENSFERRY

ARCHAEOLOGICAL EVALUATION

PLANNING REF. 19/05158/FUL

commissioned by IKM Consulting

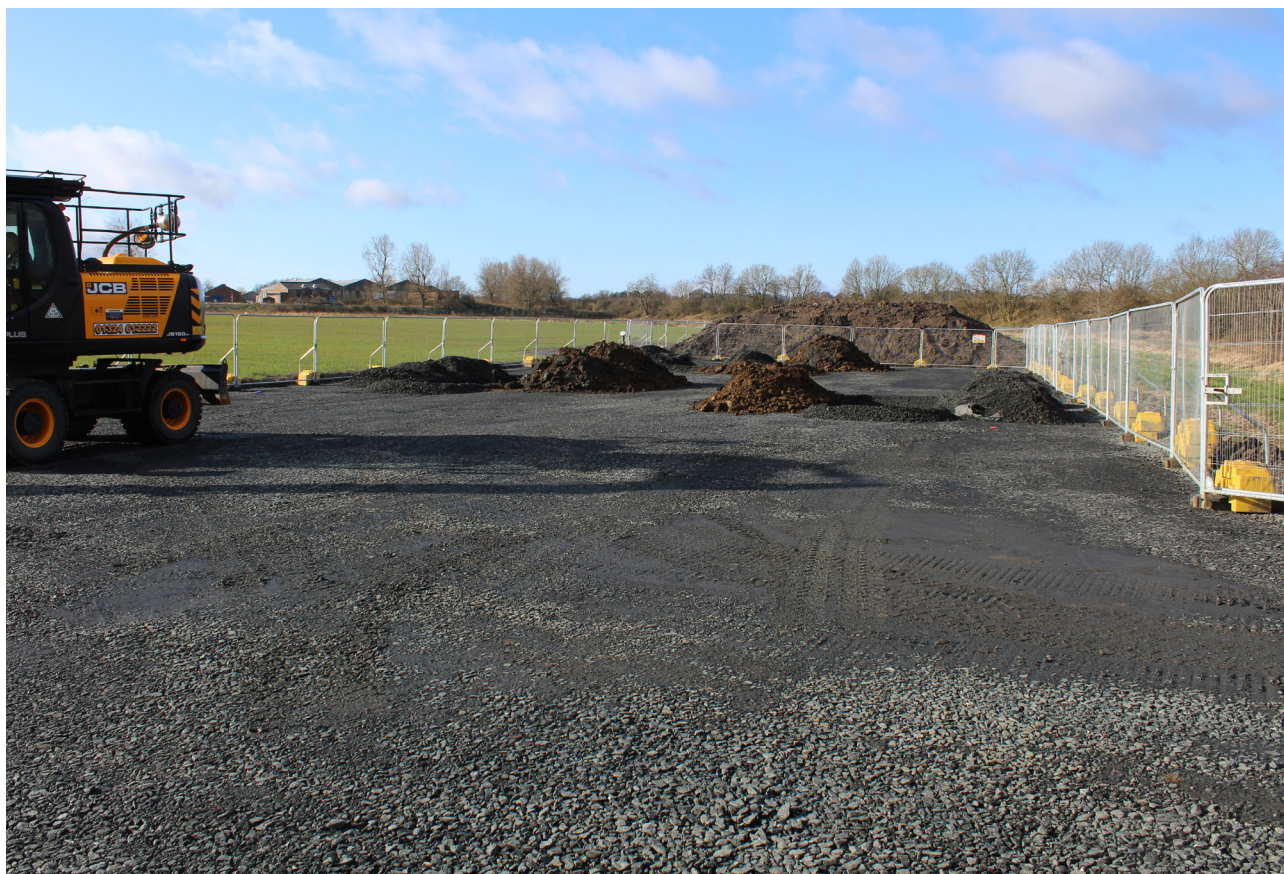
**ILLUS 2** General view of the evaluation area

The site was located within agricultural land 500m to the south of Dalmeny, South Queensferry (NGR: NT 1426 7674; Illus 1). It is to the west of Standingstone Road and the main railway line between Edinburgh and the north. The area was bounded to the north by a farm track and to the south and west by further agricultural land. Prior to the archaeological works the site had been stripped of topsoil and a temporary compacted gravel surface had been laid within the field (Illus 2).

The evaluation was carried out on the 27th February 2020 in dry and bright conditions. At the time of the evaluation the area had already been stripped of topsoil and covered with compacted gravel (see Illus 2). The size of the area and the surrounding herras fencing

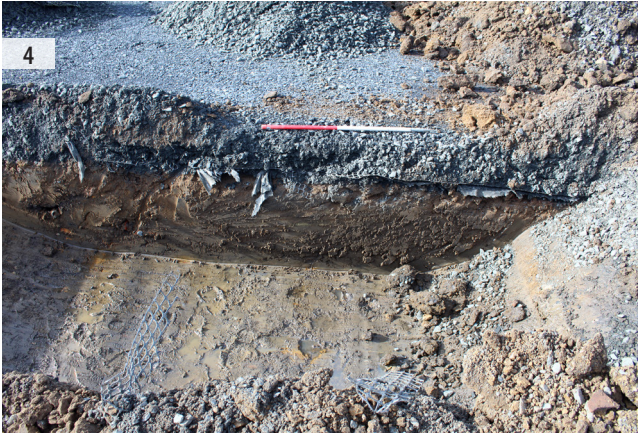
Five evaluation trenches were excavated across the area and the descriptions and dimensions of these can be found in Appendix 1. The geological subsoil of mid-yellow sandy clay (1002) was exposed in all trenches. The stratigraphy and depths of the trenches was similar across all five trenches. In order to ascertain if the yellow sandy clay exposed during the initial topsoil strip was geological subsoil or redeposited material the excavation of Trench 1 continued to a maximum depth of 1m (Illus 4). This revealed that the yellow clay was underlain by a yellowish grey clay (1003) with occasional small stone inclusions. The interface between the two layers was very diffuse suggesting that both layers were geological in formation.

**ILLUS 4** East facing section of Trench 1    **ILLUS 5** View of linear cut [3002] in Trench 3    **ILLUS 6** View of drain in Trench 4

Located to W end of the area. Gravel (1001) 0.25m deep over 0.5m of yellow sandy clay with occasional stone inclusions (1002). Basal layer of yellowish grey mottle clay with occasional stone inclusions (1003). One modern field drain aligned NE/SW to the south end 0.35m depth

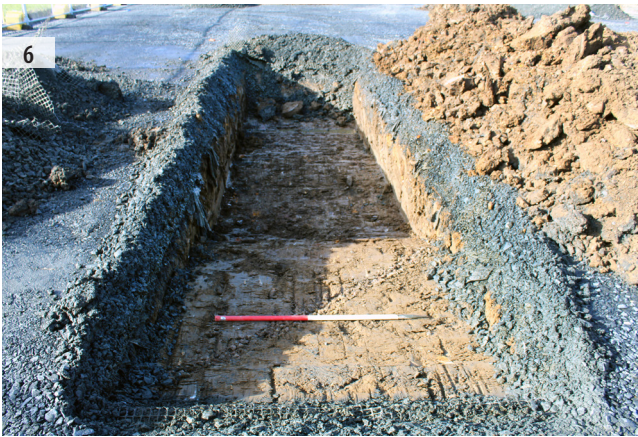
Field drains were recorded in four of the five trenches (Trench 01 and Trench 03–05). The majority of these were modern plastic drains covered with pea gravel (Illus 6) with a single drain recorded in each of the four trenches. Trench 04 also included a red ceramic tile drain. The modern drains were all 0.3 to 0.35m below ground level and the tile drain was recorded at a depth of 0.4m.

Located to the east end of the area. Gravel (1001) 0.25m deep over 0.5m of yellow sandy clay with occasional stone inclusions (1002). One modern field drain aligned NE/SW to the west end 0.35m depth
