Project Code: YWN07
Date of report: 20th August 2008
Client: Enviros for Your Energy Ltd

Results of Archaeological Evaluation

Daventry Wind Farm, Yelvertoft, Northamptonshire

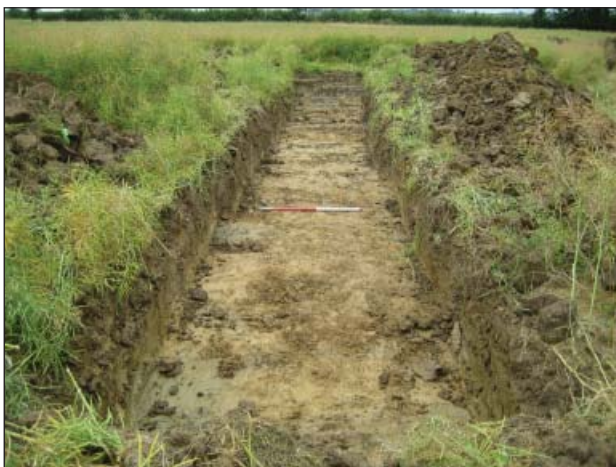
Illus 3
Trench 4

Trenches 3 & 4 were excavated in a field of mature oil seed rape at the northern limit of the site, to the immediate west of the location of Trenches 1&2. The stratigraphic sequence revealed within these trenches was very similar to that observed in trenches 1&2 although the natural clay was encountered at slightly shallower depth. A single land-drain, crossing the north-eastern corner of Trench 3 was the only observable feature in either trench.

Length: 20m Alignment: E-W Average depth: 0.65m Maximum depth: 0.85m

Context No.	Description	Depth of deposit (m)
400	Topsoil	0.23m
401	Subsoil: light yellow-brown compact clay loam	0.33m
402	Natural: Light creamy yellow-orange and grey mottled clay

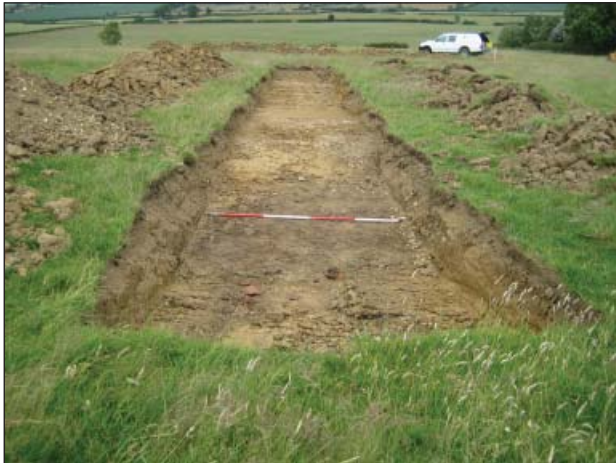
Illus 4
Trench 9

Trenches 9 & 10 were located in a further field of pasture at the southern extent of the site. Trench 9 was aligned north to south and was located on a southern incline. Trench 10 was aligned north-west to south-east toward the foot of the same slope. Trenches 9 & 10 were the shallowest of all the excavated trenches, averaging a maximum depth of just under 0.5m, where the characteristic, plastic yellow boulder clay was encountered. The faint remains of 2 possible furrows were identified, aligned north-west to south-east at a distance of just over 6m apart in Trench 9. Sample excavation determined that the furrows survived to a maximum depth of 0.08m and were approximately 2m wide. These were infilled by the mixed loam-clay deposit seen throughout the trench, sealed by the topsoil. A further potential linear feature, located at the southern end of Trench 9, was sample excavated and subsequently identified as the remains of a probable tree throw pit. Trench

10 revealed a single ceramic land drain and no continuation of the possible furrows from Trench 9 was

observed. No further features or deposits of an archaeological nature were identified within either trench.

Context No.	Description	Depth of deposit (m)
900	Topsoil	0.26
901	Subsoil: Mid yellow brown mottled clay loam	0.15
902	Cut/interruption of tree bole 1.8m wide x 2m long	
903	Mid-dark brown clay loam infill of 902	0.05
904	Natural: Yellow and grey mottled boulder clay	
905	Cut of possible furrow 2.1m wide x 2m long	
906	Mid yellow brown mottled clay loam infill of 905 (as 901)	0.08m
907	Cut of possible furrow 2m wide x 2m long	
908	Mid yellow brown mottled clay loam infill of 907 (as 901)	0.05m

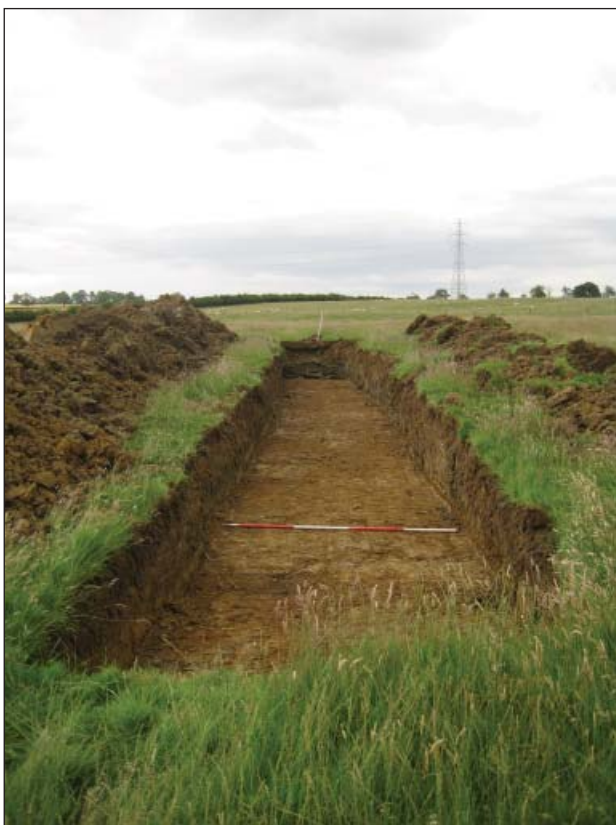
Illus 5
Trench 12

Trenches 11 & 12 were excavated at the approximate centre of the site in a field of pasture, within which the remains of upstanding, but poorly preserved ridge and furrow was observed.

The natural was encountered at depths of be-

tween 0.75 and 1.1m and comprised mottled clay with broad seams of orange, fossil rich stone, as seen across the drier, less clayey parts of the site. Overlying the natural was the familiar yellowish brown clay-loam, which appeared to represent, in trenches 9 & 10, a remnant plough soil, sealed by the modern topsoil.

Despite its presence elsewhere in the field, no evidence of ridge and furrow was readily observable in the immediate area of the trenches, nor was any trace seen within them.

Context No.	Description	Depth of deposit (m)
1200	Topsoil	0.33
1201	Subsoil: Light brown-yellow plastic clay loam	0.22
1202	Natural: Mid yellow-grey boulder clay

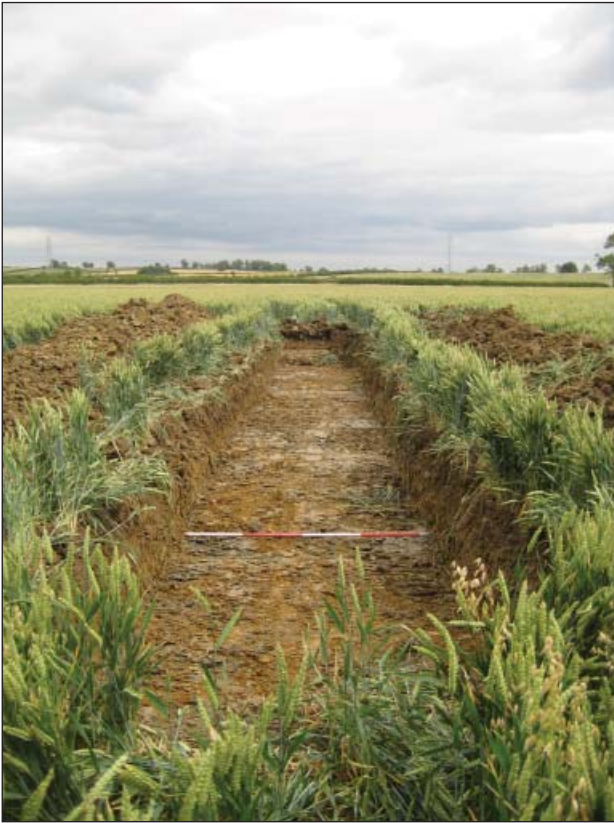
Illus 6
Trench 16

Trenches 15 & 16 were excavated in a standing wheat crop toward the north-western limit of the site boundary. Similar to Trenches 5 & 6, which were just to the south, these trenches were quite deep, the surface of the natural clay being encountered at depths of up to 1.0m. Trench 15 revealed a much greater blue-grey clay component forming the natural than had been seen across other parts of the site. This was machine tested accordingly to ensure that the correct level had been achieved. Trench 16 to its south also contained an element of blue clay but also contained more of the familiar yellow and orange material, interspersed with more stone than Trench 15. Again, the natural was sealed by a characteristic clay-loam, overlain by the modern topsoil. A single ceramic land drain was encountered, aligned north-west-southeast, spanning Trench 15, no features or deposits of an archaeological nature were identified within either trench.

Context No.	Description	Depth of deposit (m)
1600	Topsoil	0.22
1601	Subsoil: mid- yellow-brown mottled clay loam	0.51
1602	Natural: Mid yellow and dark blue boulder clay with orange mottling
