Project Code: RWMC08
Date: February 2008
Client: Scottish Borders Council

Data Structure Report: Melrose Cauld River Wall Repairs

Archaeological Watching Brief

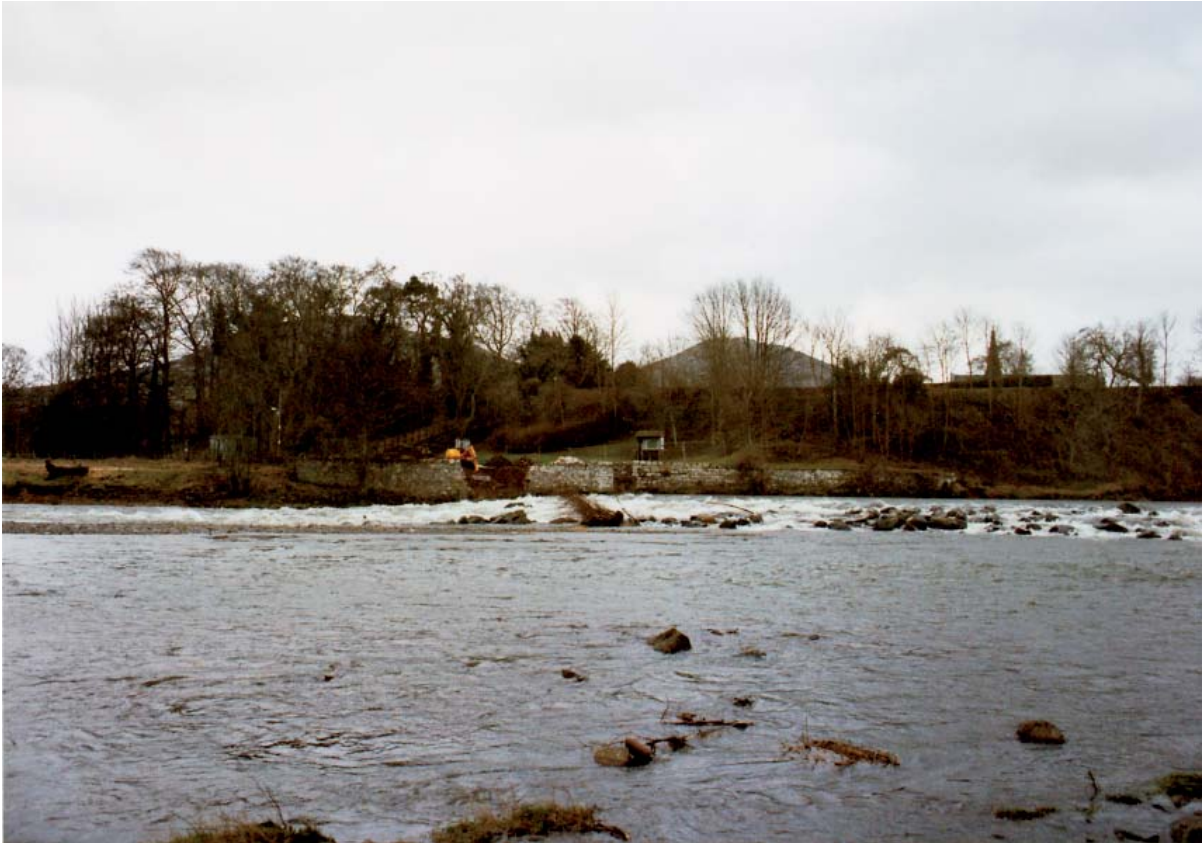
Plate 1
Site shot from N side of river

The site is located to the north of the town of Melrose on the southern bank of the River Tweed, 100 m west of the Gattonside Footbridge (Figure 1, Plate 1) in the Parish of Melrose and County of Roxburgh. It is bounded on the northern side by the River Tweed and the Southern Upland way path is located directly to the south. The underlying geology in the area consists of recent riverine and lacustrine alluvial deposits overlain by alluvial soils.

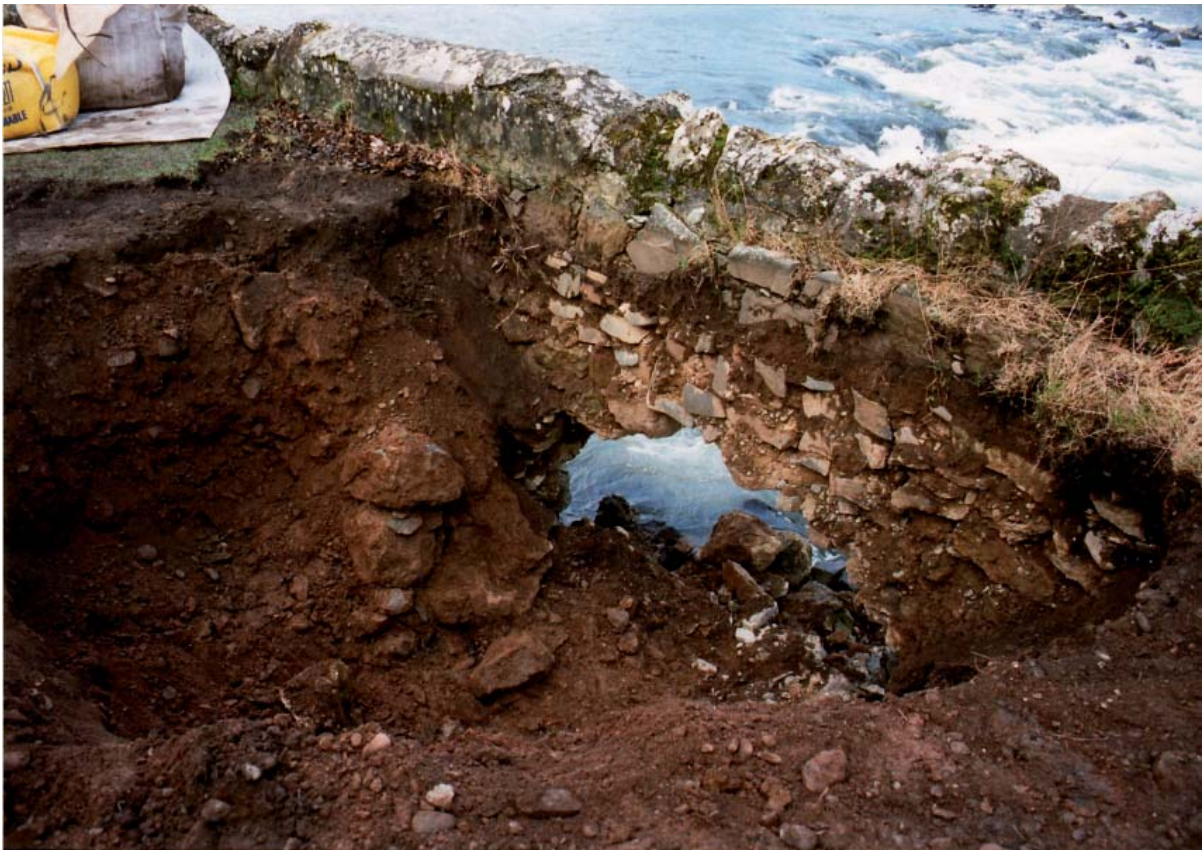
The excavated area ranged from 0.10 to 2.20 m in depth. Stratigraphy consisted of a 0.05 m thick deposit of topsoil (001) overlying a layer of redeposited alluvial material (002) containing river rounded cobbles and clay lenses. A 1 m wide, randomly coursed whinstone wall bonded with clay [003] was located 0.60 m below the present ground level (Figure 2). It was aligned east to west and ran parallel with, and 0.30 m to the south of, the existing river wall. The wall was bonded to an underlying wall, also constructed from randomly coursed whinstone blocks [004], with a yellowish white lime mortar (Plates 2 & 3).

Plate 2
General shot of walls 003 & 004

It is likely that walls [003] and [004] are the remains of the same earlier river wall, the difference in bonding can perhaps be explained by repair to the wall. There was no distinguishable difference in the sands and river gravels surrounding the earlier wall. There are two hypotheses that can be advanced to explain this observation. Either the wall once abutted an earlier riverbank, but the line of this bank cannot be distinguished from redeposited sand and gravel dumped when the existing wall was built. Alternatively, the recorded section of earlier wall was freestanding and was covered intact when the riverbank was raised during the building of the existing river wall. Given the rough construction of the wall the former explanation seems most likely.

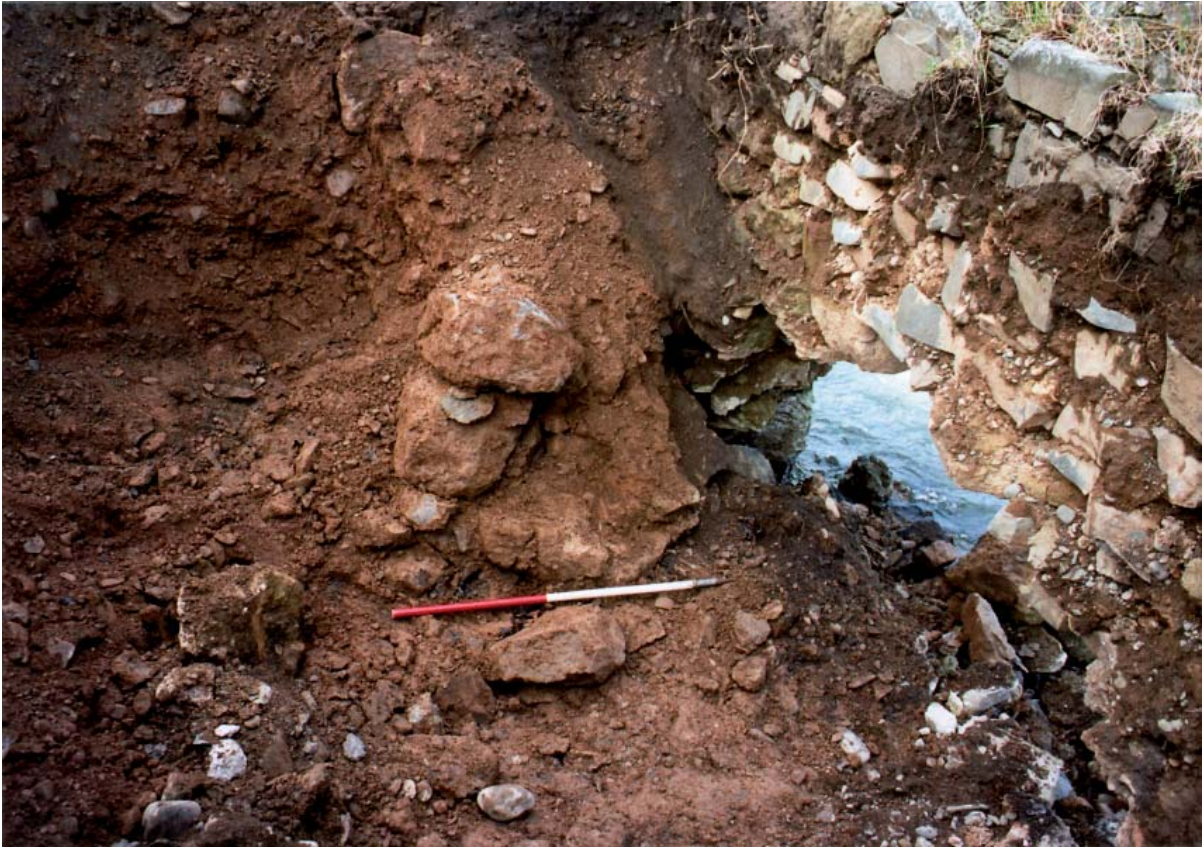
Plate 3
Detail of wall 003
