ROSEWOOD FARM, CRONTON, KNOWSLEY

*Level 1 Historic Building Record
for Craig and Louise Knight*

August 2021

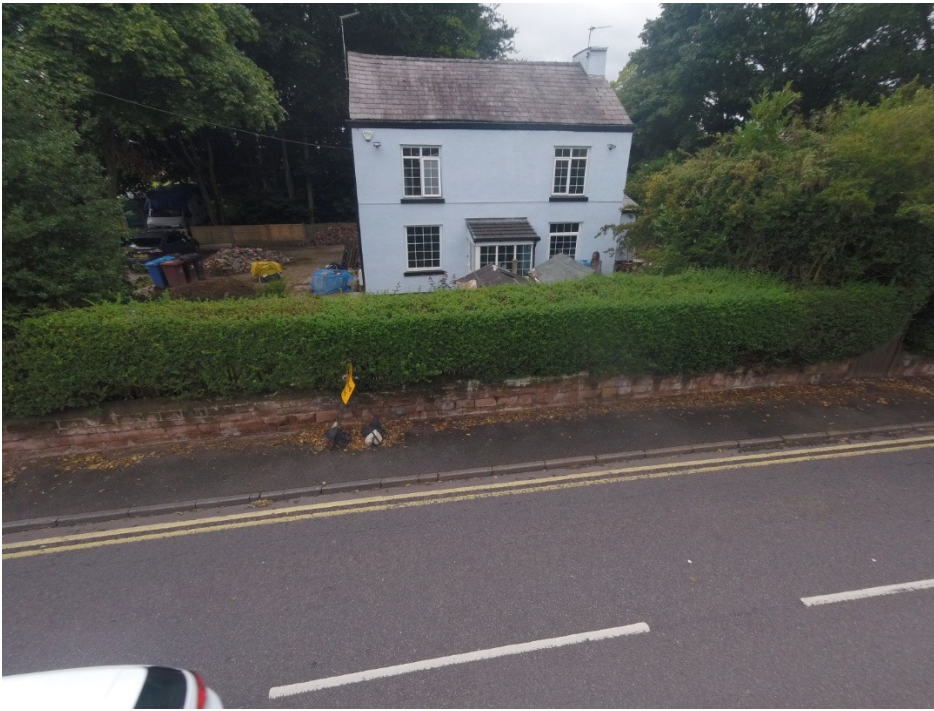
Figure 2. Rosewood Farm, general view facing east from Chapel Lane

- 1.3. Figure 1). The site is currently occupied by the house, its gardens and a tarmaced drive (Figure 2). The plot boundaries are defined by tall hedges fronting Cronton Road and Chapel Lane, by a small plot of woodland to the west and a small stone and brick barn and a brick single storey outbuilding to the south. The outbuilding is tentatively identified as a former piggery attached to the farm. The barn was not inspected in detail, but perhaps dates to the late 18th or early 19th century, though part is constructed in stone and may be earlier.

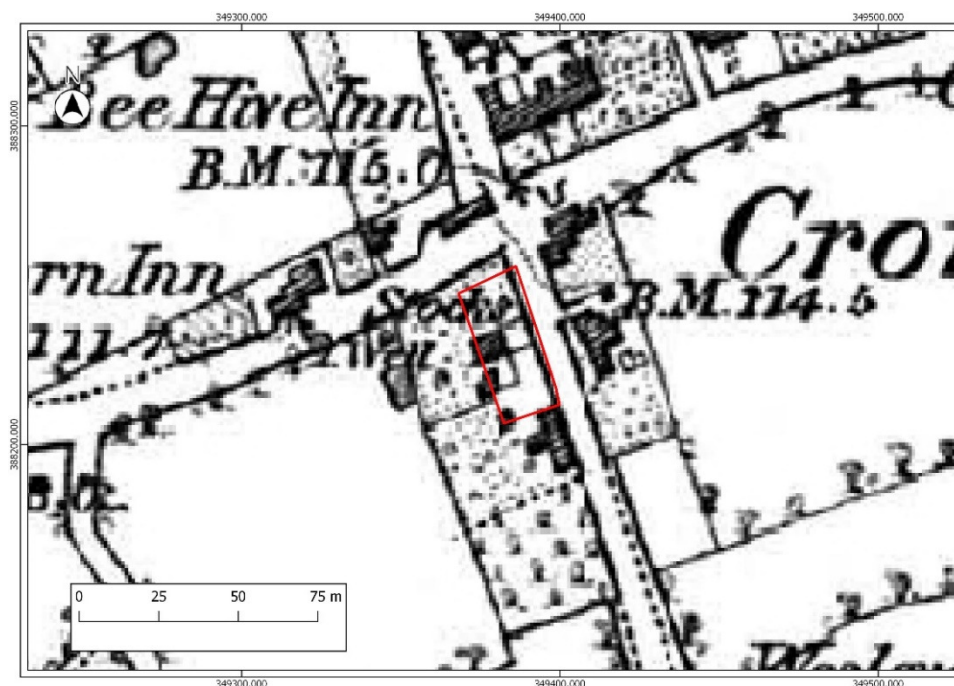
Figure 6. Part of the 1st Edition Ordnance Survey Sheet 114 surveyed 1845-6, published 1849.

- 6.2. This shows the house with a rectangular ground plan at its current location with a since demolished out house of uncertain function to its south.
- 6.2. Detailed accounts of the occupancy of individual dwellings were only gathered for the Census from 1841, when Rosewood Farm was occupied by James Houghton, a Farmer aged 67, his children Thomas and James, Thomas' wife Kate and grandchildren Agnes and Walter. This is presumably the same James Houghton listed as the occupant on the Tithe Apportionment and the family seem to have occupied the site until at least the 1890s.
- 6.2. The 1st Edition 25 inch to the mile survey was surveyed in 1891 and published in 1893. It shows the site largely unchanged, though a small projection of uncertain function is shown at the south-western corner of the house.

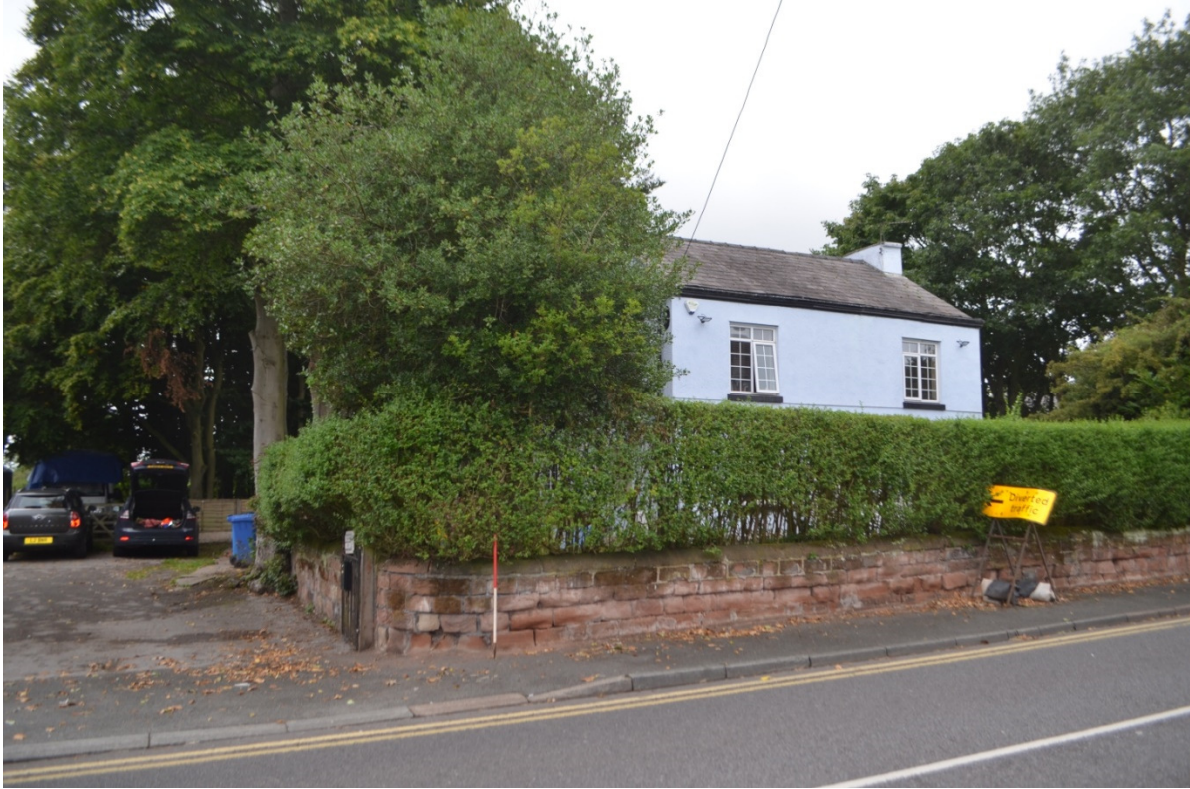
Client: Mr & Mrs Knight	Photo No. 001	Date: 17/08/21	Direction Taken: WNW
-----------------------------------	-------------------------	--------------------------	--------------------------------

Description: General View – wider setting of Rosewood Farm, view to west north west from Chapel Lane

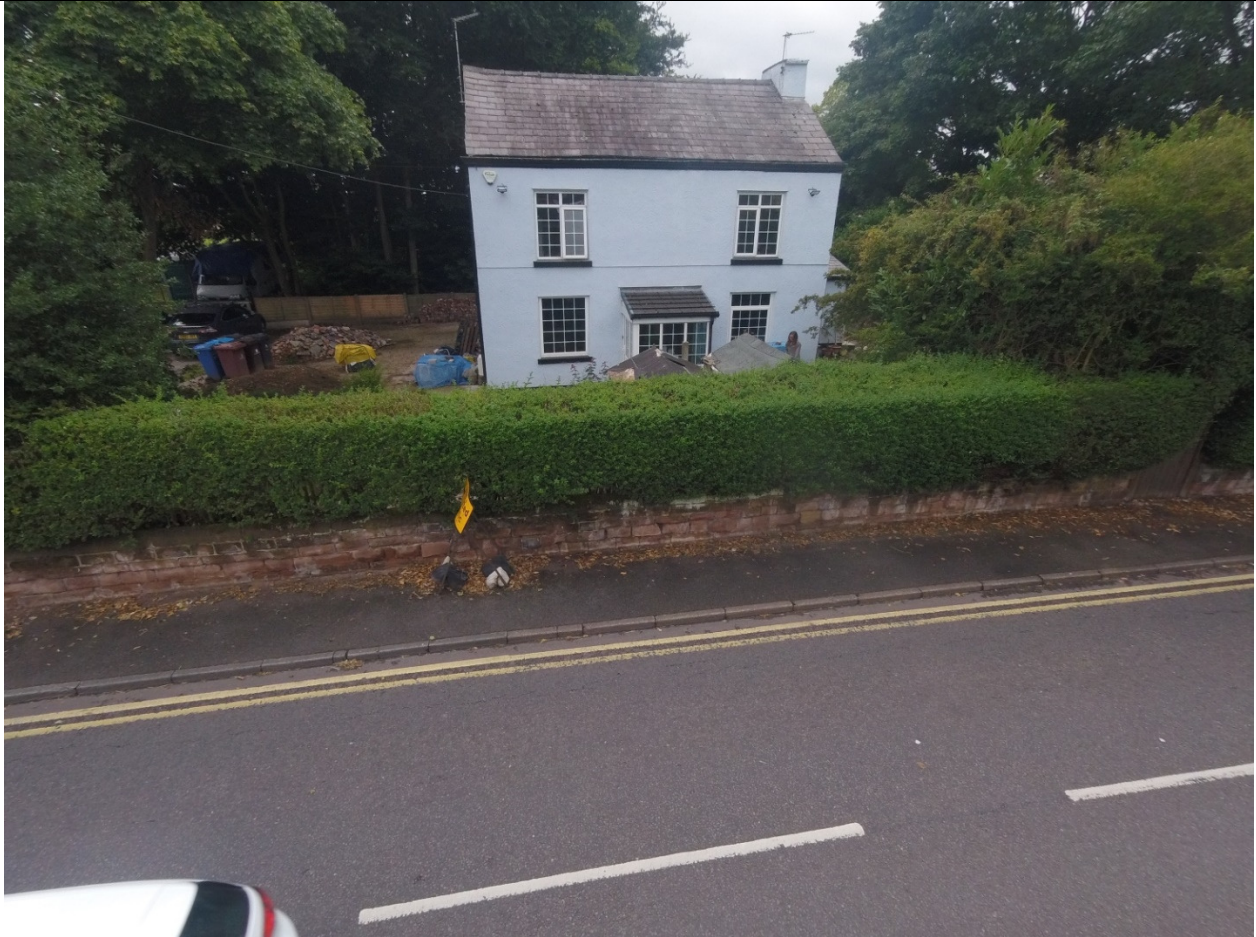
Client: Mr & Mrs Knight	Photo No. 002	Date: 17/08/21	Direction Taken: W
-----------------------------------	-------------------------	--------------------------	------------------------------

Description: General View – wider setting of Rosewood Farm, view to west from Chapel Lane

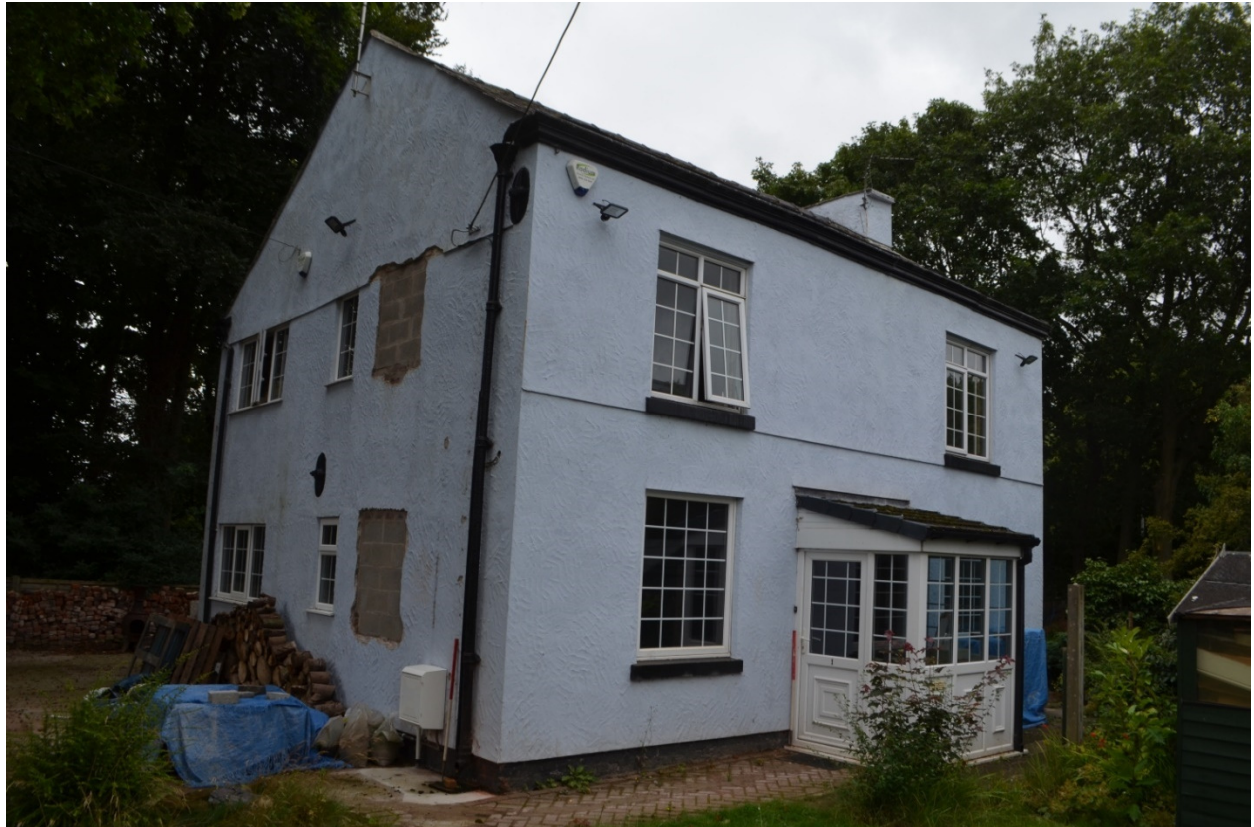
Client: Mr & Mrs Knight	Photo No. 003	Date: 17/08/21	Direction Taken: NW
-----------------------------------	-------------------------	--------------------------	-------------------------------

- 7.1. The windows on the east facing elevation retain their original sandstone sills and appear to be in their original form, size and location though the frames have been replaced (photos **003 004**).

Description: Rosewood Farm, south and east facing elevations view to north west

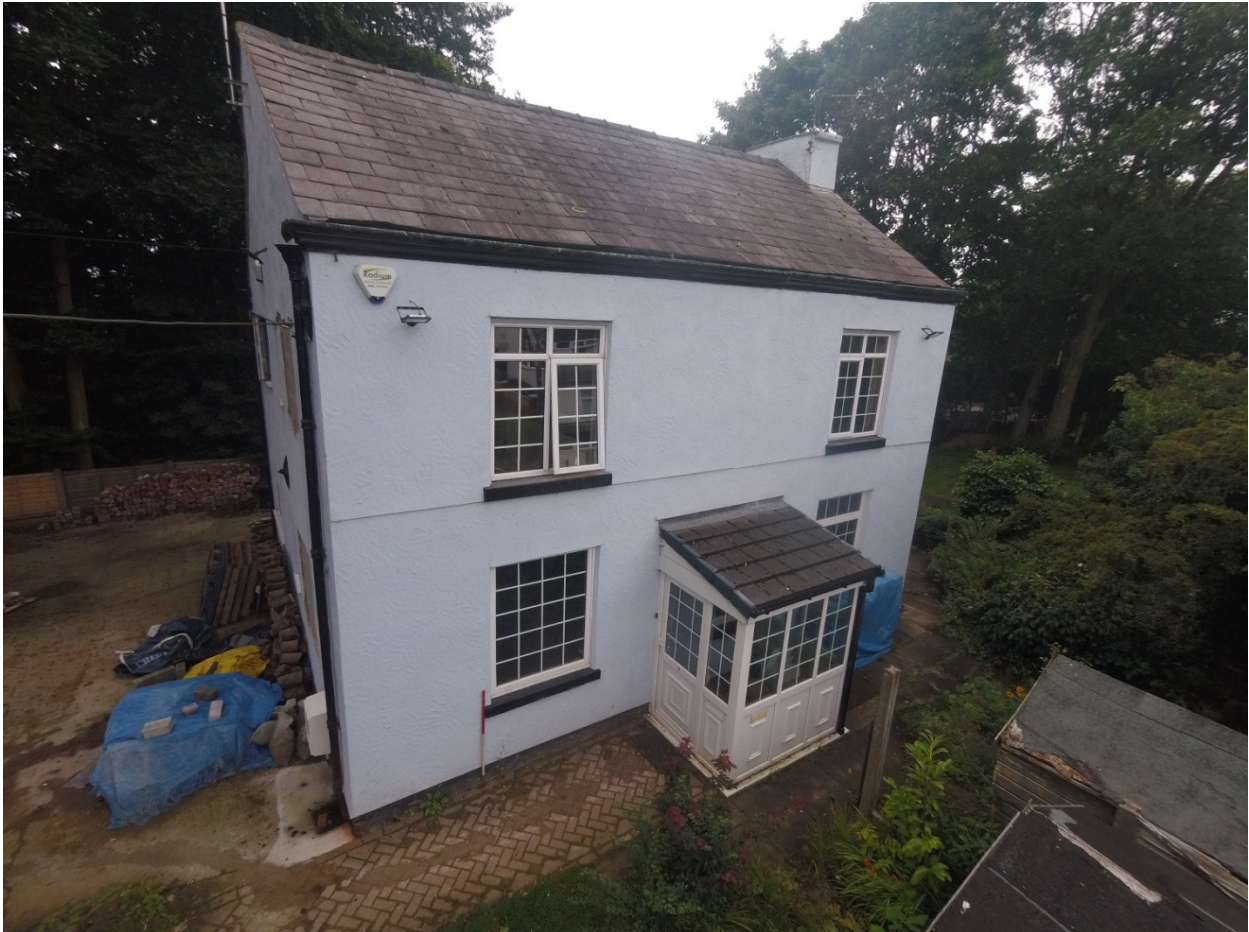
Client: Mr & Mrs Knight	Photo No. 004	Date: 17/08/21	Direction Taken: WNW
-----------------------------------	-------------------------	--------------------------	--------------------------------

Description: Rosewood Farm, east facing elevation view to west north west

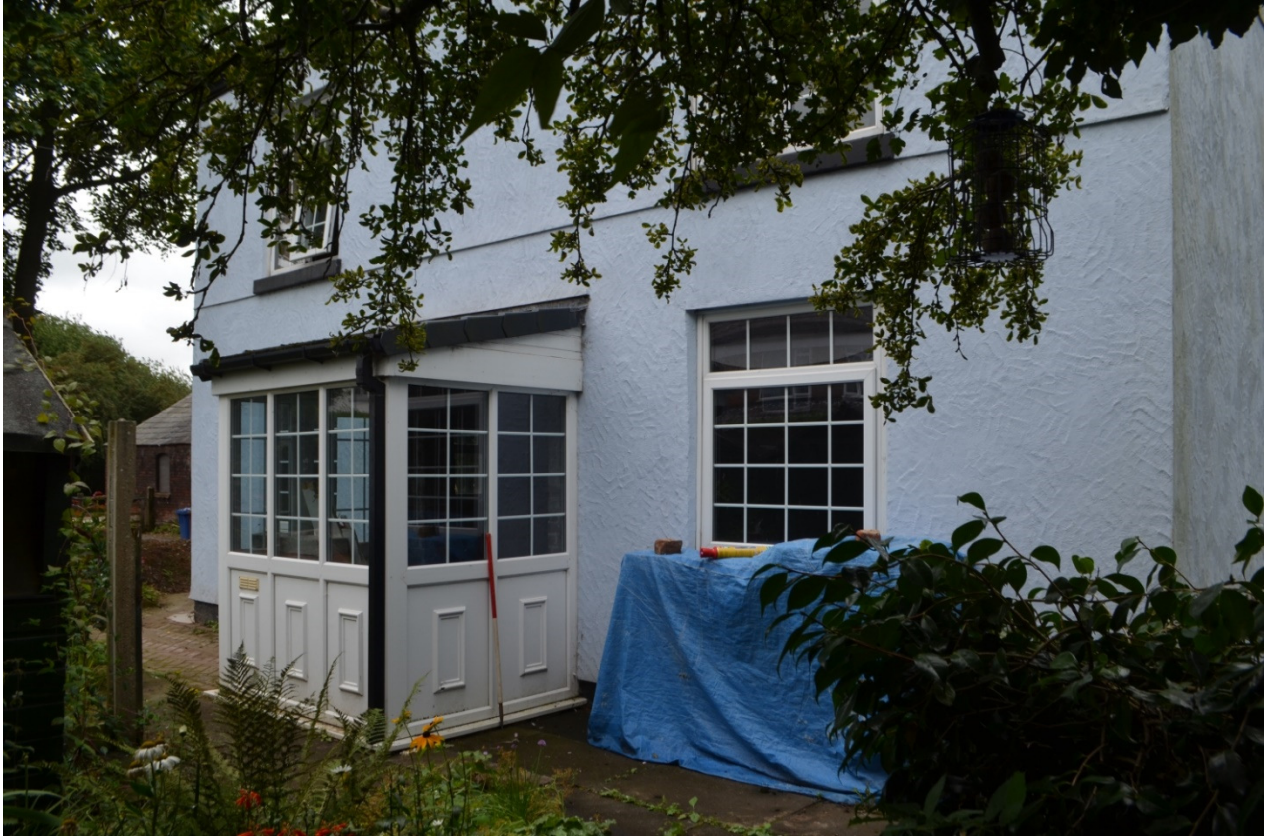
Client: Mr & Mrs Knight	Photo No. 005	Date: 17/08/21	Direction Taken: SW
-----------------------------------	-------------------------	--------------------------	-------------------------------

- 7.1. There are two mid to late 20th century extensions, a small UPVc porch on the east facing elevation (Photos **003, 004, 005**) and a single storey brick extension to the north facing elevation (Photos **006, 007**). The latter has a pent roof sloping to the east. There is also a small 20th century porch on the west facing elevation (Photos **008, 009**)

Description: Rosewood Farm, detail east facing elevation view to south west

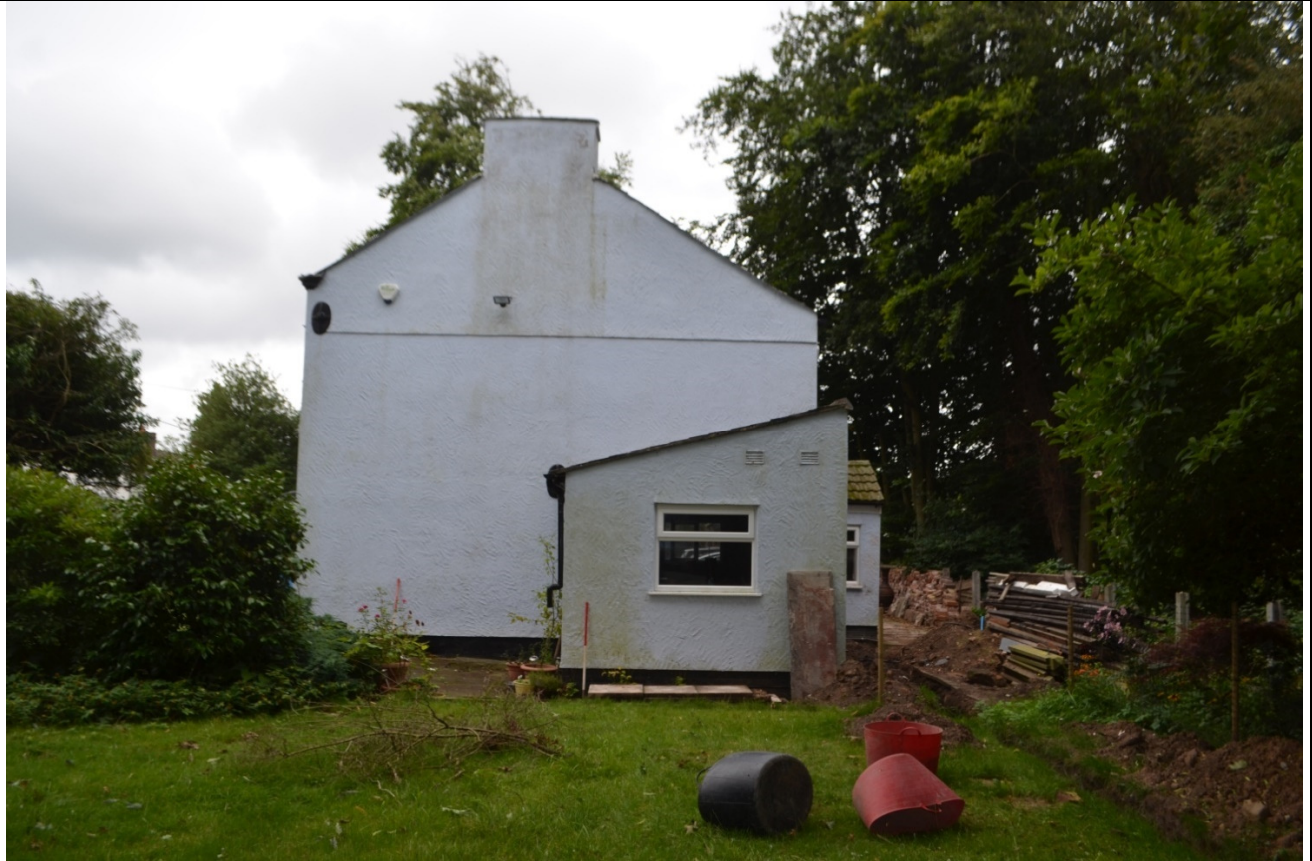
Client: Mr & Mrs Knight	Photo No. 006	Date: 17/08/21	Direction Taken: S
-----------------------------------	-------------------------	--------------------------	------------------------------

Description: Rosewood Farm north facing elevation, view to south

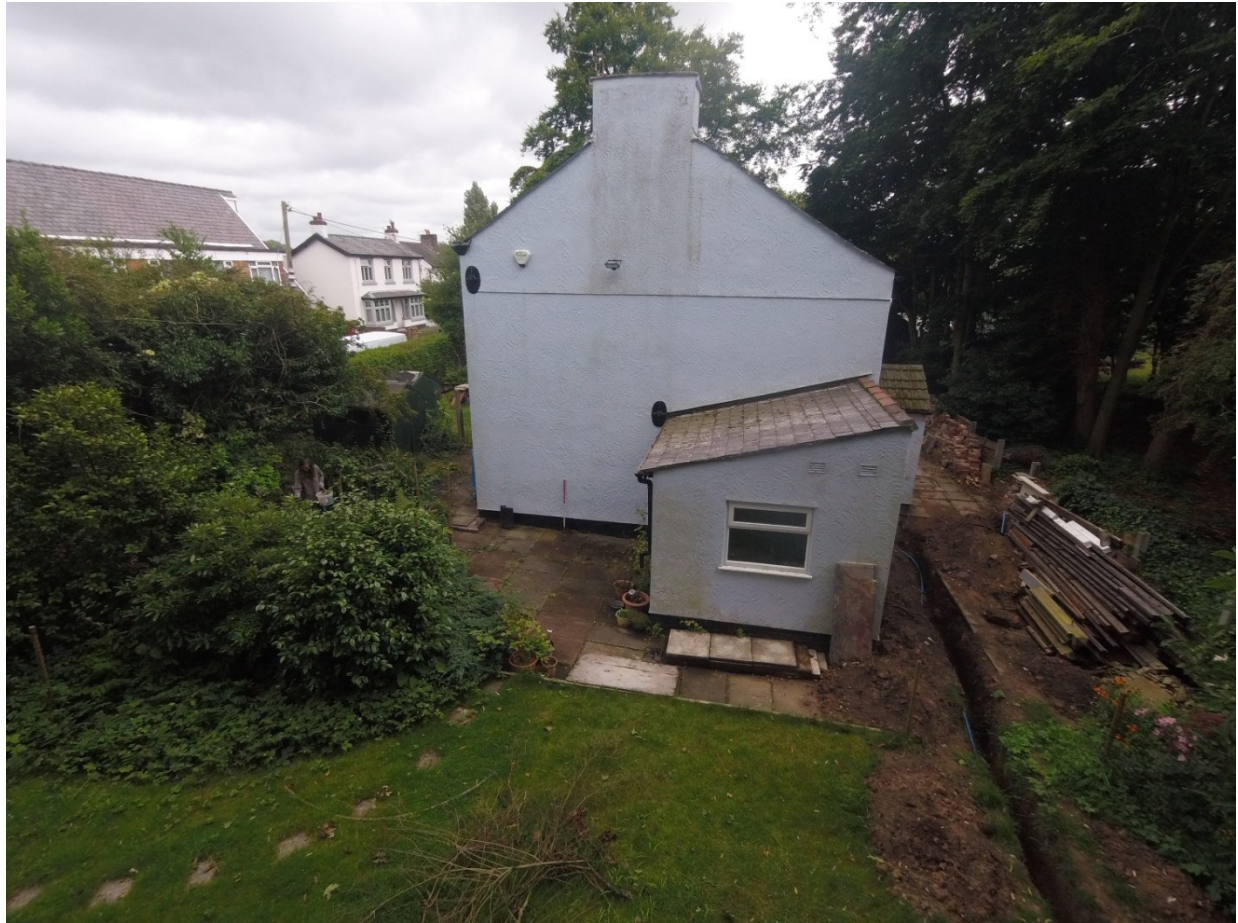
Client: Mr & Mrs Knight	Photo No. 007	Date: 17/08/21	Direction Taken: S
-----------------------------------	-------------------------	--------------------------	------------------------------

Description: Rosewood Farm north facing elevation, view to south

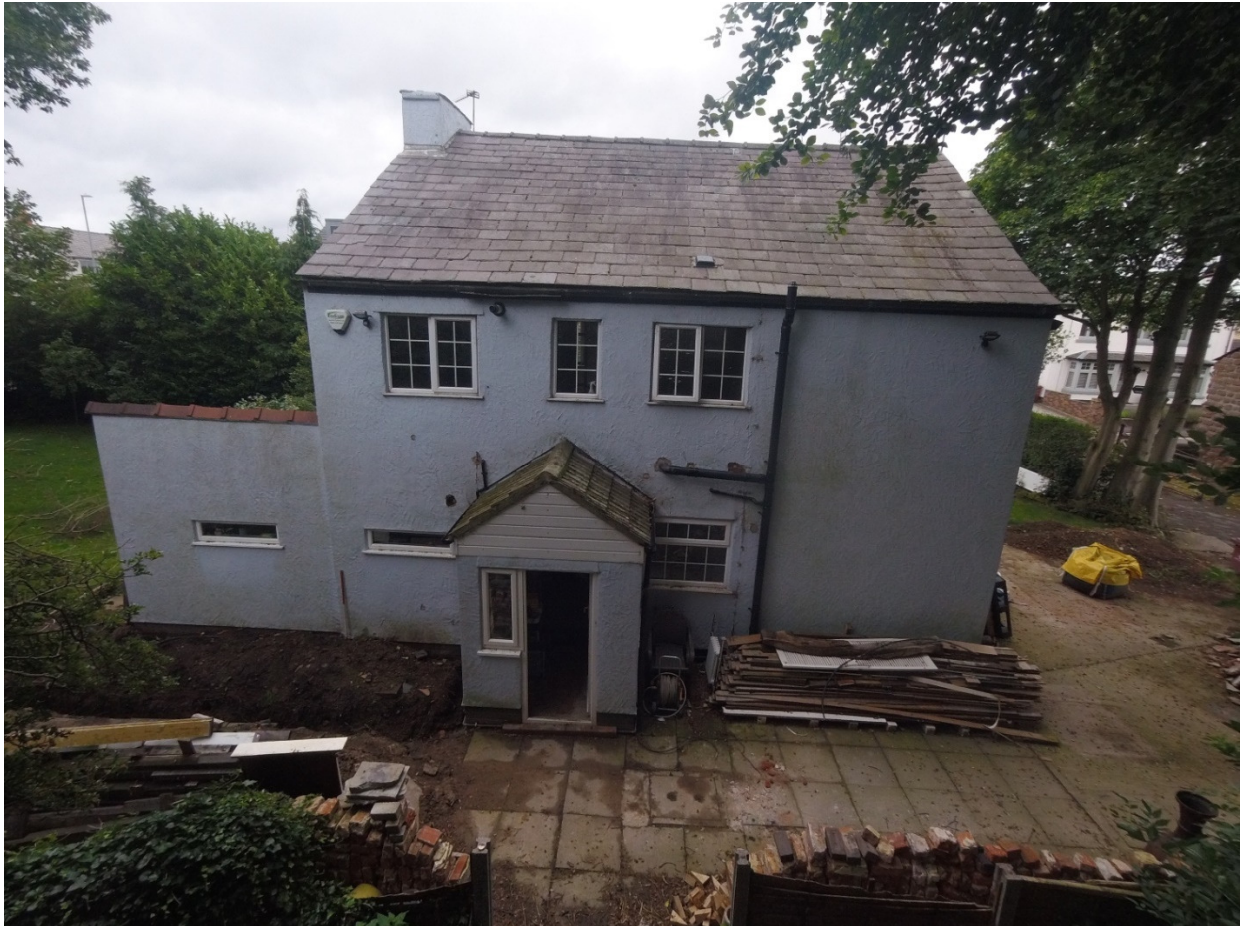
Client: Mr & Mrs Knight	Photo No. 008	Date: 17/08/21	Direction Taken: E
-----------------------------------	-------------------------	--------------------------	------------------------------

Description: Rosewood Farm west facing elevation, view to east

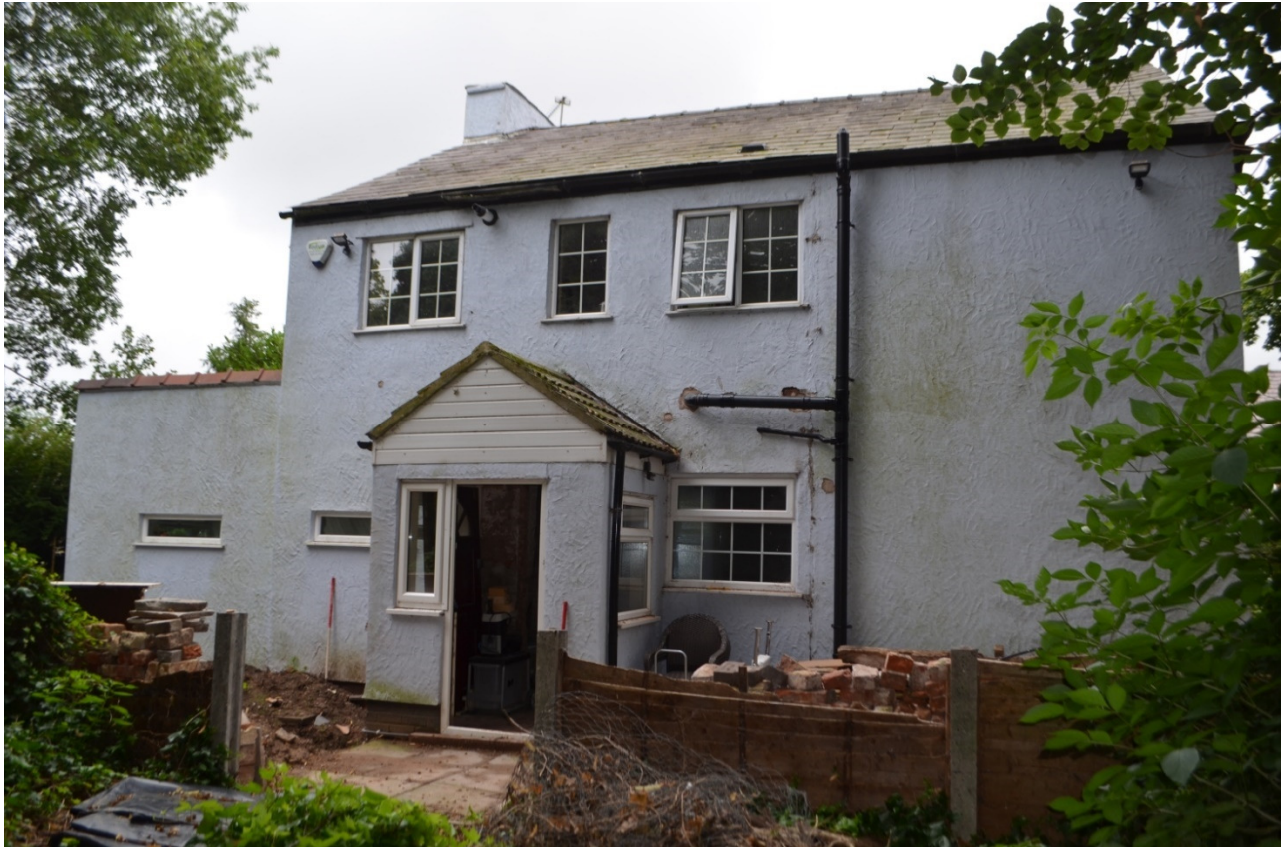
Client: Mr & Mrs Knight	Photo No. 009	Date: 17/08/21	Direction Taken: NE
-----------------------------------	-------------------------	--------------------------	-------------------------------

Description: Rosewood Farm west facing elevation, view to north east

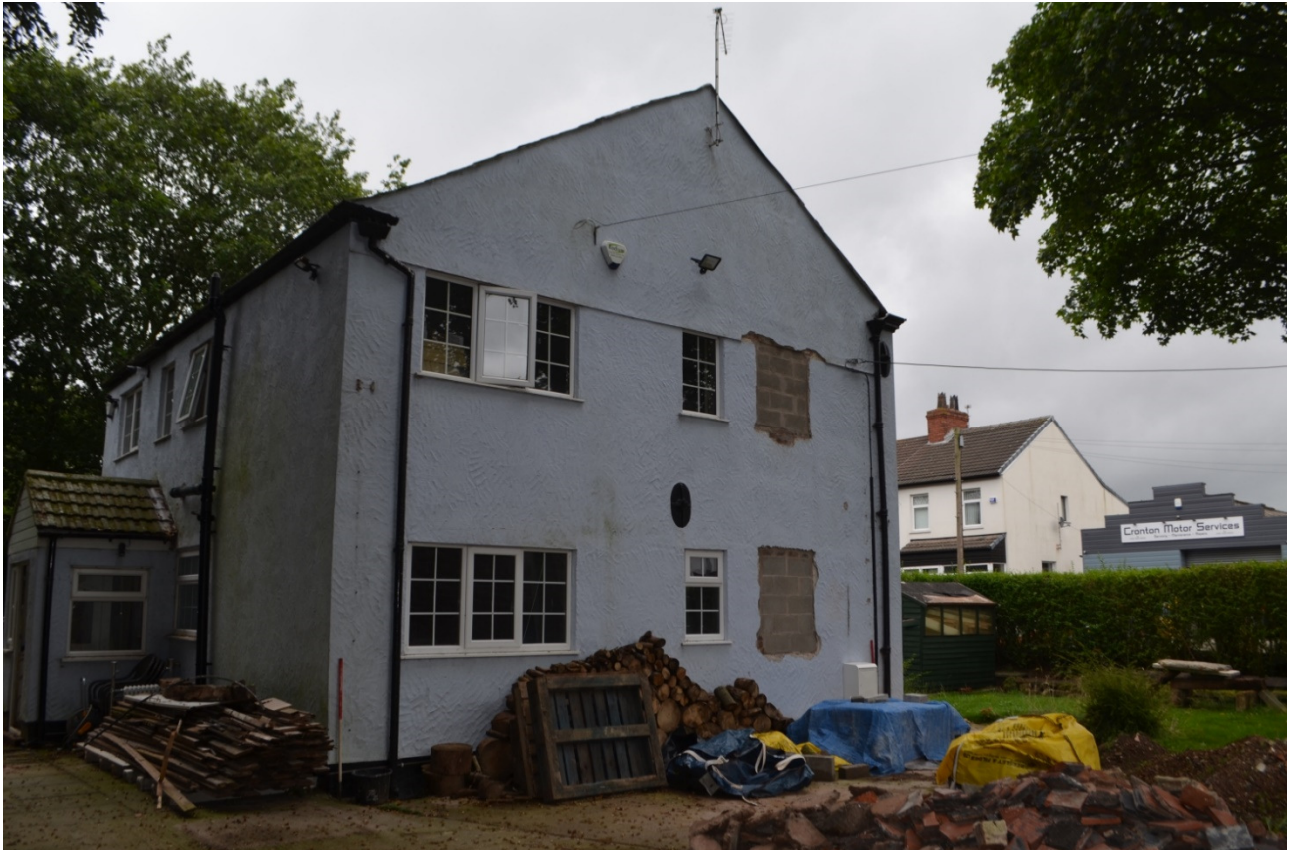
Client: Mr & Mrs Knight	Photo No. 010	Date: 17/08/21	Direction Taken: NE
-----------------------------------	-------------------------	--------------------------	-------------------------------

- 7.1. The house is of two storeys with a pitched roof clad in Welsh Slate and a short chimney stack at the top of the north facing gable (Photos **001, 002**). A chimney stack which would have been present above the southern gable end has been removed, probably in the late 20th century and windows located at its former location (Photos **010, 011**)

Description: Rosewood Farm west and south facing elevations, view to north east

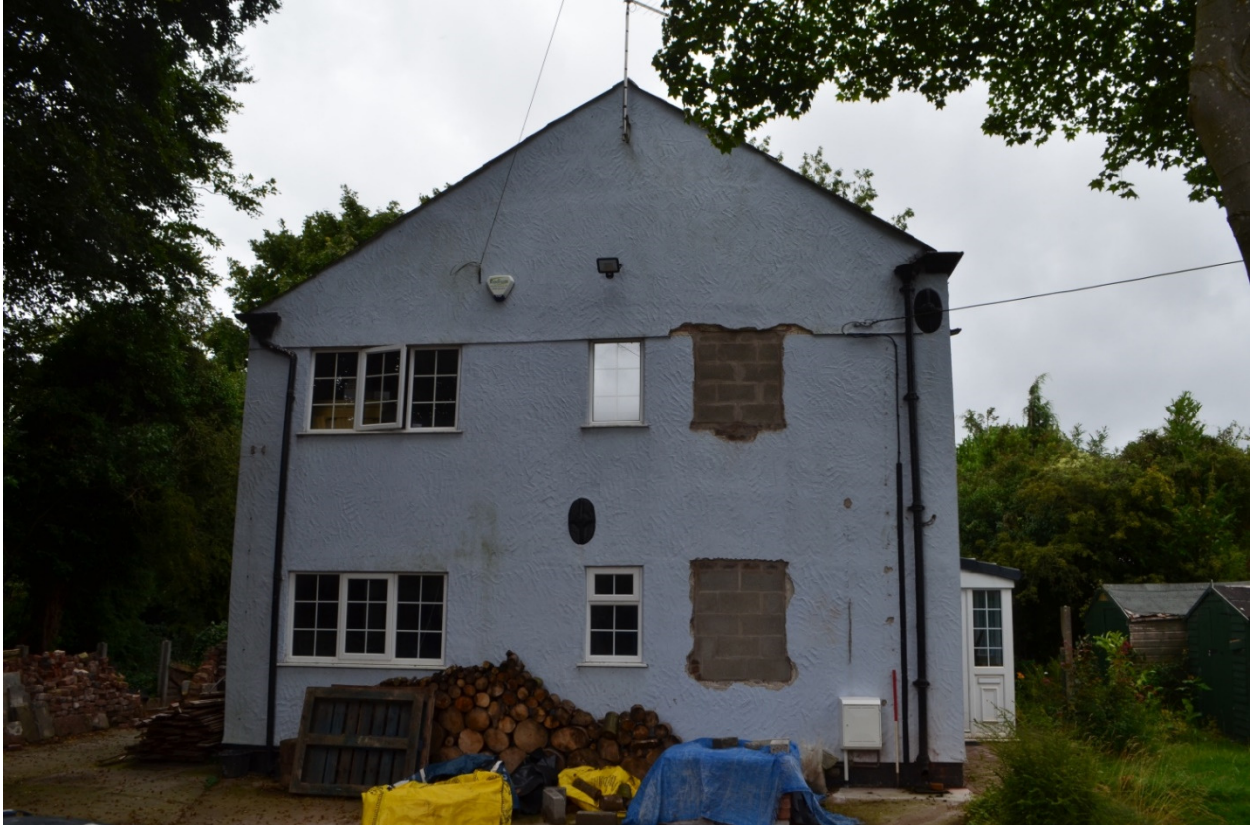
Client: Mr & Mrs Knight	Photo No. 011	Date: 17/08/21	Direction Taken: N
-----------------------------------	-------------------------	--------------------------	------------------------------

Description: Rosewood Farm south facing elevation, view to north

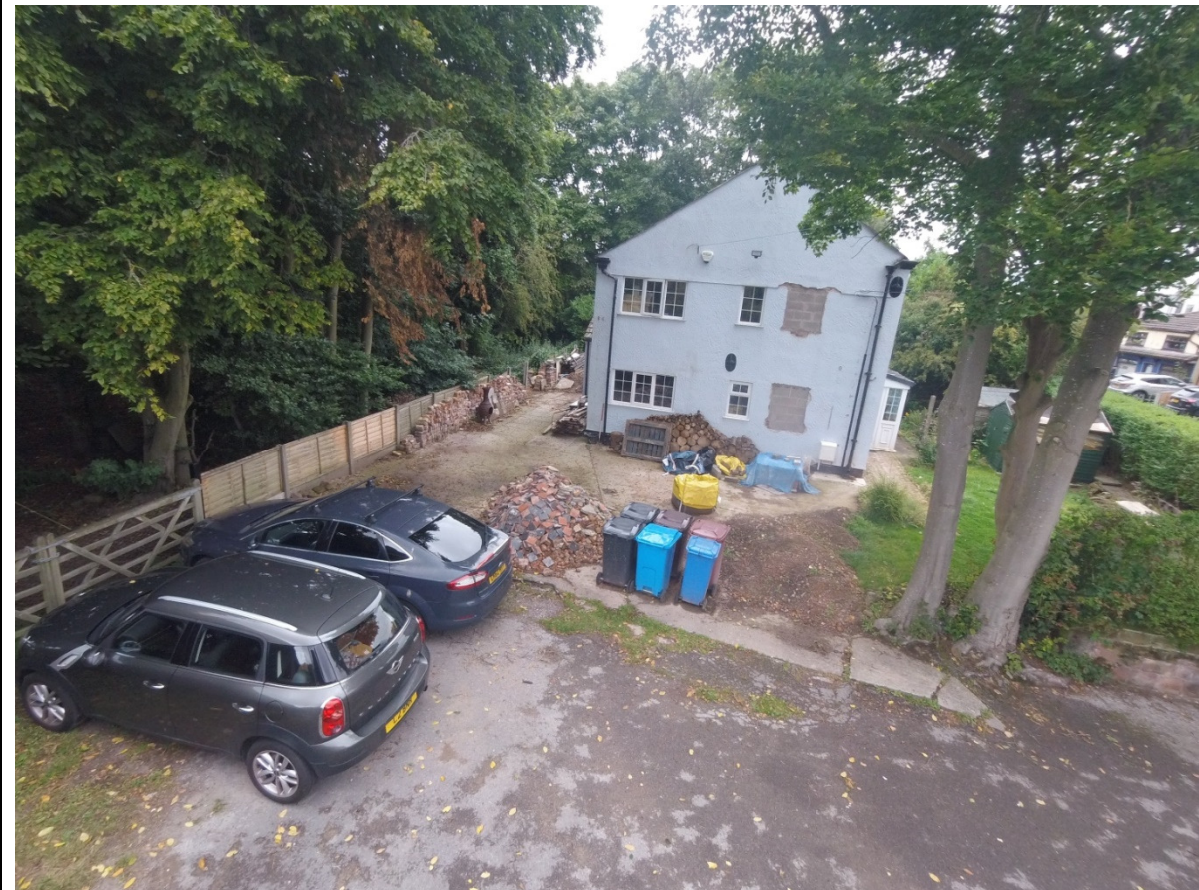
Client: Mr & Mrs Knight	Photo No. 012	Date: 17/08/21	Direction Taken: NNW
-----------------------------------	-------------------------	--------------------------	--------------------------------

Description: Rosewood Farm overview of yard from south

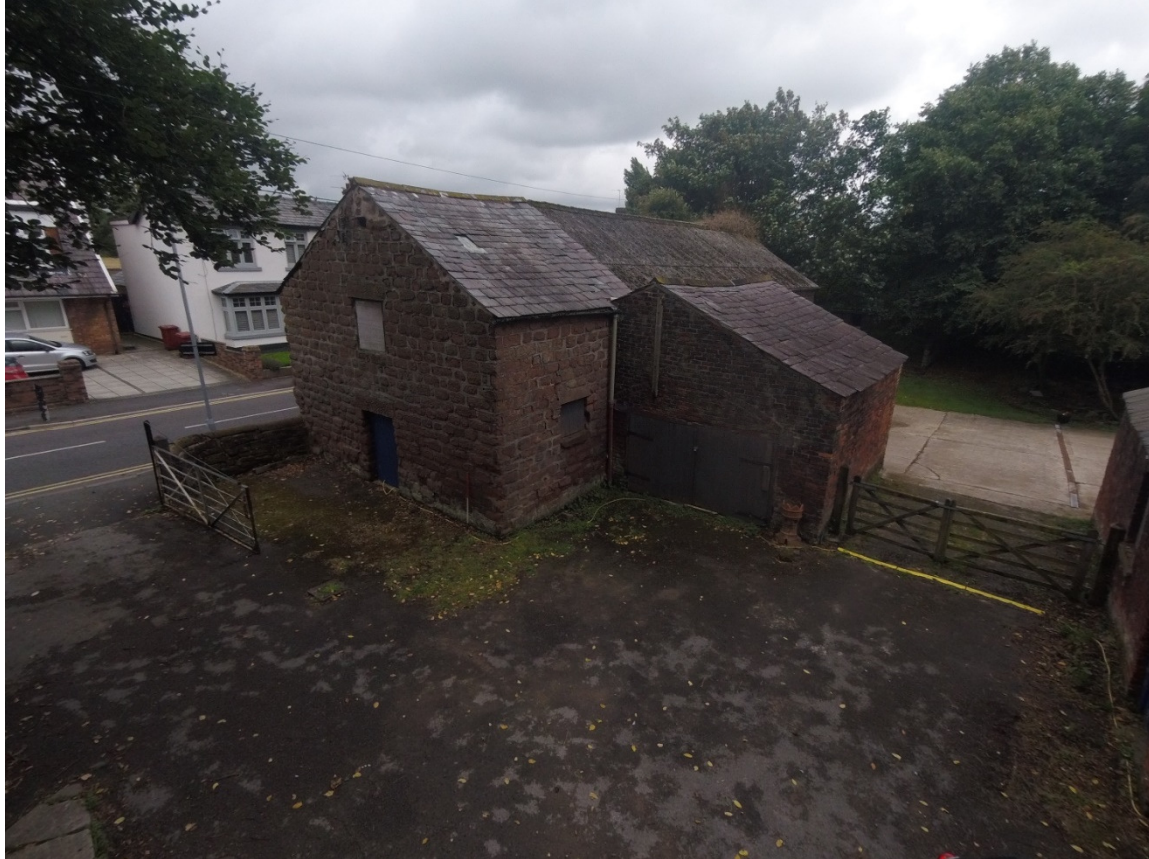
Client: Mr & Mrs Knight	Photo No. 013	Date: 17/08/21	Direction Taken: SE
-----------------------------------	-------------------------	--------------------------	-------------------------------

Description: Rosewood Farm, overview of barn to south, view to south east

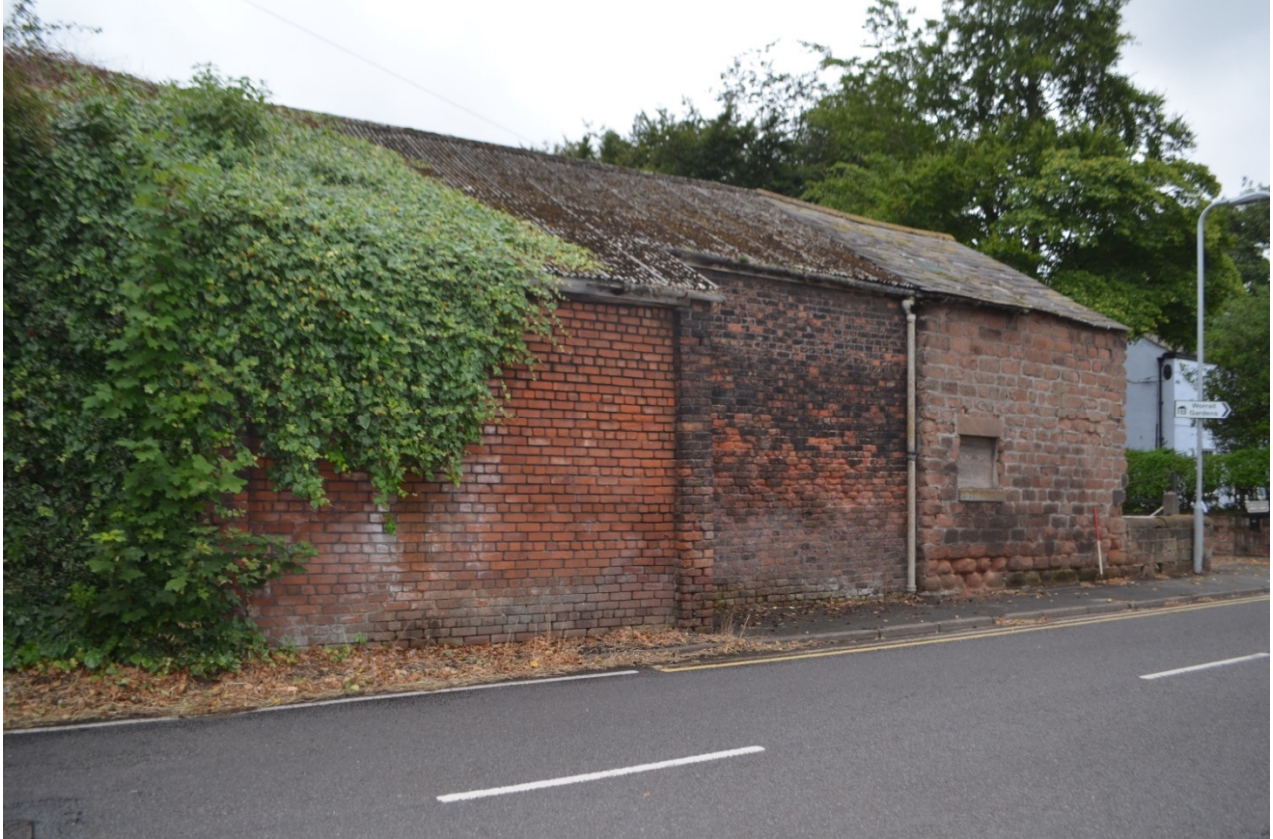
Client: Mr & Mrs Knight	Photo No. 014	Date: 17/08/21	Direction Taken: NW
-----------------------------------	-------------------------	--------------------------	-------------------------------

Description: Rosewood Farm, barn to south, view to north west

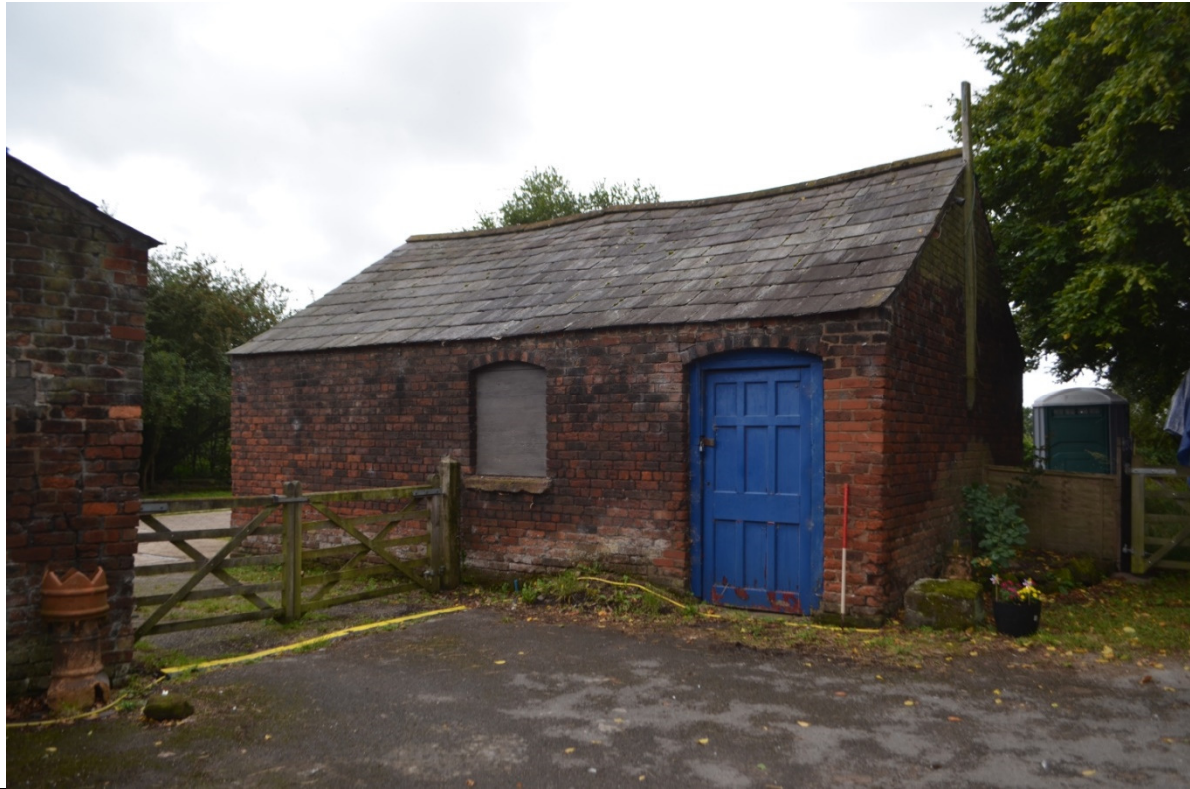
Client: Mr & Mrs Knight	Photo No. 015	Date: 17/08/21	Direction Taken: SW
-----------------------------------	-------------------------	--------------------------	-------------------------------

Description: Rosewood Farm, outbuilding, former piggery?, view to south west

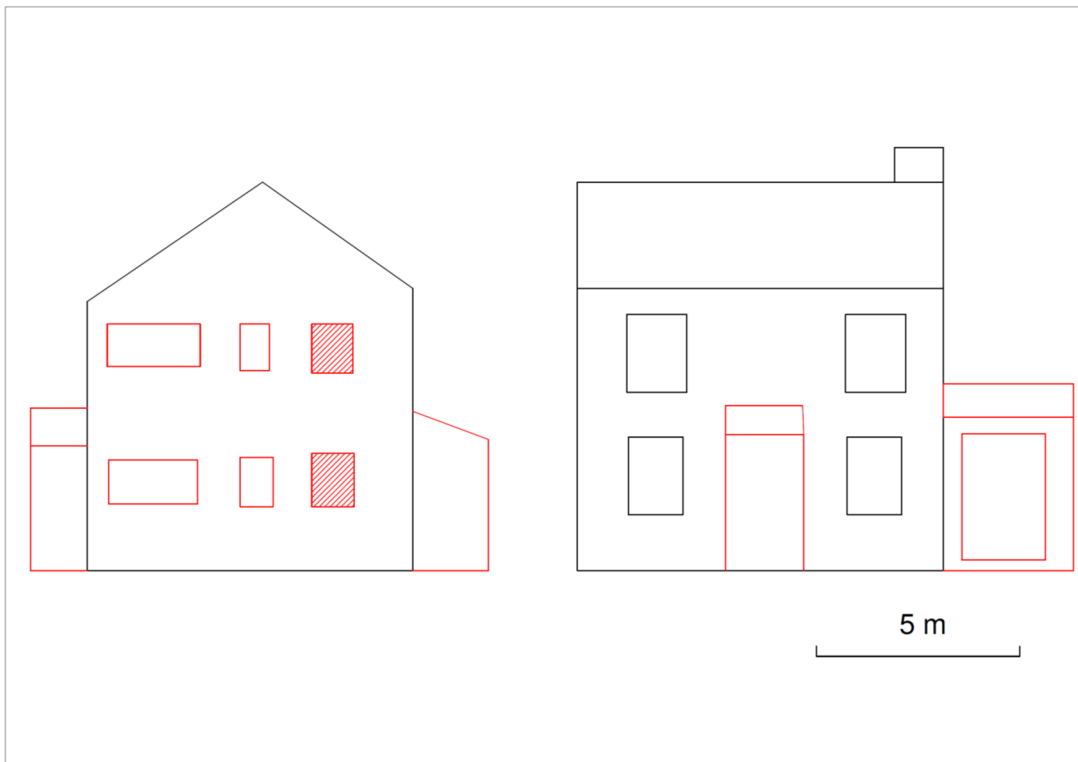
Figure 9. Sketches of the south (left) and east (right) facing elevations, red lines indicate 20th century additions

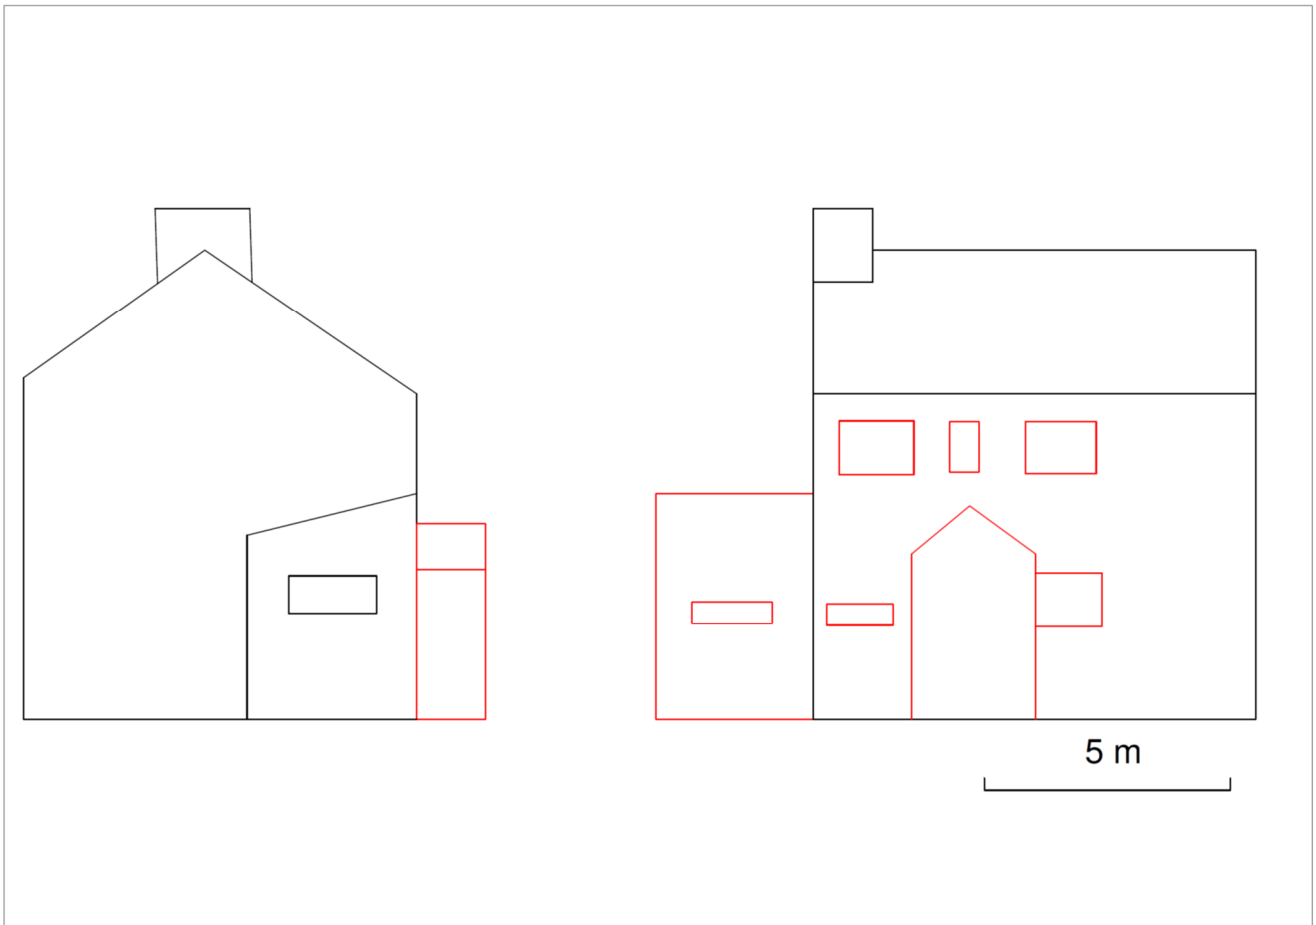
Figure 10. Sketches of the north (left) and west (right) facing elevations, red lines indicate 20th century additions.
