# C.RO PORTS KILLINGHOLME ADDITIONAL VEHICLE STORAGE

ARCHAEOLOGICAL DESK BASED ASSESSMENT & HERITAGE STATEMENT

PROJECT CODE:	P20-105
DATE OF REPORT:	2 September 2020
CLIENT:	LDA Design Consulting Ltd
REPORT TITLE:	C.RO Ports Killingholme Additional Vehicle Storage Archaeological Desk Based Assessment & Heritage Statement
AUTHOR(S) NAME(S):	Kate Brown
APPROVED BY:	Owen Raybould

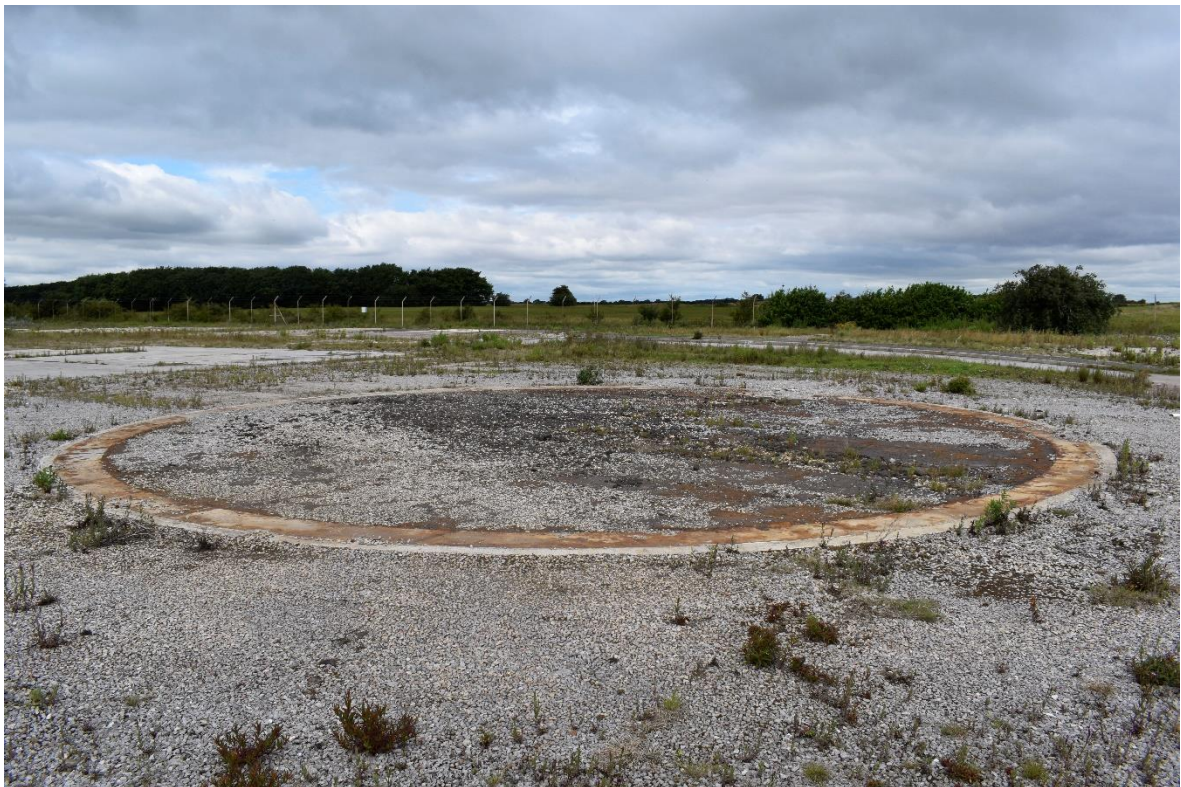
*Figure 3. Remains of the demolished Killingholme A power station.*

- 2.3.4 Possible remnants of the demolished Killingholme A power station, that was located here from 1990 to 2017, were located in the northern section of Part A (Figure 3), and there was a concrete feature at the northern boundary of the current compound (Figure 5) of Part A which may also relate to the demolished power station.

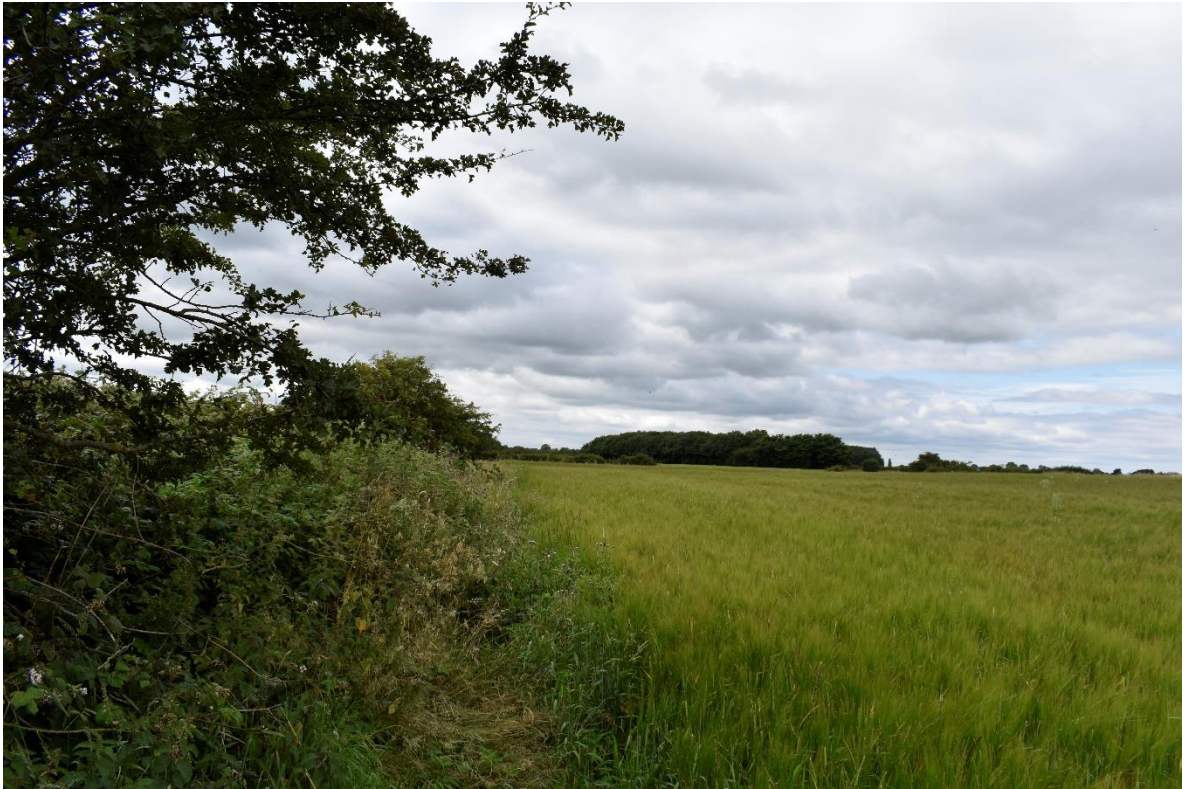
*Figure 4. Location of Romano-British settlement site as outlined in HER (HDL99).*

- 2.3.1 A site visit was conducted on the 16 July 2020 by Headland Archaeology. The weather conditions were overcast but dry following a period of heavy rain.
- 2.3.2 Part A was mainly concrete with grass scrub land around the demolished Killingholme A power station. The grass had grown quite long so visibility of any potential features on the ground was poor. There were also some arable fields to the east and north of the demolished power station, which was bounded by large ditches (Figure 6, Figure 7).
- 2.3.3 It was not possible to see any above ground indicators of the Romano-British settlement to the east of Part B (Figure 4).

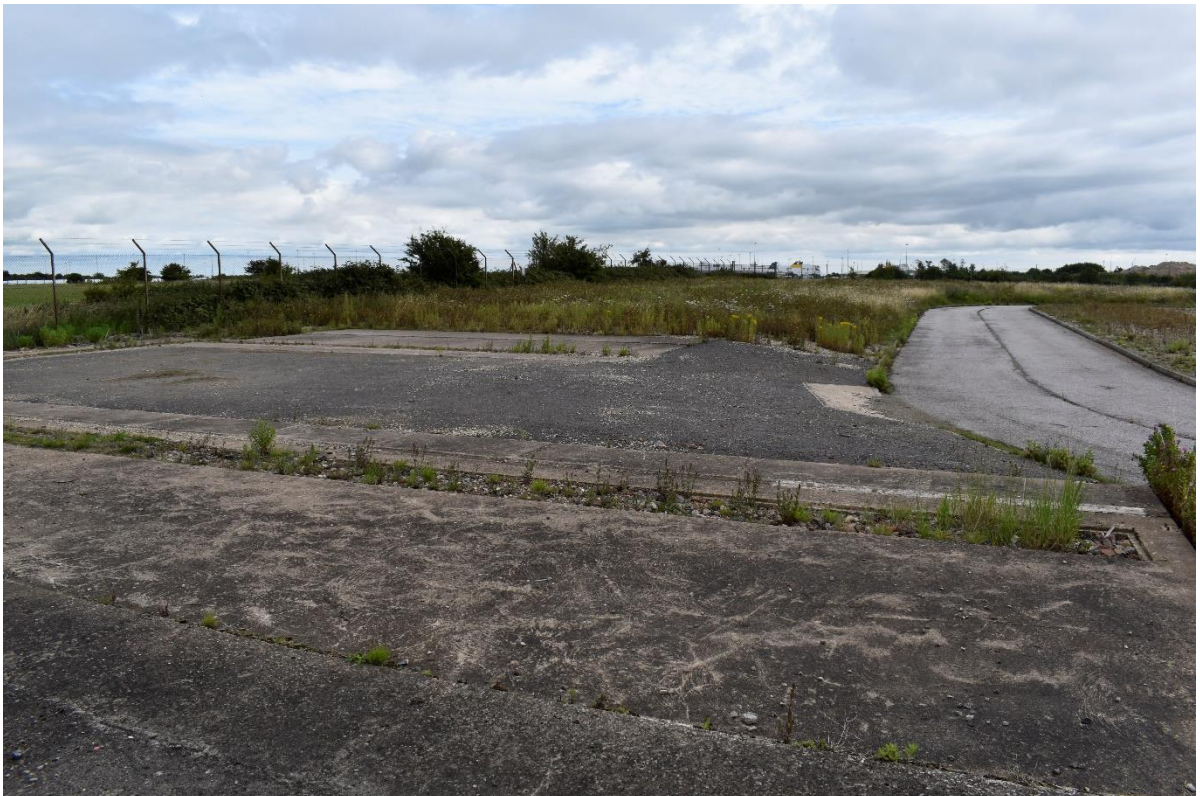
*Figure 5. Concrete feature at eastern boundary of Part A, potentially part of the demolished Killingholme A power station.*

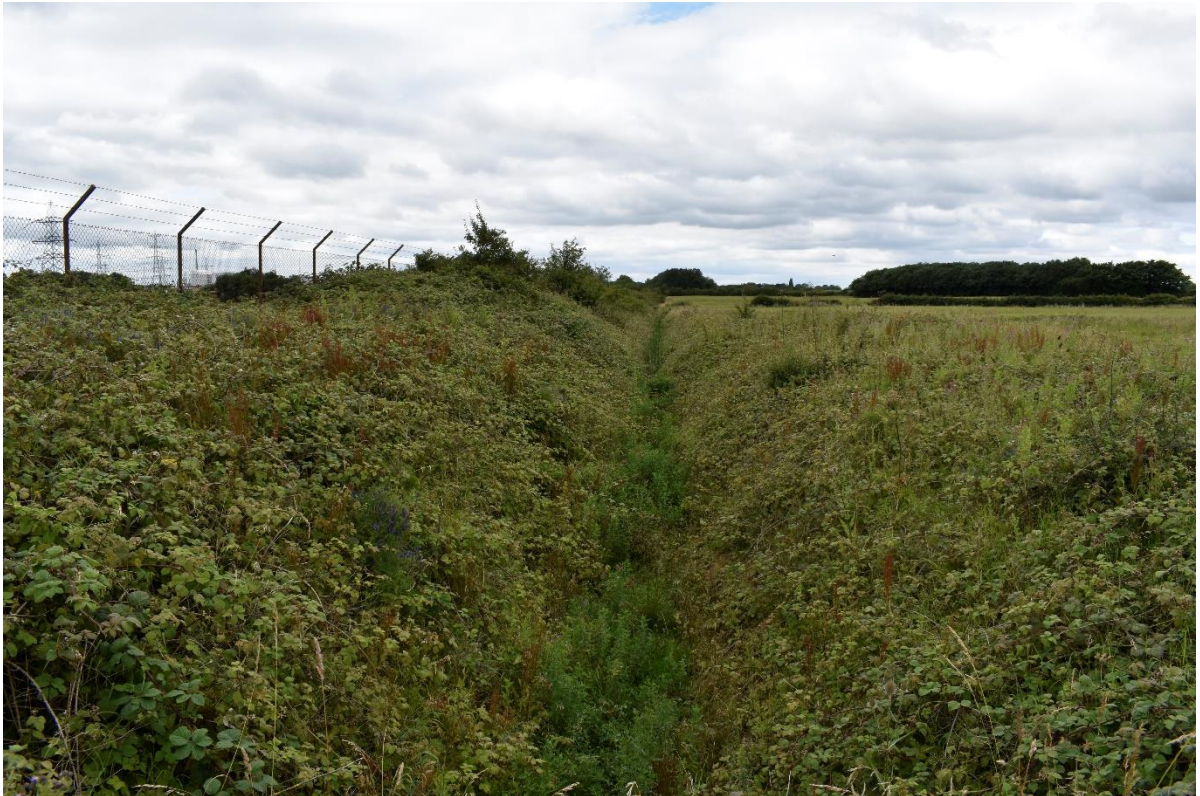
*Figure 6. Ditch on northern boundary of demolished Killingholme A power station.*

- 2.3.5 A large ditch runs along the eastern and northern boundaries of the demolished Killingholme A power station (Figure 6, Figure 7).
- 2.3.6 Buildings belonging to the power plant (now demolished) obstructed views to the west and south west, and a wooded area blocked sightlines to the north west.

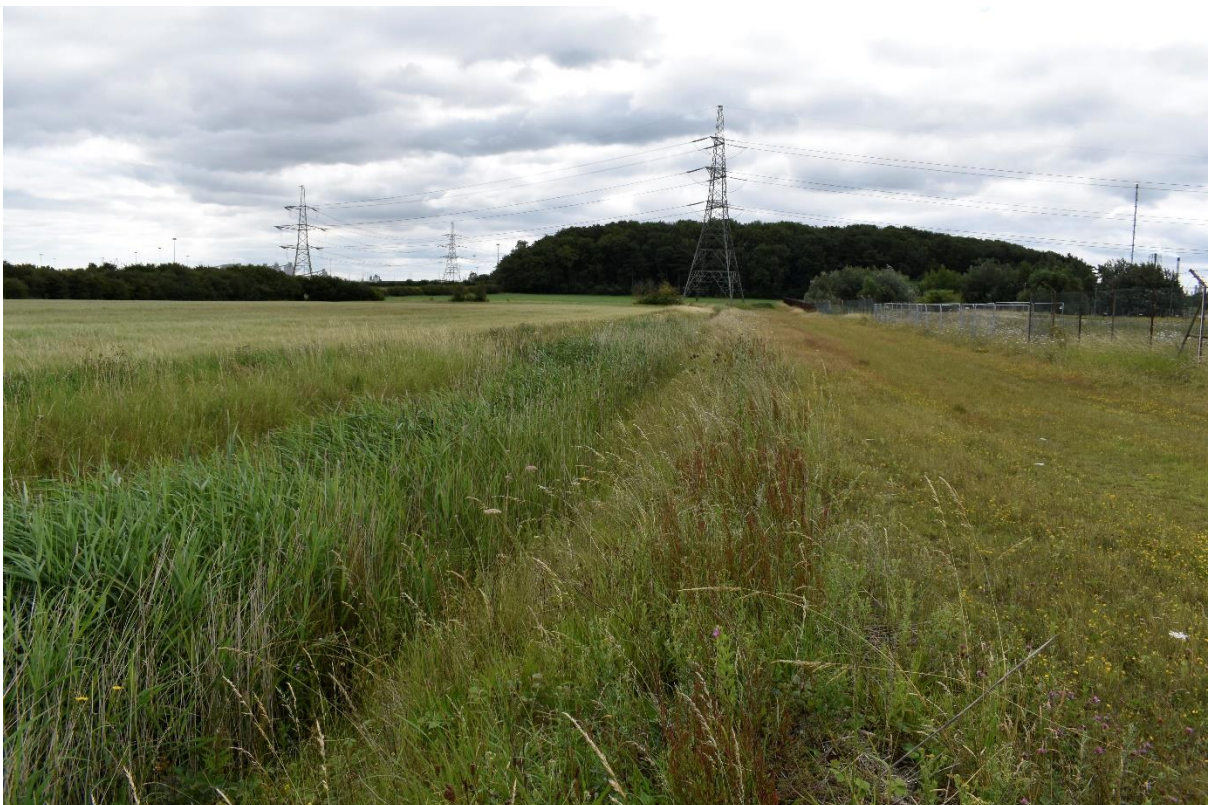
*Figure 7. Ditch on eastern boundary of demolished Killingholme A power station.*

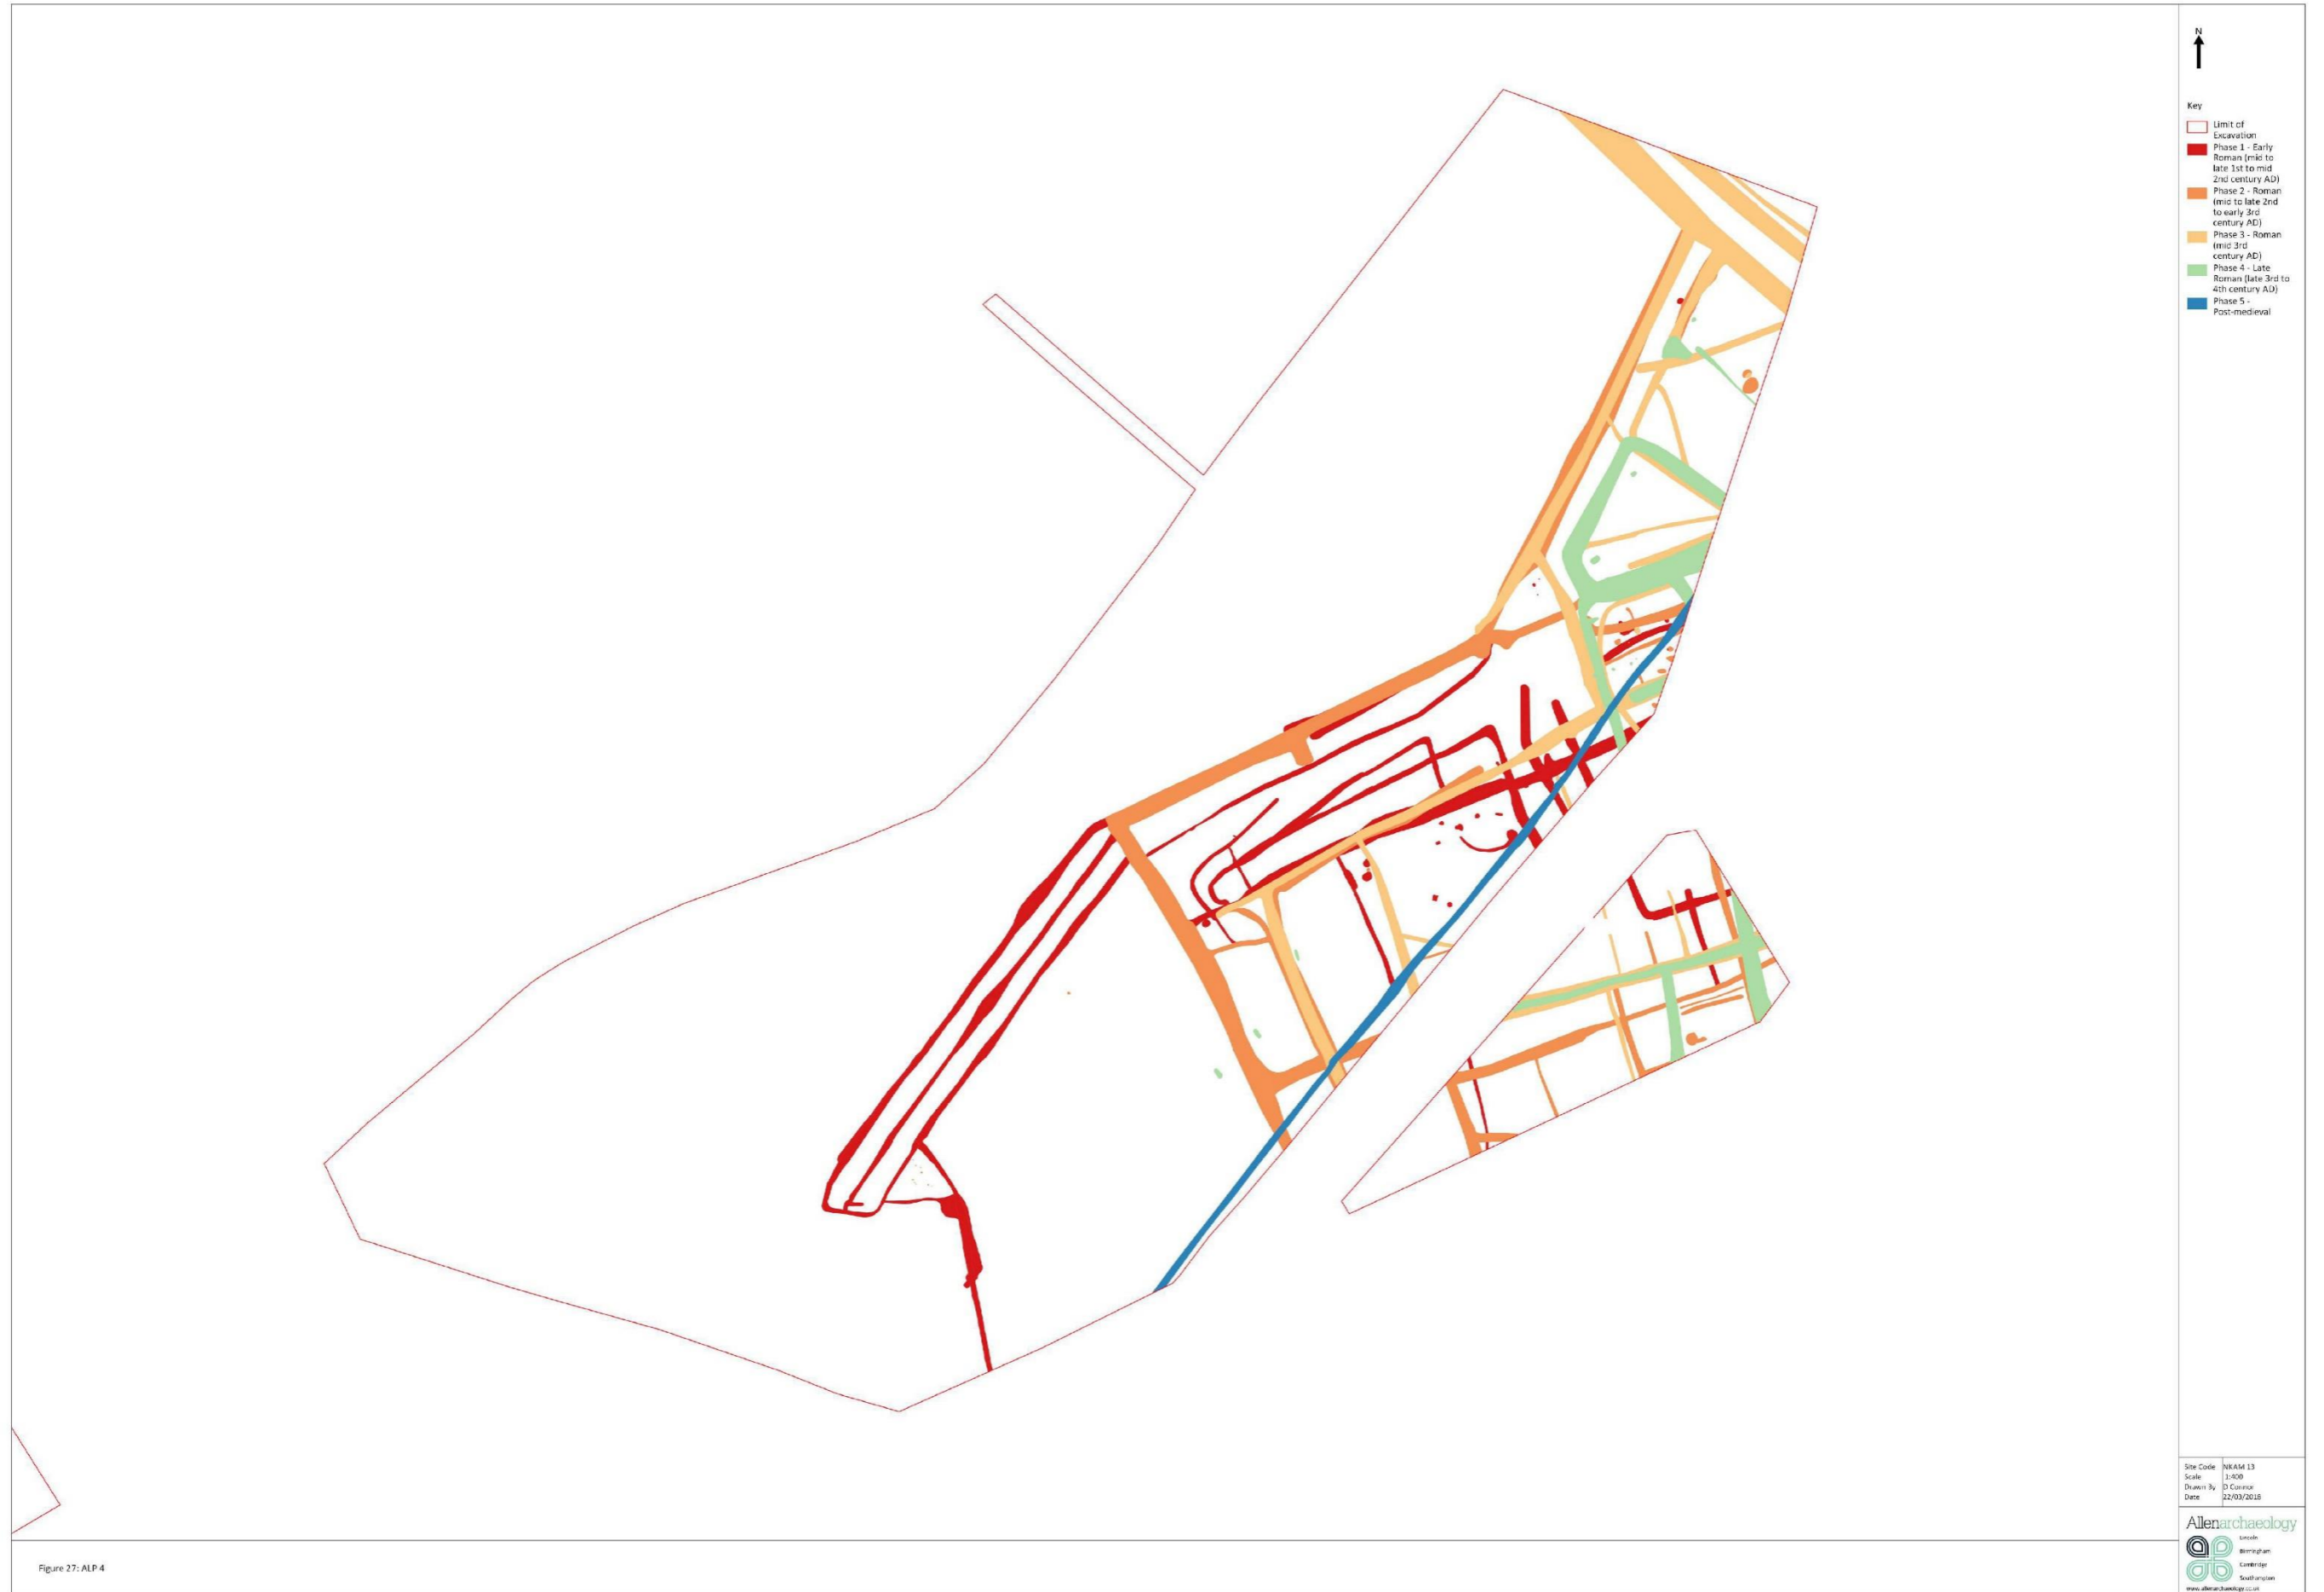
Figure 12. An extract from the archaeological assessment report for Able Humber Port produced by Allen Archaeology in 2018 showing the results of evaluation in area ALP4

- ALP3 centred on a large sub-square enclosure which was occupied from the late Iron Age through to the early 3rd century A.D;
- ALP4 (Figure 12) found a series of densely packed Roman sub-enclosures of mixed agricultural and domestic use. A large well and ladder were excavated within the enclosures. A large assemblage of burials was also recovered, with fifteen cremation and three inhumations recorded. These are thought to be contemporary with the enclosures also found within ALP4. Further currently known remains relating to these findings could be located within the development site.

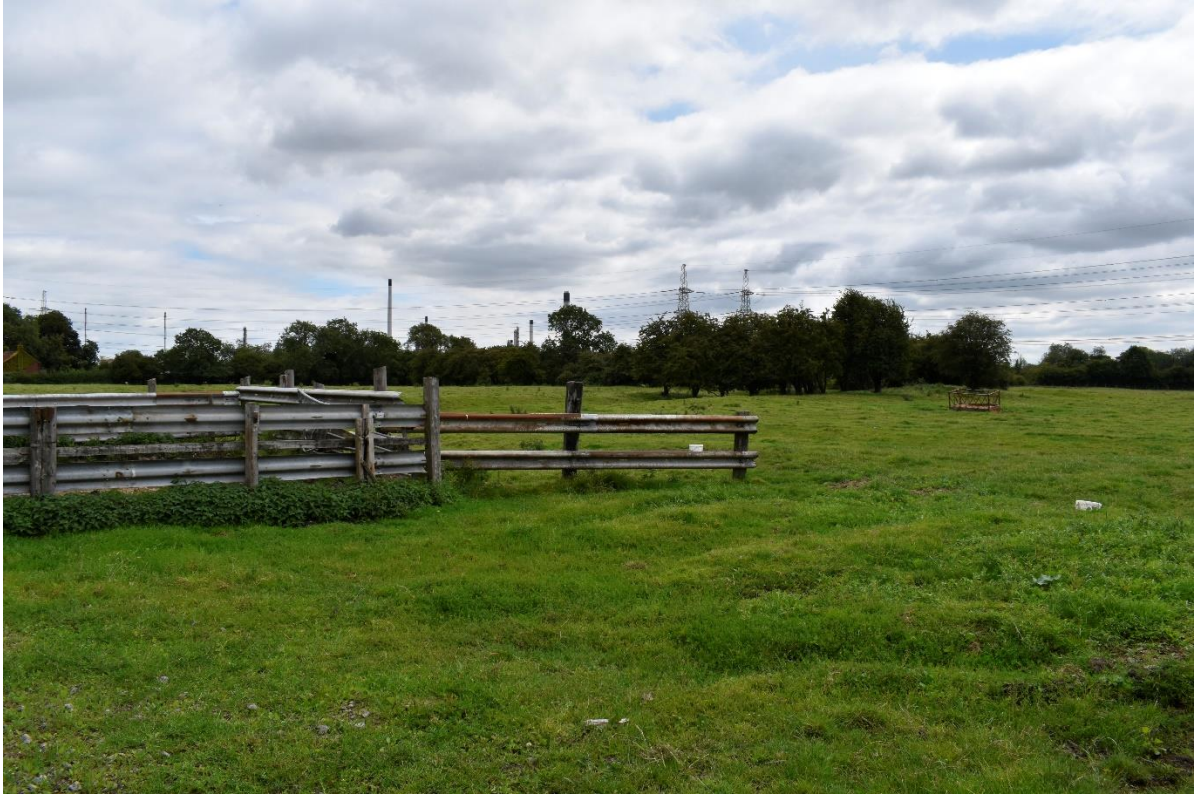
*Figure 19. View towards site from North Garth moated site (HDL265)*

- 2.3.8 Each Scheduled Monument (Figure 11) was visited and the potential for impacts of the proposed development was assessed. There were no sight lines between North Garth moated site (HDL265, 1.5 km south west of the site), the moated site at Baysgarth Farm (HDL263, 1.3 km south west of the site) or Manor Farm moated site (HDL264, 1.2 km west of the site).

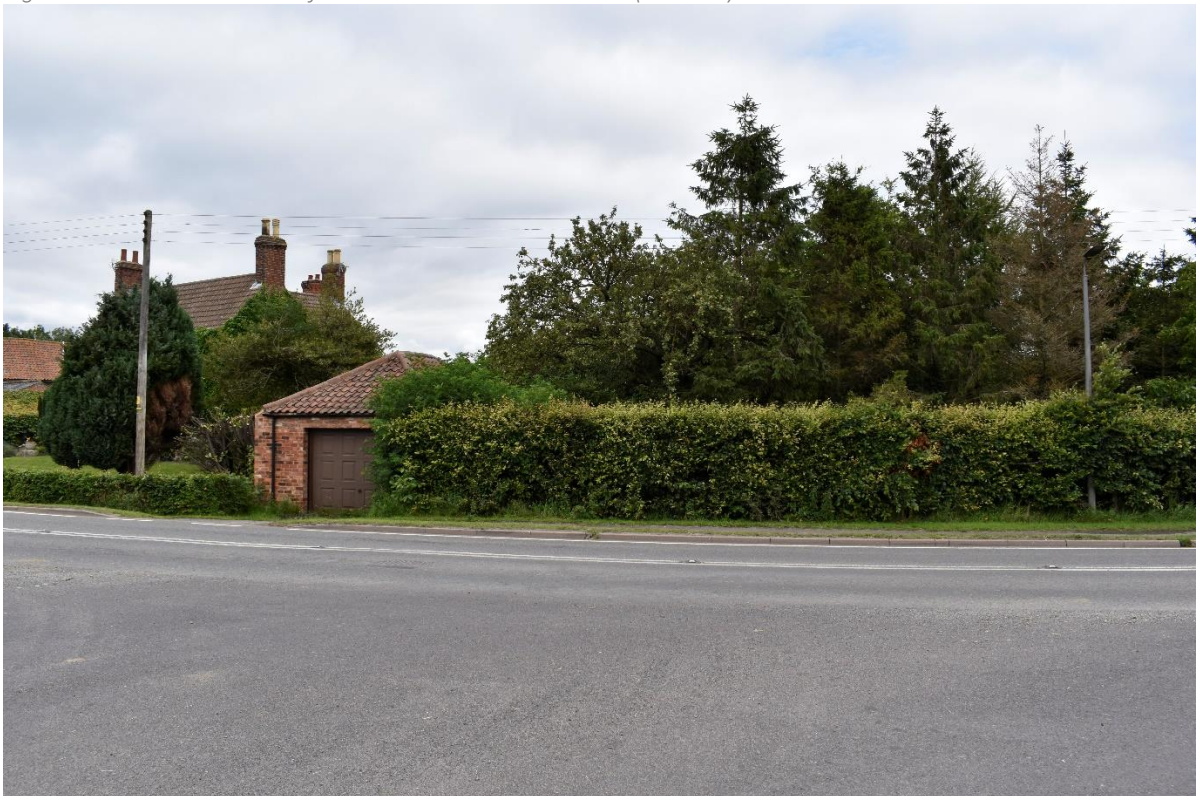
*Figure 20. The moated site at Baysgarth Farm is well screened by trees and other vegetation*
