HEADLAND HEADBOLT LANE, KIRKBY, KNOWSLEY

Archaeological Trial Trenching and Level 1 Building Recording

PLANNING REF. 21/00563/FUL

Final v.1.3
10/02/2022

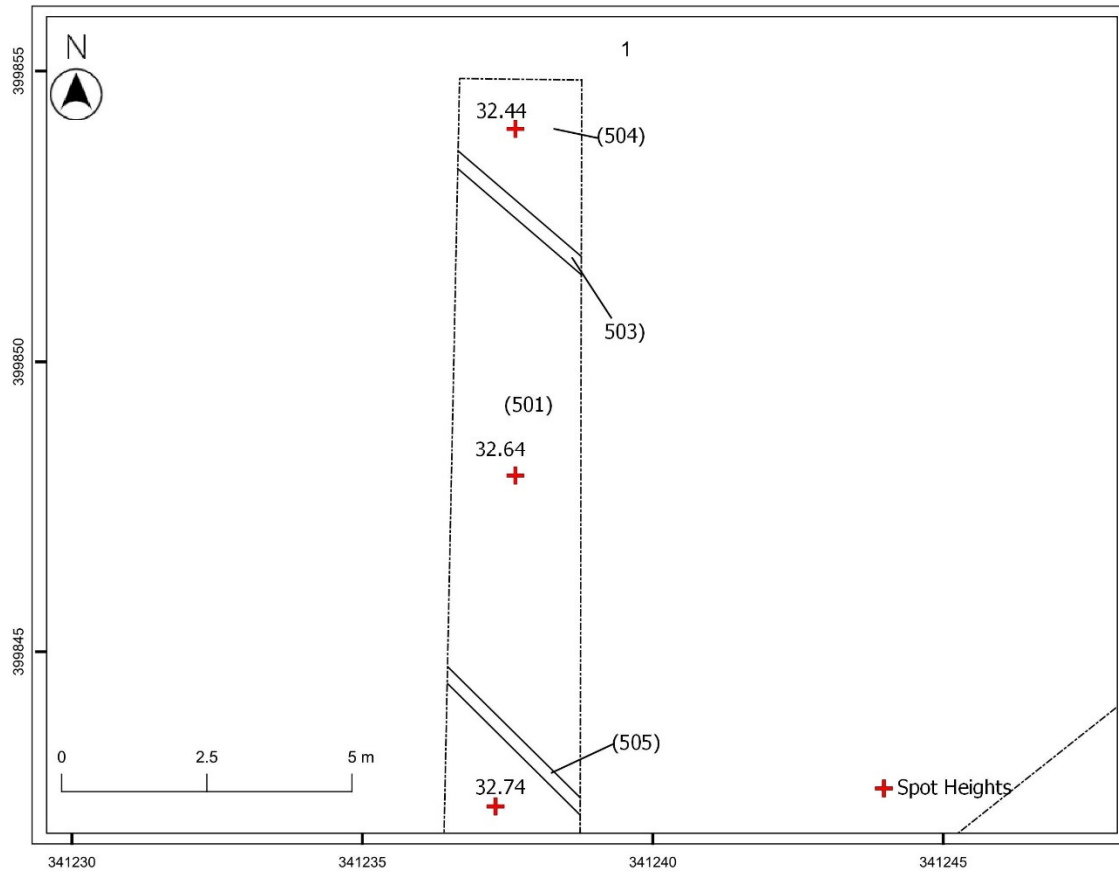
Illus 3. Plan of northern end of Trench 1

At the southern end of the trench was a north-west to south-east aligned double skin brick wall (505) constructed in unfrosted, locally made, red brick and off-white lime mortar (*Illus 3*). Its location and orientation was consistent with it being the east wall of a building depicted on the 1893 OS map.

At the northern end of the trench was a cobbled surface (504) constructed using large (up to 200 mm across) igneous cobbles (*Illus 3* and *Illus 4*). This was bounded along its southern edge by a red sandstone wall (503) which was 0.4 m wide and is probably the northern wall of the building depicted on the 1893 OS map.

Walls 503 and 505 were sealed by (501) a deposit of crushed red brick rubble and lime mortar c. 0.6-7 m deep. This was sealed by (500), a layer of dark reddish brown topsoil 0.35 m thick.

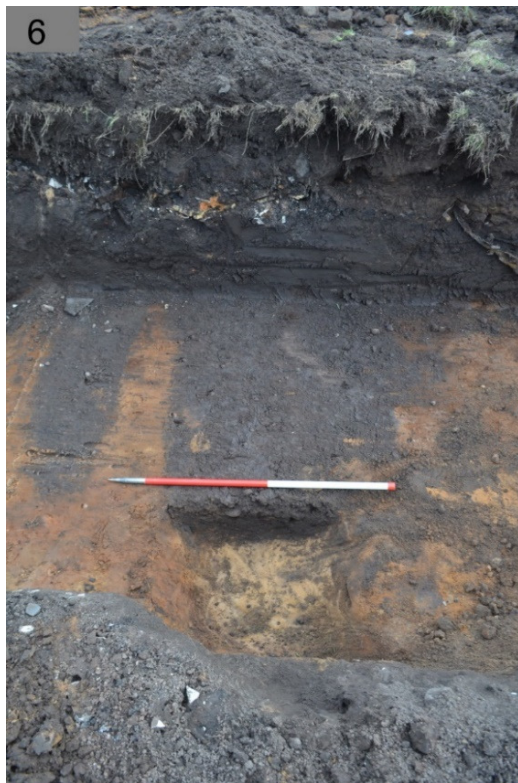
Illus 6. North facing section across contexts 403/4 Trench 2. View looking south. Scale 1 m.

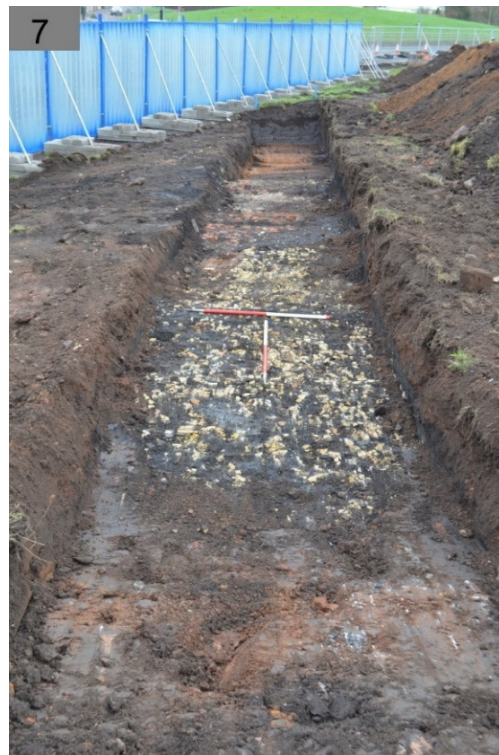
Illus 7. Rubble 401 in Trench 2. View looking east. Scales 1 m.

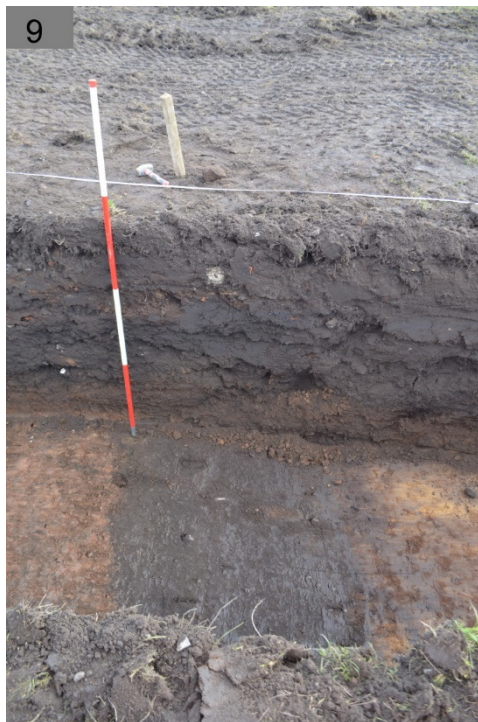
Illus 9. Pre-excavation view of cut 206 in Trench 3. View looking south. Scale 2 m.

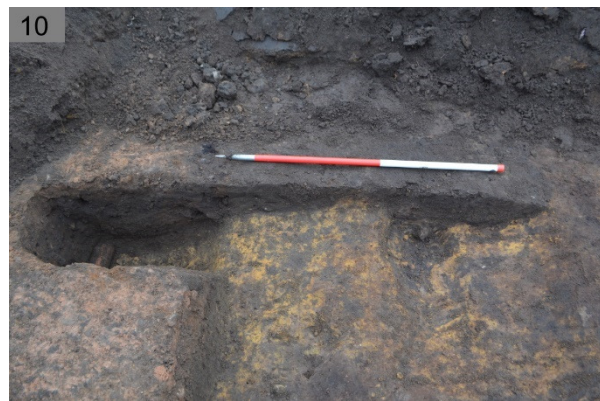
Illus 10. Section across cuts 206 (right) and 208 (left) in Trench 3. View looking south. Scale 1 m.

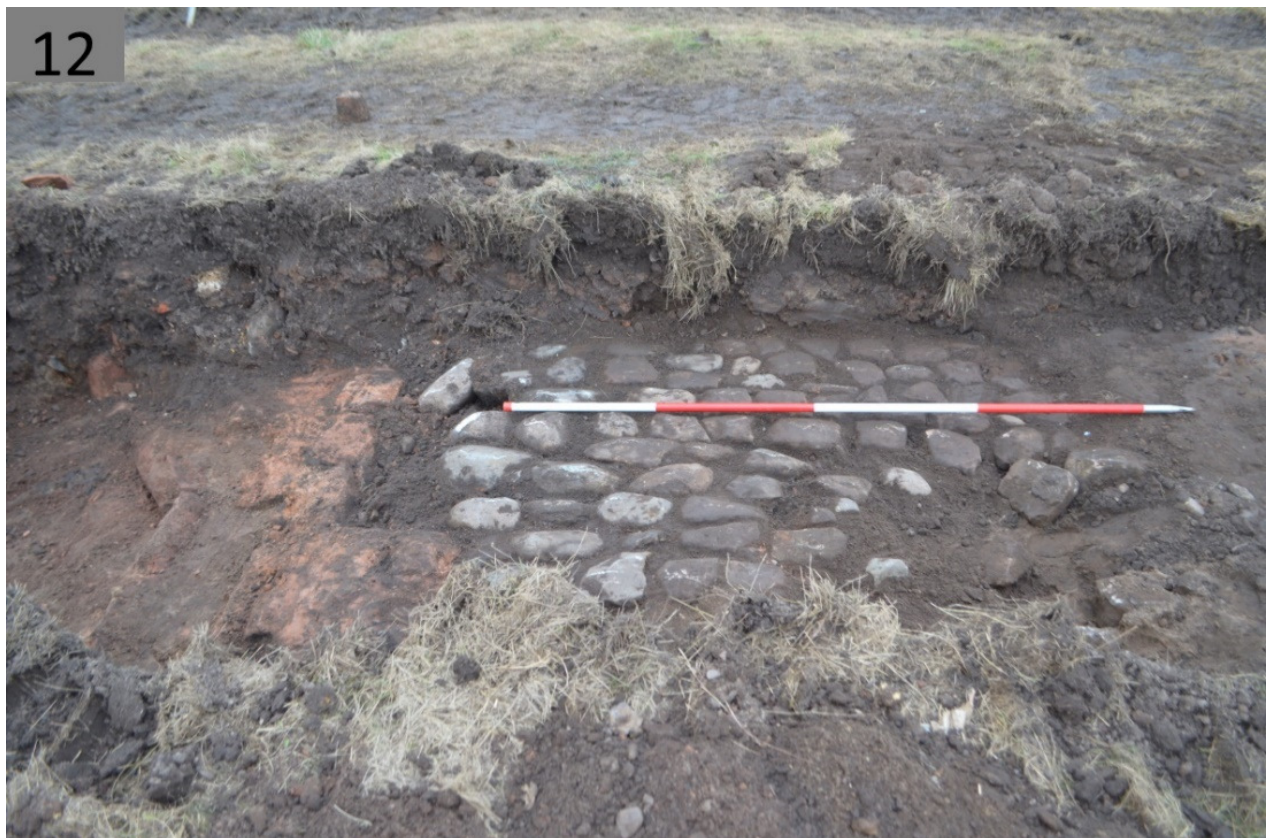
Illus 12. Cobbles (304) in Trench 4. Cut 303 is just visible on the left. View looking south.

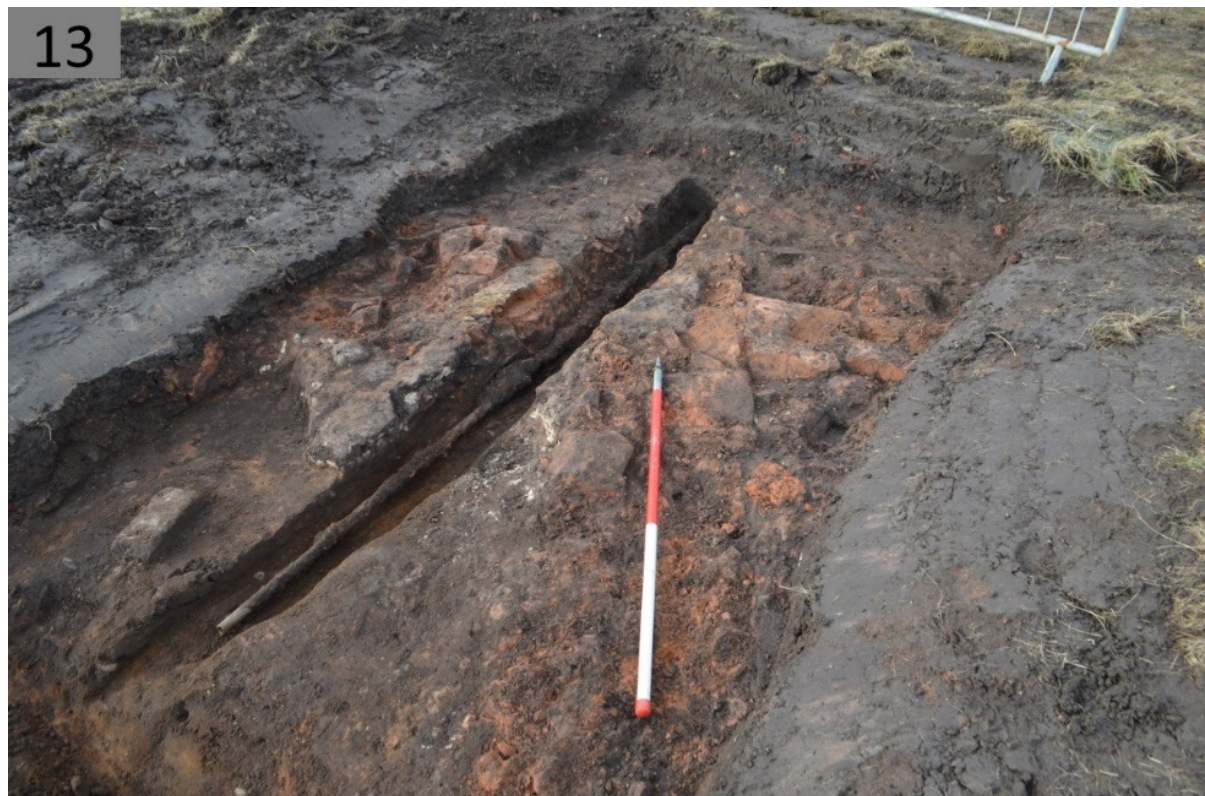
Illus 13. Sandstone 605 at north end of Trench 5 with pipe cut 604. View looking north-west. Scale 1 m..

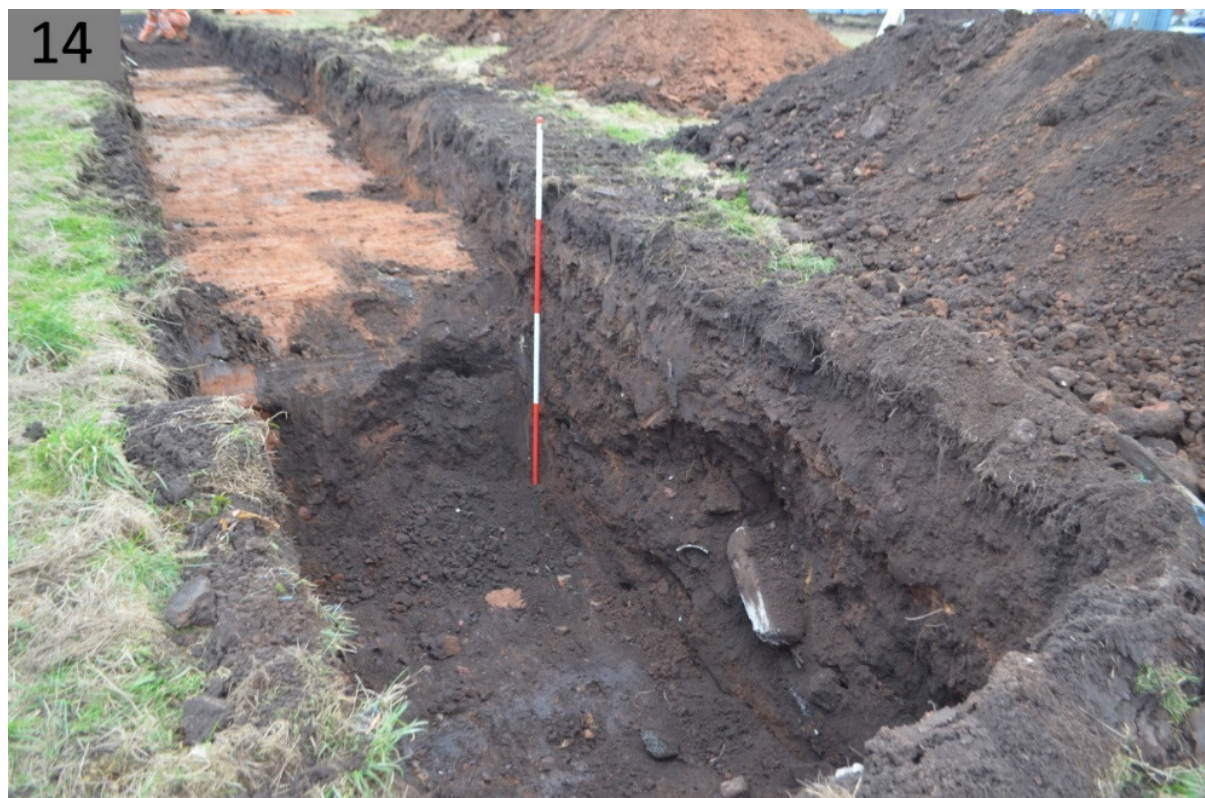
No clear evidence was found for the edge of the quarry depicted on historic mapping, though the height of geological deposits and the depth of the trench (1.4-1.8 m) suggests that the quarry may

Illus 14. Quarry face (612) at southern end of Trench 5. View looking north-east. Scale 2 m.

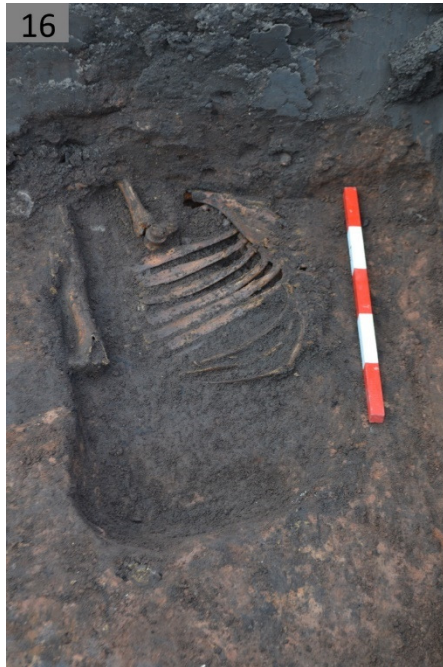
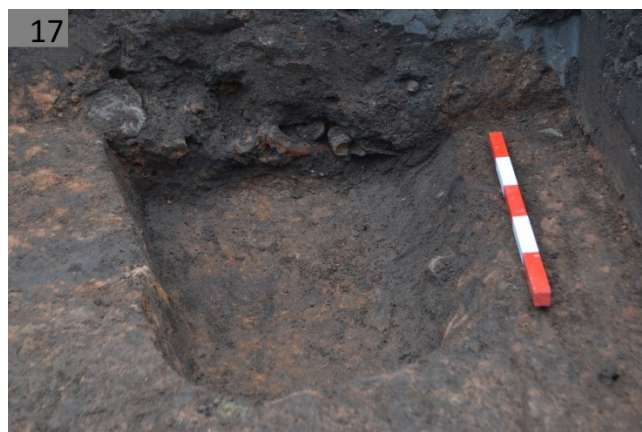
The fill (103) was a loosely compacted, friable humic dark brownish grey sandy clay with approximately 2% angular red sandstone pebbles. Within the fill was a partially articulated animal skeleton (Illus 16 and Illus 17) consisting of the spine and ribs, other fragments of bone in the fill were probably from the same animal.

Illus 16. Articulated animal bone on cut (104) Trench 1. View looking north. Scale 0.5 m.

Illus 17. Cut (104) Trench 1. View looking north. Scale 0.5 m.

The animal bone found in pit fill (103) is tentatively identified as a pig, though specialist analysis would be required to confirm this. Its date is uncertain, no ceramics or other finds evidence was recovered

in association with it, however, the bone is in good to excellent condition. This suggests that it is of relatively late date, probably 19th or early 20th century, because bone preservation in the region's sandy soils is generally very poor unless deposits are waterlogged. Assemblages in contexts pre-dating c. 1600 AD tend to be very small and badly eroded, often consisting only of calcined fragments (e.g. Irby (Philpott & Adams 2010)), or confined to waterlogged contexts (e.g. Big Lea Green Farm, Sutton (Towle & Speakman 2012)).

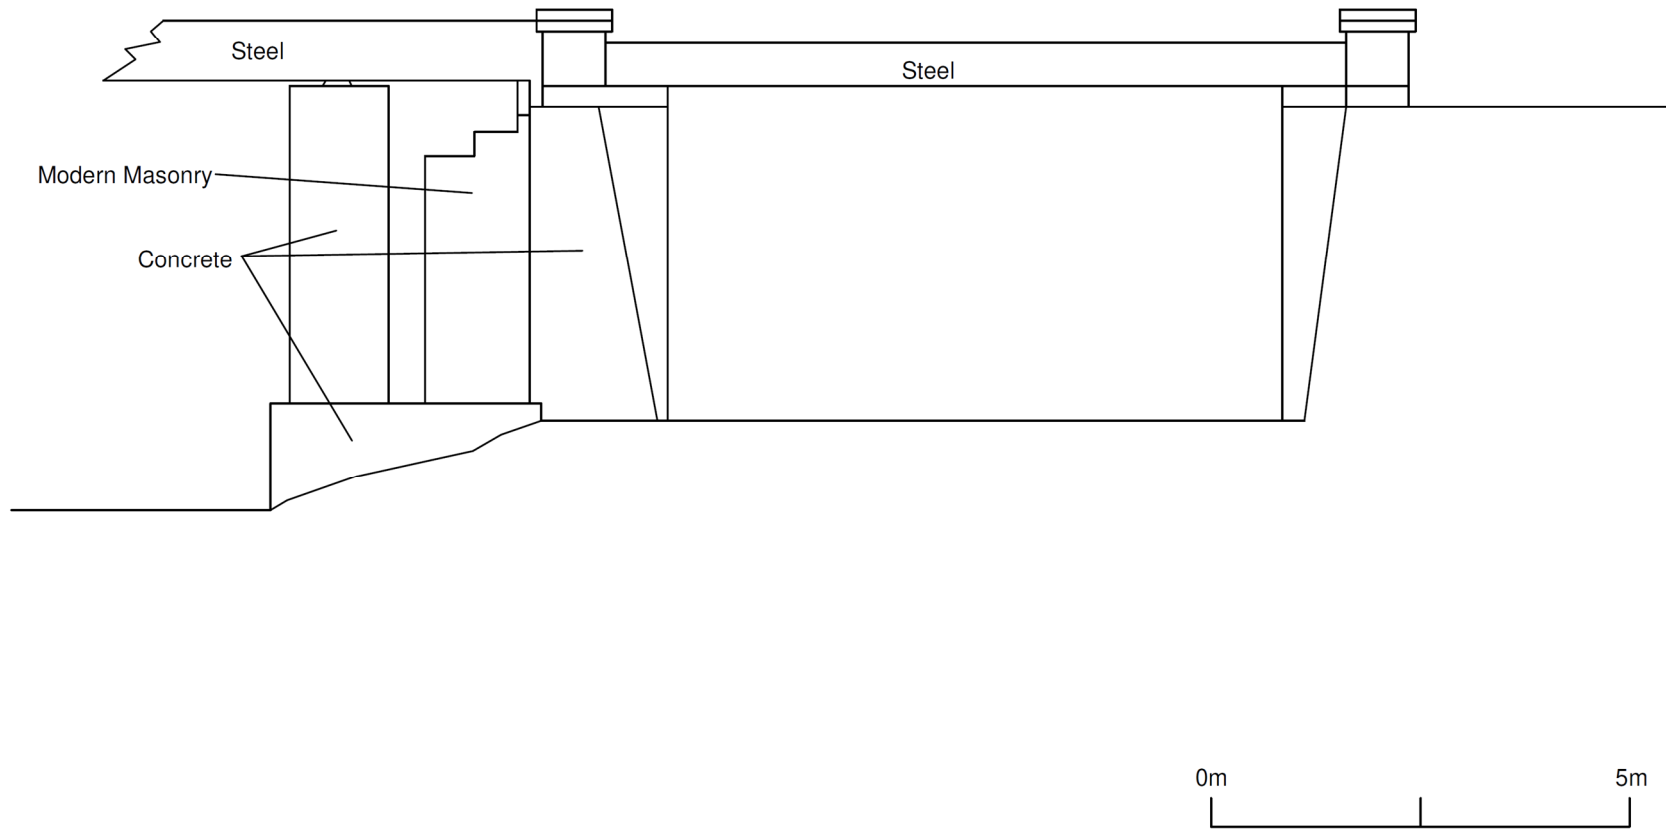
The earliest phase lies to the west of the modern line of County Road and was constructed in 1847. This element consists of two piers spaced c. 7.5 m apart and c. 4 m in height, constructed in rusticated red sandstone masonry, the tops are capped by a single course of red sandstone ashlar which carries the trackbed. The sandstone is likely to have been quarried locally.

Illus 18. Underbridge 55. Sketch of north facing elevation. Unlabelled elements are original masonry.

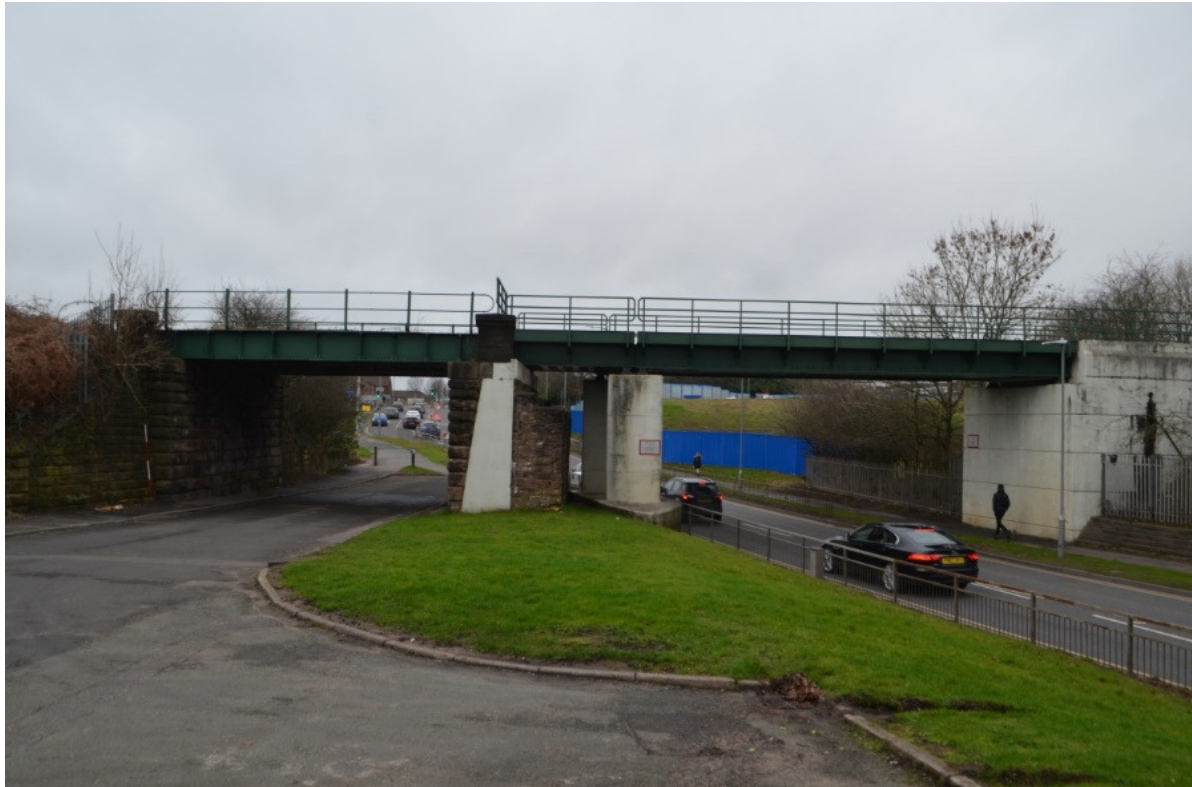
Record drawings cited in ARUP 2021 (No source or reference is given) indicate that the western span of Underbridge 55 (over County Road), was constructed in 1847, though the original superstructure was replaced with the existing deck in 1930. In 1970 the remaining two spans of Underbridge 55 (over the A506), an intermediate pier and eastern abutment were built as part of works associated with the construction of the present day A506.

Illus 20. View of Underbridge 55 from the south. The original line of County Road is on the west (left).

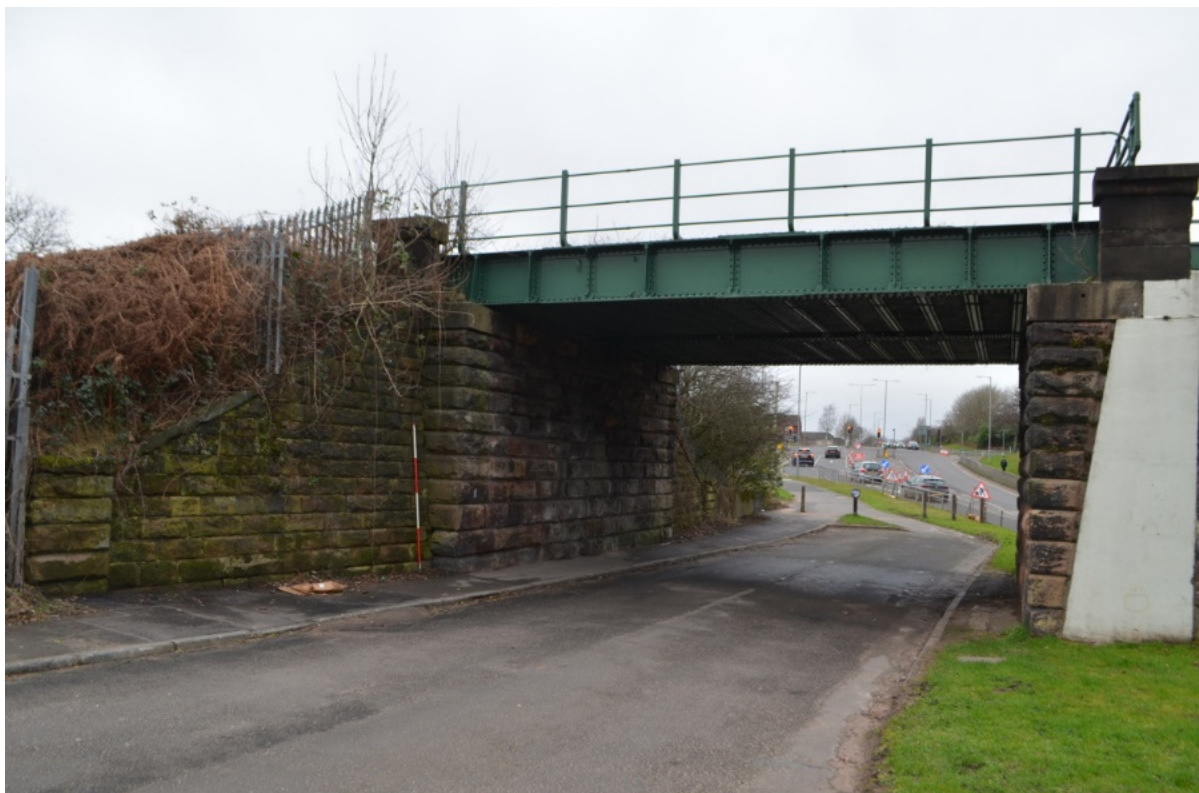
Illus 21. Detail of the southern side of Underbridge 55 showing Phase 1 piers and retaining wall and Phase 2 trackbed.

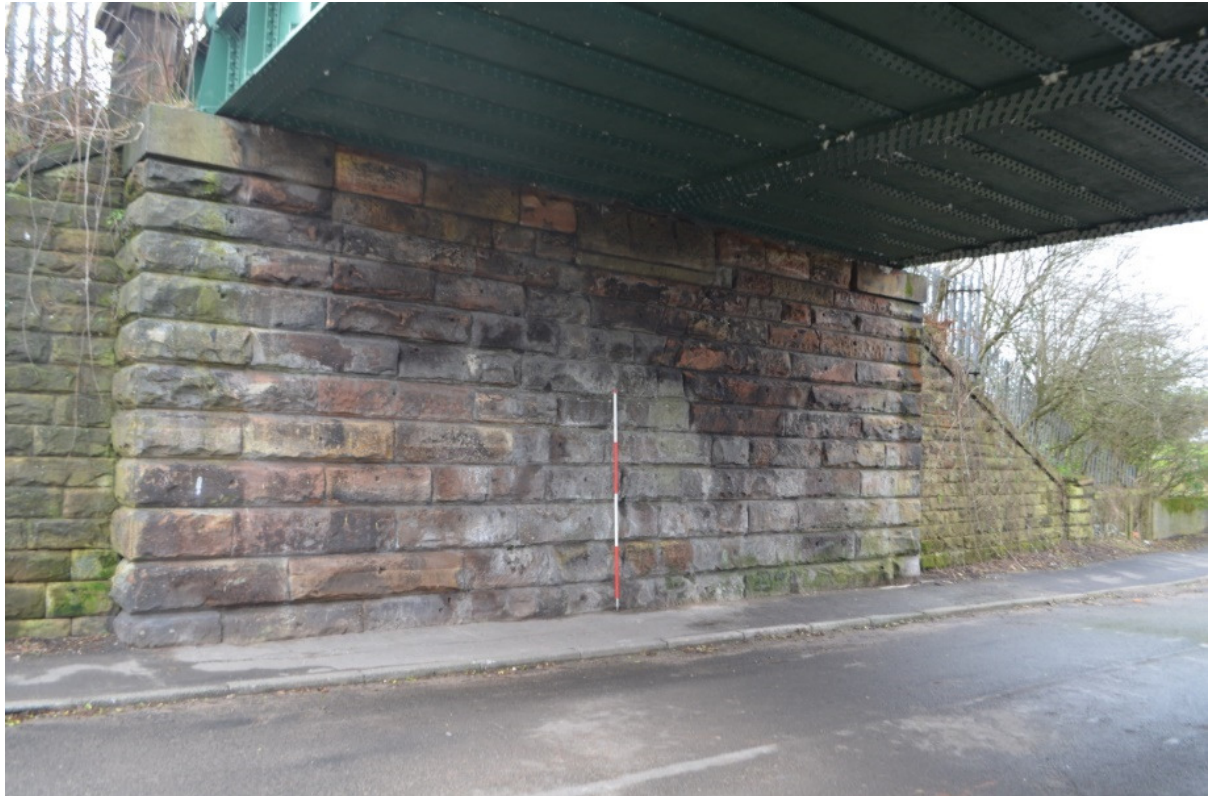
Illus 22. Detail of western Phase 1 pier.

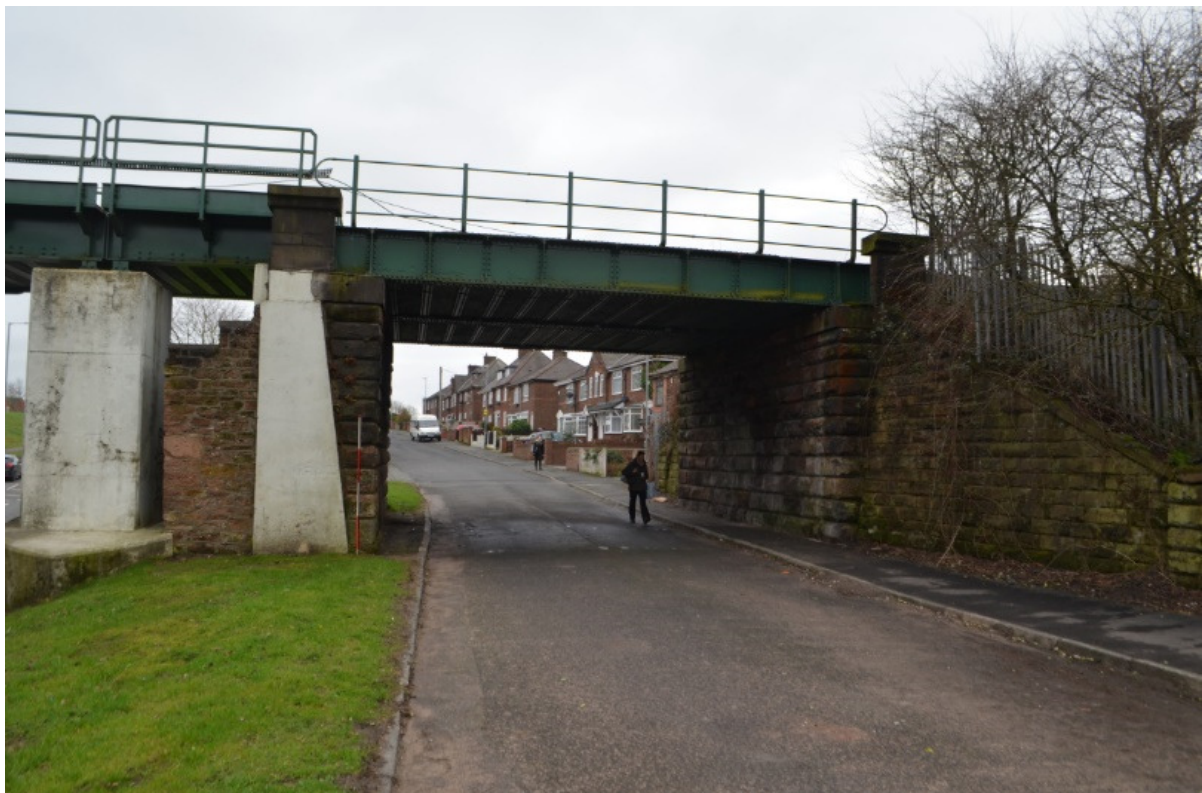
Illus 23. Detail of the northern side of Underbridge 55 showing Phase 1 piers and retaining wall and Phase 2 trackbed. The former line of the eastern embankment retaining wall is defined by the white painted concrete.

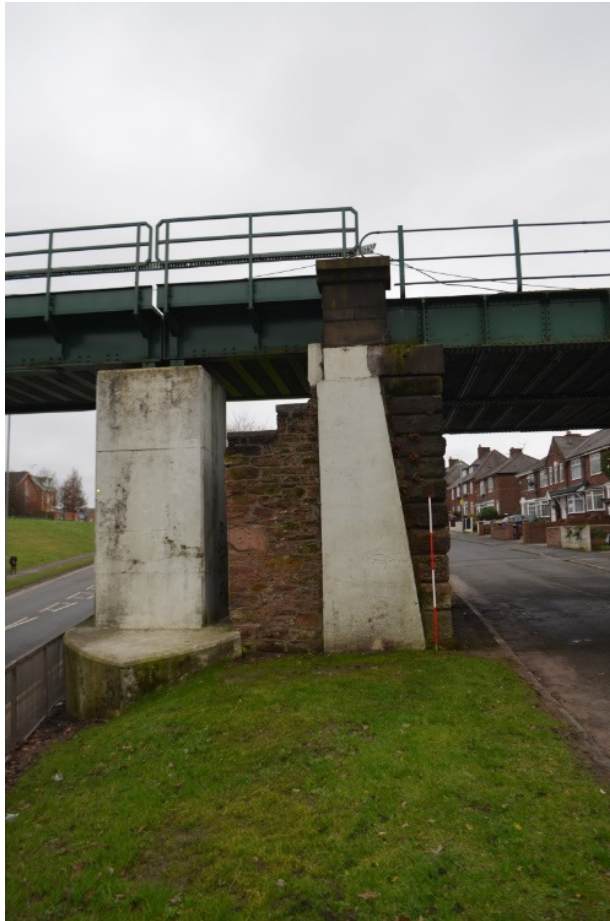
Illus 24. Detail of Illus 23 showing the former line of the embankment retaining wall.

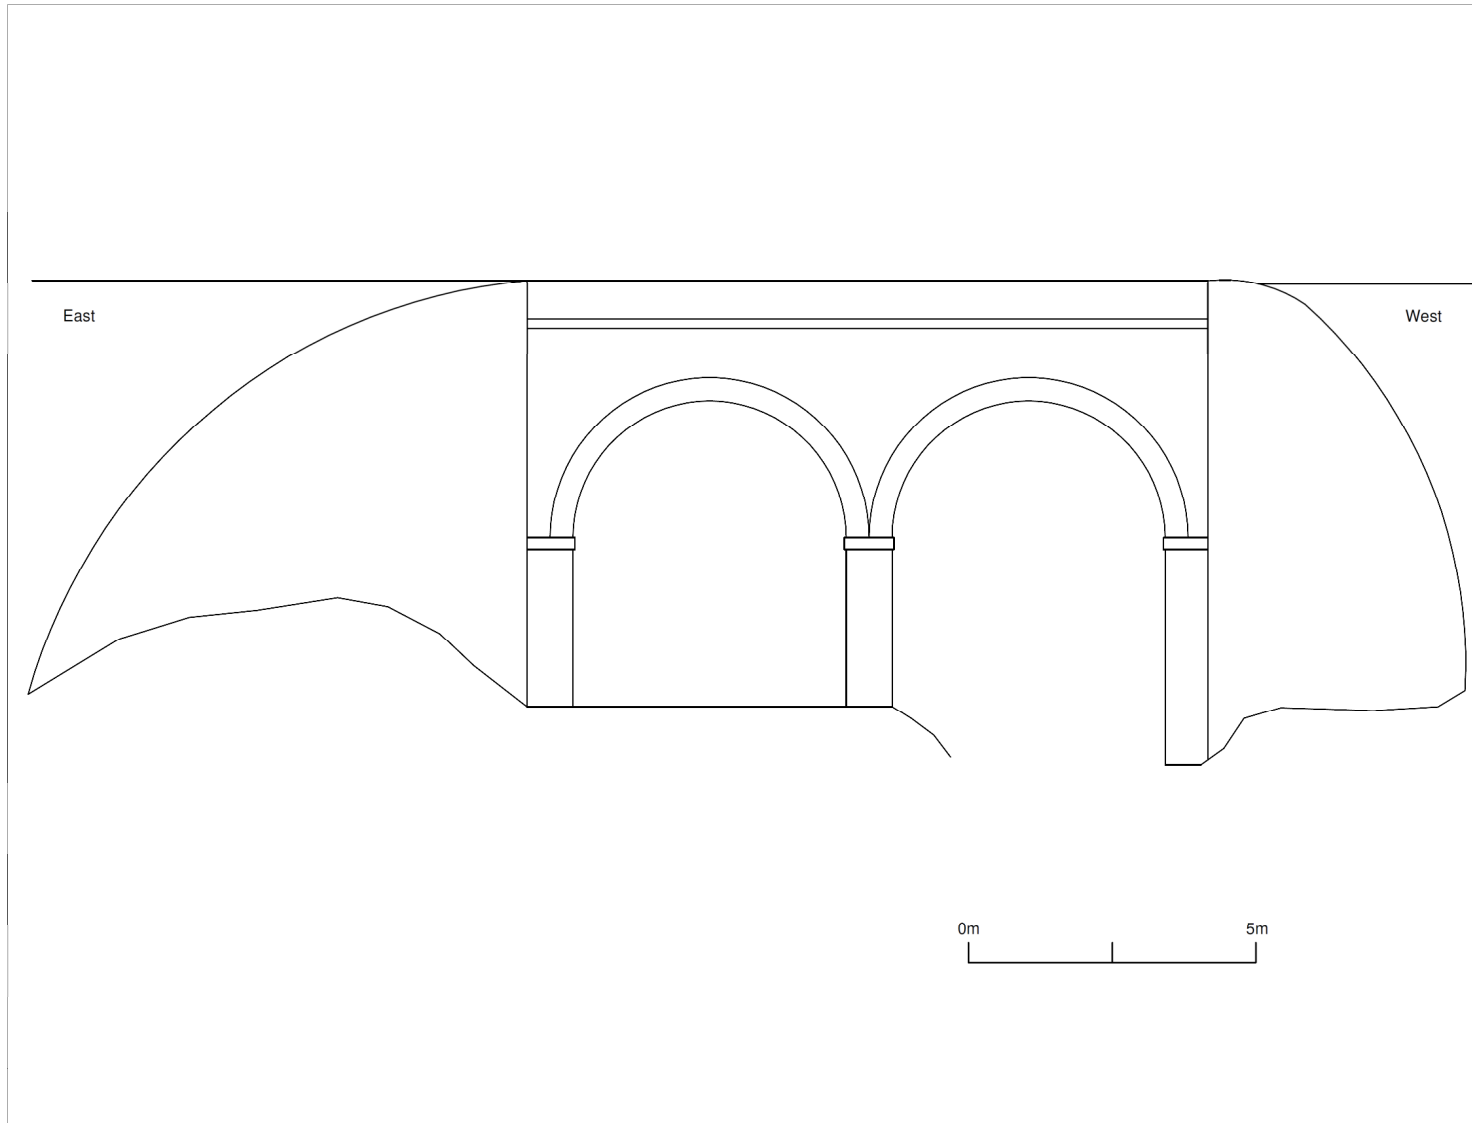
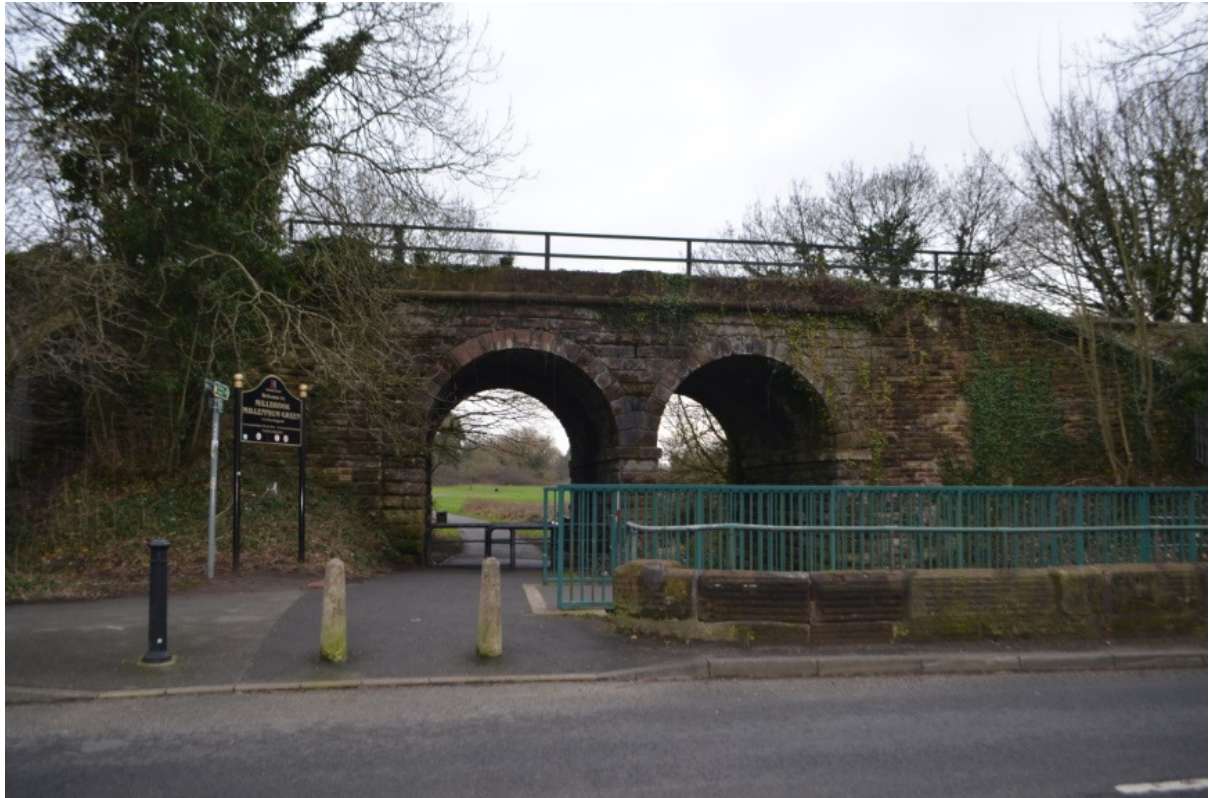
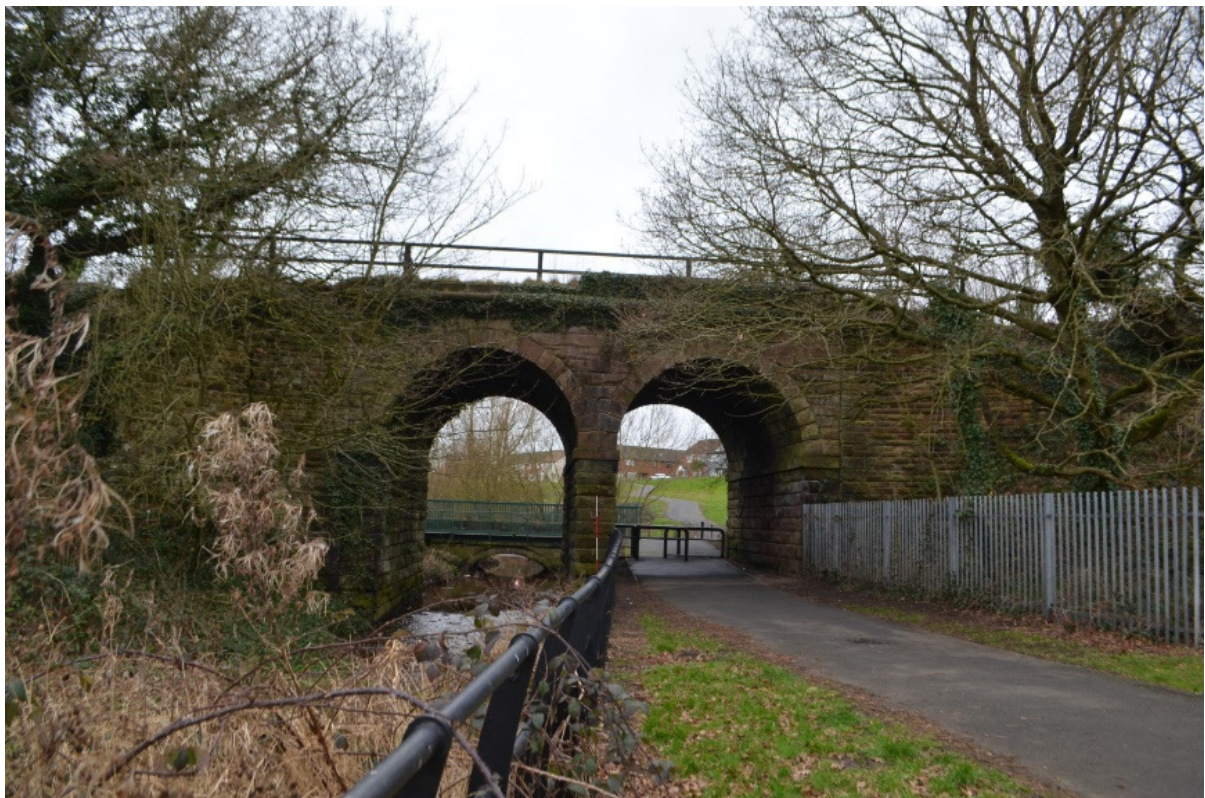
Underbridge 56 is composed of two arched spans c. 4.75 m across and 7 m long with retaining walls to either side for the embankment (Illus 26 to Illus 30). The supporting piers for the arches are in rusticated red sandstone masonry and carry two semi-circular arches in red sandstone ashlar supported on a plinth course of red sandstone ashlar.

Infilling above the arches is in rusticated red sandstone and supports a red sandstone ashlar parapet.

The embankment retaining walls are in rusticated red sandstone masonry using smaller blocks than are found in the piers and infilling. They are capped using red sandstone slab copings.

Illus 26. Underbridge 56. Sketch of north facing elevation.

Illus 27. Sketch plan of Underbridge 55. Dashed lines are sections obscured by the trackbed.

Illus 28. Underbridge 56, north facing elevation. Mill Bridge is in the foreground.

Illus 29. Underbridge 56, north facing elevation.

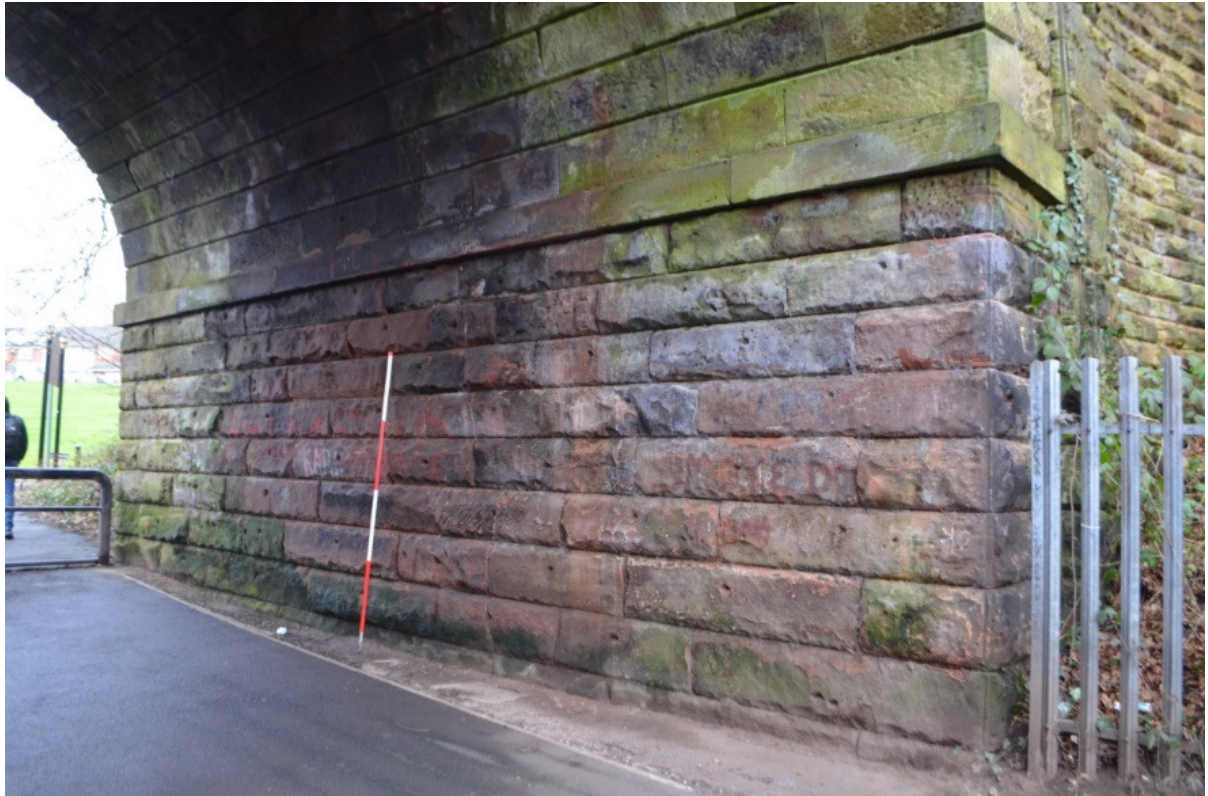
Illus 30. Underbridge 56, detail of eastern pier.

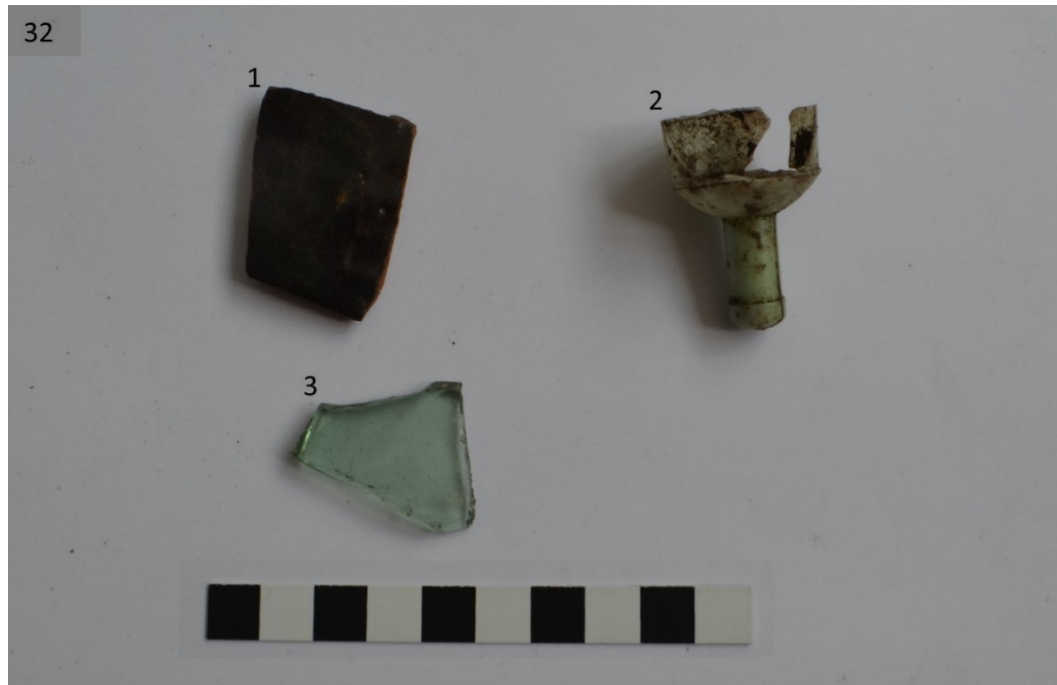
Illus 32. Finds from Context 205. 1=Late Coarse Darkware; body sherd, 2= Plastic, 3= Bottle Glass. Scale = 10 cm.

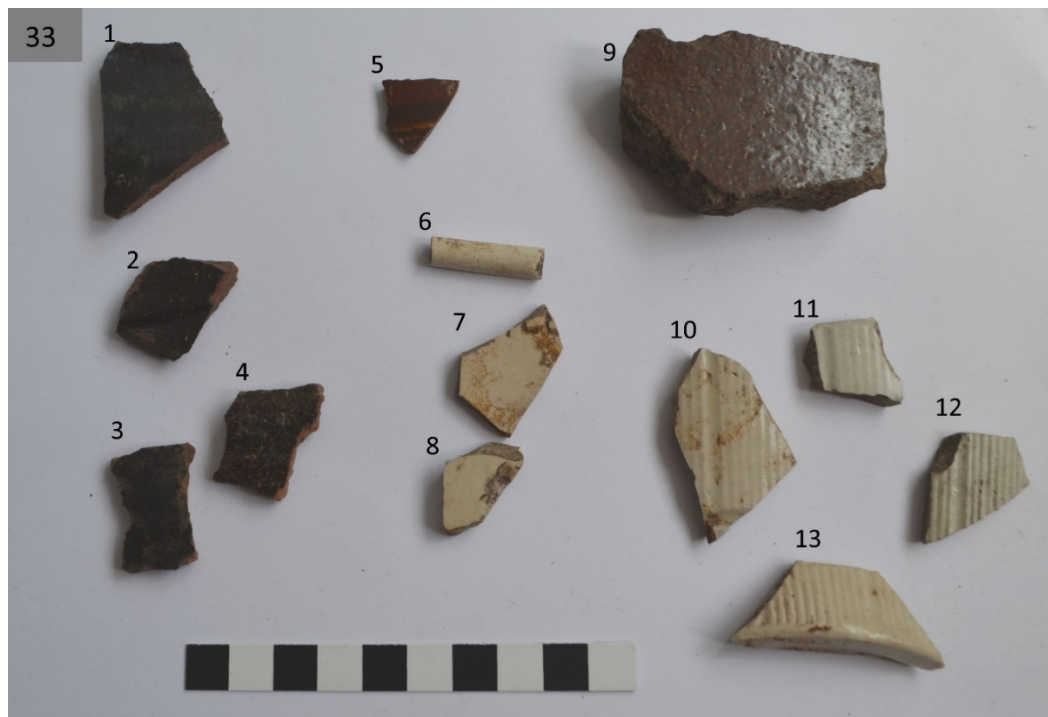
Illus 33. Finds from Context 603. Scale = 10 cm. 1-4= Late Coarse Darkware, 5=Glazed Earthenware, 6= Tobacco pipe stem, 7 & 8= Stoneware 'Ginger Beer Bottle', 9= Stoneware; drainpipe, 10-13=Stoneware; Marmalade Jar; body sherds

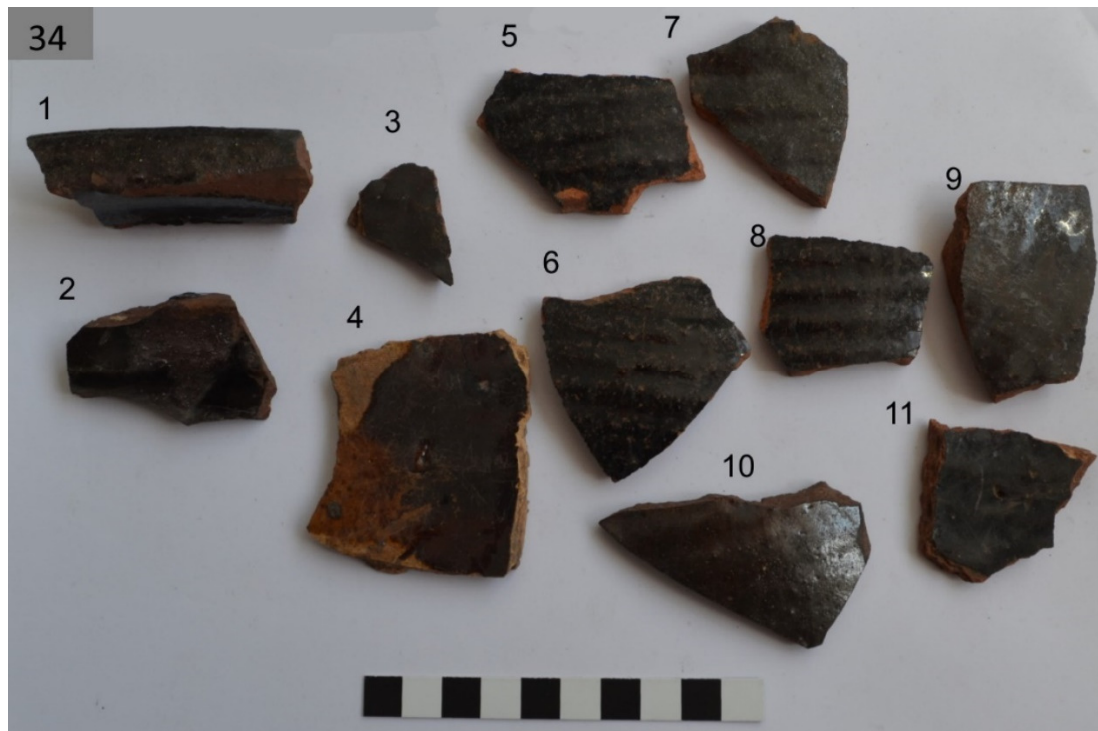
Illus 34. Finds from Context 601. Scale = 10 cm. 1 & 2 = Late Coarse Darkware; rim sherds, 3-11 = Late Coarse Darkware; body sherds

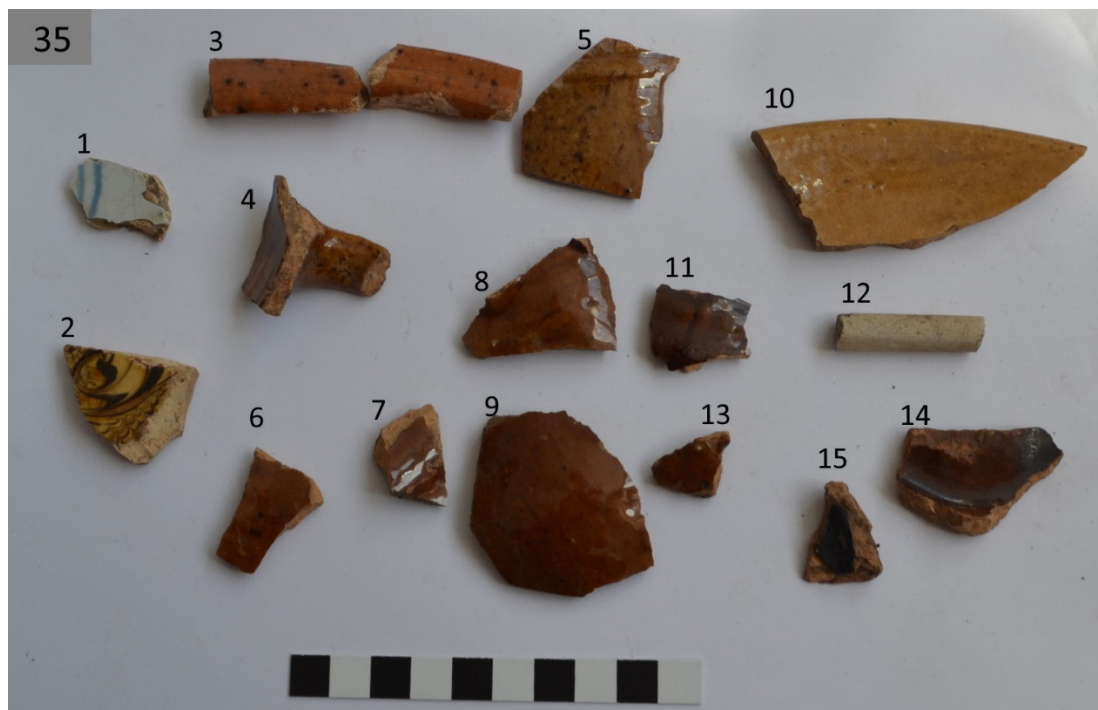
Finer wares are represented by finds such as a small fragment of tin-glazed earthenware found in context 601, trench 5 and fragments of mottled wares found in the same context which include the wall of a small globular cup which was probably similar to one excavated at Big Lea Green (Towle & Speakman 2012, Fig 4.15, 174). The rim of a Yellow Ware plate, also found in context 5 is late 17th to 18th century in date and similar to another vessel from Big Lea Green (ibid, Fig 152, 64).

Illus 35. Finds from Context 601. Scale = 10 cm. 1= Tin-Glazed Earthenware, 2= Combed Slipware, 3 = Mottled Ware; rims, 4= Mottled Ware; cup handle, 5-9, 11 & 13= Mottled Ware; body sherds, 10= Yellow Ware; plate rim, 12= Tobacco Pipe Stem, 14 & 15 = Mottled Ware; bases

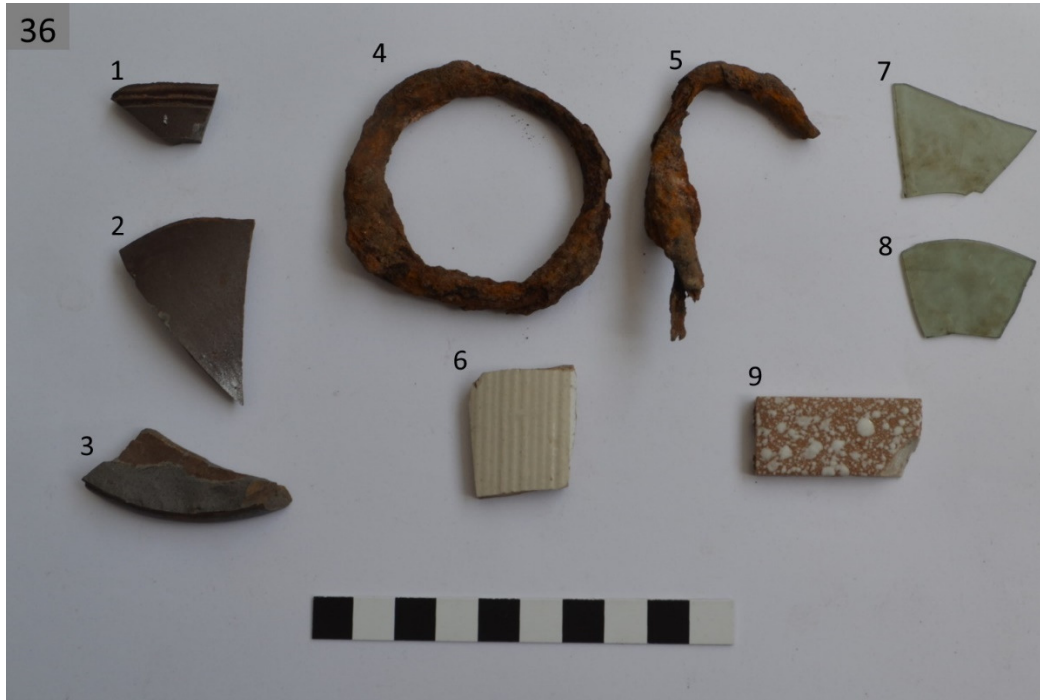
Otherwise the retained finds assemblage (Table 1) consists largely of 17th-20th century ceramics (41 sherds weighing 485.g in total) recovered from Trenches 3 and 5. Two small fragments of window glass found in Context 601 Trench 5 have a green tinge and are c. 1 mm thick which indicates an 18th century date, though a 19th century date is also possible.

Illus 36. Finds from Context 601. Scale = 10 cm. 1 & 2 Stoneware; body sherds, 3= Stoneware; base ,4 & 5 Iron fixture, 7 & 8= Window Glass, 9 = Ceramic wall tile.

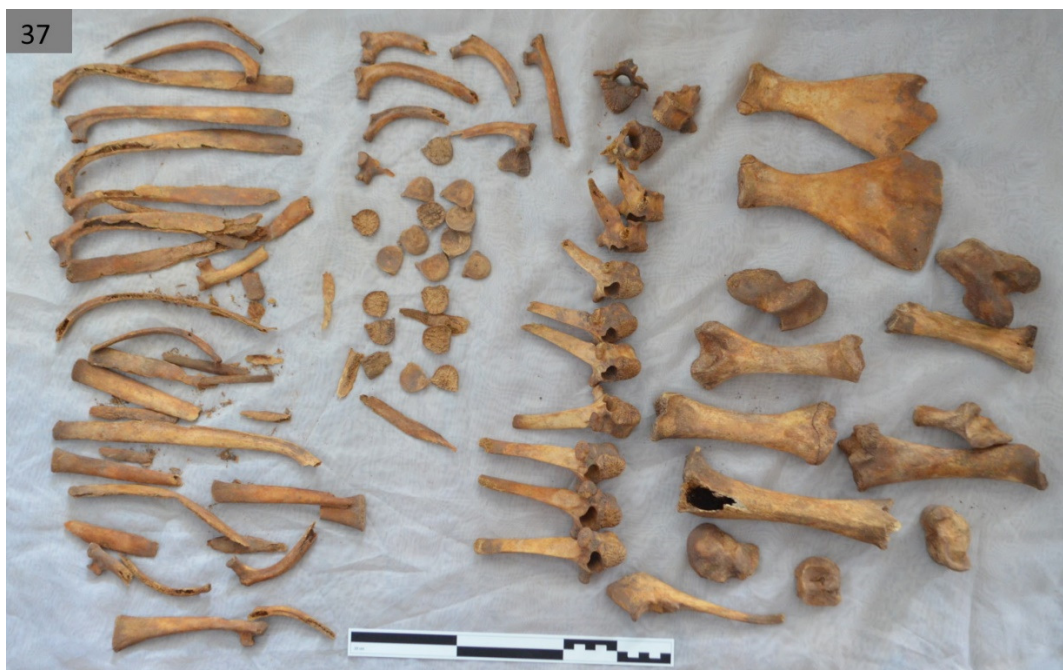
Illus 37. Animal bone from Context 103. Scale= 30 cm.
