The Soapworks (former Gardiner Haskins Homecentre), Bristol

Historic Building Recording

for Soapworks Development S.a.r.l

29/11/2022

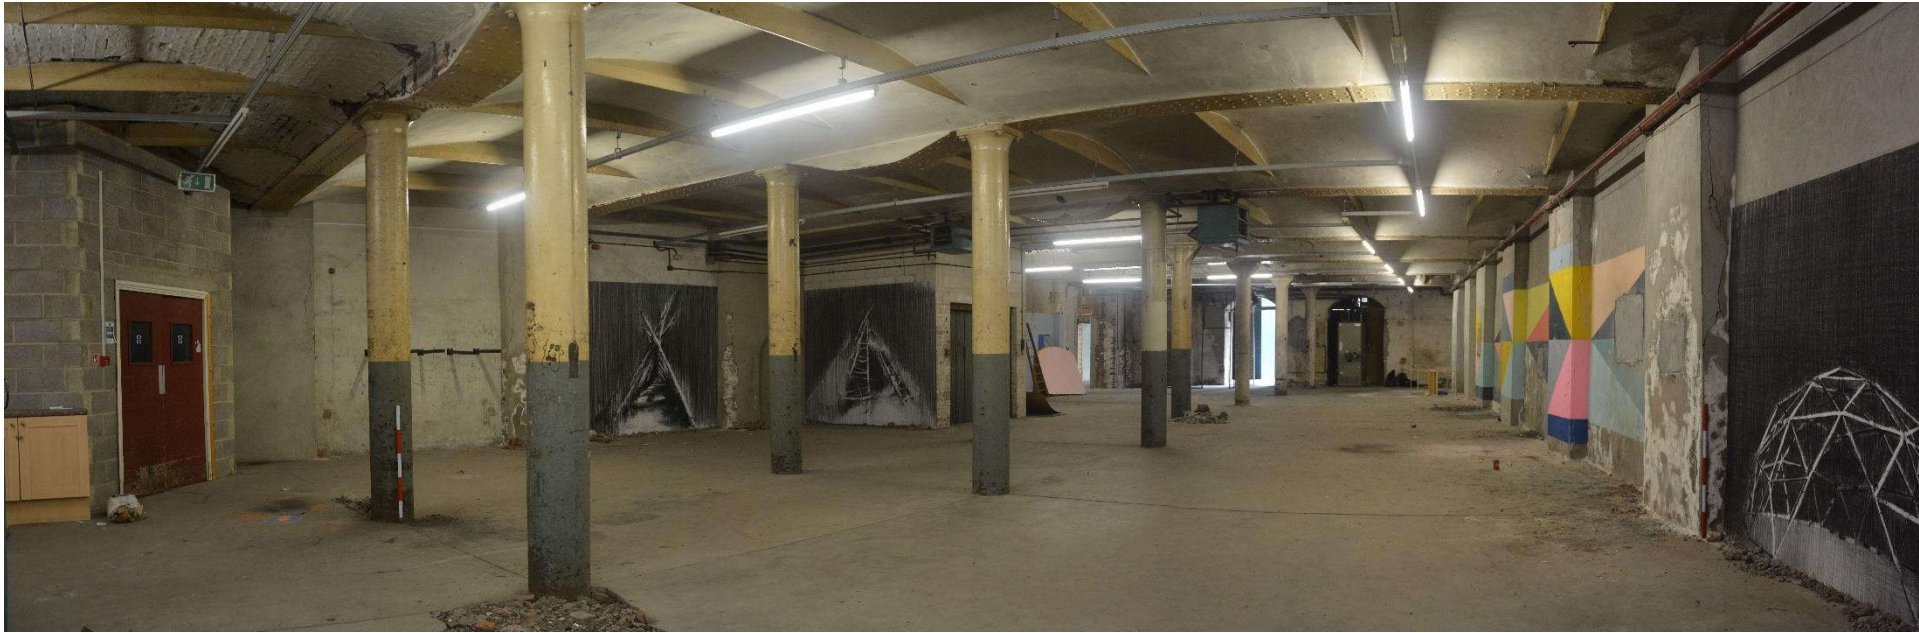
Illus. 10. Panorama of Room LG. 1 from its western end, looking east

- 7.1.7. Modern stud walling was present only within the northern wall of LG. 1; its elevations were primarily rendered, with some modern painting in some areas. A painted metal staircase of probable 20th century date took up much of Room LG. 2. Room LG. 1 was lit with strip lighting whilst Rooms LG. 2 and LG. 3 were lit with wall lights. A mid- to late 20th century sign relating to the building's use by Gardiner Haskins was noted on the southern wall of Room LG. 3. Apart from the lift which ran throughout the building, no other modern fixtures or fittings were seen.

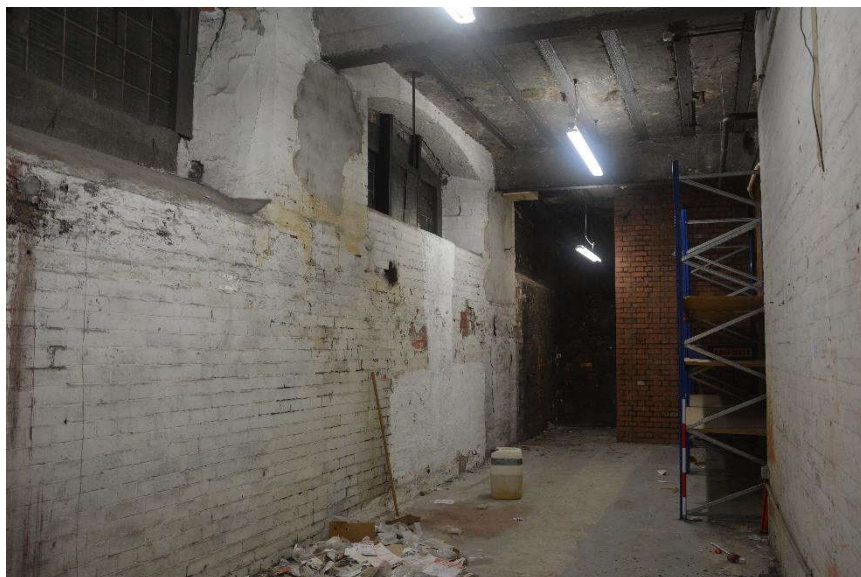
Illus. 14. Largely unaltered segregated area in the north-eastern corner of Room LG. 4, looking east
