Worrall Street, Ordsall Archaeological Excavation

PLANNING REF. 20/76684/FUL

for Bridgestone Construction Ltd

Draft v.1.3
04/07/2023

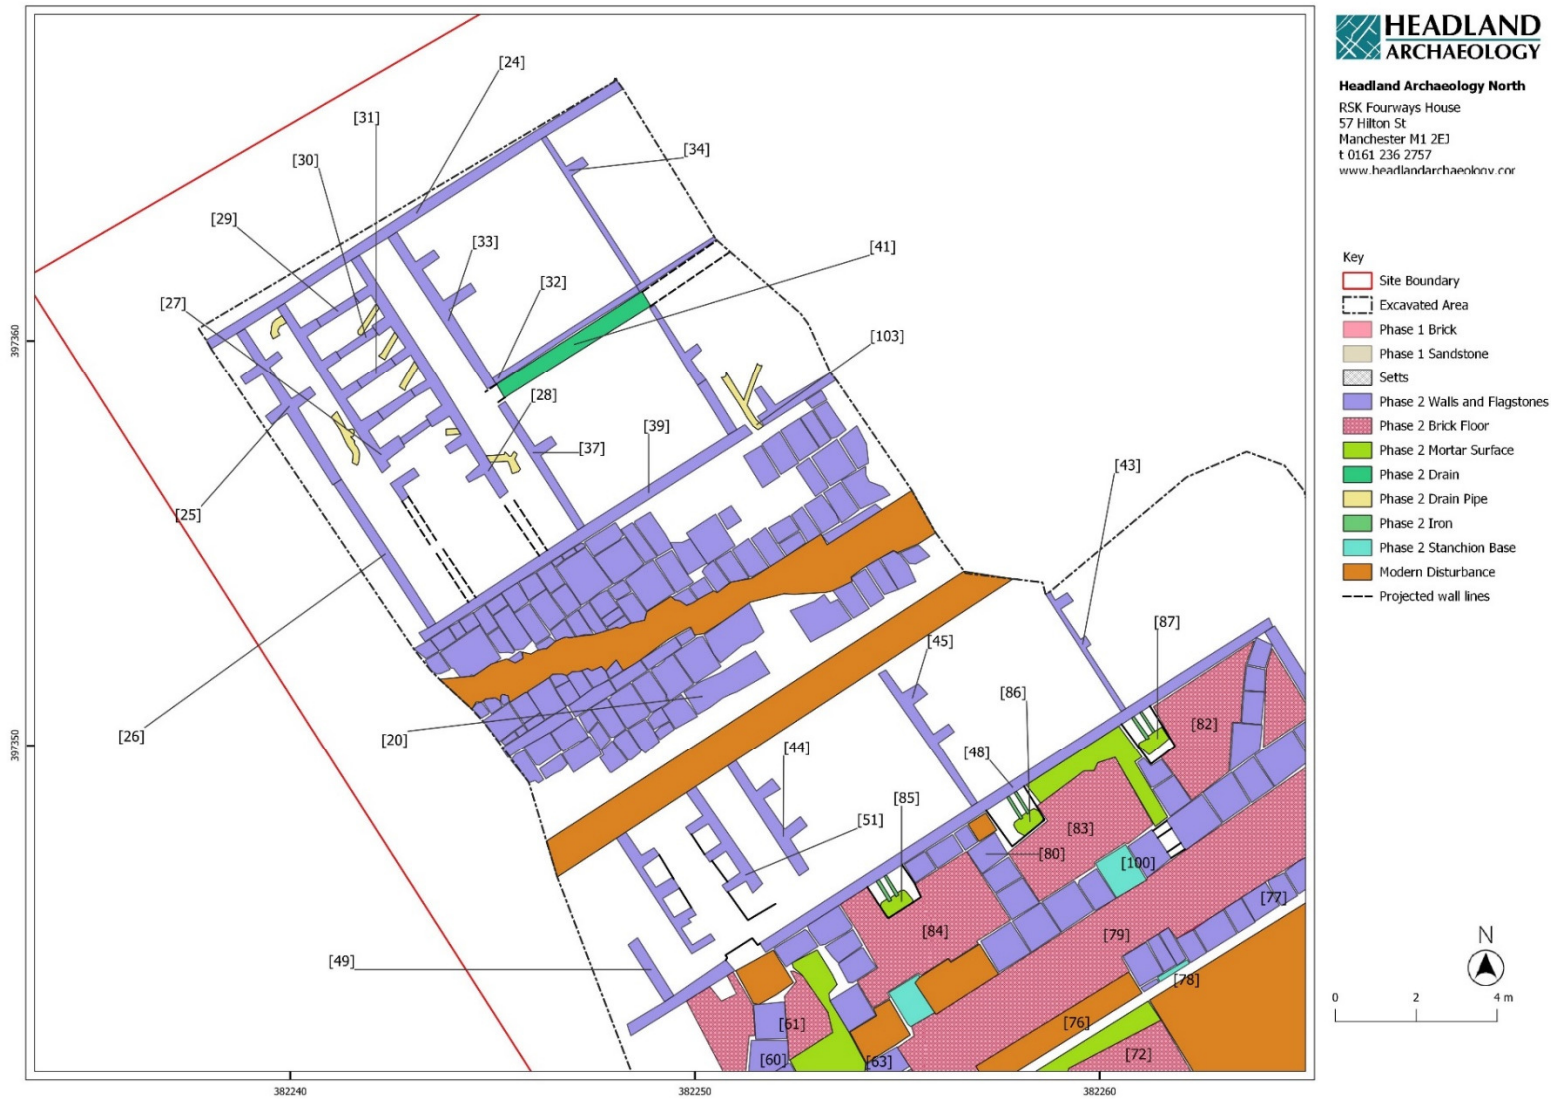
Illus 12. Detail plan of the back-to-back houses in Phase 2.

Each dwelling consisted of a single downstairs room measuring 4.2x4.2 m (13ft 6in x 13ft 6 in), a typical size for a mid-19th century back-to-back house.

The toilets are depicted on historic mapping (Illus 6) and were constructed using double skin brick walls with an apparently random mix of headers and stretchers. At 4.2 m wide the block was an identical width to the houses and the toilets may be a later insertion created by adapting a former house because a pair of eastward projecting buttresses in north-south wall [25] were identical to the fireplace foundations found to the east. However, it is possible that this change was made during construction, so the toilets are shown as part of Phase 2 on Illus 11 and Illus 12.

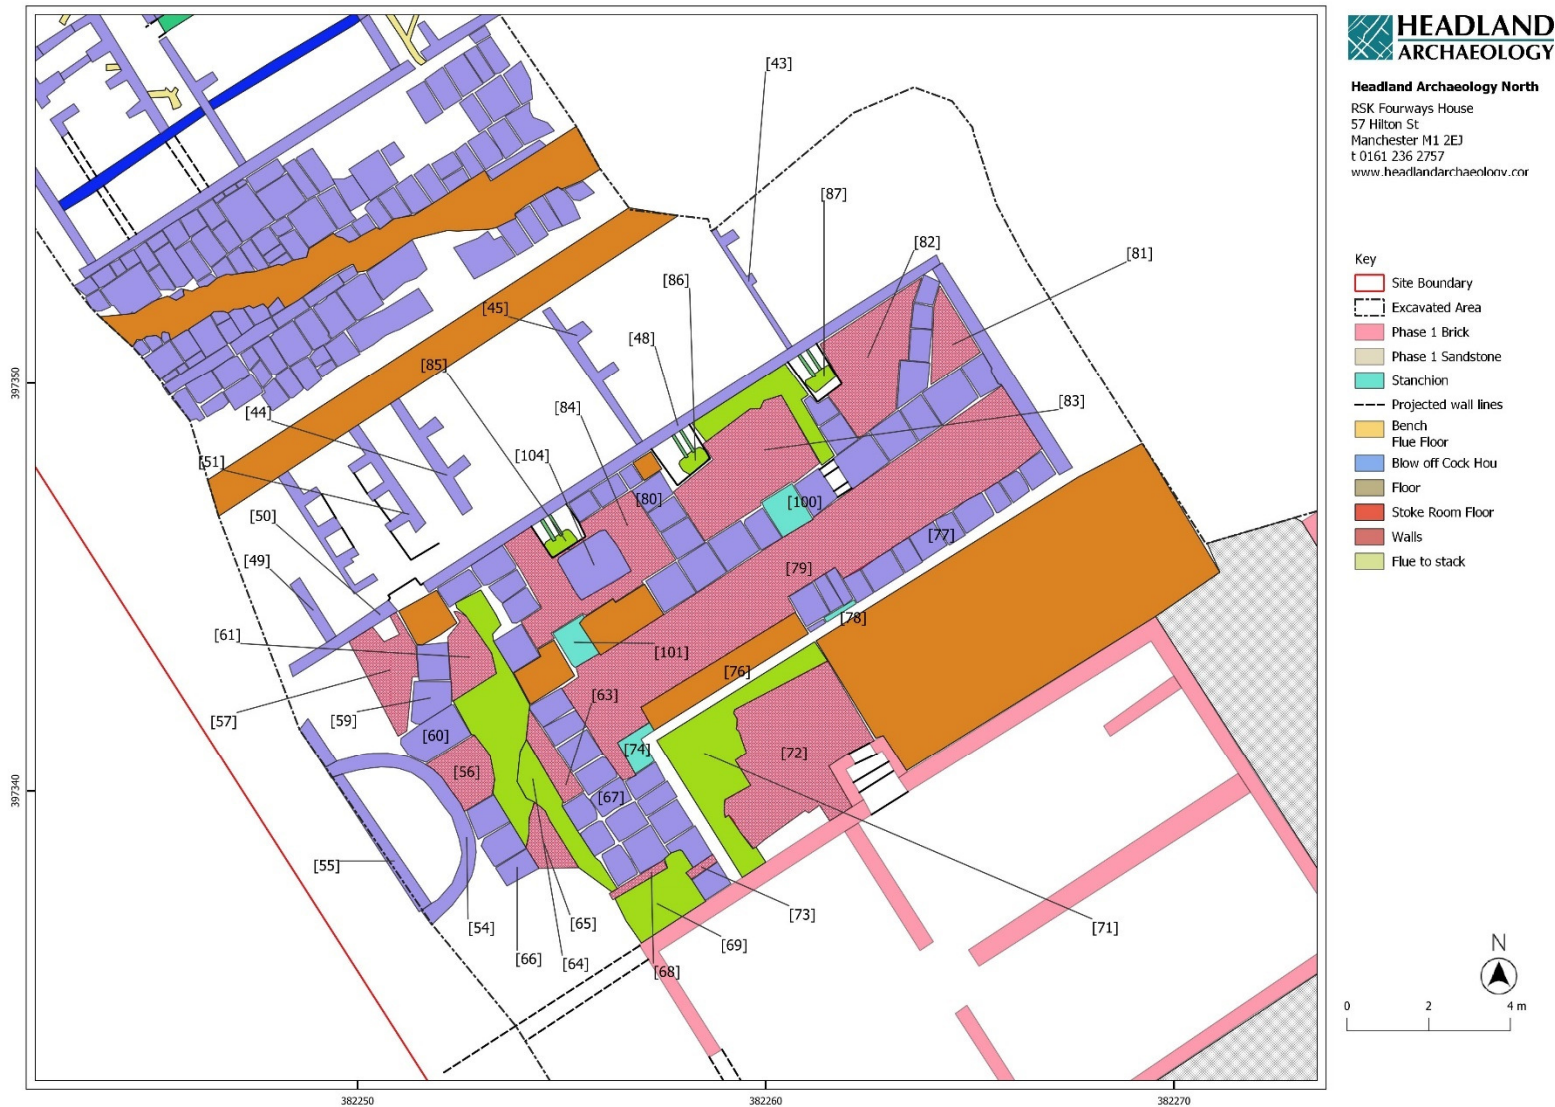
Illus 13. Plan of the Phase 2 Factory Extension and blind back houses.

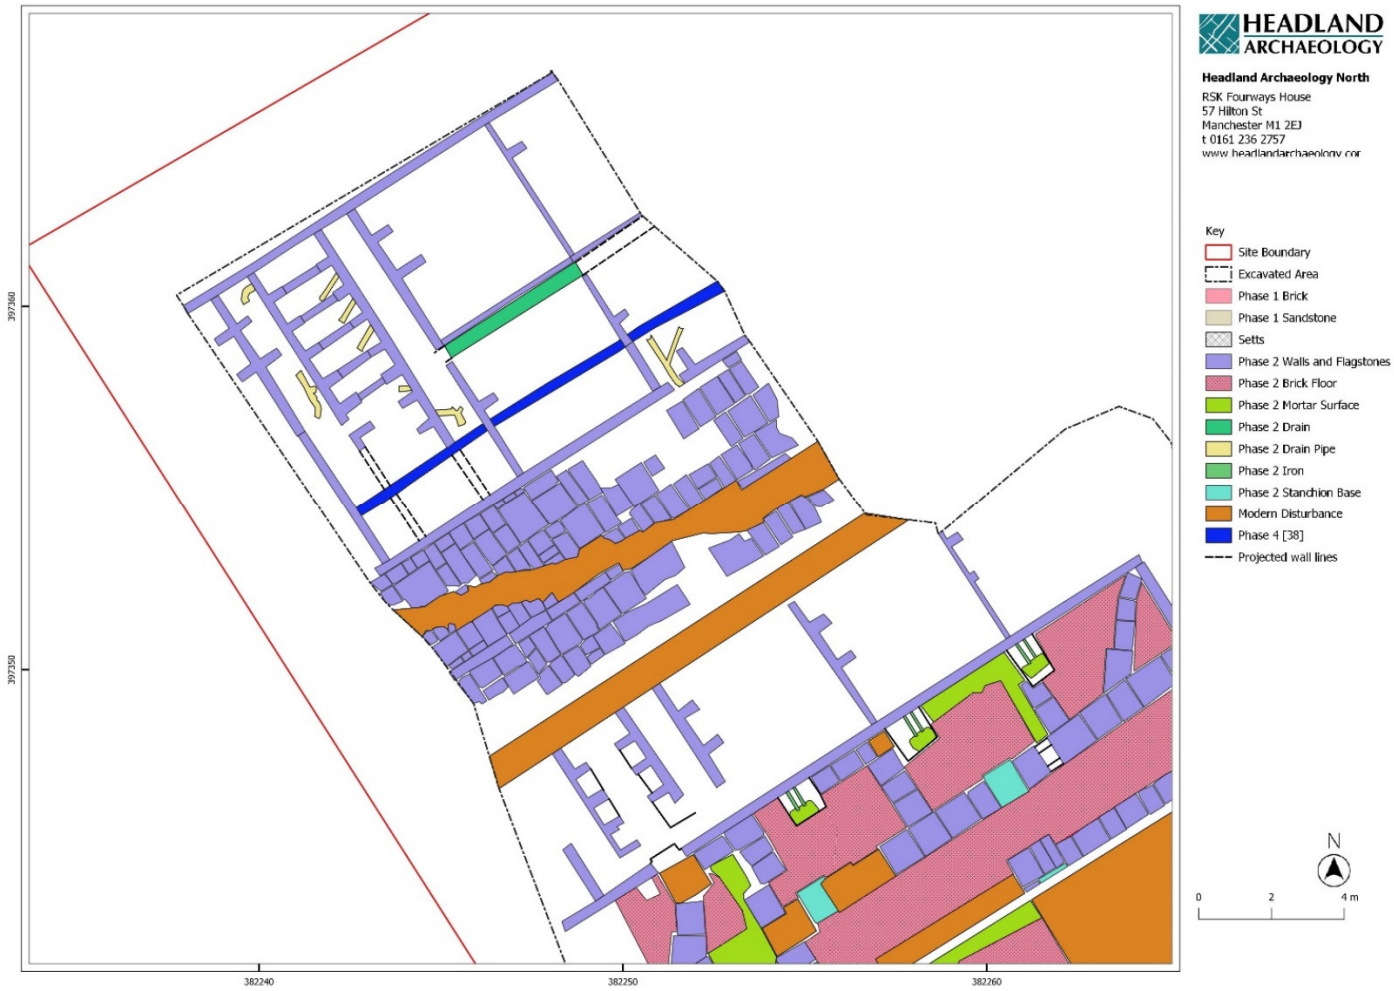
Illus 16. Detail of Phase 4 back-to-back houses

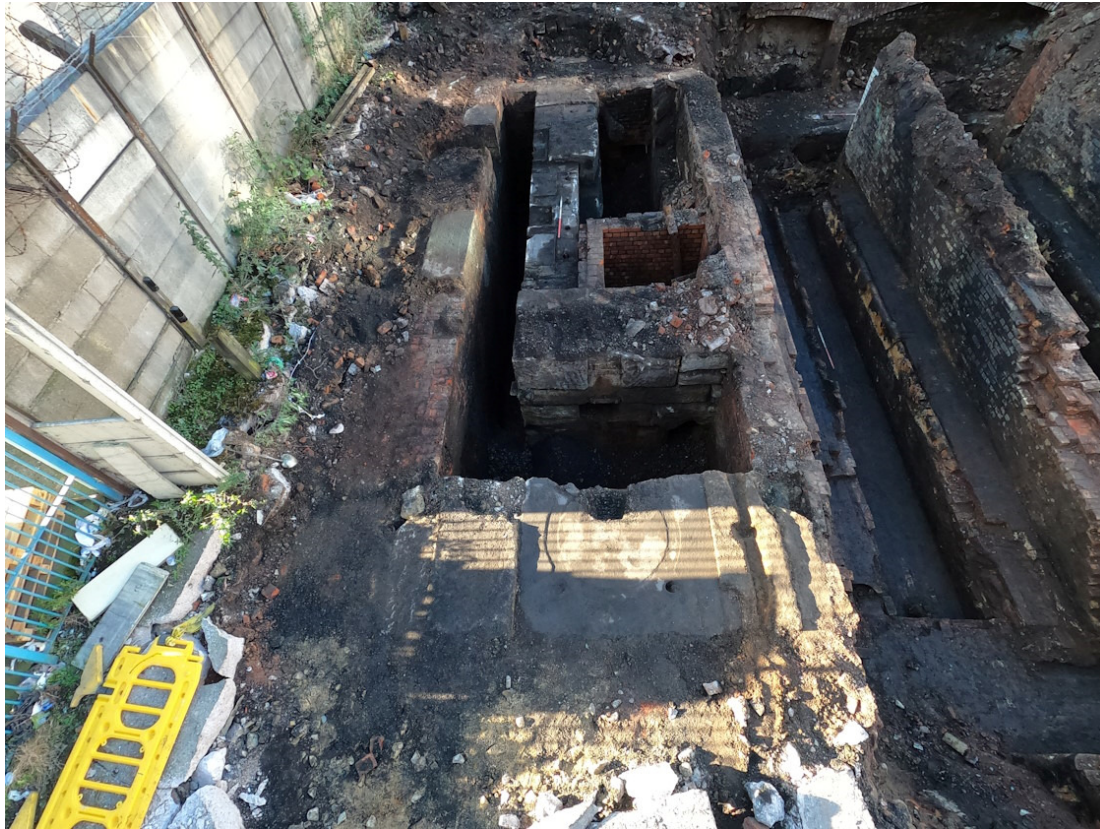
Illus 24. Overview of the Phase 1 Engine House. The cylinder mount is in the foreground. View looking north, scales 1 m.

The substantial brick and sandstone foundations of the engine house survived (Illus 24) and show that it housed a single cylinder beam engine. Although all metal items had been stripped when the engine was decommissioned (probably in 1924; see below) sufficient evidence survived within the structure to allow a broad reconstruction of its components and layout.

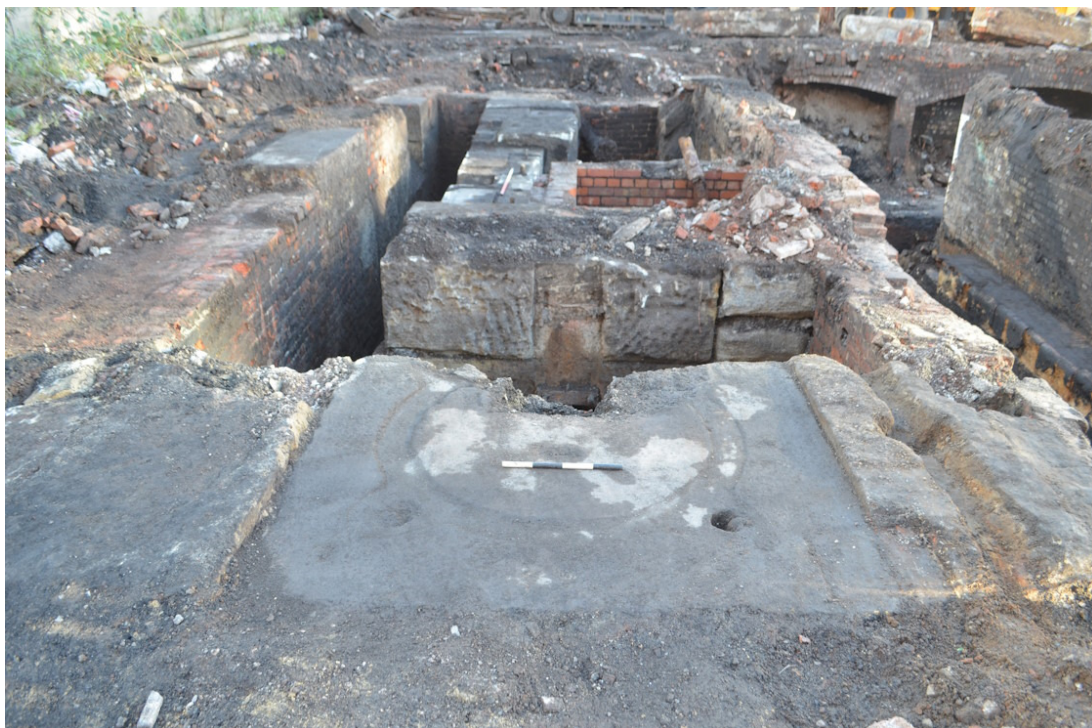
Illus 25. Detail of cylinder mount in [92]. View looking north, scale 0.4 m.

There was a mounting for a single cylinder at the southern end of the building which was housed within a large mass of sandstone masonry [92] (Illus 25). The cylinder mounting was single block of sandstone which measured 1.8 x 1.6 m in plan and was c. 0.35 m thick. The recess cut for the cylinder

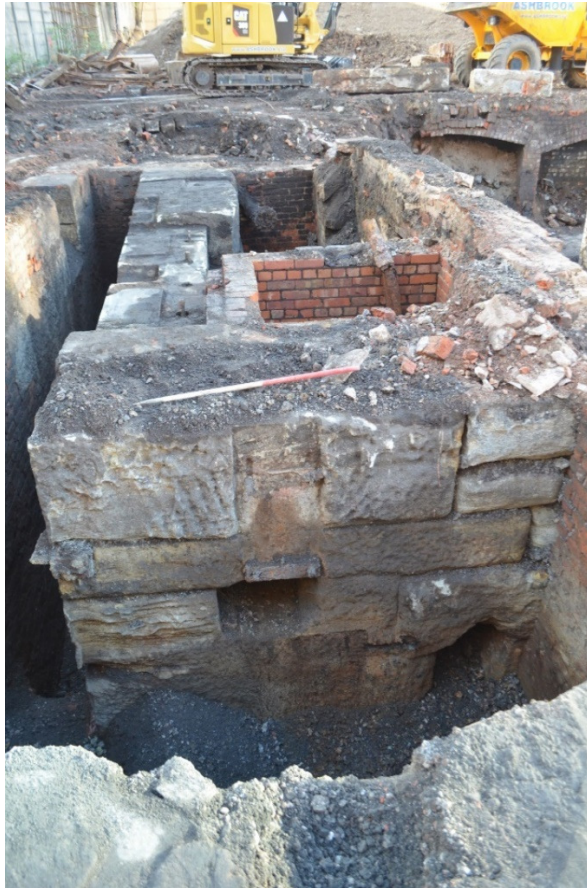
Illus 26. Detail of the central block carrying the mounting post for the beam. The openings in the masonry would have carried the pipework from the pump to the condenser tank in the foreground. View looking north, scale 1 m.

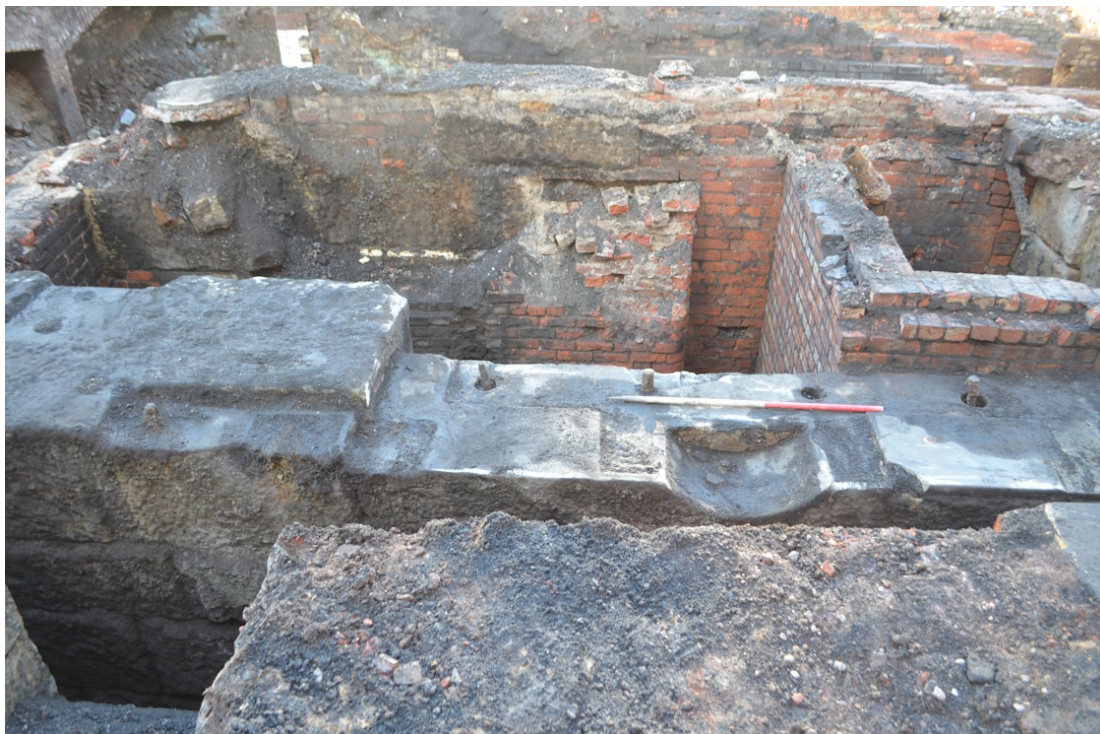
Illus 27. Detail of wall [94] in the Engine House showing the mounting for the flywheel and the possible second motion gear to the left. View looking east, scale 1 m.

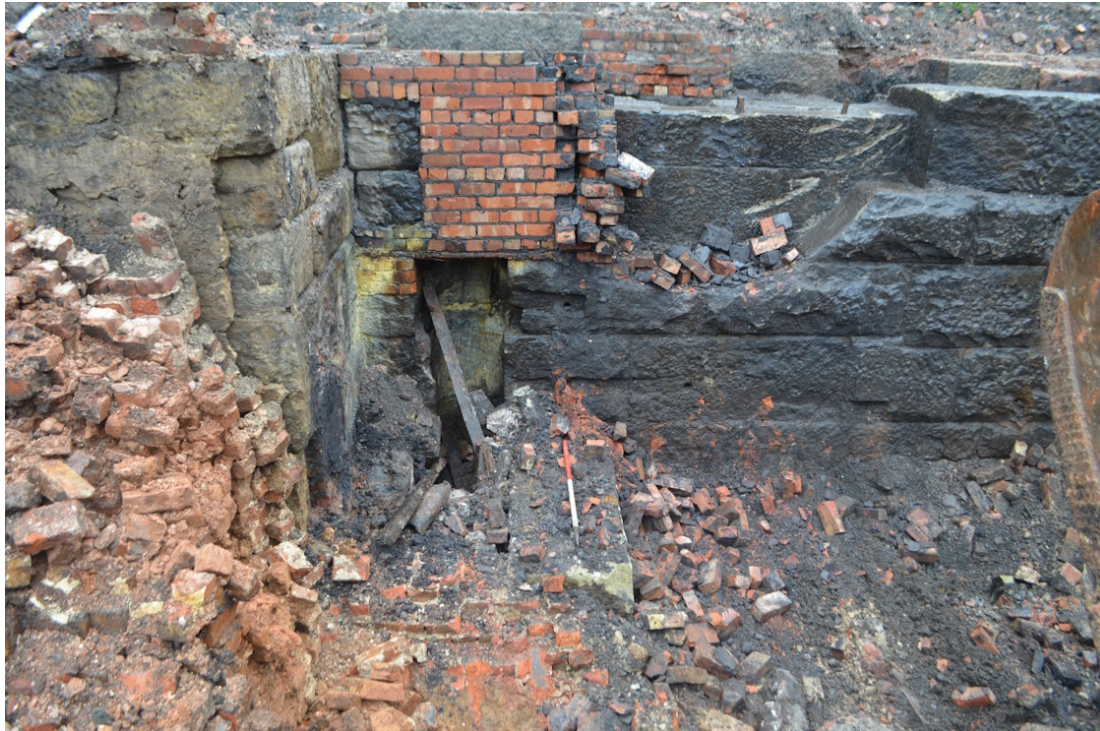
Illus 28. The Engine House during demolition showing the recesses for a water pump and flywheel gear exposed in wall [94]. The brickwork in the centre of the view is for a 20th century inspection chamber. View looking west, scale 1 m.

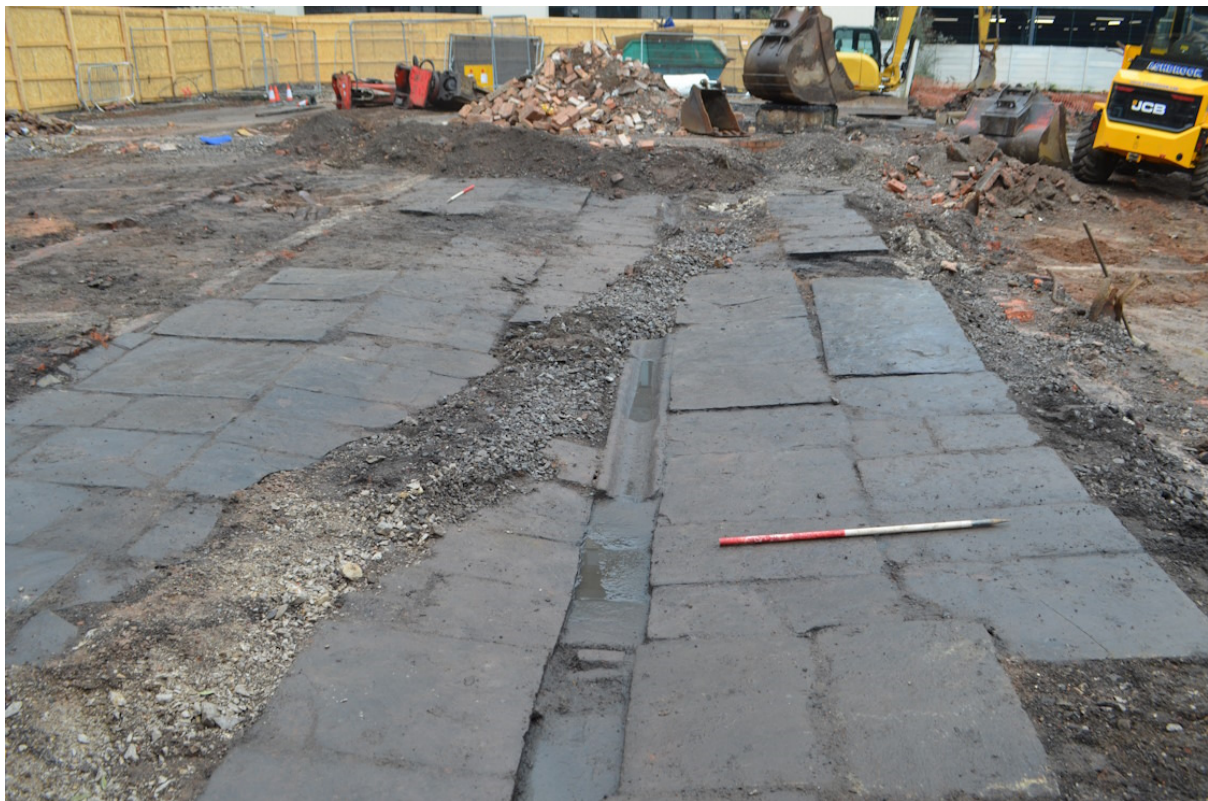
Illus 31. Flags surfacing Grey Place, note the drainage gully in the centre. View looking east, scale 1 m.

The road surface of Grey Place [20] survived well but was disturbed along its centre by a late 20th century service trench. It was paved with sandstone flags up to 1.25 m across which had been intentionally laid to give the street a V-shaped profile c. 0.2 m deep to allow surface water to drain into a stone gully at the base of the profile (Illus 31). No evidence was found for a central sewer, the drainage from the houses feeding directly into the factory drains to the south.

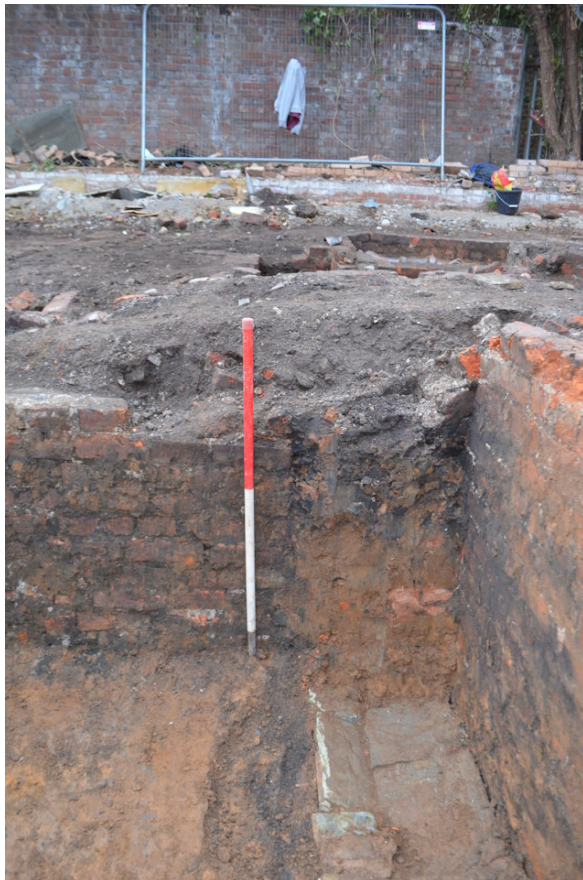
Illus 33. Gap between walls [33] and [37] for drain [41]. View looking west, scale 1 m.

Internal cross wall [32] was bounded on its southern side at the base by an east-west aligned flagstone capped brick-lined drain [41] (Illus 33) which ran through gaps between walls [33] and [37] and [34] and [36]. The drain had been buried beneath c. 1 m of infill and appeared to be an original feature of the back-to-backs with no evidence observed for a cut through [40]. This suggests that it was part of this phase and not a later, Phase 4, addition. Furthermore, walls [37] and [36] were constructed to the same depth and pattern, used the same mortar type as the walls to the north, and the northern terminals of [36] and [37] were neatly constructed so it seems likely that the gap used by the drain was an original feature of these houses.

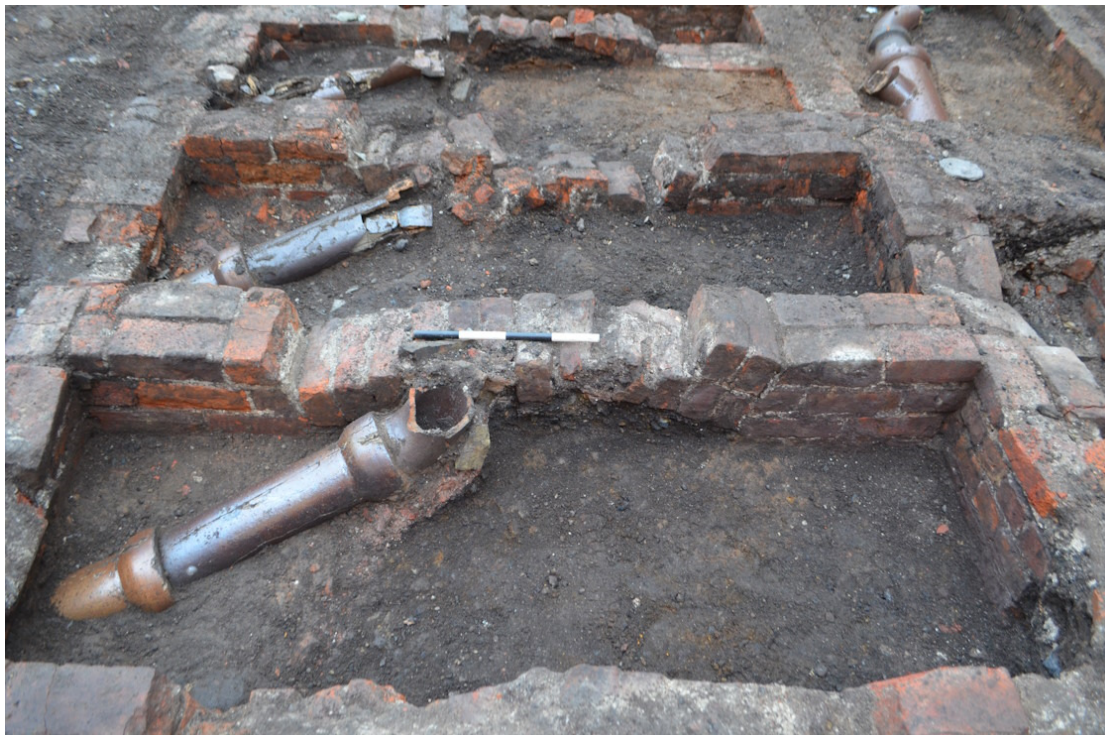
Illus 35. Detail of arched foundation [29] in the back-to-back housing.

Projecting internally from the internal north-south walls were a series of short buttresses, each 0.45 m long, spaced at 0.6-0.7 m intervals which defined a set of eight cubicles (more will have been present in the unexcavated area to the south) which correspond with similarly sized structures shown on historic OS mapping (Illus 6). Some pairs of buttresses were connected by a shallow arched foundation ([29], [30] and [31]) which rested on fill [23] (Illus 35).

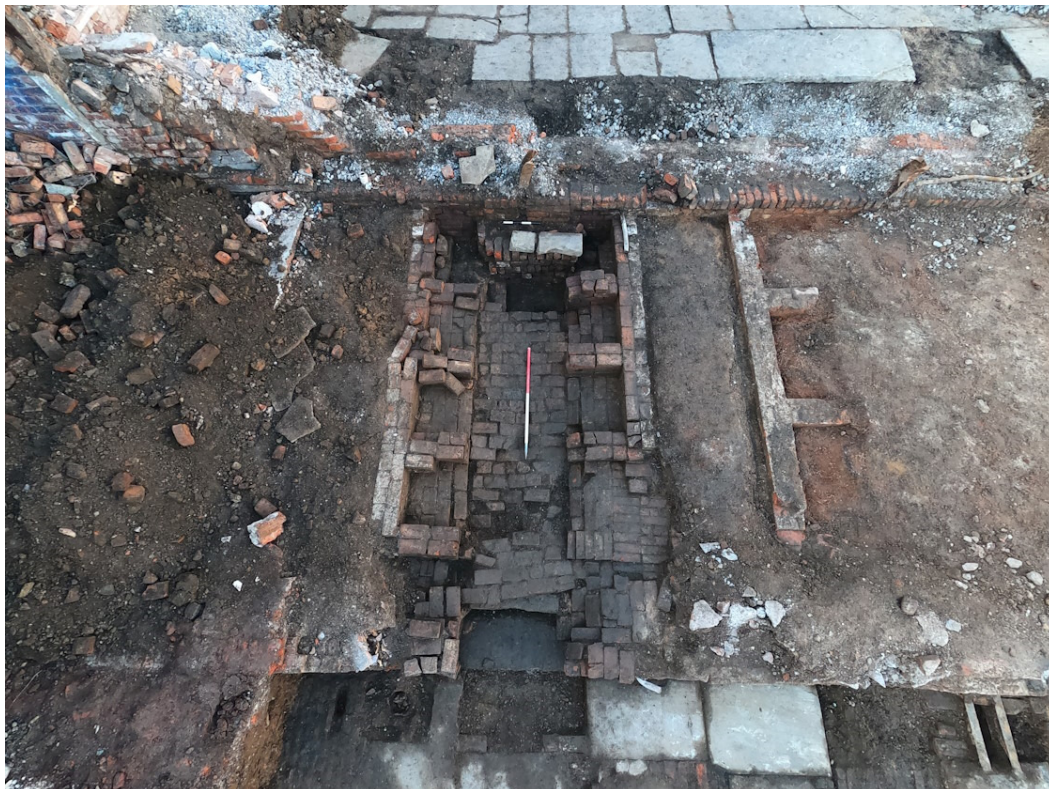
Illus 37. Overview of the toilet block [51] found with the blind back houses south of Grey Place. View looking north, scale 1m.

The toilets in this terrace [51] were constructed to a pattern broadly similar to those to the north, consisting of a range of 5 cubicles to each side (Illus 37), but differed in the details of their construction and the associated deposits. The foundations were much shallower than those to the north and there was a brick base not present in the northern range. There was no evidence for the drainage pipes seen to the north and the fill [52] around the brickwork was a loose brown coarse sandy silt with frequent brick and stone fragments markedly different to [23] and more in keeping with a demolition deposit. Fill [52] was also very similar to [53], the demolition deposit overlying the range of factory buildings to

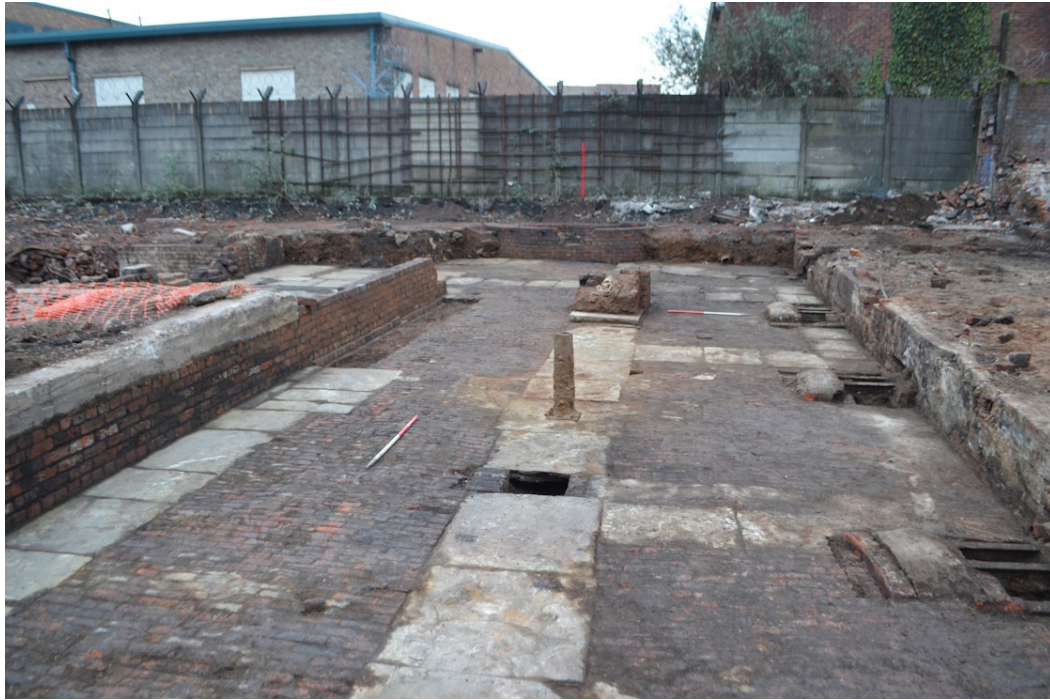
Illus 38. The factory extension looking east, a cast-iron pillar found in the demolition fill has been placed in the socket on stanchion [100]. View looking west, scales 1 m.

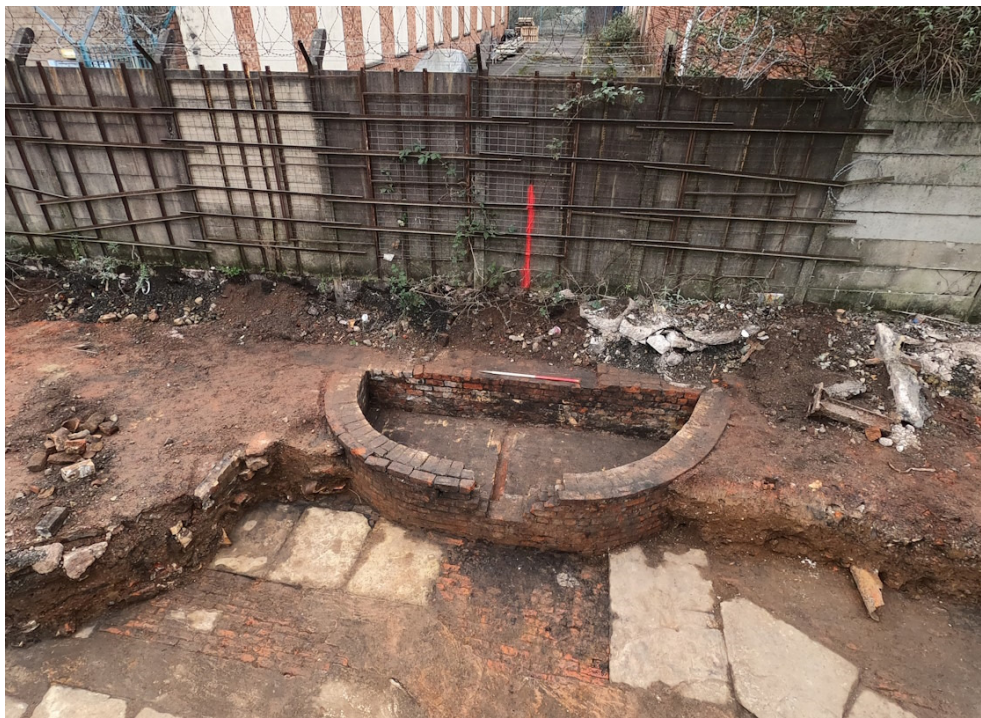
Illus 39. Possible boiler mount [54]. View looking west, scale 1 m.

A D-shaped (or possibly oval if it projected beyond the edge of the excavation) structure at the western end [54] was of uncertain function. It measured 4.60 m north to south and was at least 2.3 m wide and projected 0.70 m above the floor surface. Constructed in hand-made unfrosted brick it was lined with unfrosted firebrick, it was not clear whether it had been cut through floor surfaces [56], [60] and [66] and therefore a later structure, possibly part of another building, or if they had been butted against it and it was an upstanding part of this building. The neat finish to the external face of the brickworks suggests that it was the latter. Brick wall [55] which ran north-south across it may be a later addition.

Although the use of firebrick suggests an association with high temperature processes it is unlikely to be a chimney base. There was no evidence for a connection to a flue system and the foundations were only c. 0.75 m deep. It did not connect with the drains to its east.

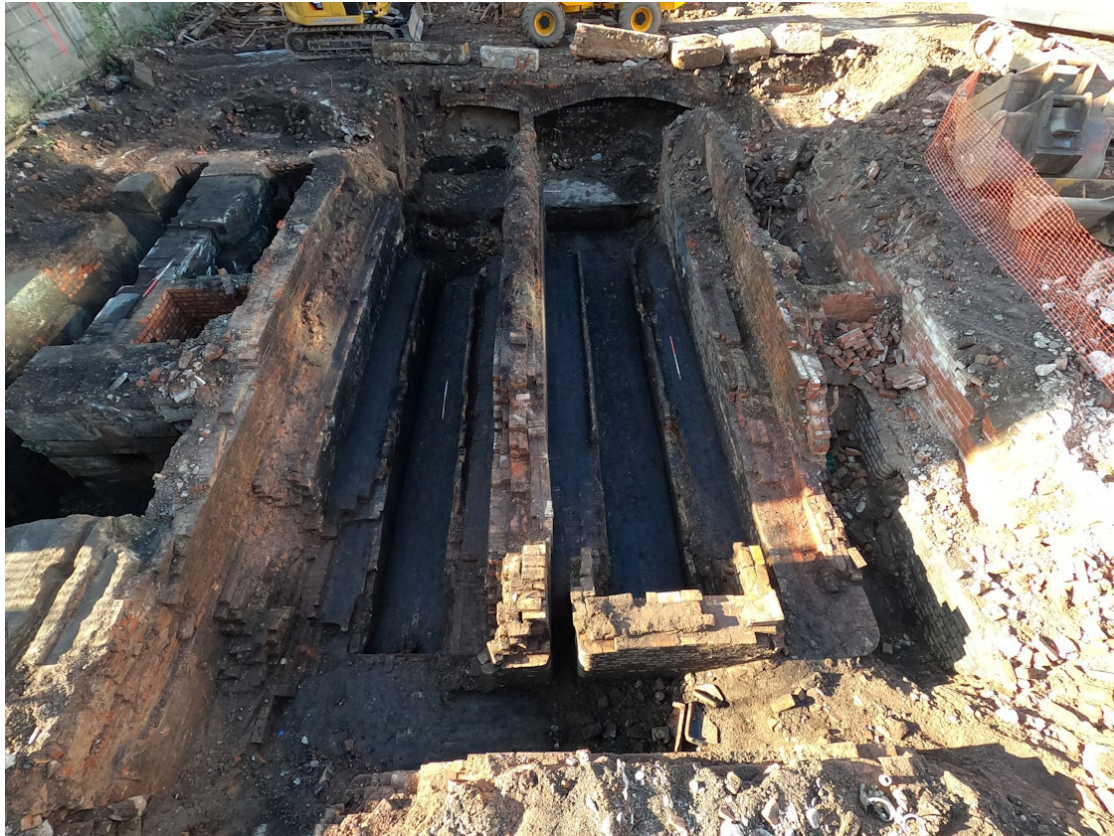
Illus 44. Overview of the Phase 3 Boiler House. View looking north, scales 1 m.

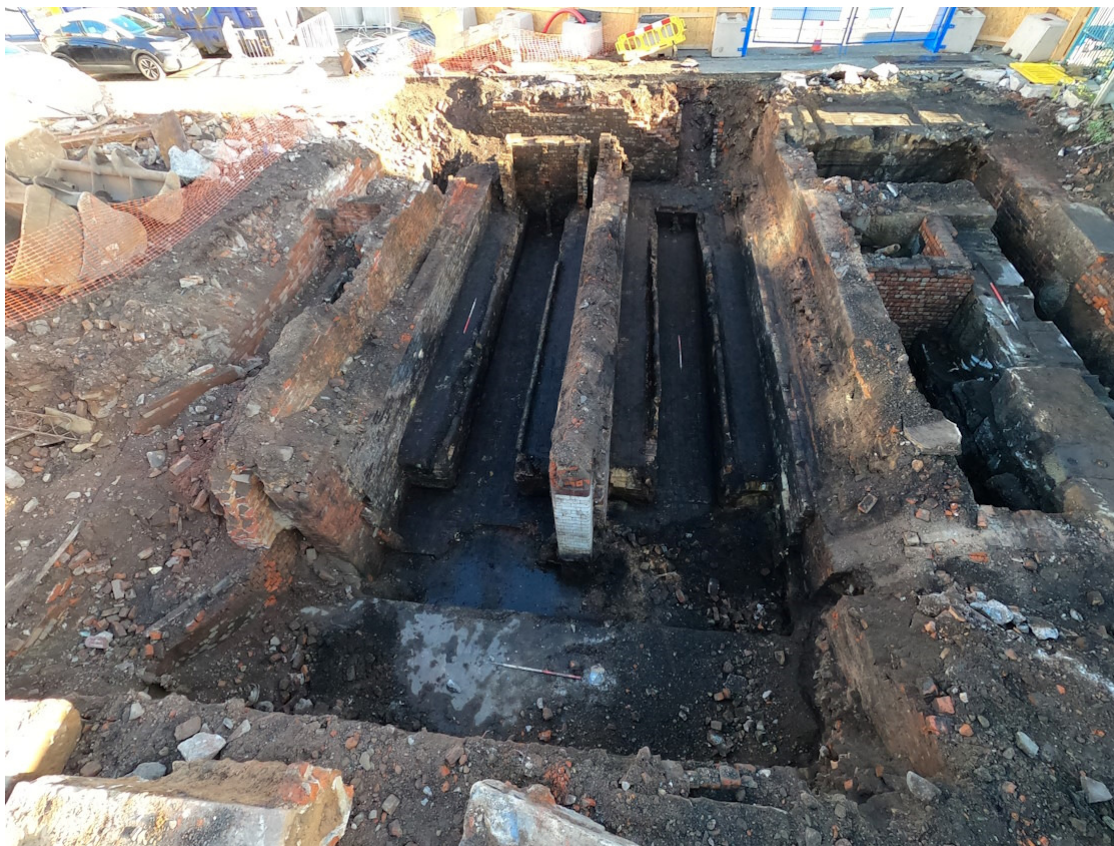
Illus 45. Overview of the Phase 3 Boiler House. View looking south, scales 1 m. The Phase 1 Engine House is on the right.

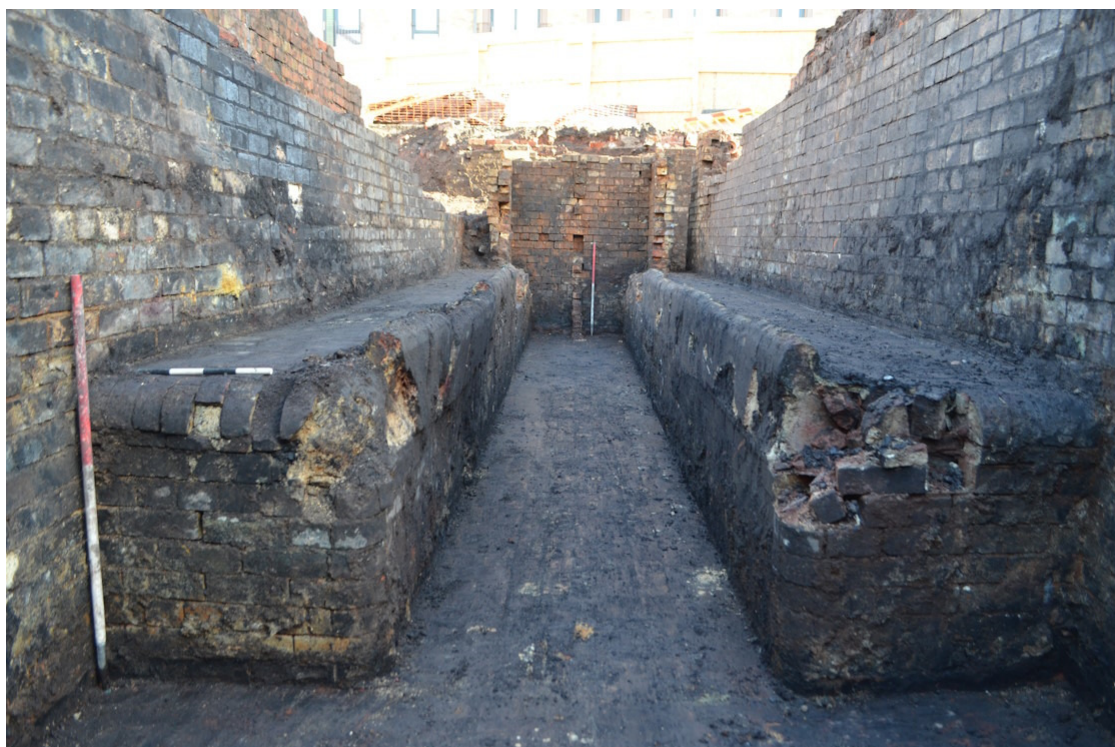
Illus 46. View along boiler bed [93] showing the mounting for the boiler. View looking south, scales 1 m.

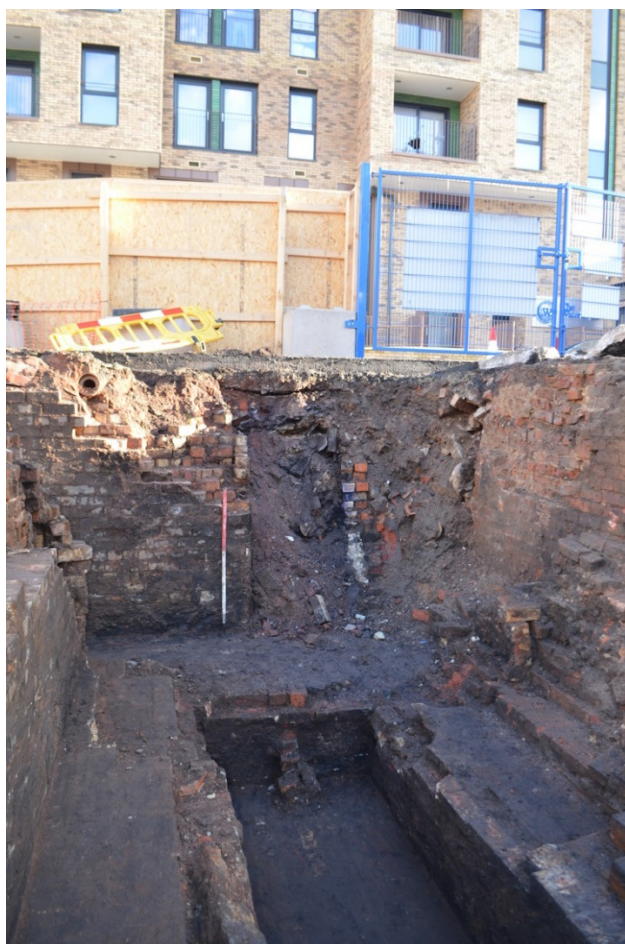
Illus 47. The truncated flue feeding the economiser visible in the southern edge of the excavation. View looking south, scale 1 m.
