Project Code: PFHO08
Planning application reference number: IN-08-239
Date of report: March 2009
Client: Tulloch Homes Ltd

Housing Development at Parks Farm, Inverness

Results of an Archaeological Evaluation

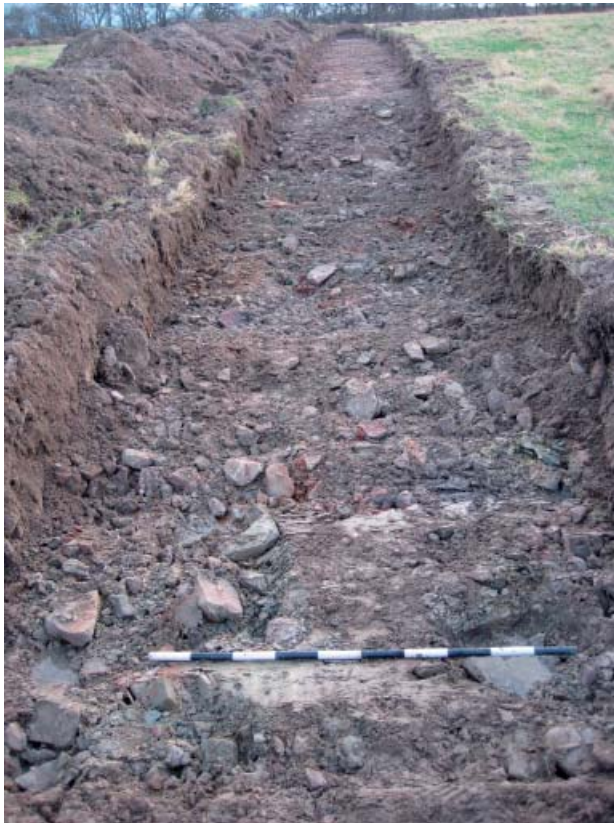
Illus 2
Trench 27

This field was located to the north-east of the steep wooded valley on a north-west facing hillside. Forty trenches were excavated within land parcels C (Trenches 41-43 and 46-59), D (Trenches 32-40 and 44-45) and E (Trenches 21-31). All trenches within this area revealed a similar stratigraphic sequence (**Illus 2**).

Subsoil was reached at an average depth of $\approx 0.40\text{m}$ below the ground surface. The subsoil was widely variable ranging from loose, light yellow brown sandy gravel to moderately compact, orange-brown clayey sand with medium to large stones and patches of shattered rock; interpreted as glacial till, as above. The glacial till subsoil was overlain by a $\approx 0.30\text{m}$ thick, mid-brown sandy silt topsoil.

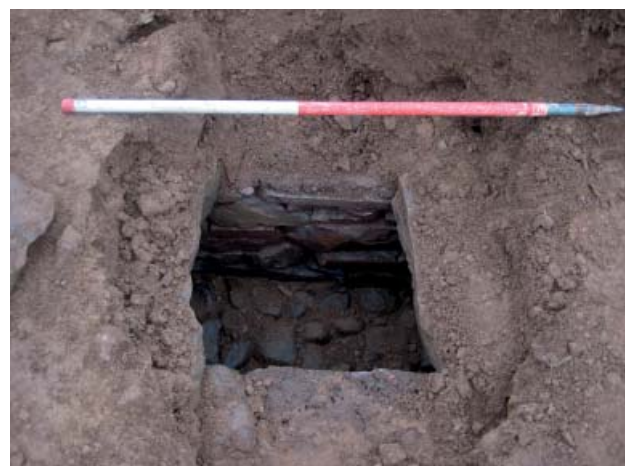
Illus 3
Stone-lined culvert [7]

The only archaeological features encountered within this area were two pits in Trench 21 and 28 (not illustrated) and a stone-lined culvert, seen in Trenches 51, 53 (**Illus 3**) and 57 (**Illus 1**). Several depressions filled with sandy silt were investigated and interpreted as non anthropogenic, geological anomalies.

Stone-lined culvert [07] was encountered at a depth ranging from 101-109m AOD and cut into the glacial

till underlying the topsoil. It was aligned NW-SE and measured ≈ 0.95 wide with a maximum depth of 0.70m . It was constructed of grey, unbonded rounded cobble stones ($\approx 0.30 \times 0.25 \times 0.5\text{m}$) capped with large stone slabs. The culvert was dry and contained small field stones at its base. Two small fragments of 19th century or later glass were recovered (not retained) in Trench 53.

The results of the trial trenching suggested that both fields within the evaluated area had been cultivated or improved for pasture by means of drainage. A stone-lined culvert, two pits as well as a number of land drains were investigated and it was concluded that they were of recent date. This was based on the finds recovered in association with the culvert and one of the pits (pit 6). The second

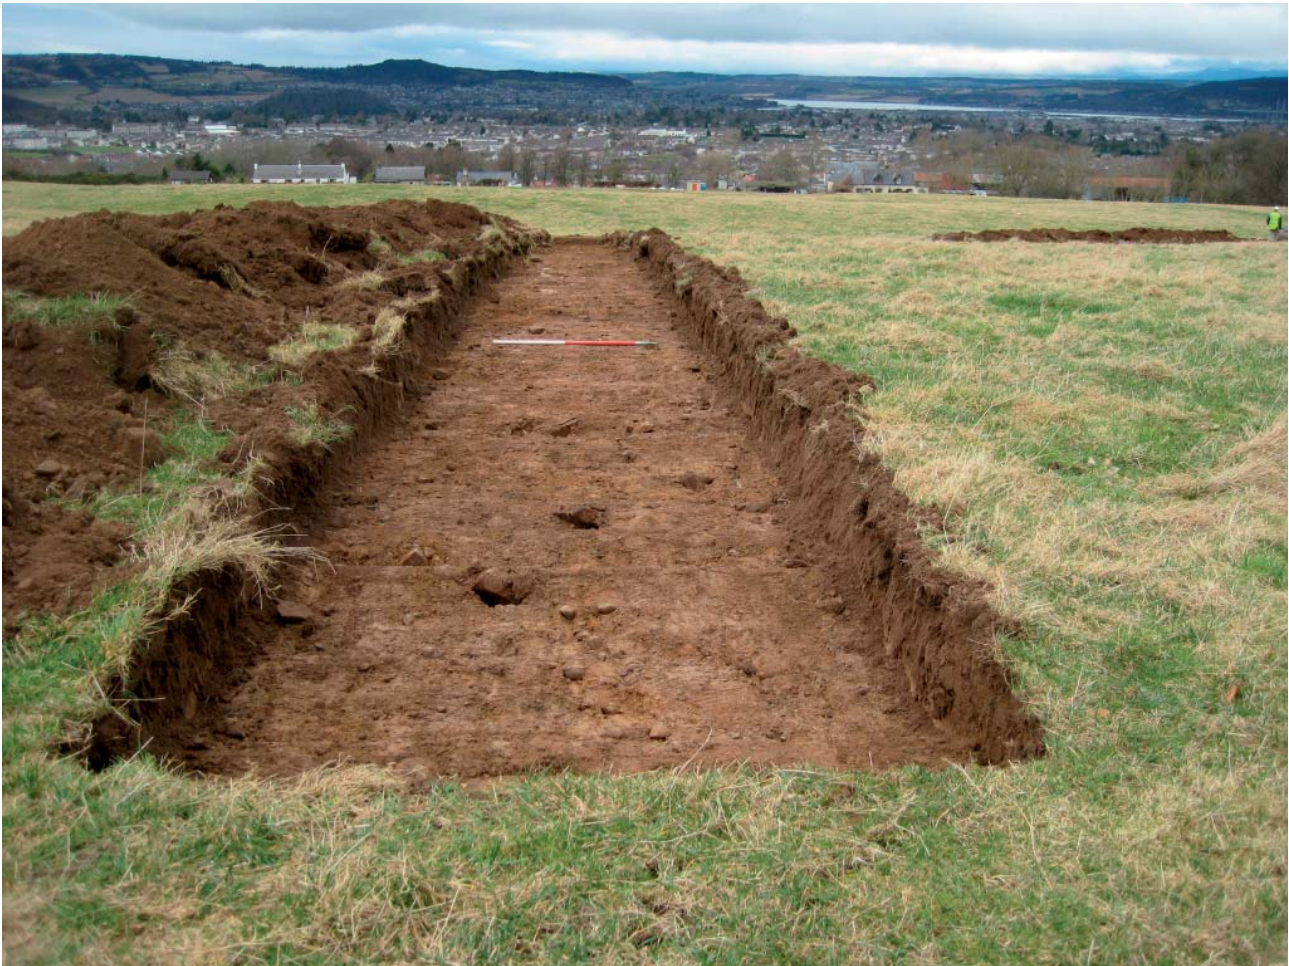
Illus 4
Trench 52

This field was located to the south-west of the steep wooded valley on a north-west facing hill. Twenty-five trenches were excavated within land parcels A (Trenches 73-85) and B (Trenches 60-72). All trenches within this area revealed a similar stratigraphic sequence (**Illus 4**). The undulating topography of the hillside ranged in height from 88m to 114m AOD.

Subsoil was reached at an average depth of c 0.30m below the ground surface with the exception of Trenches 78 and 79 located towards the bottom of the hill. In these two trenches, subsoil was located below deep colluvial deposits at a maximum depth of 1 m below the present ground surface. The subsoil was widely variable ranging from loose, light yellow brown sandy gravel to moderately compact, orange-brown clayey sand with medium to large stones and patches of shattered rock. The subsoil is interpreted as glacial till. In some trenches, the glacial till sub-stratum underlay a 0.15-0.35m thick layer of soft, light yellow sands of colluvial origin, immediately underlying the topsoil, which consisted of mid brown sandy silt.
