Project Code: MFWB09
Date of report: August 2009
Client: Benhar Developments Ltd

MOSSBAND FARM QUARRY, NEWARTHILL, NORTH LANARKSHIRE

Results of an Archaeological Watching Brief

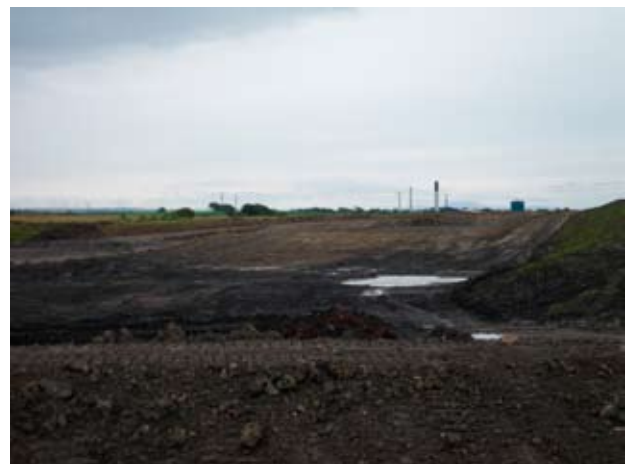
Illus 2

General shot of clay and ash deposits

The dumped deposits consisted firstly of a re-deposited orange/brown clay, with inclusions of crushed brick and modern ceramics, which appears directly under a thin layer of vegetation. This clay deposit covered a coarse black ash within the monitored area (Illus 2), as well as covering the natural dark grey clay within the quarried area to the east (Illus 3). The black ash deposit also contained modern ceramics, crushed brick, slag, metal objects and a large quantity of whole and broken glass bottles. These deposits were excavated to depths in excess of 1.2 m in places with no natural subsoil being encountered (Illus 4).

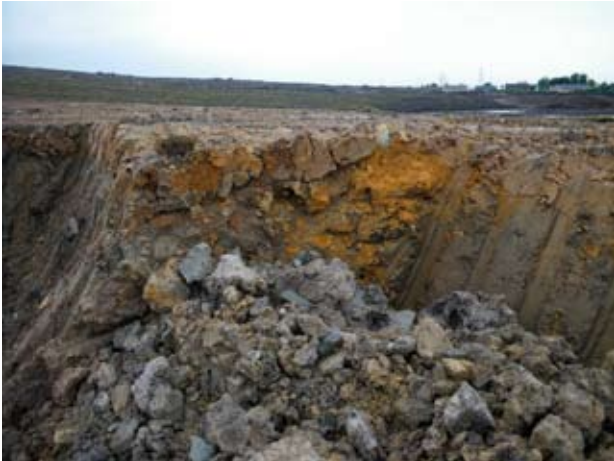
Illus 3

Shot of section showing brown clay on top of natural clay in quarried area

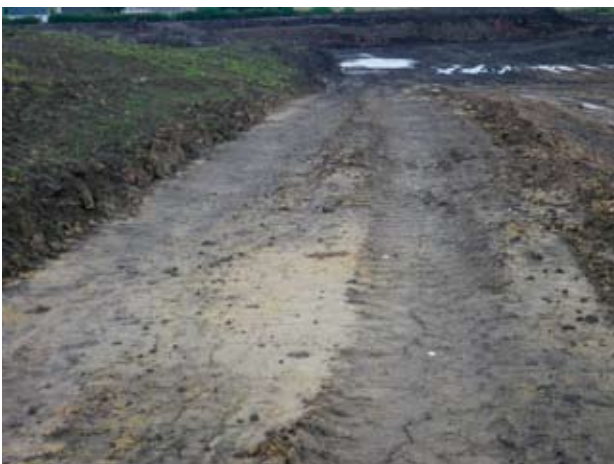
Illus 4

General shot showing depth of ash deposits
