Project Code: BCWK10
Planning Ref No: N/09/00172/PP
Date of report: March 2010
Client: The West Kilbride Community Initiative

THE BARONY CENTRE, WEST KILBRIDE NORTH AYRSHIRE

Archaeological Watching Brief and Test Pits

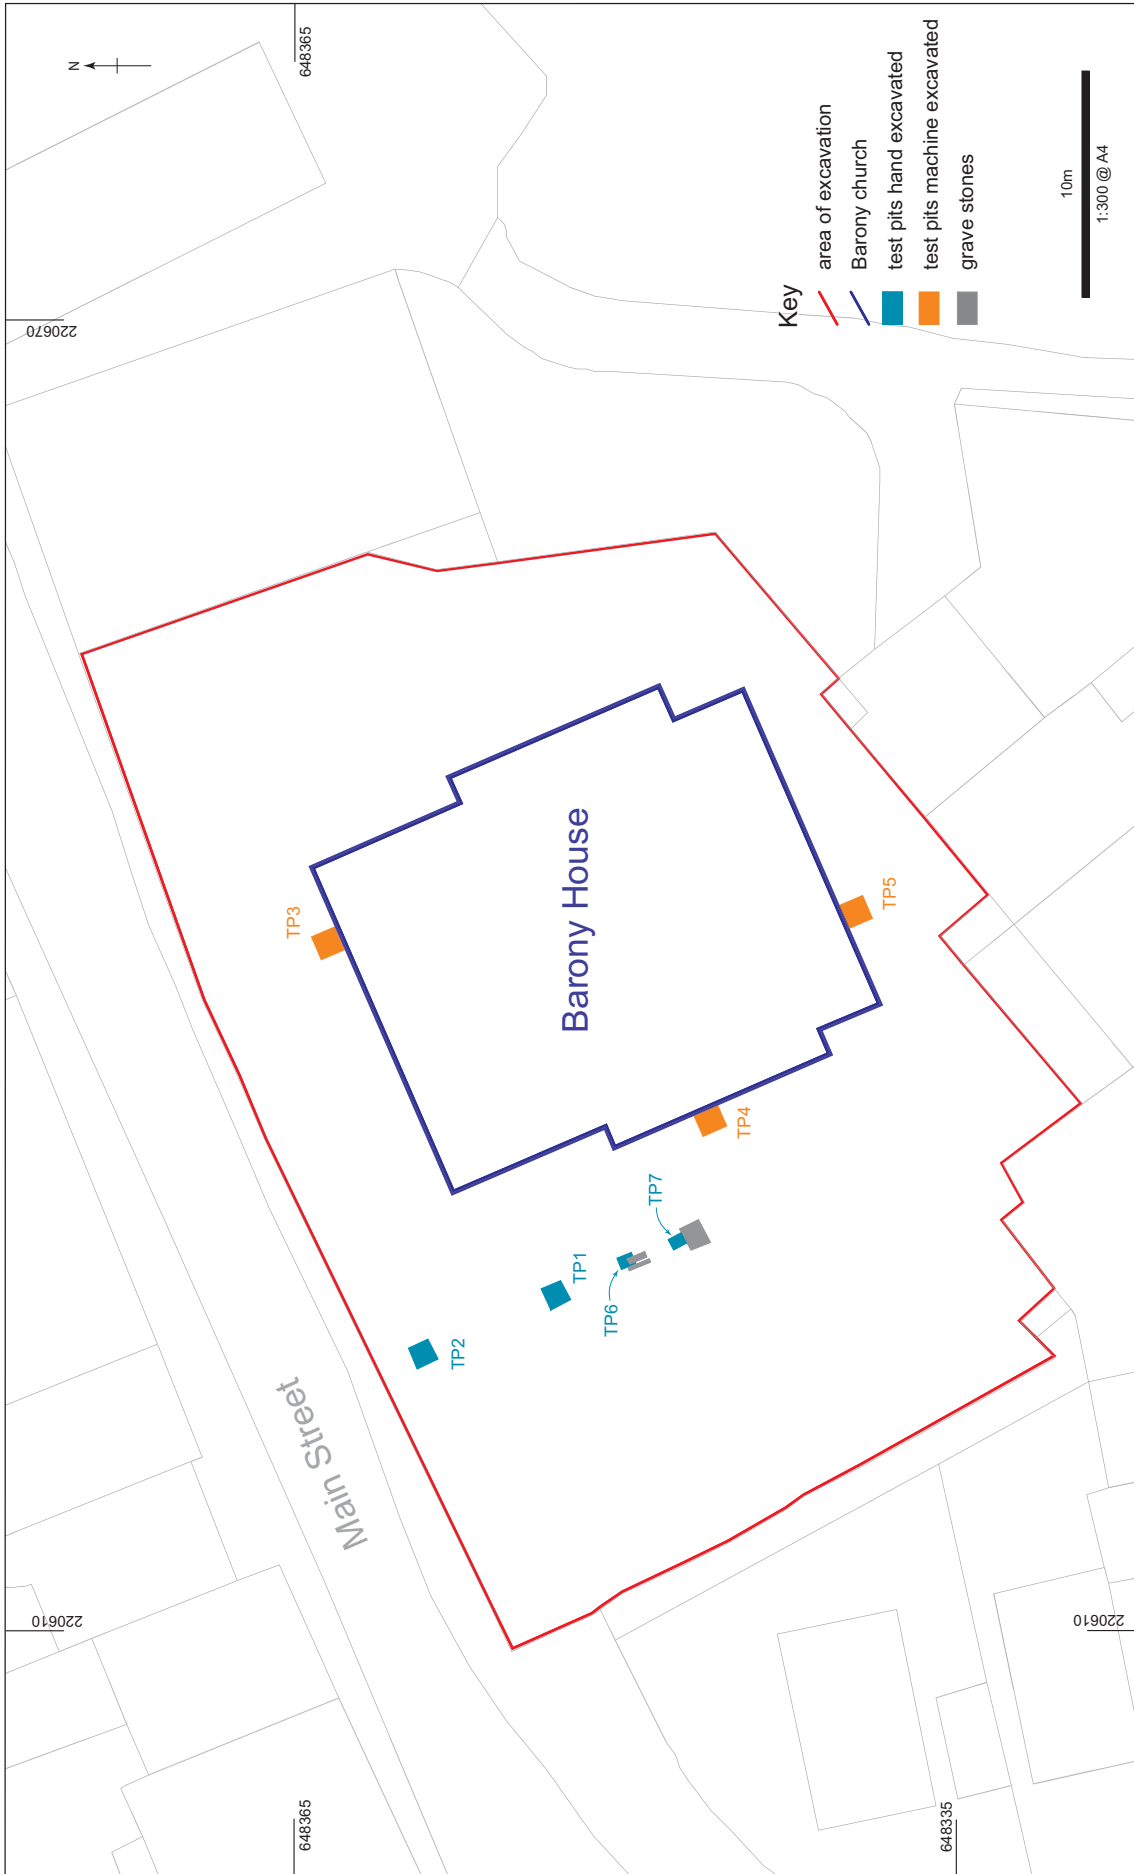
Illus 3
Plan of site showing church and test pits

Two 1m² test pits were excavated on the proposed line of the western wall of the extension on (see Illus 2). Test Pit 1 was located approx 3m south from the north-west corner of the building. Test Pit 2 was orientated over the proposed northwest corner of the extension. These were both excavated to a depth of 0.6m, with turf and topsoil retained separately for reinstating. Both test pits were fully recorded on trench record sheets and with full colour slide, b & w and digital photography. Each test pit was planned using an EDM which was mapped relative to Ordnance Survey datum.

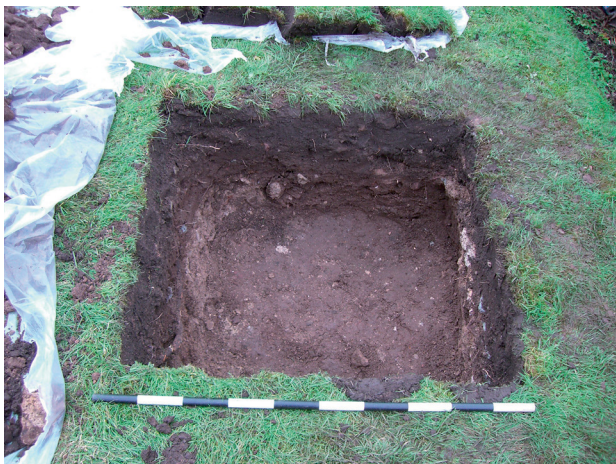
Illus 7
Photo of plan of Test Pit 1

in the WSI. Three clear deposits were identified, the lowest of which was a deposit of red sandy rubble, containing frequent sandstone fragments, occasional slate, mortar and unstamped brick fragments. Overlying this was a mixed brown sandy-silt deposit which included finer building material, which acted as a levelling material.

Uppermost being turf and topsoil (001). Some occasional disarticulated human remains, mainly phalanges (a few finger and toe bones) were discovered; however these were mixed in with building demolition material/ made ground.

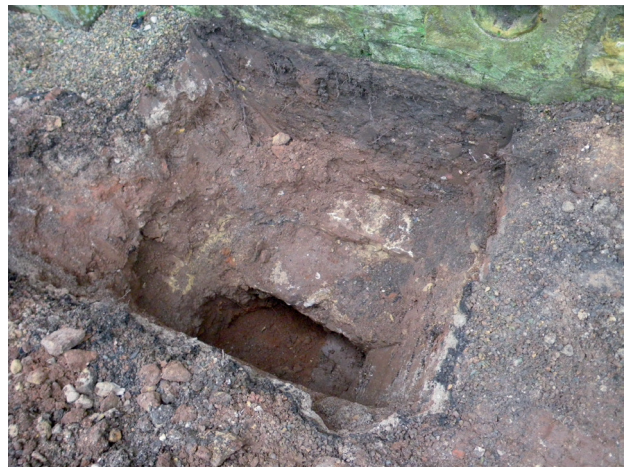
Illus 8
Machine excavated Test Pit 5, at south of church

excavated due to discovering a waste drain. All test pits contained similar material as those described in TP1 and TP2, mixed sandy rubble with frequent inclusions of sandstone, occasional brick and slate fragments. The deposits were more disturbed than those seen in the previous test pits, possibly as this is the backfill around the building.

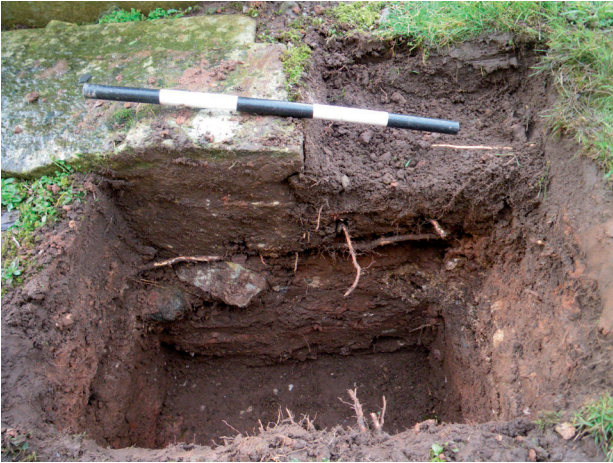
Illus 9

East facing section of Test Pit 6

encountered in test pits 1 & 2. The topsoil overlay mixed reddish sandy rubble (003) within which several fragments of human bone were discovered. These were identified in the field as small skull fragments, vertebrae and phalanges (finger and toe bones). Although both test pits included human bone within this deposit there were more fragments retrieved from test pits 7. This discovery is likely chance as the ground there has been more disturbed.

However, unlike the first test pits an extent of (003) was reached, at around 57–60cm deep. This rubble deposit overlay cleaner dark brown sandy silt (004) which appeared to resemble old topsoil/ typical graveyard soil. Deposit (003) was easily peeled from the surface of (004) and within test pit 7 slate fragments were found to be almost sealing (004).

The relationship of these deposits suggest that after the demolition of the previous church building, a significant amount of demolition material was generated – (003) then upcast over some of the existing churchyard to a depth of 60cm +. This was then turfed and some gravestones were possibly put back roughly in place.
