Project Code: BHWB08
Date of Report: November 2010
Client: West Lothian Council

DATA STRUCTURE REPORT OF ARCHAEOLOGICAL MONITORING AT BURGH HALLS, LINLITHGOW

A programme of monitoring was undertaken by Headland Archaeology Ltd at Burgh Halls, Linlithgow as a second stage of archaeological works being carried out during refurbishment of the building and construction of a rear extension by West Lothian Council. The garden area to the rear of the Burgh Halls affected by the extension lay within a Scheduled Ancient Monument (SAM No 90201). The first stage of work comprised Historic Building Recording and an evaluation in the garden that have been reported previously (Robertson 2007).

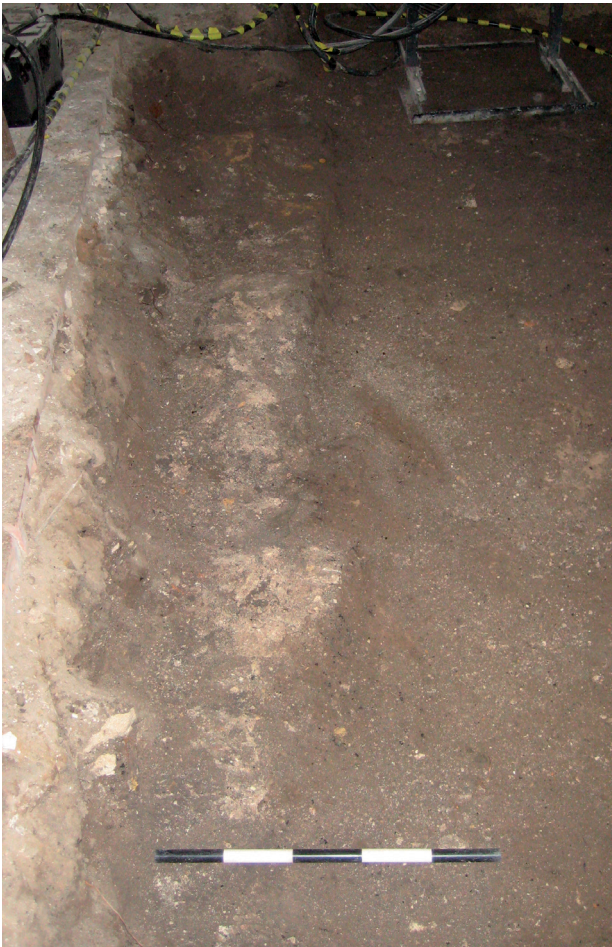
Illus 3
North facing shot of wall [145]

Within deposit [143] at the north western corner of the area, the top of a linear sandstone foundation [145] bonded by lime mortar was exposed at 0.6m depth (Illus 2 & 3). The wall foundation was at least 0.5m in width and aligned N-S, running adjacent to the current Burgh Halls' west wall,

but not parallel to it. There was no visible construction cut for foundation [145] in deposit [143], however the top of the feature was encountered at the limit of excavation and a full investigation was not possible. The upstanding wall of the current building had truncated [145] to the north.

archaeologically significant features and deposits survive beneath modern ground and floor surfaces. Internally, a buried loam mixed with rubble was exposed in the Upper Ground Floor area. This deposit contained some animal bone, indicative of household waste but also rubble and oyster shells, which may have derived from the construction of stone buildings (oysters were formerly used in the creation of lime mortar). A brass Jeton was recovered from the deposit, providing an earliest date of the 15th century for this activity. A foundation wall [145] identified in this deposit, on a different alignment from the upstanding west wall of Burgh Halls and cut by its north wall, represents the remains of an earlier structure. Presumably this could be late medieval in date, although it is difficult to be certain without better dating material. An increased concentration of rubble fragments noted to the west in the loam may reflect either building or demolition relating to a structure fronting onto Kirkgate. Certainly the alignment of the exposed foundation wall [145] closely matches that of Kirkgate.

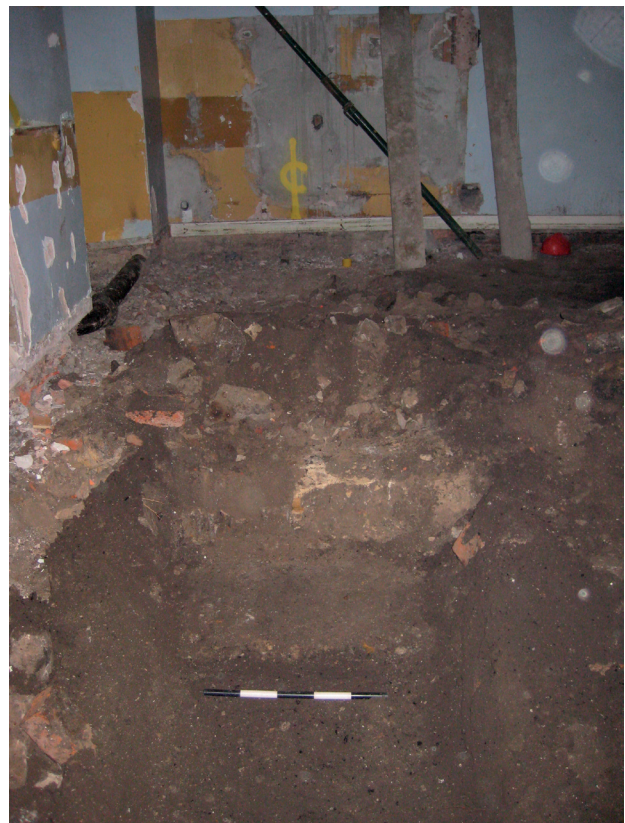
Illus 4
Wall [149]

Within the trench alongside the east wall, where excavations reached 0.8m depth, further sandstone foundations were revealed (Illus 2 & 4). Stepped foundation [149] was exposed 0.3m below the contemporary floor level, surrounded by deposit [143] with no construction cut perceptible. The 'upper step' was 0.3m wide and 0.3m

deep before the 'lower step' was reached on its north side, which was 0.57m wide and exposed to a depth of 0.2m before the limit of excavation was reached. Foundation [149] was aligned east-west but only exposed to 1m in length; it appeared to be bonded with lime mortar. The remainder of this wall was likely to have been truncated to a deeper level than the excavations reached elsewhere in this room.

A further foundation [149] recorded in the buried loam deposit in the eastern part of the Upper Ground Floor may also be the remains of an earlier, medieval, structure but was only partially exposed in a construction trench with no dating evidence associated. In the Lower Ground Floor, groundworks revealed two culverts which are likely to date to the construction of the County Halls in 1819–1821.

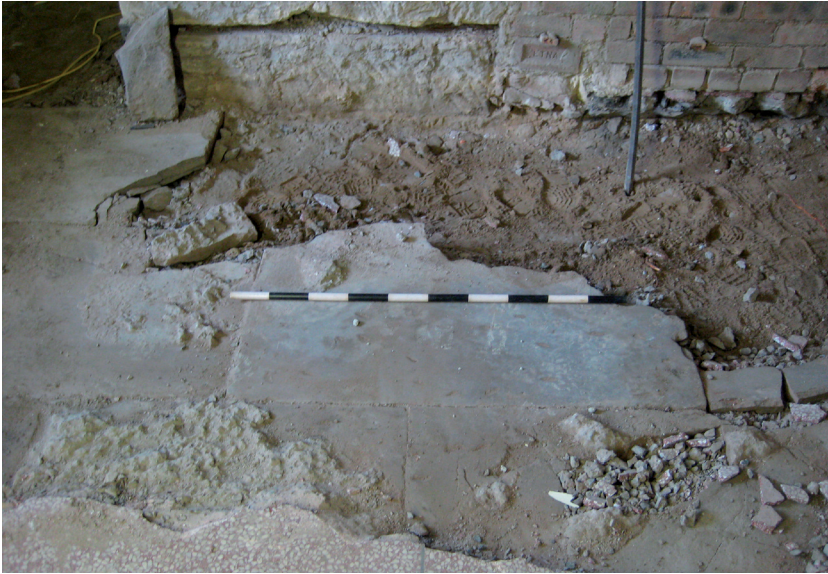
Illus 5
Flagstone flooring over deposit [143]

Overlying [143], [145] and [149] was loose stony make-up deposit [148], which was a maximum of 0.25m thick. This was sealed by sand bedding [146], which was 0.15m thick, upon which was set flagstone flooring [151], comprising rectangular slabs approximately 1.1m in length by 0.5m in width. The modern tiled floor had then been cemented directly onto flagstones [151] (Illus 5).

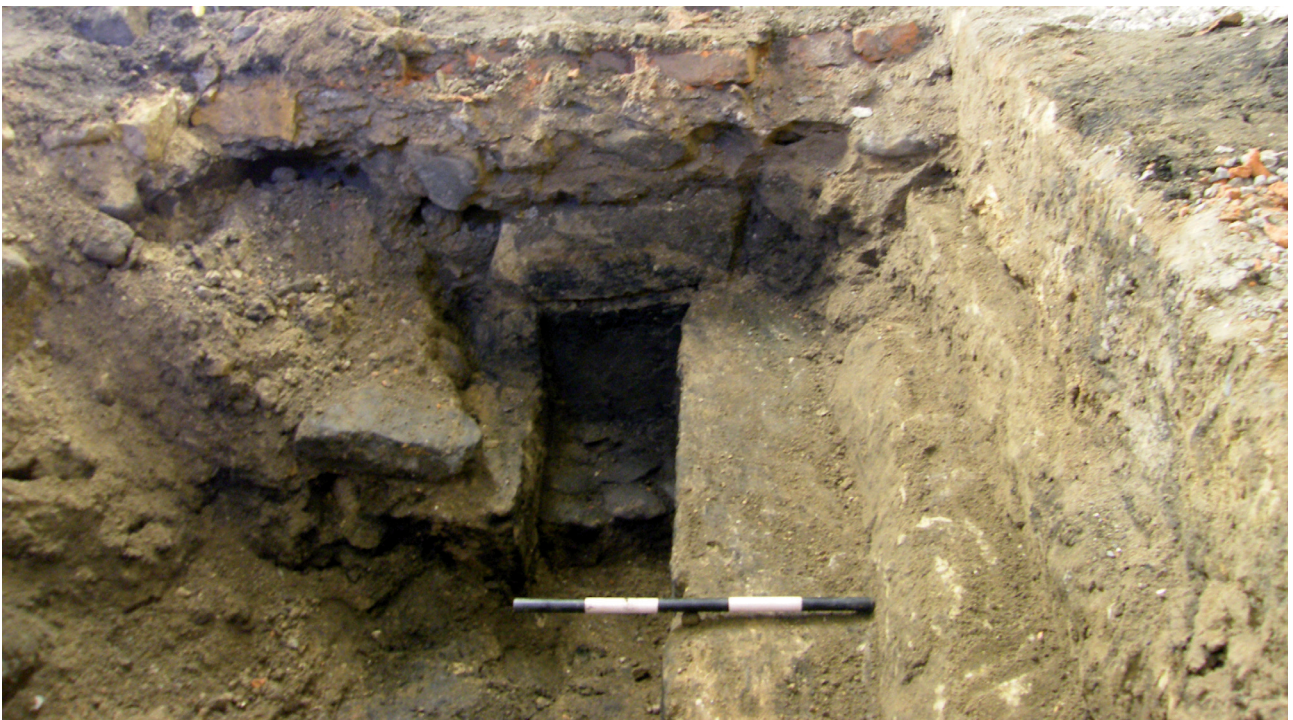
Illus 6
Culvert [147]

Excavations in a northeastern room to accommodate a lift shaft reached a depth of 1.75m below the modern floor surface. At the limit of excavation fine yellow sand was encountered. Although it was only exposed in a small area, it is likely to represent clean geological sediments. Overlying this was dark brown sandy loam [144] which contained frequent stones as well as oyster shell. Substantial sandstone foundations were encountered along the northern and eastern extents of the room, surrounded by deposit [144]. They corresponded with the upstanding north and east walls of the room; however at a higher level those walls are constructed of brick and this presumably represents a later phase of alteration to the Burgh Halls. The north wall foundation was stepped and had a stone culvert [147] running along its southern side. The culvert capping comprised stone blocks and was exposed at 1.2m below the contemporary floor surface. It was 0.22m thick and partially overlay the stepped foundations, which formed the culvert's north wall. The south wall of [147] was formed by rectangular stone blocks 0.3m wide and at least 0.46m deep, while flat stones lined the base. The interior space of the culvert

had dimensions of 0.3m width by 0.33m depth, and was completely filled by black silty deposit [150] (Illus 2 & 6). Culvert [147] extended eastwards, running beneath the east wall sandstone foundations.

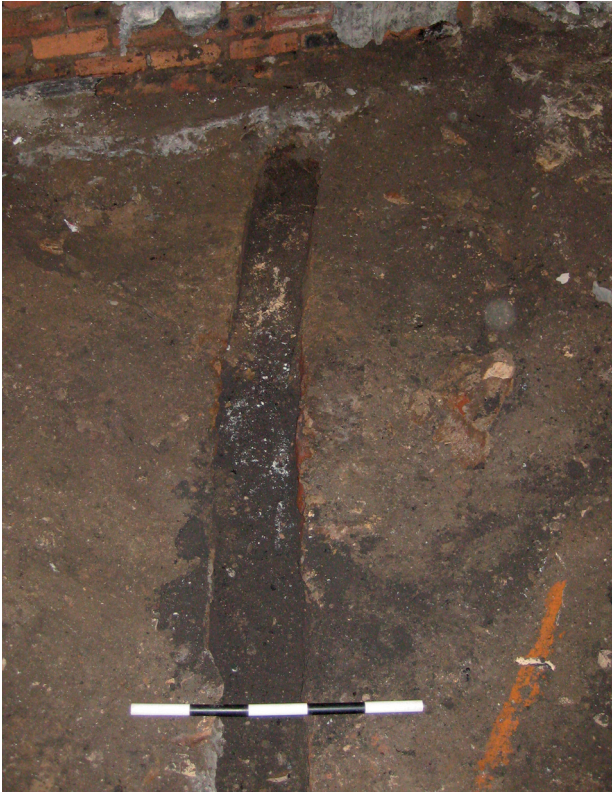
Illus 7
 Culvert [153]

In the former WC block, immediately west of the new lift shaft, excavations were carried out to 0.35m below the modern floor surface. A stone culvert [153] was identified 0.1m below the floor, aligned N-S. It was 0.22m wide and 0.14m deep (Illus 2 & 7). Culvert [153] cut dark brown mixed loam [152], which contained inclusions of rubble, ceramic drain and occasional oyster shell. No further deposits were encountered before the limit of excavation was reached.

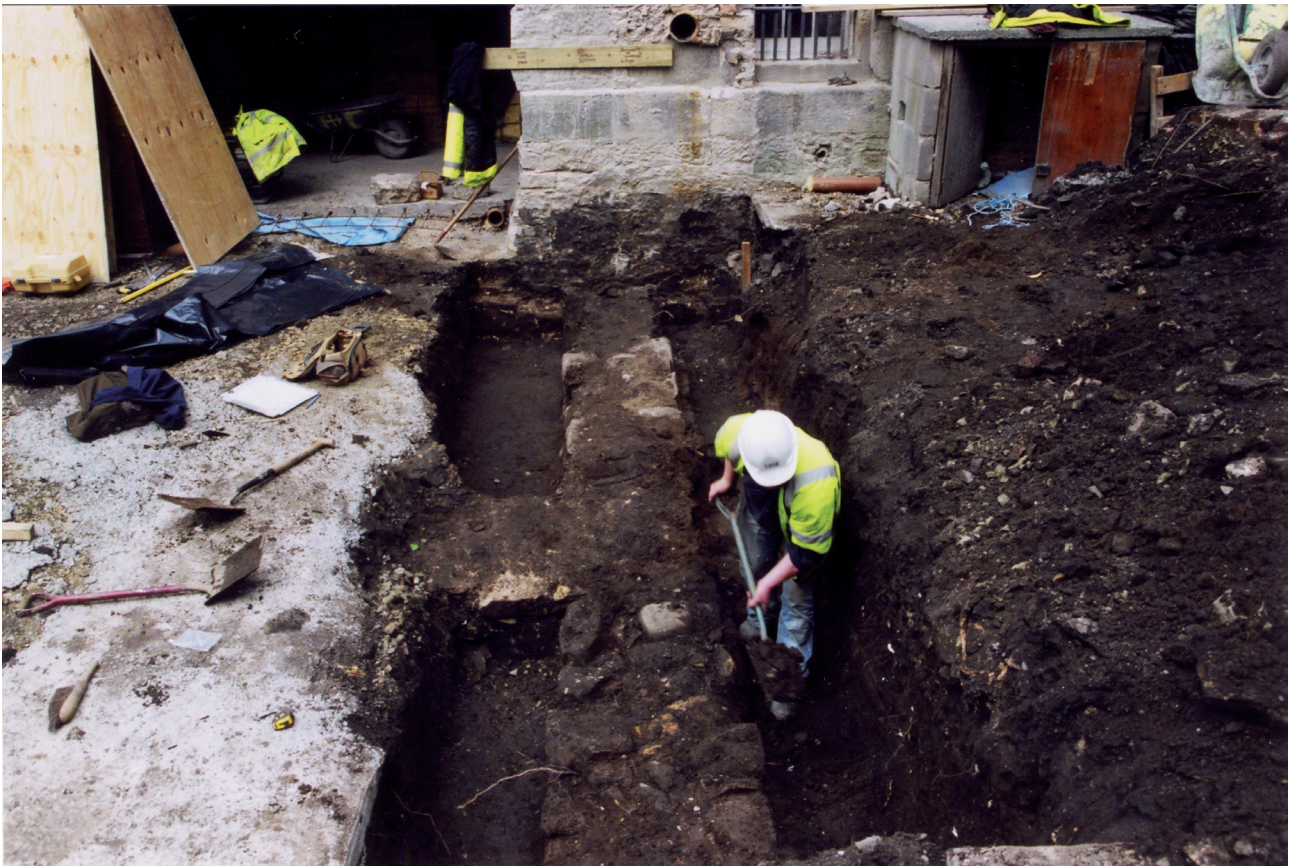
Illus 9

West facing shot of wall [102]/[104], with wall [103] extending southwards

recorded in the evaluation (Robertson 2007). A second, contemporary wall [103] was part of the same construction as wall [102/104] and extended south from it. It was 0.8m wide and exposed to a length of 1.3m. Again the base was not reached but a depth of at least 0.7m was recorded. Identical in composition to wall [102/104] and built firmly into it, wall [103] was faced on both its east and west sides

Sandstone wall foundations [102]–[104] were identified in the western half of the garden. The nature of their construction suggested that foundation [102/104] formed the northern external wall of a building with wall [103] forming an internal partition that created two basement rooms.

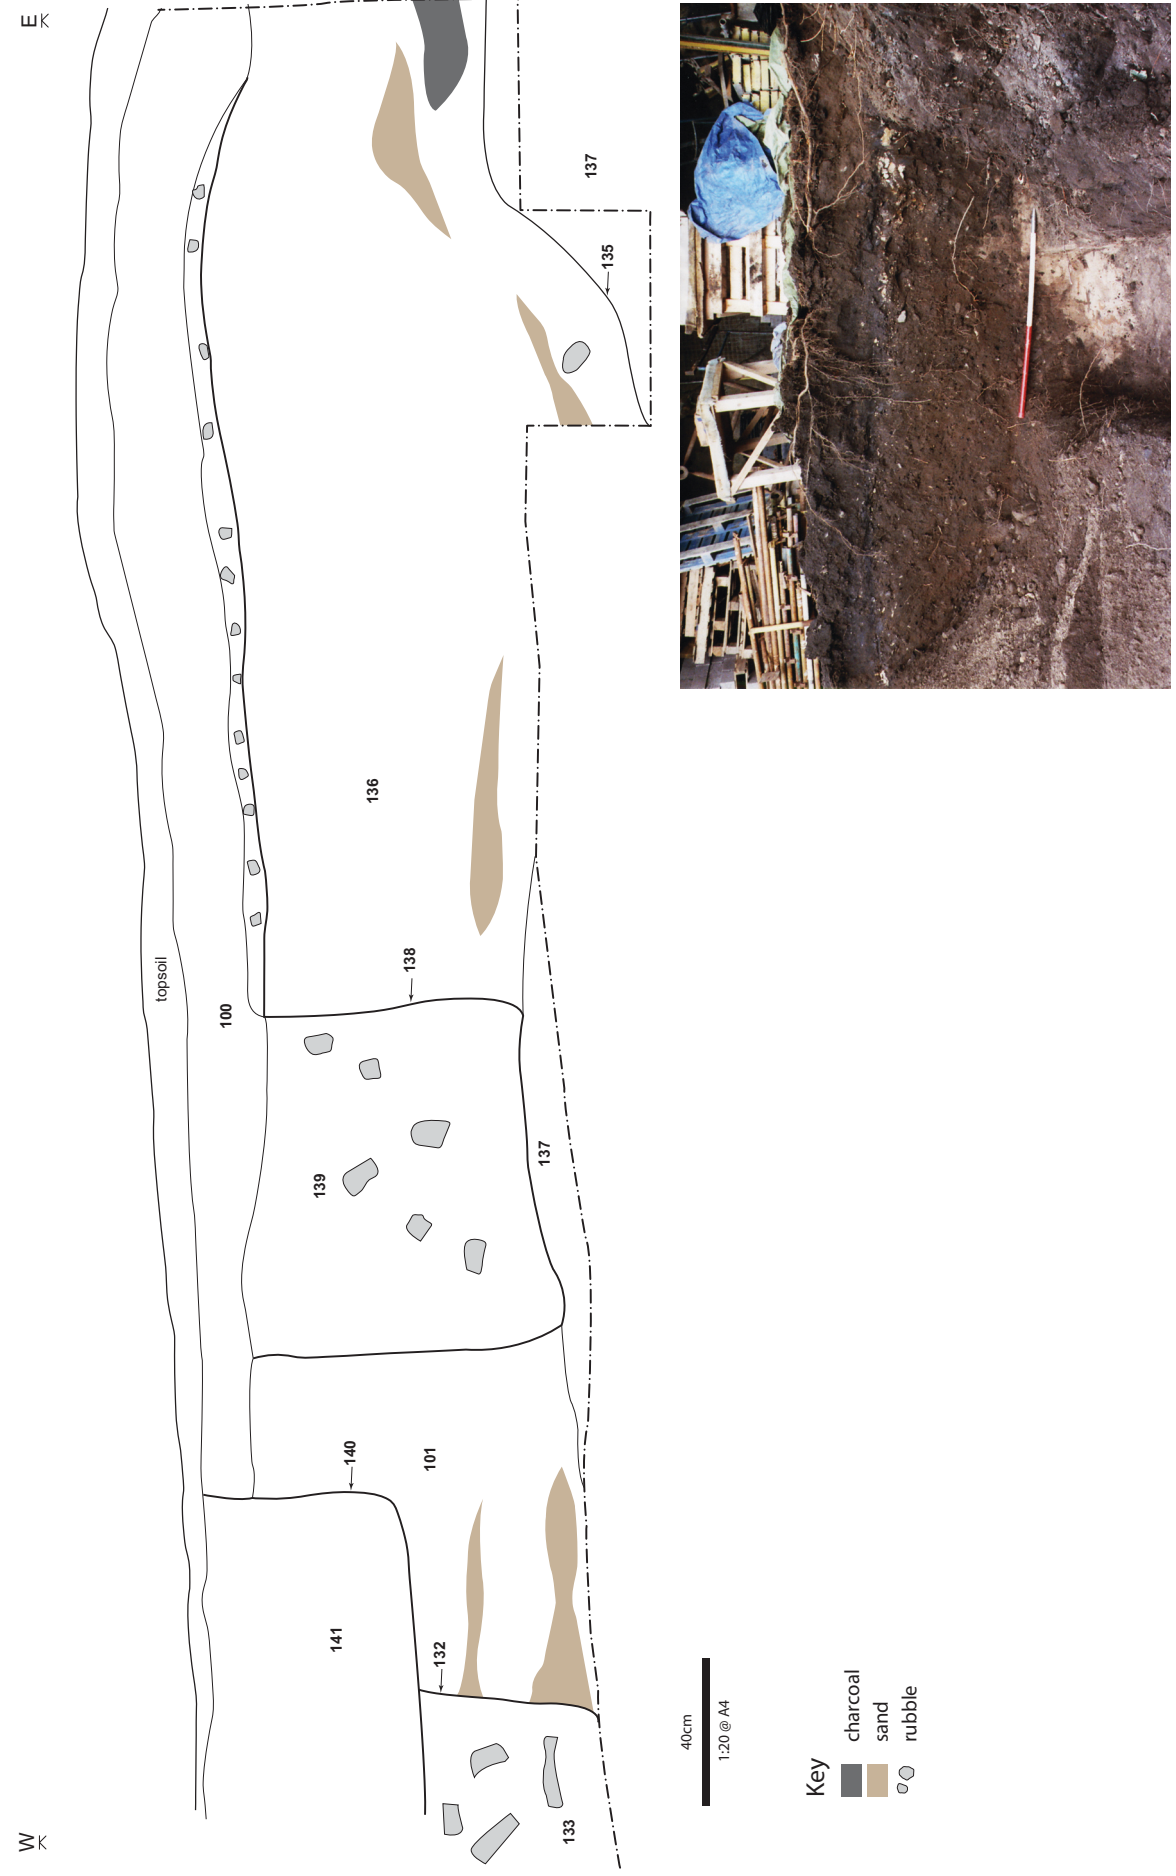
Illus 12
South facing section showing pits [135] and [138]

A trench excavated north–south down the east edge of the excavated area in the garden revealed pale yellow sand [137] at its northern end (Illus 12). It was identified at a depth of 1.1m below the contemporary ground level and was interpreted as a geological

deposit. The northern trench section partially revealed a feature cut into [137]. Cut [135] was at least 0.4m in depth with sloping sides and may represent a pit or ditch cut. It was filled by mid brown clayey silt [136] which contained frequent charcoal, moderate amounts of oyster shell and occasional fragments of green glazed and white ceramic pottery fragments that are dated to the 15th–16th century. Deposit [136] was 1m in depth and very similar in character to surrounding deposit [101]. Immediately west of [135], a second possible pit/ditch cut [138] was recorded in the trench section. Cut 138 truncated deposits [136] and [101] and was 0.8m deep by 0.9m wide. It was filled by greyish yellow sandy silt [139], which contained frequent stones and occasional mortar and charcoal fragments. The top of deposit [139] was 0.3m below the contemporary ground surface. Overlying deposits [101], [136] and [139] was modern deposit [100]. Two pits ([132] and [140]) to the west of feature [138] truncated deposit [101] and contained modern material.

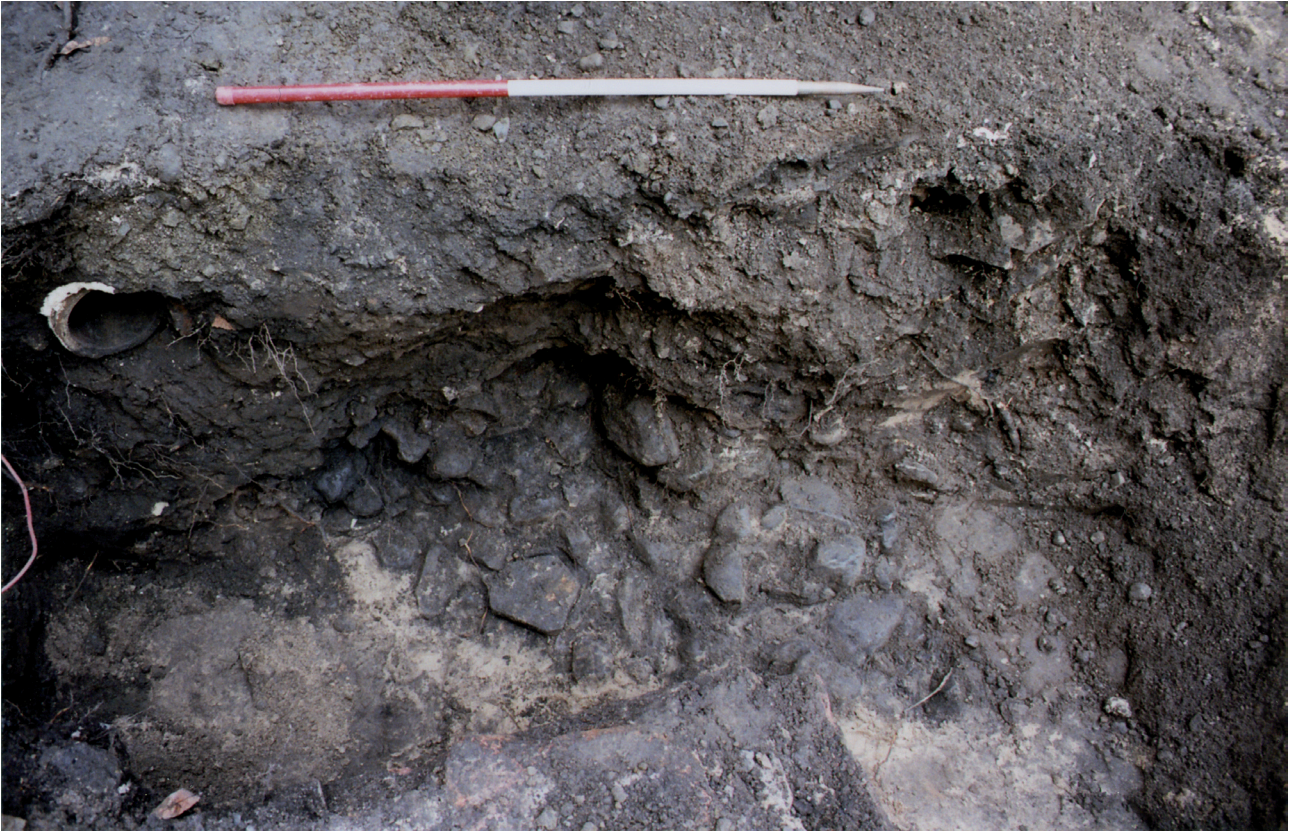
Illus 13
Remains of rubble wall [142]

A narrow foundation trench aligned approximately east–west in the northern part of the garden area of excavation exposed the remains of a rubble wall [142] (Illus 2 & 13). It followed a northwest–southeast alignment and was bedded into natural sand identified 1.1m below the contemporary ground surface. Wall

[142] was 0.7m in width, 0.3m in height and only uncovered to a length of 0.85m. It is likely to have extended further southeast but groundworks here did not reach the depth the wall was initially exposed at. The wall was of fairly crude construction, with no evidence of bonding material or worked stone and was overlain by a modern deposit [100].

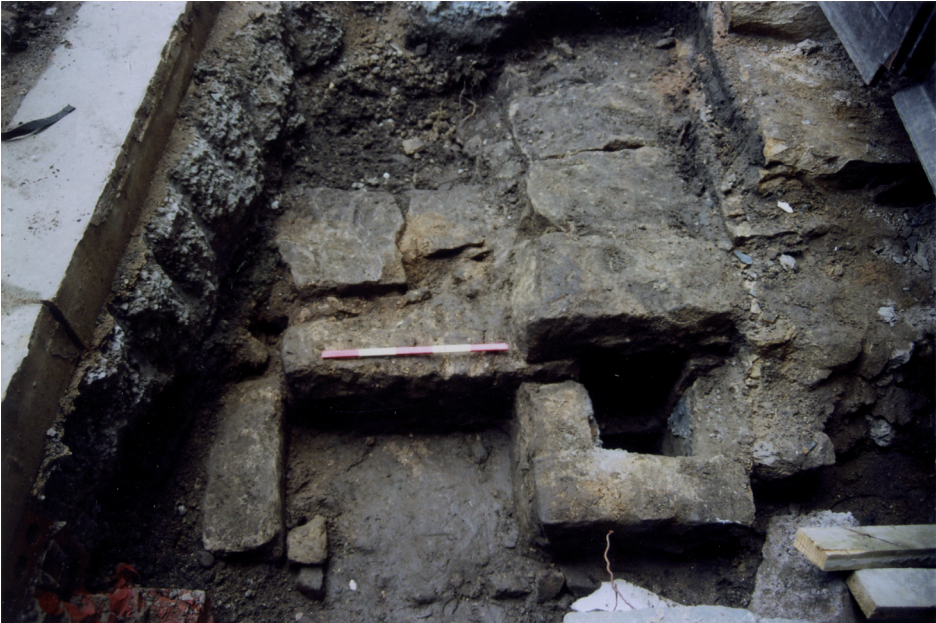
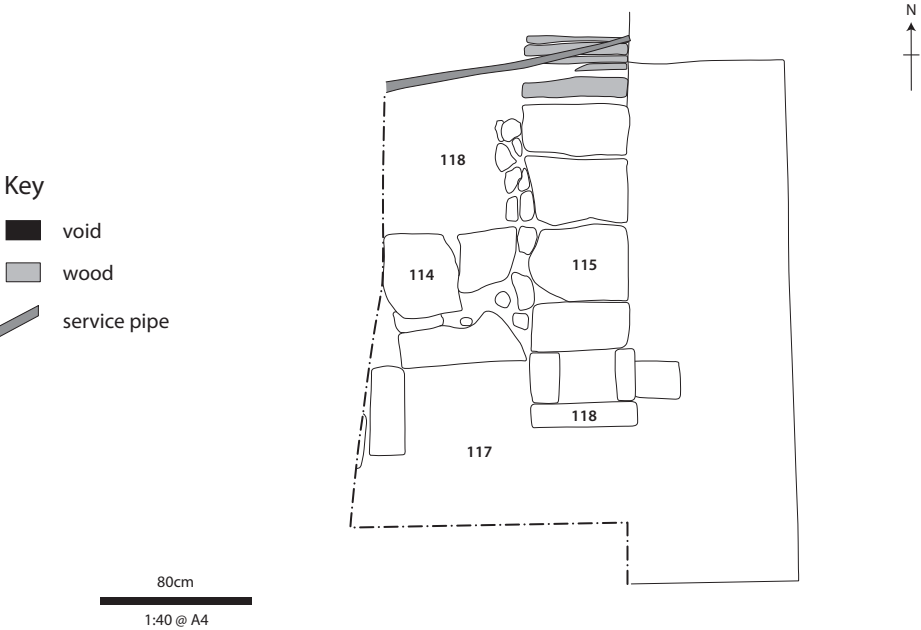
Illus 14
Wall [114] and culvert [115]

Culvert [115] was 0.25m wide, 0.4m deep and exposed to a length of 1.34m. Its east side abutted the outer west wall of the Burgh Halls. Stone structure [118] abutted the southern end of culvert [115]. Structure [118] was C-shaped in plan and formed a terminus to the culvert. The internal void was 0.5m in length by 0.4m wide and dropped vertically 1.9m. Although unable to be fully investigated, it was noted that the north side of the vertical shaft of [118] was walled to a depth of 1.2m, before a further void was encountered. Culvert [115] contained ashy, sandy silt [119]; in which were occasional animal bone fragments. A thin deposit of crushed mortar [122] overlay culvert [115] and deposit [116]. It was 0.05m thick and contained small rounded stones. Mortar [122] was sealed by a 0.06m lens of grey-white ash. Over this was dark brown, sandy clay loam [120], containing tree roots and occasional charcoal and round stones. It was 0.1m thick and located 0.37m below the contemporary ground surface. Deposit [120] was overlain by a layer of modern hardcore.

At the western entrance of the Burgh Halls, another sandstone wall foundation [114] is likely to pre-date a

deposit containing 16th–17th century finds and this may also relate to a medieval structure. Although only a short stretch of this wall was exposed its alignment and build appeared to match that of the late medieval walls in the garden. It had a slightly smaller width but it was also well-built and bonded with lime mortar. It is possible that this foundation and those in the garden and Upper Ground Floor may all relate to the same, substantial, late medieval structure. However, it is also close to the line of a historic property division (on the line of the current southern garden wall) and it may well have related to a building in another property entirely.

The culvert [118] noted on the east of wall [114] post dated its construction and is likely to relate to the building of the County Halls. The vertical shaft associated with feature [118] may be associated with the culvert and perhaps heads towards a deeper drain.

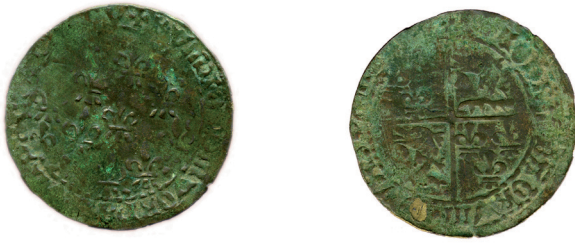
Illus 15

animal bone fragments. A brass jeton or merchant's trade token, dating to the late 15th century, was also recovered from [143] (Illus 15). There were frequent inclusions of rubble in the deposit- with a notable increase in rubble fragments in the western half of the deposit compared to the east.

Late 15th C. Brass Jeton recovered from deposit [143]

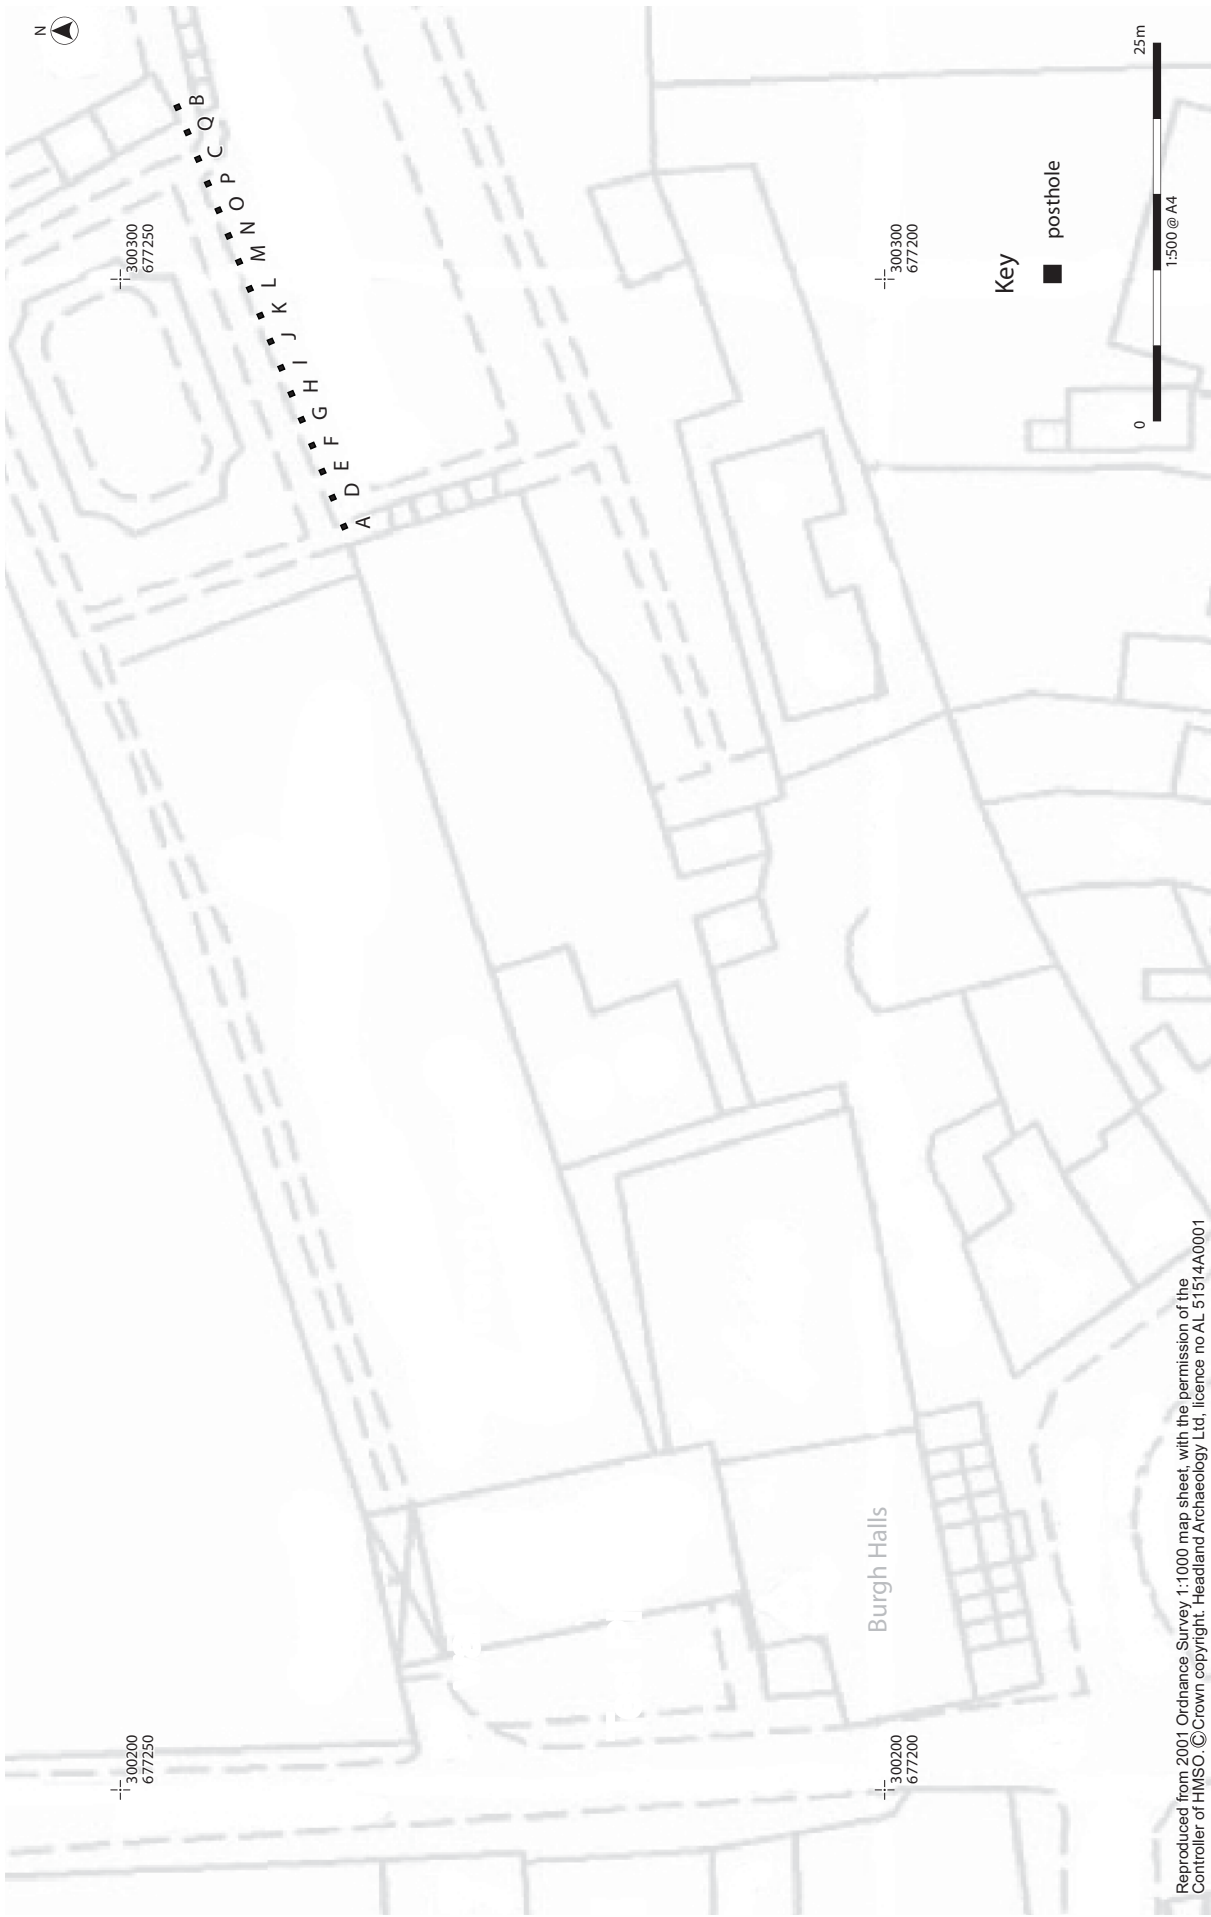
Illus 16
Location of postholes monitored in April 2011

Within posthole A and postholes D through to K, the topsoil lay above pale yellow sandstone, interpreted as a possible wall foundation, which measured 0.2m in depth. Below the topsoil, within postholes M to P and in posthole C, a layer of mixed concrete, red brick and fragments of wood and slate with a depth of 0.38m was encountered. This was interpreted as a possible surface, or again, a foundation. In both cases, the interpretations offered here are speculative as only a small area was visible. However, the postholes are located on a boundary (Illus 16) and a likely location for a former wall.
