Project Code: RME07
Planning Ref: 06/02788/FUL
Date of report: June 2010
Client: National Museums Scotland

DATA STRUCTURE REPORT OF ARCHAEOLOGICAL WORKS IN THE ROYAL MUSEUM OF SCOTLAND

Address ROYAL MUSEUM OF SCOTLAND, CHAMBERS STREET, EDINBURGH

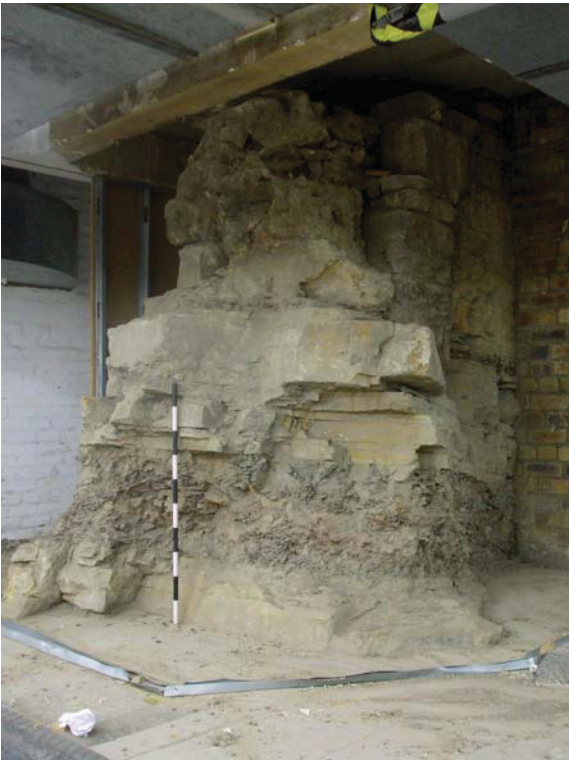
Illus 8
Flodden Wall in Area B

The base of the Flodden Wall in area B was approximately 1.3m above the surrounding floor level. It sits on and had been built onto sandstone bedrock. The wall reaches a

maximum height of 1m and is 1m in width. Aligned east-west, it consists of north and south facing outer layers of dressed sandstone blocks with typical dimensions of 0.5x0.4x0.3m, and bonded by light brown lime mortar. Between the faces is an inner core of unworked stone and mortar, 0.3m in width. A modern brick support for the floor above has been cemented onto the east end of the wall.

The three upstanding sections of the medieval Flodden Wall, which had survived the later construction of the museum, were found to be in a good state of preservation despite some modern alterations especially evident at location B. These sections of the Wall have been preserved *in situ*.

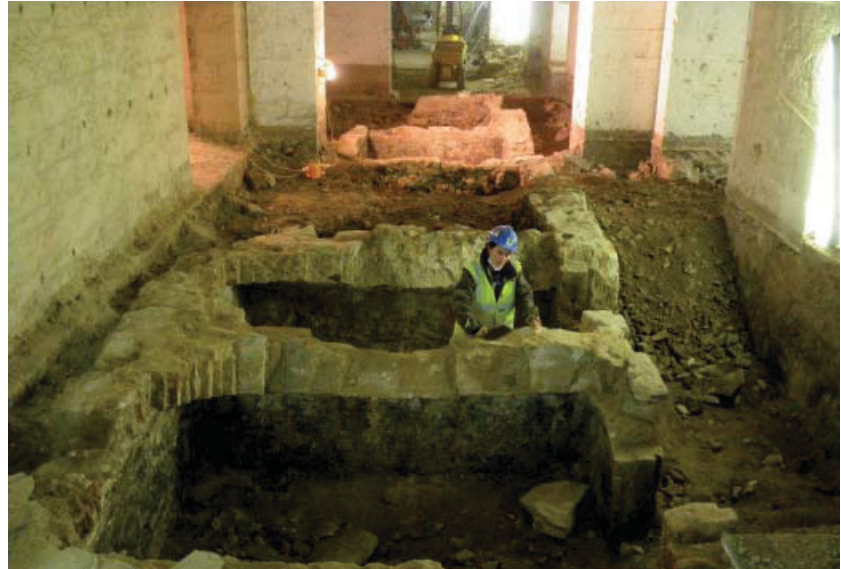
Illus12

East facing shot of vaulted basements in cellar 4

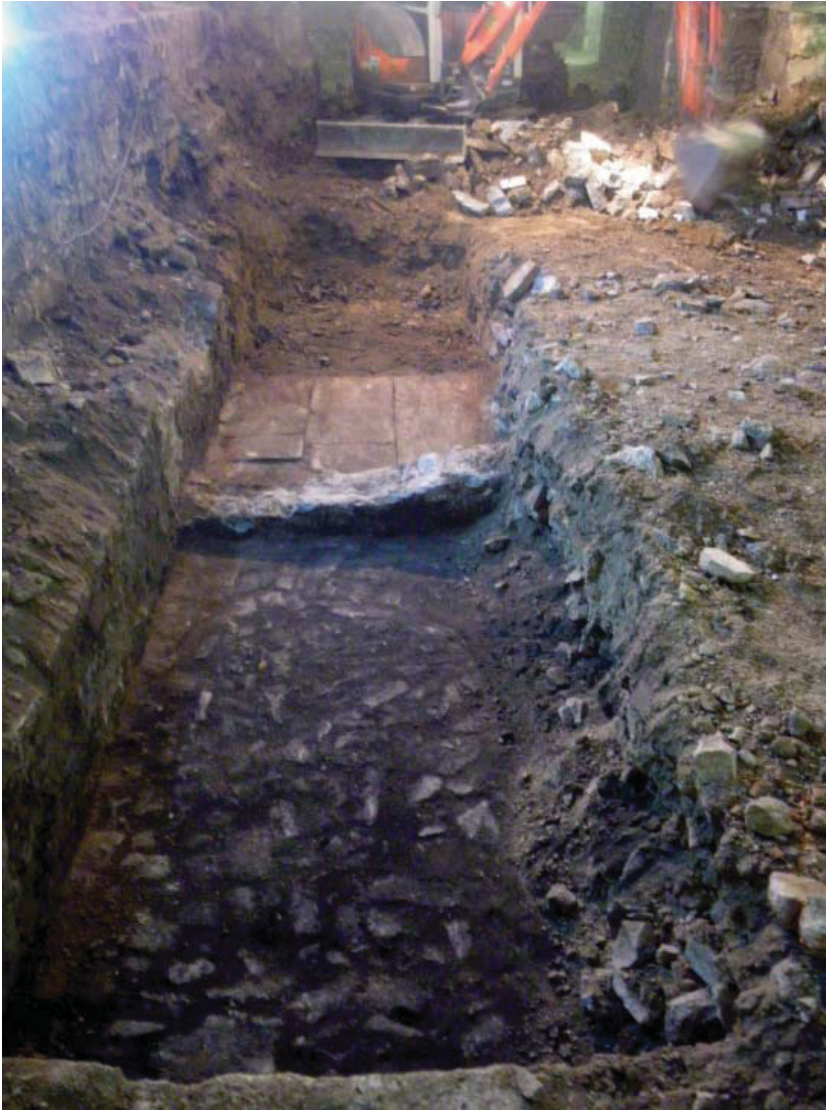
Illus 13

West facing shot of the floors of structures 1 and 2, with structure 1 in foreground

Structure 1 was encountered 3m east of structure 5, with the gap between them backfilled by a mixed deposit of brown loam, slate and stone. Structure 1 was also a vaulted basement room, measuring 2.7m x 2.3m in plan. The south wall and entrance was formed by walls 120 and 121, the north wall by 115, the east wall by 117 and the west wall by 124.

Structure 2 was the third vaulted room encountered and lay on the east side of structure 1. With dimensions of 2.7m x 1.4m, it was narrower than structure 1. The south wall and entrance was formed by walls 121 and 122, the north wall by 125, the east wall by 119 and the west wall by 117.

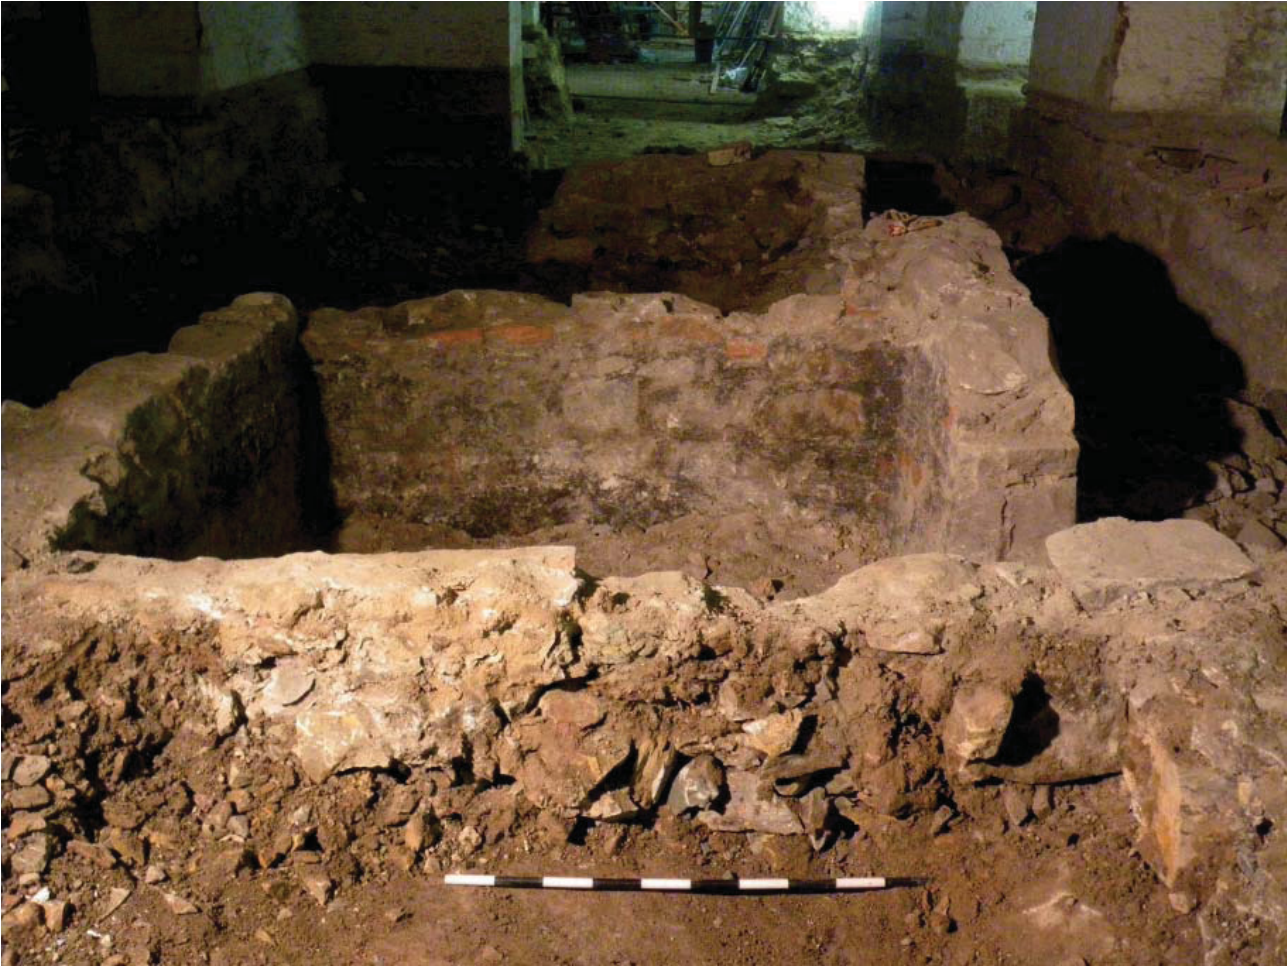
**Illus 14**

Vaulted basement 3 showing contrast in wall faces

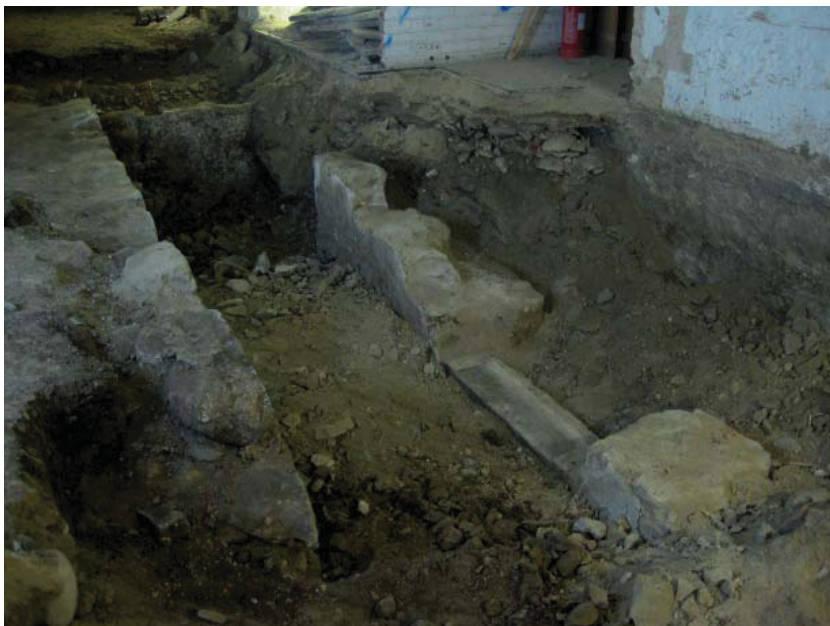
Illus 15

Southeast facing shot of wall 073 with window sill setting

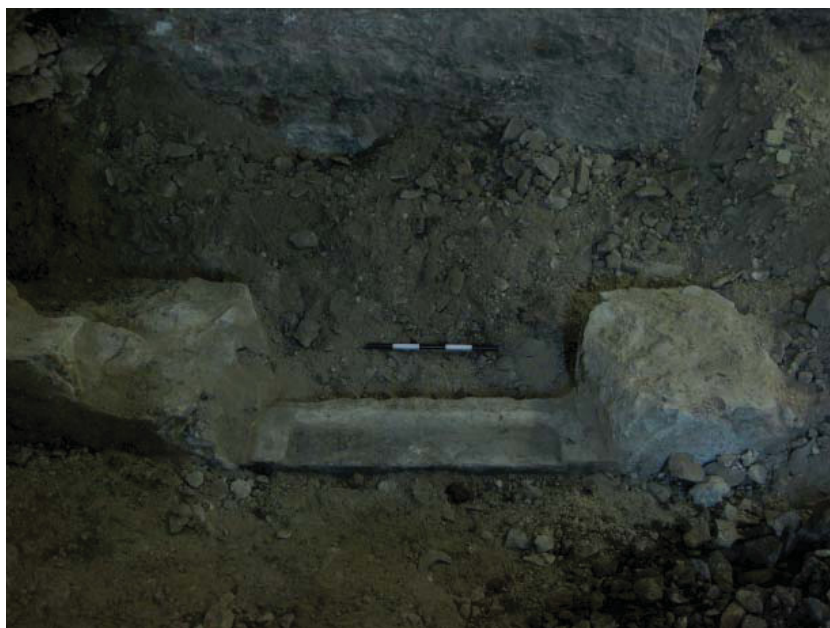
Illus 16

South facing close up shot of window sill setting in wall 173

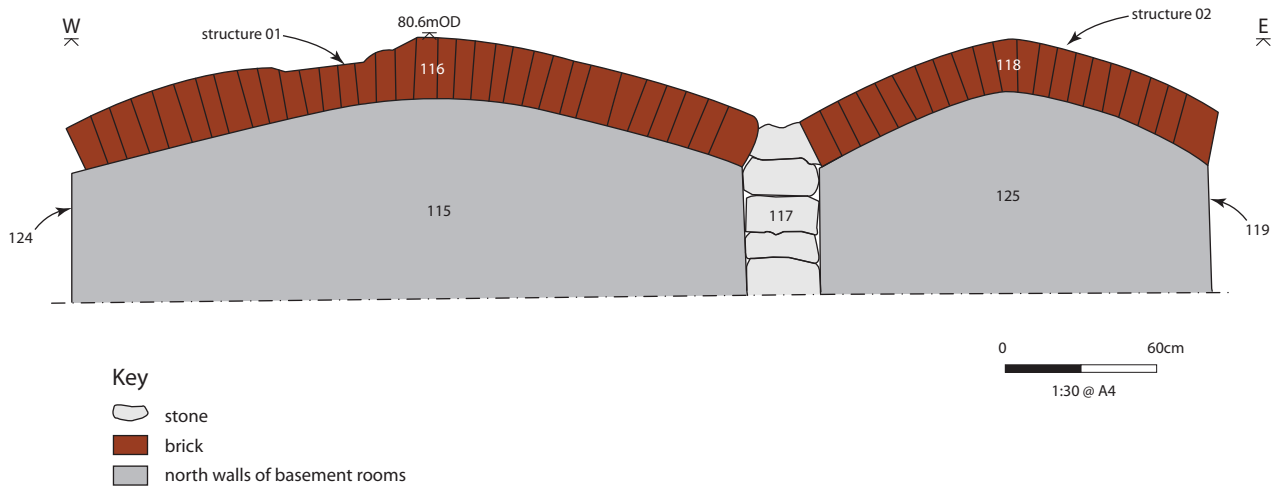
Illus 17
Elevation of vaulted cellars 1 and 2

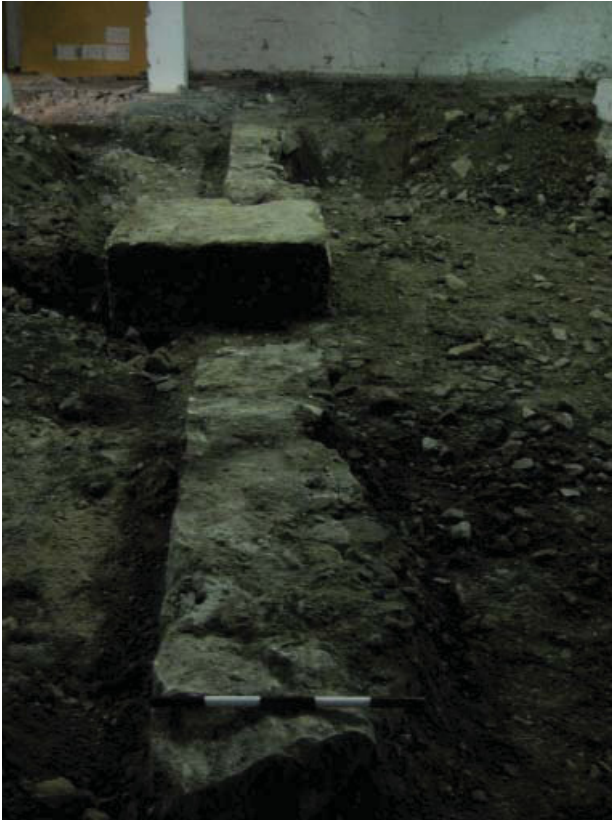
Illus 18

East facing shot of walls 100 and 105, cut by block in cellar 15

1m in depth. The top of the wall was exposed immediately below the basement floor at 80.1m OD. 112 was randomly coursed, mortared sandstone which was faced and finished on its west side. The east side was rough and irregular. East-west aligned walls 100 and 105 lay to the west of 112 and may have formed a west return wall for 112. Wall 105 was 3m long, 0.5m wide and exposed to 0.48m in height. Made of sandstone, only the north face had a mortar render. It was truncated at its eastern end by a concrete pad and its western end by a sandstone block, both associated with museum foundations. On the same alignment as 105, extending west, was wall 100. Wall 100 was 1.9m long, 0.6m wide and exposed to 0.35m depth.

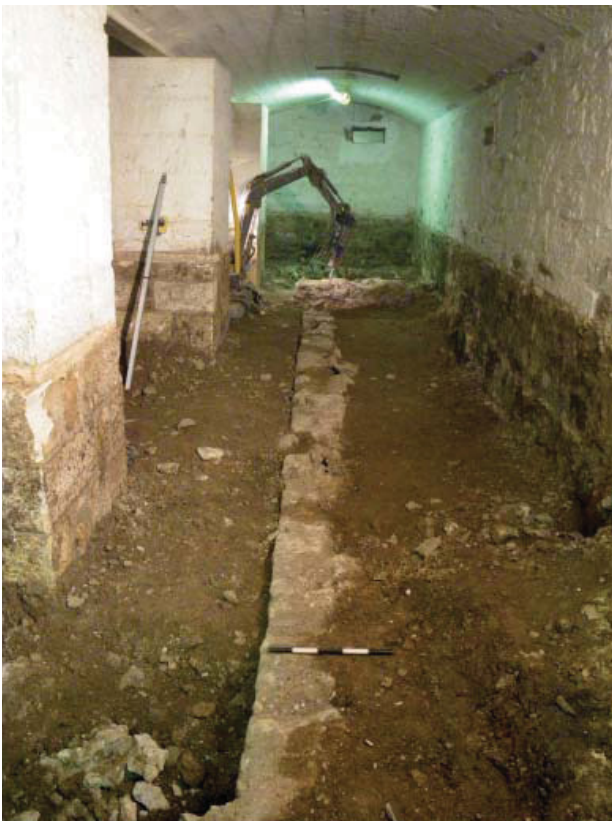
Illus 19

East facing shot of wall 164 in cellar 5

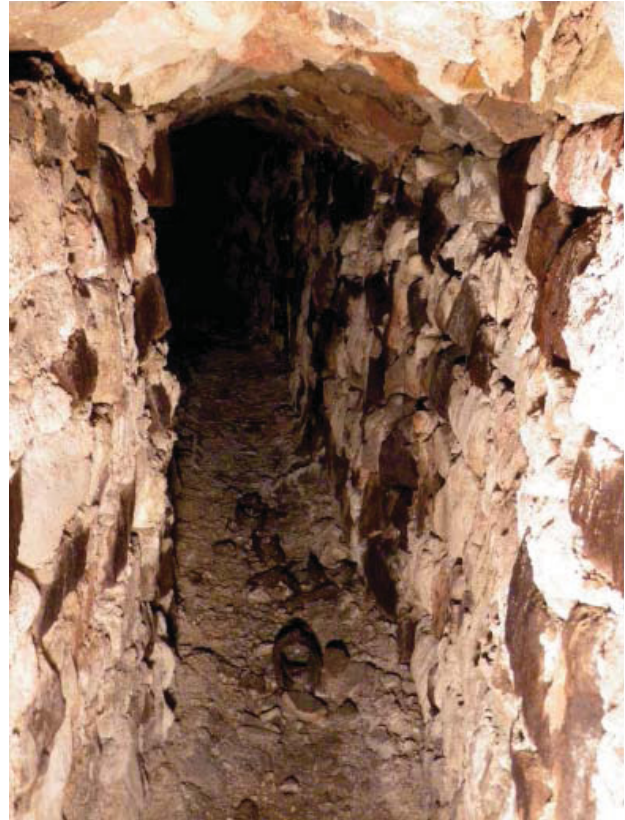
Illus 20
Culvert structure 6

The vaulted culvert revealed in cellar 2 (structure 6), which ran approximately north-south, was an unanticipated feature and in an excellent state of preservation. There was no construction cut visible or finds retrieved to assist with dating the structure. The section exposed had not been damaged by the museum foundations, which suggests it was in use at the time. The culvert was not damaged during redevelopment works and a membrane was laid down to ensure concrete did not directly adhere to it.

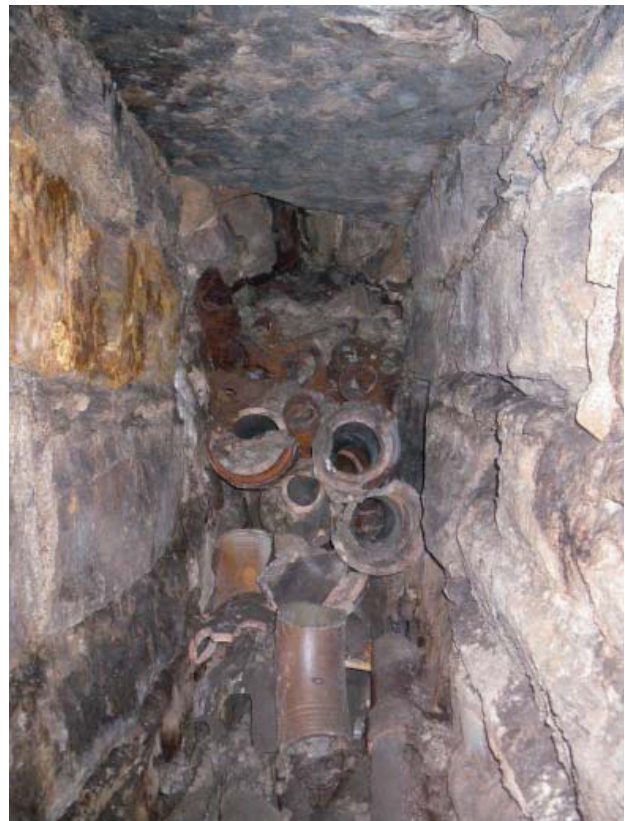
Illus 21
Blocking of culvert structure 6

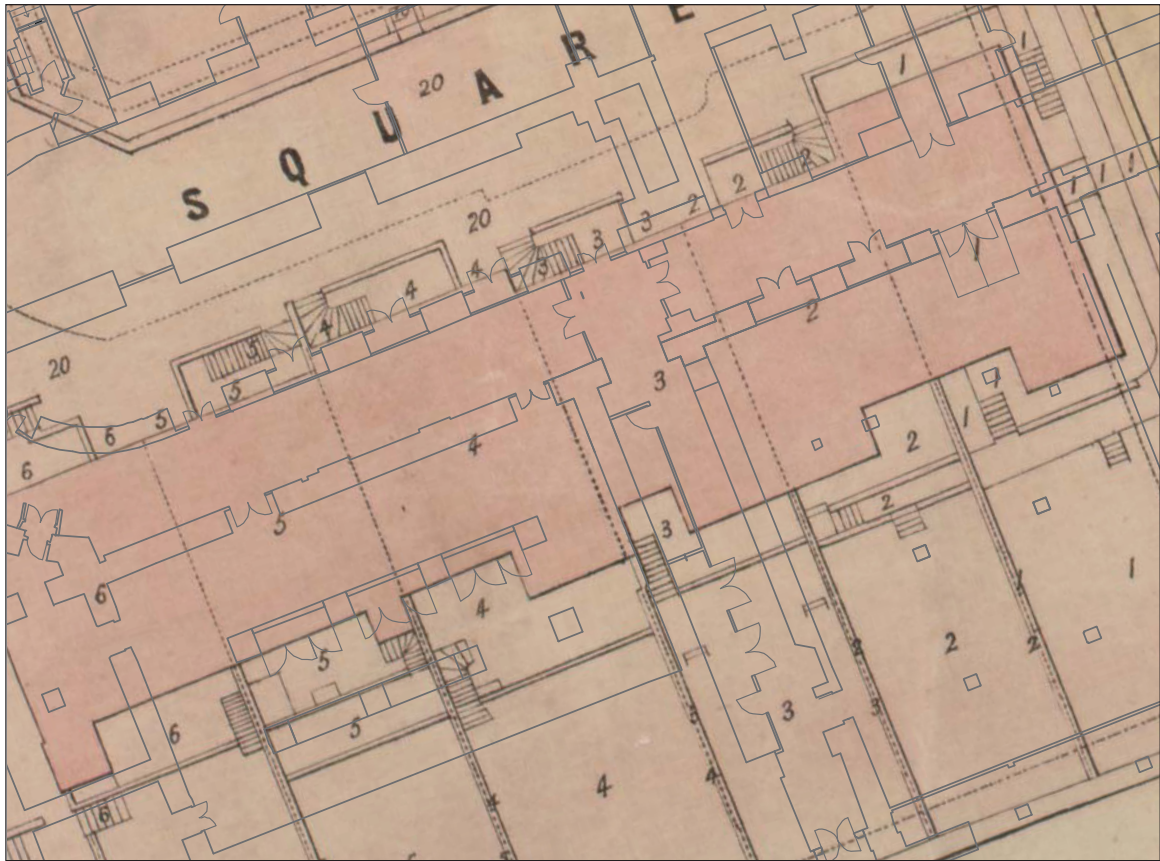
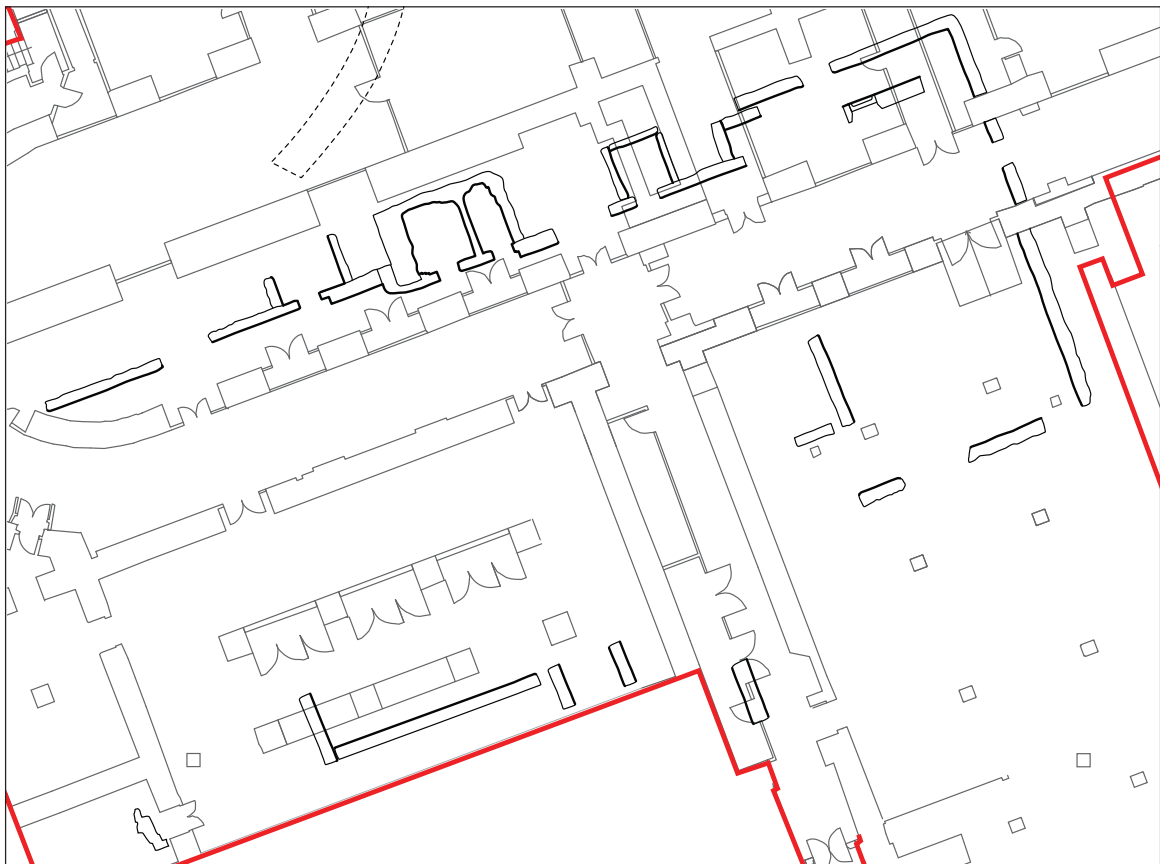
Illus 25

Comparison of revealed structural features with Argyll Square buildings
