Project Code: LAMR10
Date of Report: October 2010
Client: Forestry Commission, Scotland

A TOPOGRAPHIC ARCHAEOLOGICAL SURVEY OF THE 18TH CENTURY MILITARY ROAD AT LOCH ARKLET

<i>Client</i>	FORESTRY COMMISSION, SCOTLAND
<i>National Grid Reference</i>	NN 370 095
<i>Parish</i>	BUCHANAN
<i>Council</i>	STIRLING
<i>NMRS No.</i>	NN 40 NW 3
<i>Oasis No.</i>	HEADLAND1-84300
<i>SMR No.</i>	2653
<i>Project Manager</i>	DR. SORINA SPANOU
<i>Text</i>	MAGNAR DALLAND
<i>Illustrations</i>	JULIA BASTEK
<i>Typesetting</i>	ANNA SZTROMWASSER
<i>Fieldwork</i>	MAGNAR DALLAND JOHN McCARTHY JAMES McMEEKIN
<i>Schedule</i>	
<i>Fieldwork</i>	SEPTEMBER 2010
<i>Report</i>	OCTOBER 2010

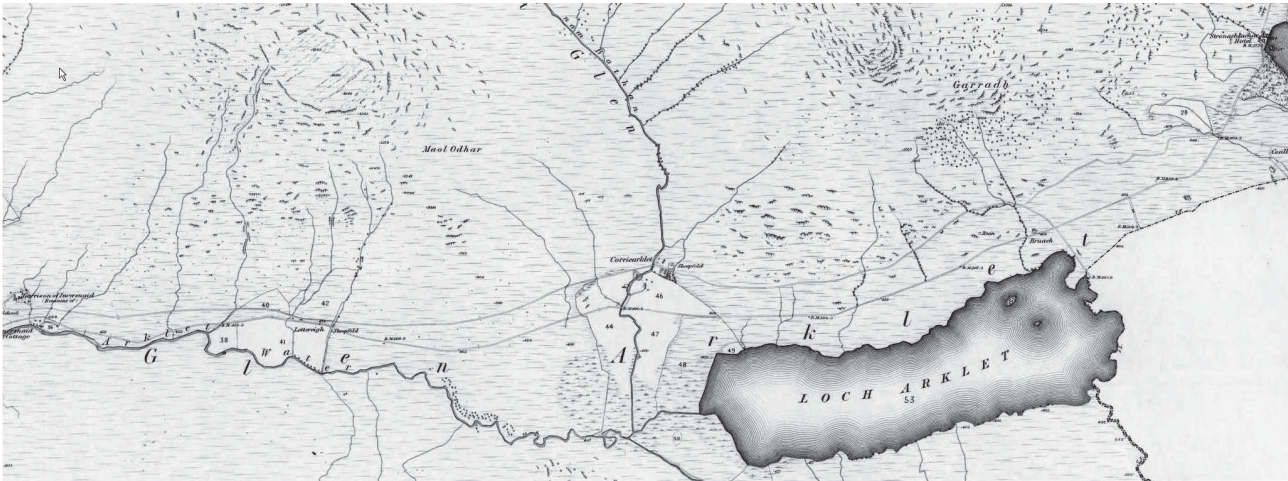
Illus 3

1st edition OS map surveyed in 1861

The 1st edition OS map surveyed in 1861 shows the current road running parallel with the old road from Inversnaid to Stronachlachar (Illus 3). When the Loch Arklet dam was built in 1914, the new road had to be shifted north in the area around the west end of the reservoir to avoid the dam and to move the road out of the flooded area, thus destroying a 650m long segment of the 18th century road.

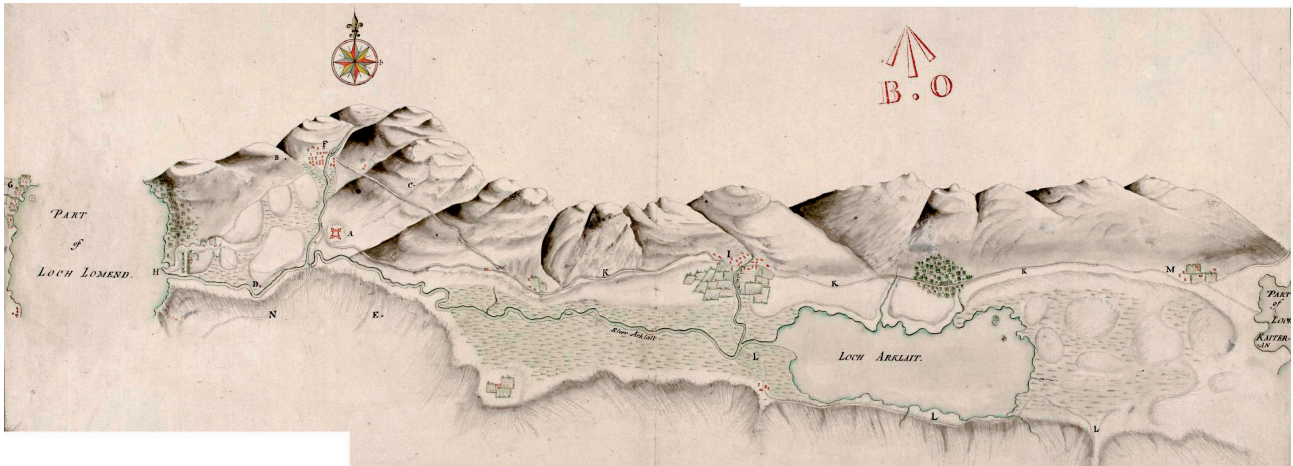
Illus 5

Map from 1718 of the area around Inversnaid garrison showing the military road in detail

built along the line of an older road. This older road is depicted on maps dated to 1718, showing military roads linking 'Inversnait, Ruthven of Badenock, Kiliwhiman and Fort William' (Illus 4). A separate map of the area around Inversnaid garrison shows the road in more detail which resembles the layout of the pre-1718 road that was recorded in the area to the north of the Arklet dam (Illus 5).

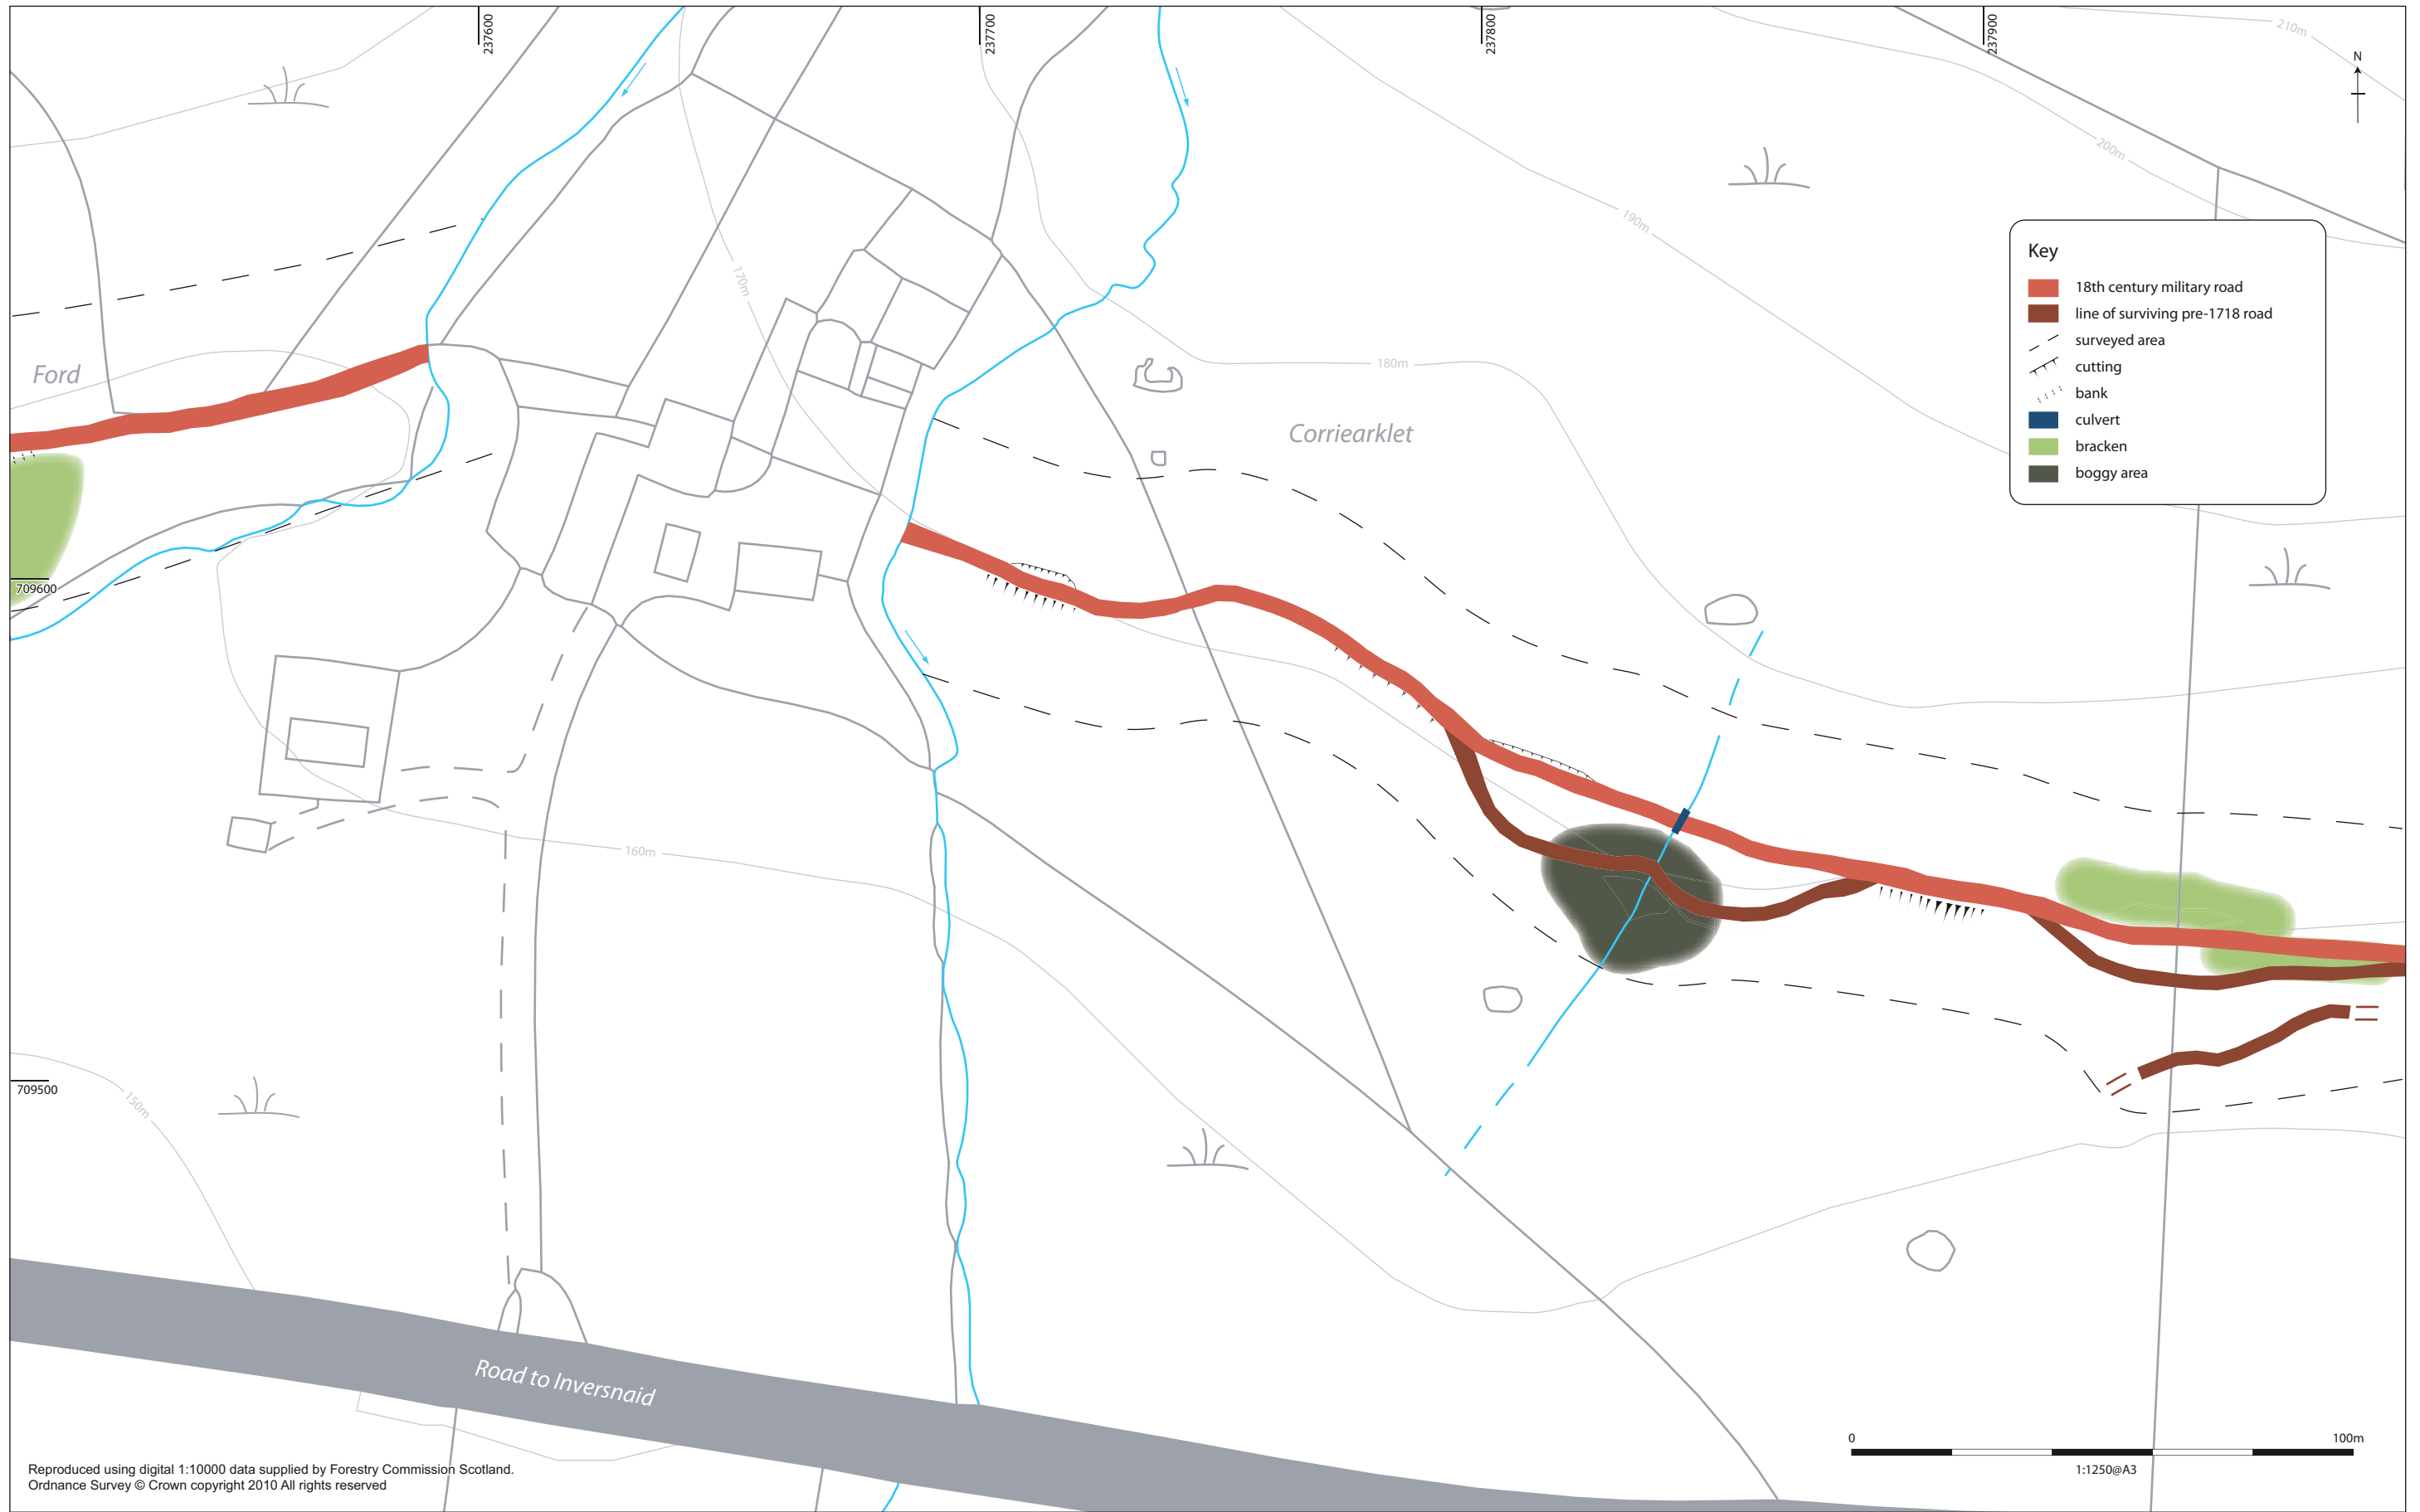
Illus 1.7

An older and more sinuous road line was recorded at several stretches along the road. At one point three phases of the road were noted (237950, 709520) (Illus 1.7,

Appendix 3). The two road lines were generally intertwined with the later route appearing to have been built as part of a 'road-straightening' upgrade. This pattern was most prominent along the central sections of the road. The eastern end of the road deviated significantly to the north before merging into the later road line just east of Inversnait Garrison. There were no traces of an earlier phase at the western section beyond Bruach reservoir.
