Project Code: HIGH10
Date of report: June 2010
Client: Malcolm Fraser Architects on behalf of Mark & Sylvia Hamilton

BUILDING RECORDING AND WATCHING BRIEF

343 High Street, Edinburgh

HEADLAND
ARCHAEOLOGY Ltd

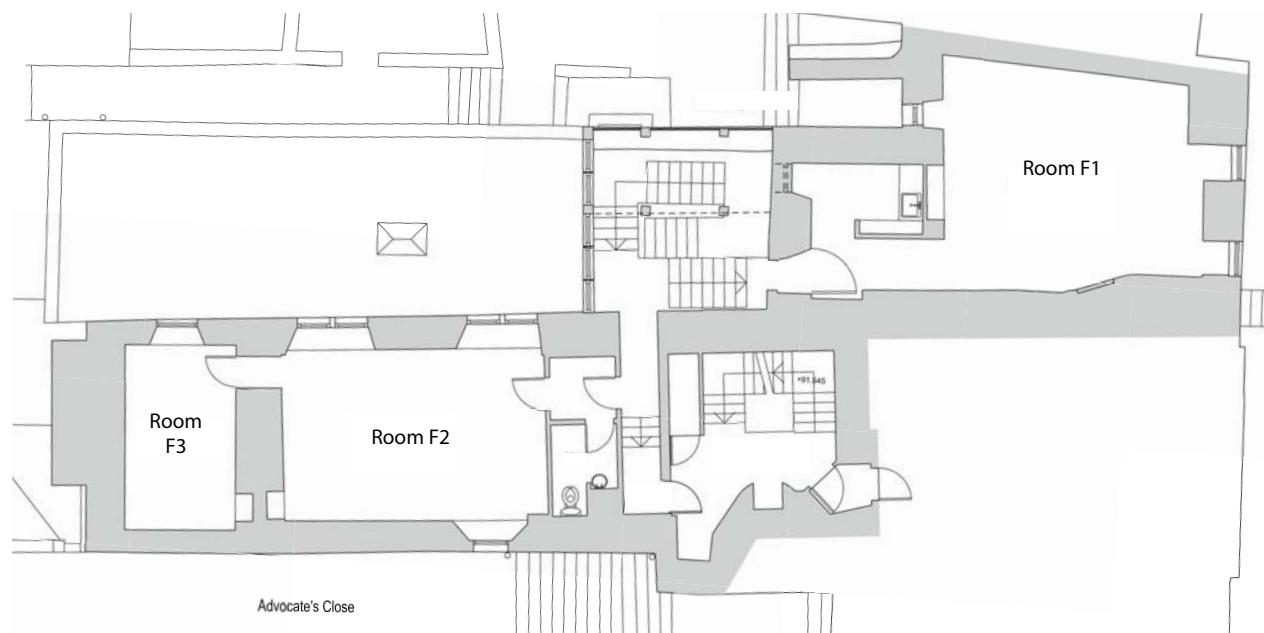
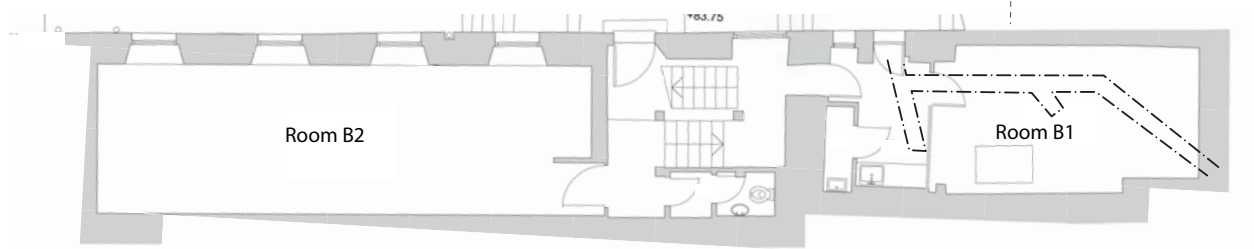
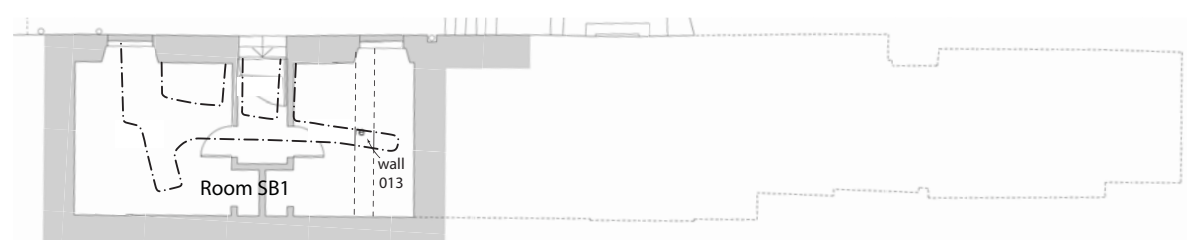
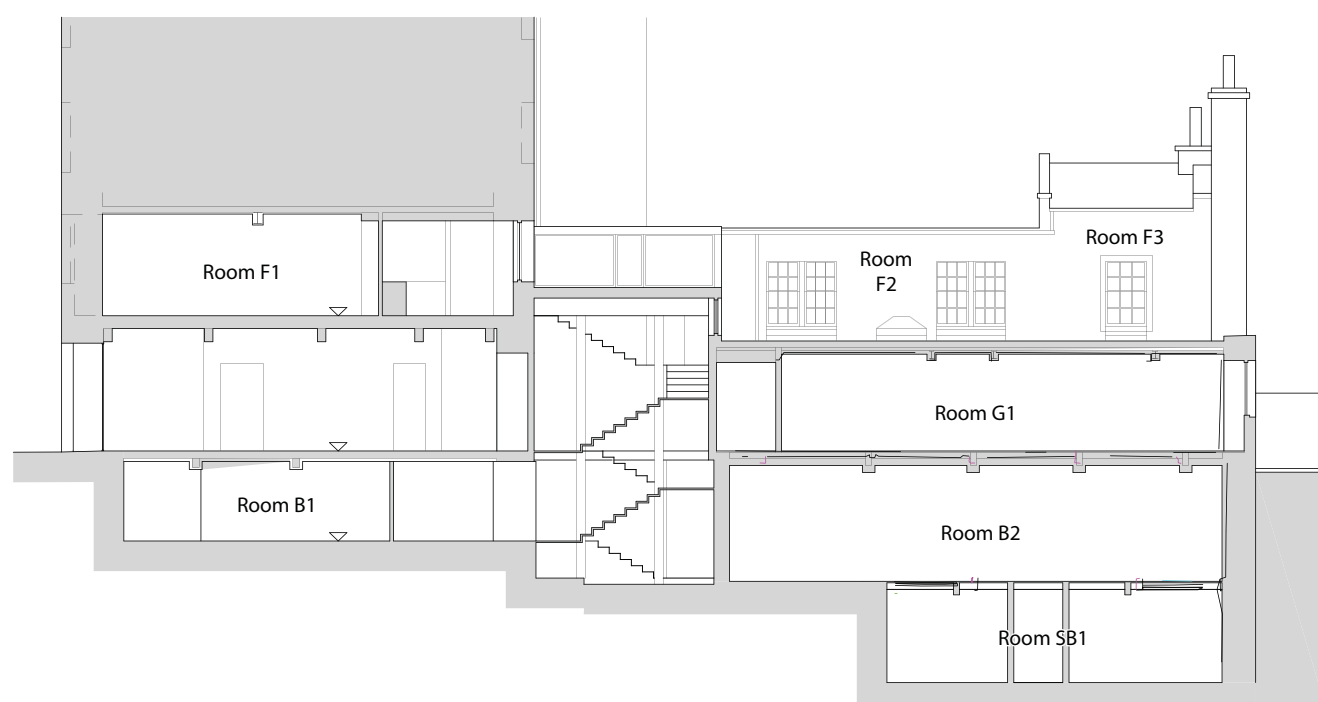
Illus 7
Site plan

Brief descriptions of each room and the features within them are included in a feature/context register in Appendix 3. This section includes an interpretive summary based on the evidence outlined in the gazetteer. A labelled site plan is included as Illustration 7.

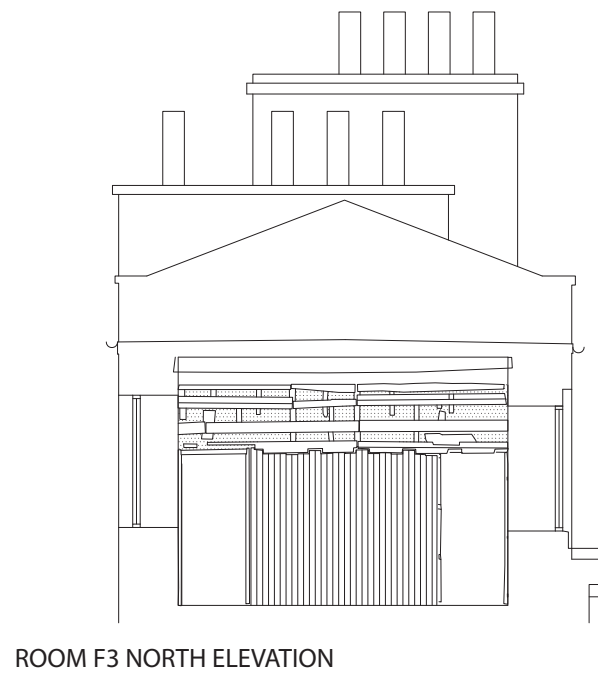
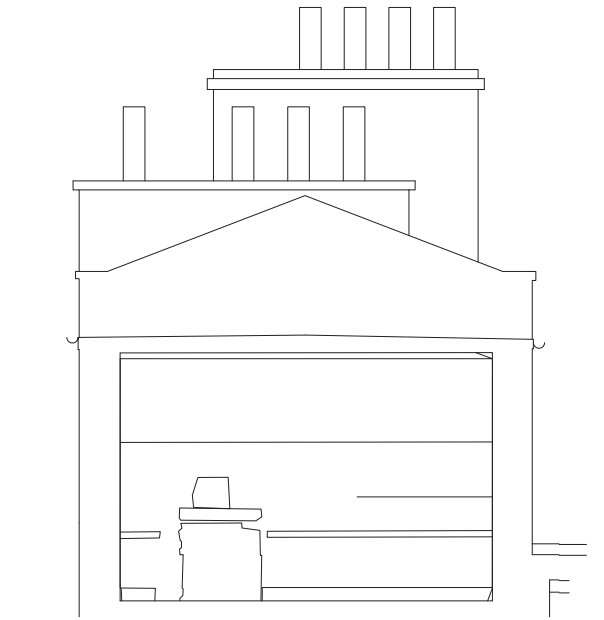
ROOM F3 NORTH ELEVATION

The removal of the ceiling revealed narrow ceiling joists while removal of the lath and plaster on the elevations revealed the stonework beneath. The N wall contained a blocked hearth against the W wall (F57) above which were a timber lintel (F57) and some large, squared, grey sandstone blocks (F59). These latter features were apparently associated with some form of repair or rebuild in this area and may be connected to a blocked feature, possibly a doorway seen above ceiling height in the N wall (F74). Other features in this wall, which was probably once a party wall with a building to the south, were a scar formed by the removal of a large timber beam (F74) in the N wall and, above this an area of slightly projecting rough masonry (F67). The exact nature of this uncertain but it could represent the remains of an earlier fabric in the N wall.

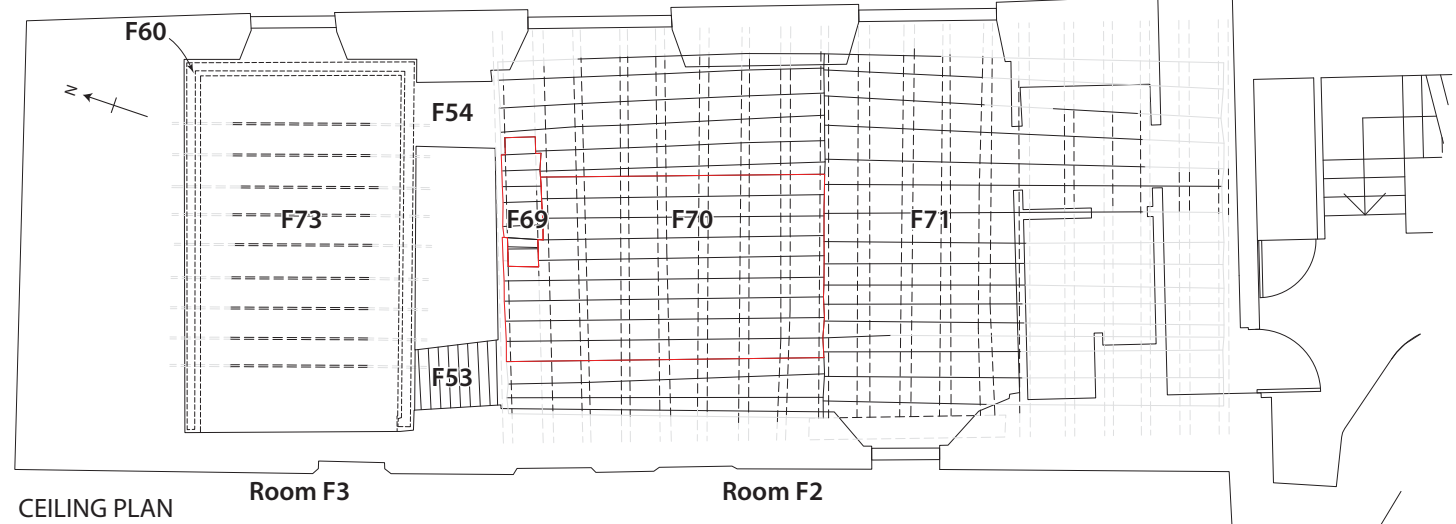
CEILING PLAN

central part of the room charred joists and the use of plain sawn boards (F70) demonstrate that part of the roof has, at some point, been damaged by fire. Against the N (partition wall) can be seen a short lengths of additional, 'reinforcing' timber boards that project a short way into Room F2 (F69). These are thought to represent support for a hearth stone on the floor above (now demolished).

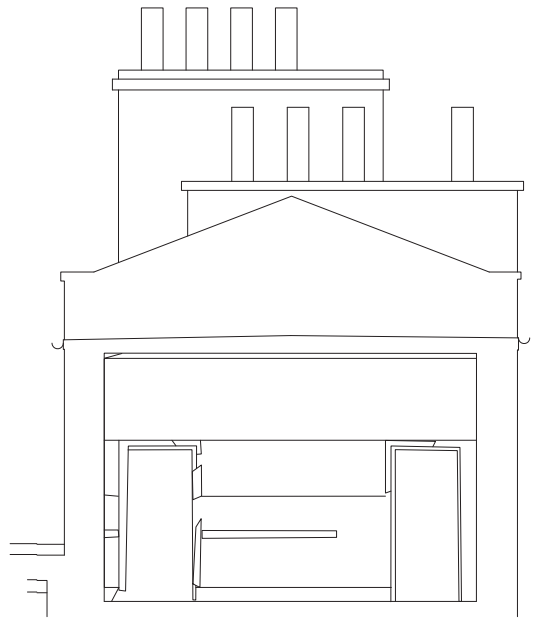
ROOM F3 SOUTH ELEVATION

The south partition wall is a thick wall with a doorway at both the E (F54) and W (F53). Neither of these doorways are probably original, they are very poorly squared with the room and the area above F53 has, apparently been significantly repaired at some point.

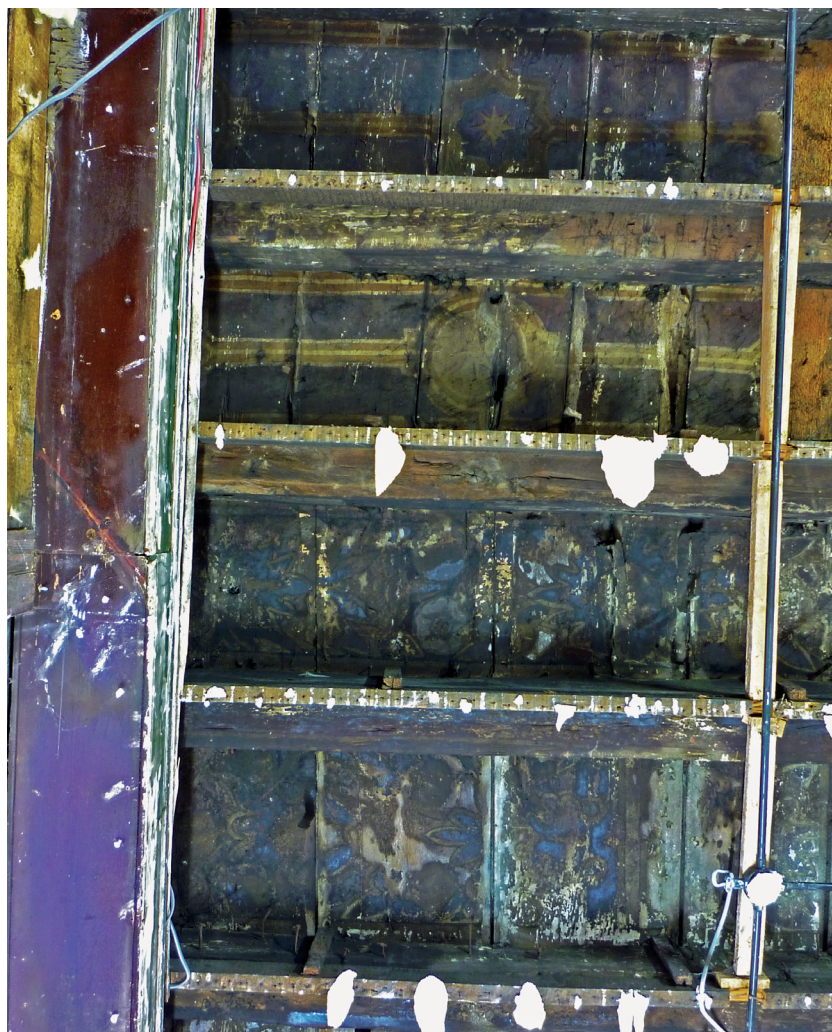
Illus 9

The painted ceiling Room F2

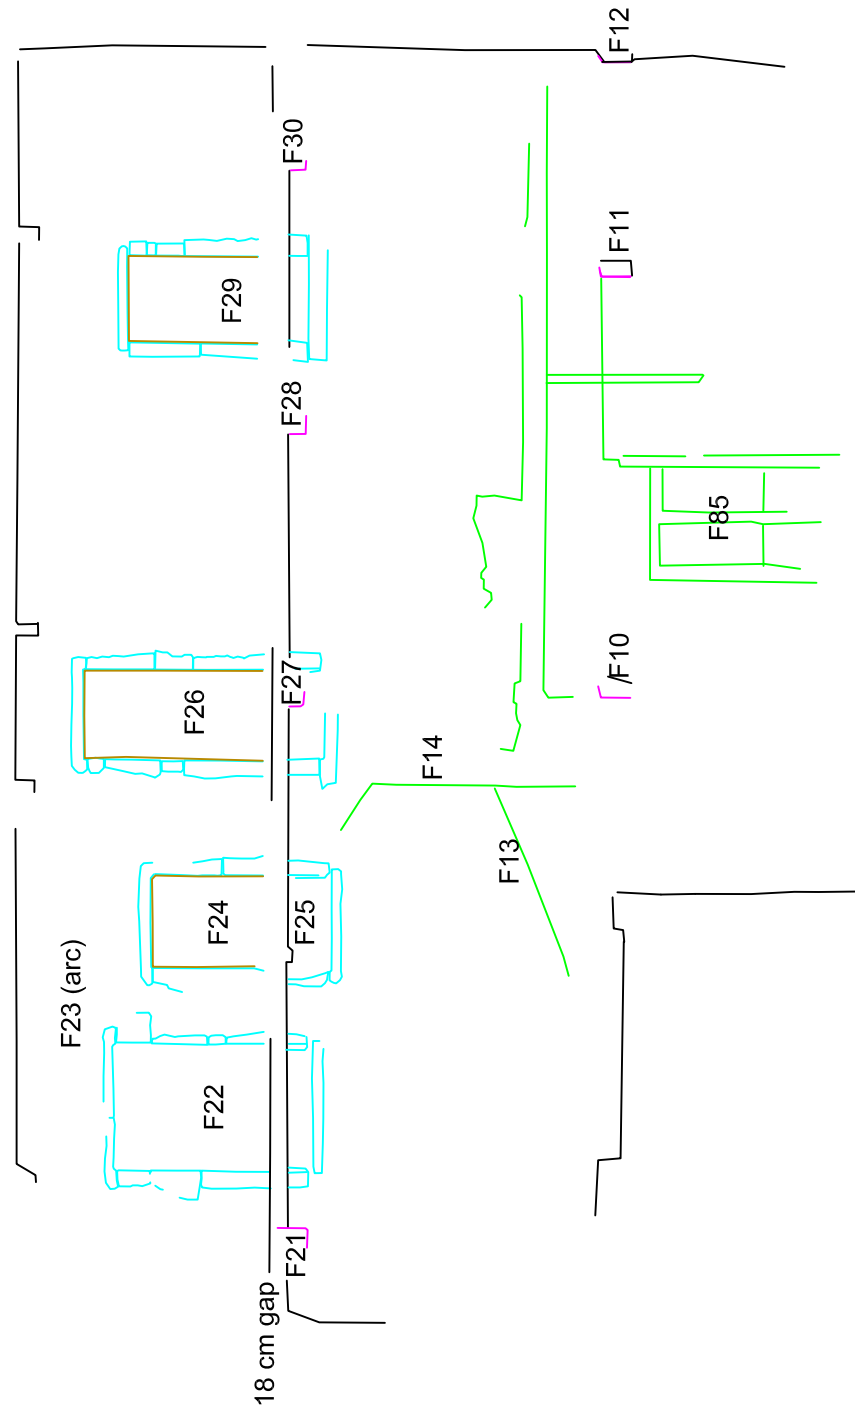
Rooms SB1, B2, G1. Internal west elevation

The W wall reveals the base of a number of blocked openings defined by dressed stone margins that continue above the current floor line into Room G1 (F22,24,26,29 – see also Room G1). Below these openings

the masonry wall has numerous lime wash shadows that relate to structures that have been built up against it at various times in the past. The phasing here is somewhat complicated but, in summary they appear to show traces of a substantial wall (F14), now demolished, running up the centre of the current W wall. To the N of this, the floor level was evidently several feet higher than the current floors. On the S side of the demolished wall there was, at some time, a lean-to with a pitched roof resting on this. These observations confirm the suggestion that the current E wall is just the last phase of a number of building and demolition episodes constructed against the old building that fronted Advocate's Close to the W.

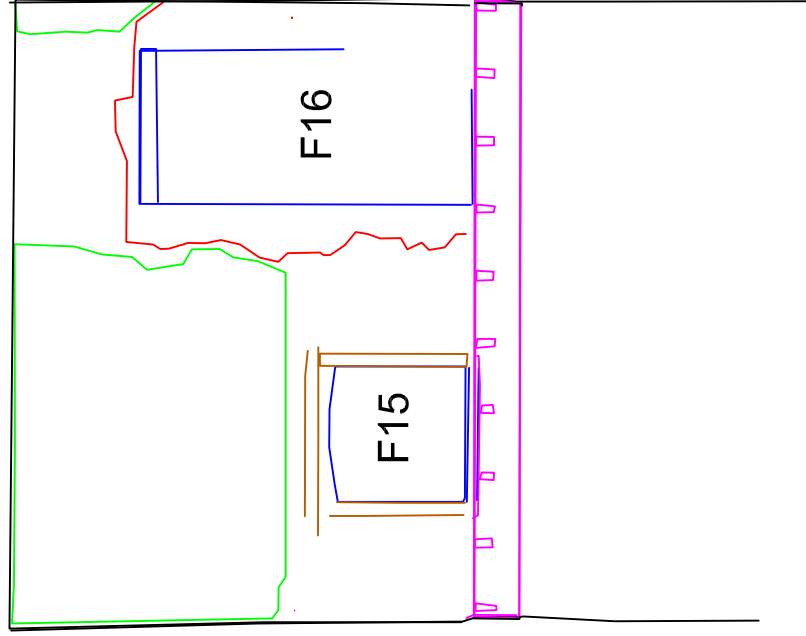
Rooms SB1, B2. Internal north elevation

The N wall contains the blocked remains of a fireplace (F15) and a door (F18), apparently recent, which gives access to the building to the N.

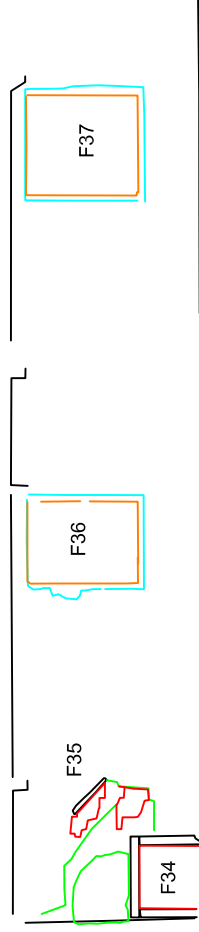
Room G1. Internal east elevation

At the N end of the E wall is a fireplace, now blocked with brick and with a painted stone surround (F34). The area around the fireplace has been significantly modified several times, with some rebuilding, presumably associated with the insertion of the fireplace into the masonry of the E wall. Above and to the S of the fire place, and apparently a part of this rebuilding, is a sloping feature (F35), patched and filled with red brick and small diameter masonry. On the face of it, this has the appearance of a scar for a pitched roof against the E wall but the masonry above and below appears to be older and of one build. A more likely interpretation is that this represents the line of a chimney flue that has been inserted into older masonry from one of the fireplaces on the lower floors (e.g. SB1), connecting with the flue of F34.

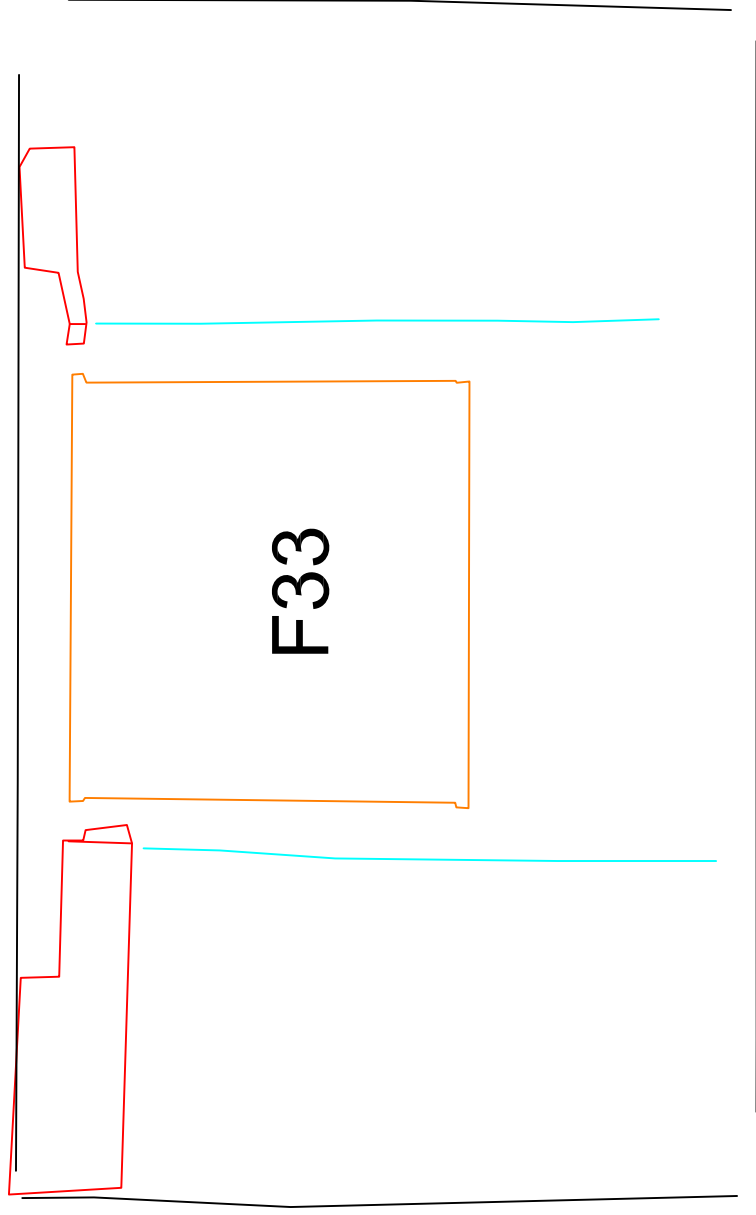
Room G1. Internal north elevation

The N wall supports a single blocked window while the W wall incorporates four blocked openings each with dressed and stugged stone margins (F22, 24, 26 & 29). These are of varying heights and sizes
