ARCHAEOLOGICAL GROUND MONITORING AT GRANGE COURT, LEOMINSTER, HEREFORDSHIRE

for Herefordshire County Council

DCNC2009/0435/CD

February 2011

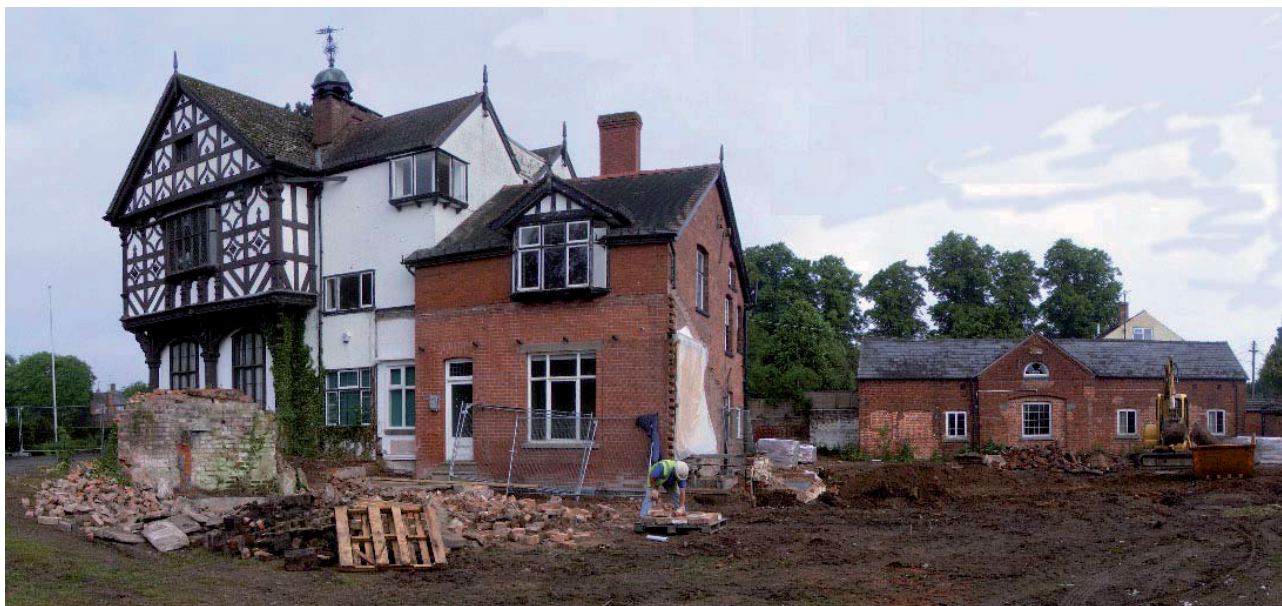
Illus 3

Overview of site facing north

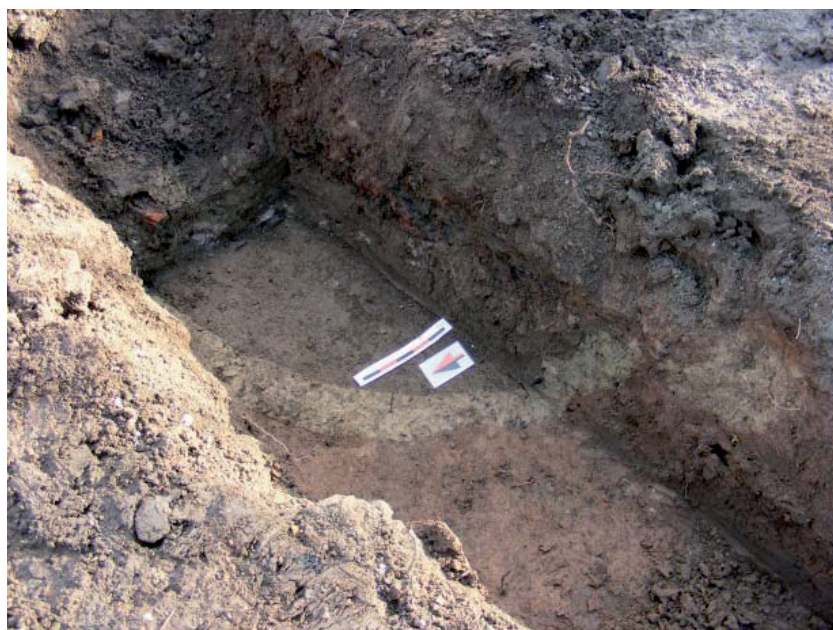
Illus 4

No continuations of the ditch and gully reported by Mercian Archaeology have been found, but the demolition deposits noted in their Trench 2 were seen in the drainage and landscaping of the northwest corner of the garden area. A well was recorded during excavations for the south wing, and a probable clay-lined pond feature nearby in associated drainage works.

Pond [108] facing southeast
