THE MILL HOUSE, LANSDOWN, BOURTON-ON-THE-WATER, GLOUCESTERSHIRE

Watching Brief

for Stuart Scott-Cooper

February 2011

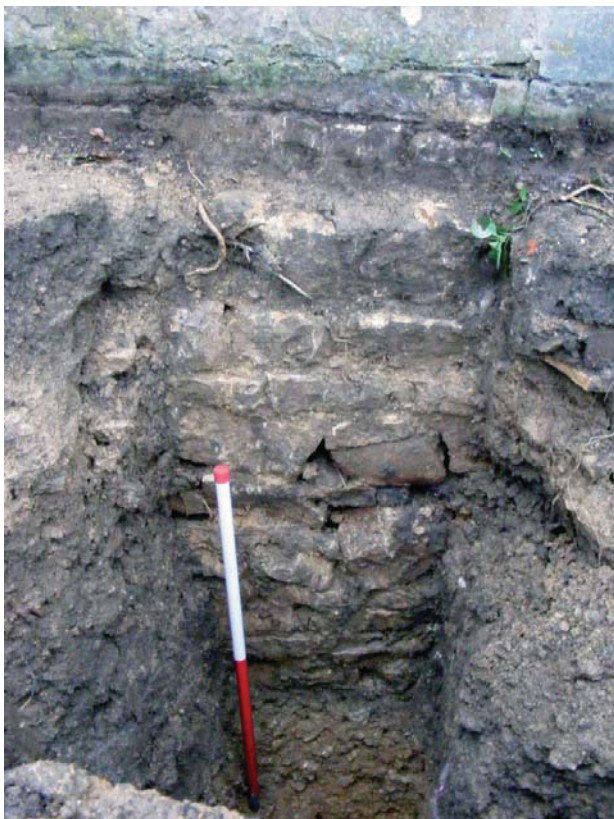
Illus 3

The southwest facing section was stepped back 1m to the northeast in two places to accommodate the link between the proposed orangery and the standing building. The step measured 1m in width and revealed the limestone footing of the standing building [007]. This foundation consisted of three layers of stones, each measuring approximately 0.3 by 0.2m with a total depth of 0.6m. Underlying the layer of dressed stone was another footing consisting of smaller, sub angular stones of varying size measuring a total depth of 1m [108]. Both stone structures were bound with lime mortar. Without further investigations it is difficult to determine whether this is the foundation of another building on the site (possibly the old mill known as Upper Mill of Bourton) upon which the more recent, standing building has been built, or whether the stones

Close up of wall foundations in west-facing section

have been removed from another building nearby and reused in the foundation for the standing building.

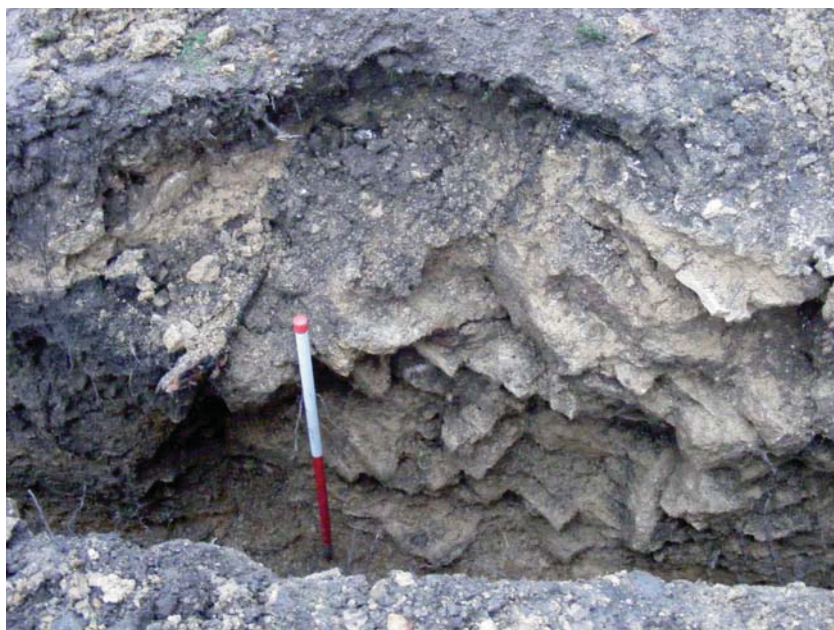
Illus 4

The southeast facing section was stepped back 0.5m, revealing a substantial stone wall [002] consisting of sub-angular stones of varying sizes, some measuring 0.5m by 0.2m. The wall was at least 1.2m deep, the top having been disturbed by modern services. The face of the wall had already been removed, exposing the rubble core of the wall. The type, shape and size of stones are similar to those identified under the foundation of the standing building in the southwest facing section.

No structures were present in the west and south trenches. The north and east trenches revealed the footing of the standing building and what is likely to be the footing of an earlier building underneath. Judging by the similarities in the size and type of stones and similar bounding material, it is likely that the structures in both north and east trenches are the same building. It is possible that this is the foundation of the former mill known as Upper Mill of Bourton, although the limited extent of the excavations and the lack of any dating evidence make this difficult to determine for certain.

Close up of possible foundation of the old mill in south-facing section
