JOPPA SALT PAN WORKS

Archaeological Excavations

for Edinburgh City Council

May 2011

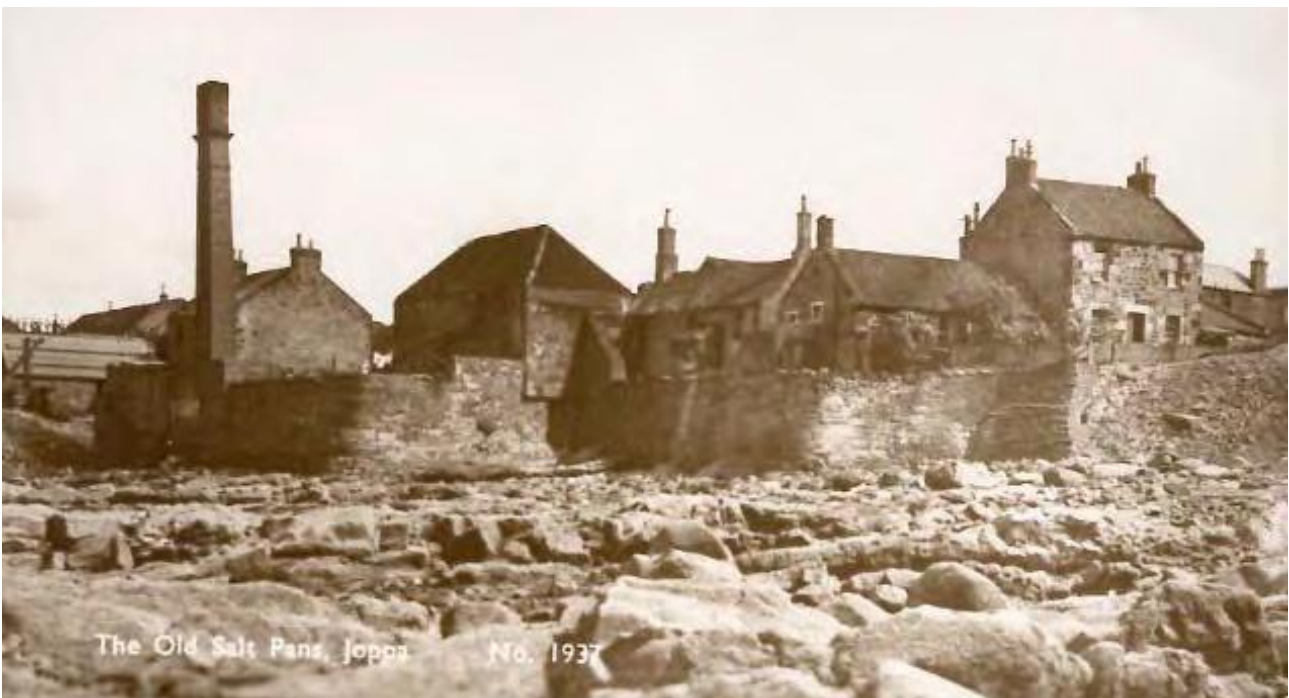
Illus 3
Postcard photo

Postcards from 1908 show two chimneys belonging to the salt works. This early photographic evidence of the site shows a complex series of buildings most of which seem to be constructed of rubble stone. A tramway ran east to west to the south of the salt works and Seaview terrace opposite the works was constructed between 1896 and 1908 suggesting that Joppa expanded during this time.

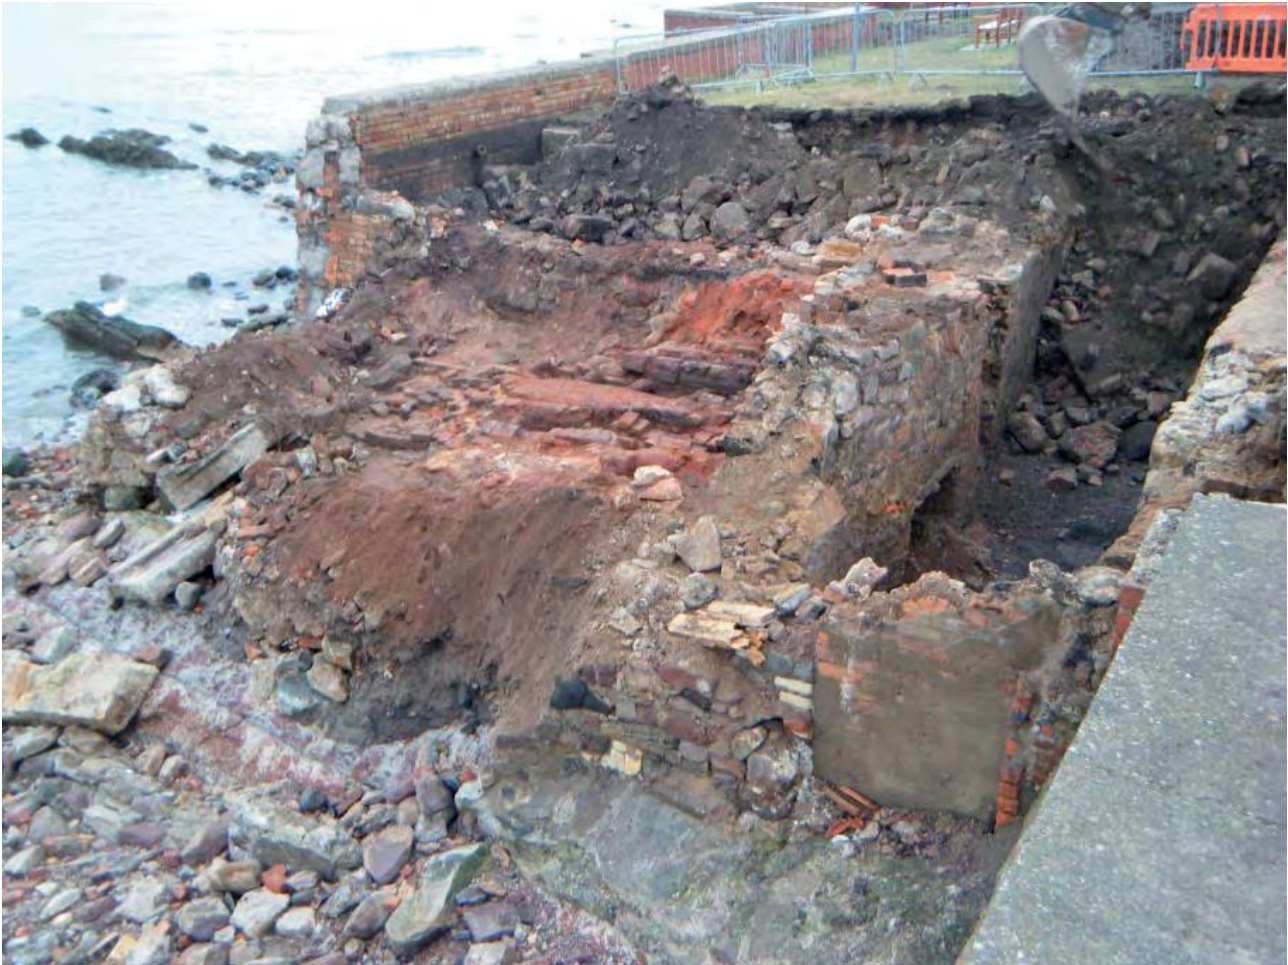
Illus 5

View of excavation area facing NE

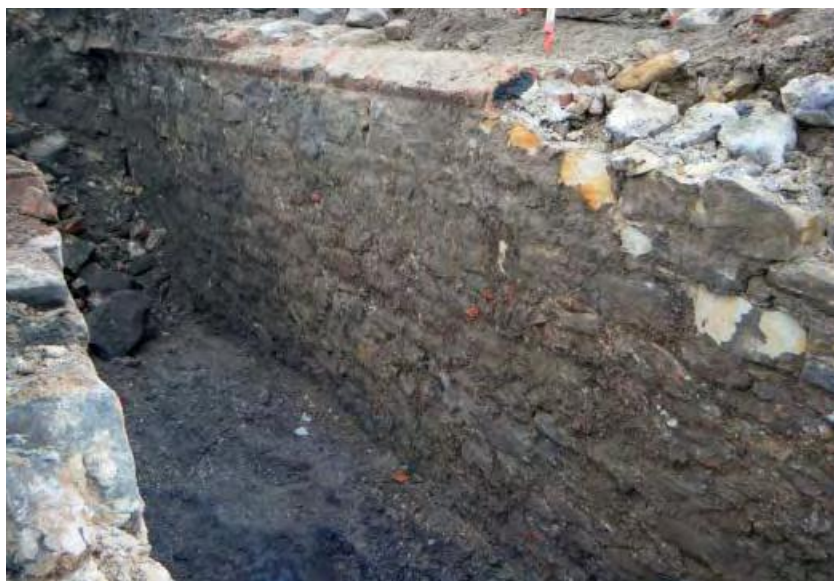
Illus 6

View of N elevation of stone wall [019] facing SE

Three lime mortar bonded rubble stone walls ([019], [020] & [022]) formed the earliest phase of activity within the excavation area. The southern edge of the excavation area was bounded by wall [019] that comprised an east-west aligned stone wall standing 1.8m tall. The wall was built upon on the underlying bedrock and it was topped with a course of red bricks [027] set at an angle in order to form the base of a brick arch. Wall [020] located 2.1m to the north and aligned parallel to [019] would have supported the opposing side of this arch creating a covered channel between the two walls. This second wall [020] was keyed into wall [022] at its eastern end (the wall actually continued eastwards beyond the limit of the excavation). Wall [022] was aligned north-south running between wall [020] to the south and the surviving sea wall to the north. Both these walls stood to a maximum height of 2.1m with the foundations again built on the bedrock.

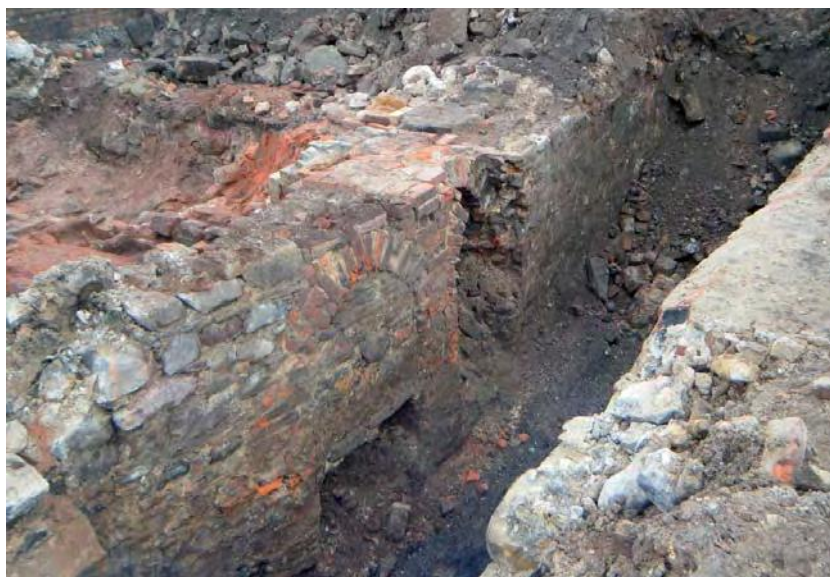
Illus 8
View of brick arches [023] and [024] facing NE

Wall [020] was the only one of these stone walls that had been significantly altered. Two large brick arches ([023] & [024]) had been inserted into the wall. The bricks were all un-frogged hand made bricks bonded with soft sand. Some of these bricks had been stamped 'Hunter & Co Patent Portobello' indicating a local source for the bricks. It was clear that these arches had been inserted into an existing wall because on the south elevation of wall [020] the brickwork on the west side of arch [024] was irregular and clearly constructed to cover the damage caused from its insertion. Also the north elevation of this wall [020] was entirely faced with brickwork that butted up to the existing stone wall at the east and west ends. The two arches stood to a maximum height of 1.6m and were 0.95m wide on the southern elevation. The width of these arches reduced significantly as they ran through the wall being only 0.45m wide on the north elevation.

After the flues ([052] & [053]) had gone out of use the western arch [024] had been blocked with stone [049]. The second arch [023] to the east had been in-filled with beach cobbles with a cast-iron double door [051] inserted close to the top of the south face of the arch. These doors formed an opening 0.4m² within the original arch and were held in place by a surround of 'ETNA' stamped fire bricks. The opening continued through wall [020] leading to a narrow brick-lined flue [035]. The flue was 0.25m wide and 0.5m high with brick sides and base. Immediately beyond the north elevation of the wall [020] the flue turned 90° to the east continuing 1.6m along the wall face until it reached the W face of wall [022]. At this point the flue turned north continuing along the west face of wall [022] for approximately 2.5m beyond

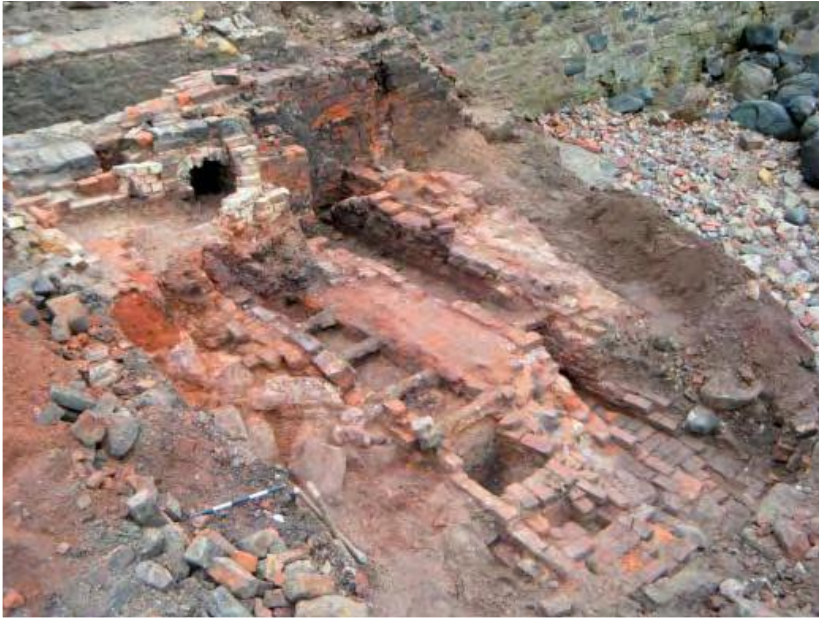
Illus 9
General view of pan house flues [052]
and [053] facing SW

Two long brick flues ([052] & [053]) were attached to the arches on the north side of wall [020] and continued to the northern end of the excavation area. Both these flues were 0.42m wide and 3.15m long and were constructed of hand-made bricks. The flues ran parallel to each other with a 0.62m wide sand and brick in-fill [055] between them. The side walls of the flues stood to a maximum height of 0.9m although this reduced significantly at the north end, due to damage caused by the collapse of the sea wall. The tops of the walls had been significantly discoloured due to heat action. The eastern wall of flue [053] also included a single course of large heat affected bricks [062] that had chamfered inner faces. A large amount of corrosion was also recorded on the inner faces of these bricks. A series of heavily corroded iron supports approximately 1m apart and aligned east-west along the tops of the flue walls were also recorded. A section through the flues revealed a shallow 0.12m thick layer of coarse grey ash [063] at the base.

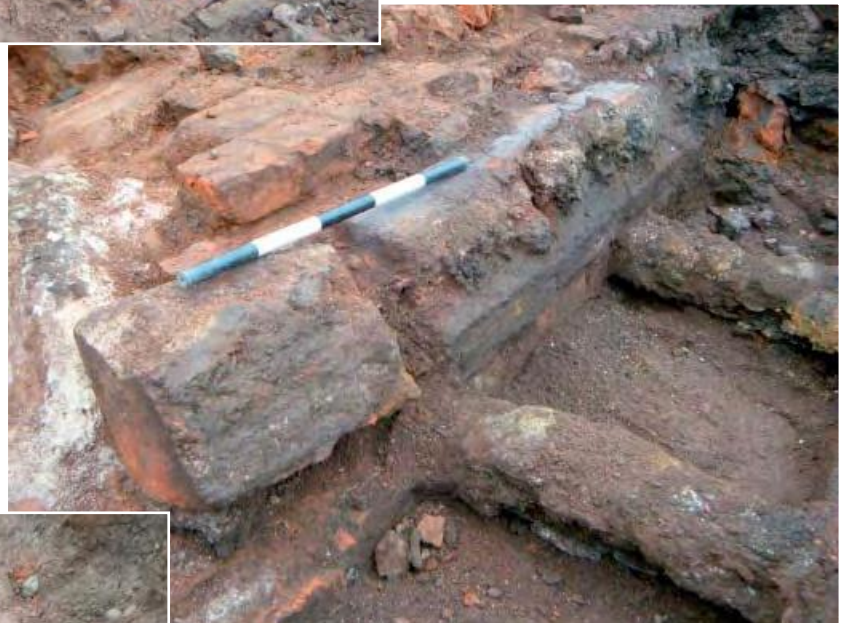
Illus 10
Detail of bricks [062] on flue wall

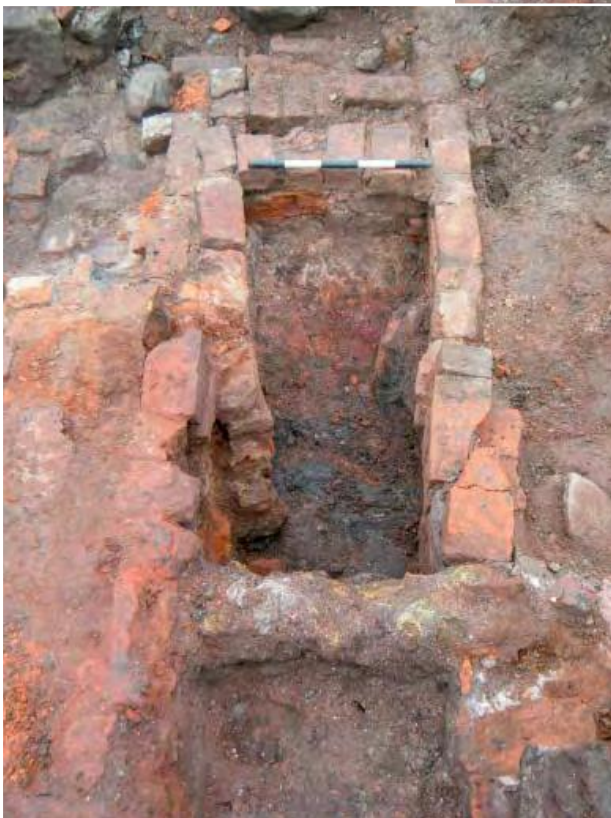
Illus 11
Detail showing the narrowing of flue [052]

The brick sides of the flues gradually curved inwards close to the north end forming a slightly narrower channel. Only the base level of the flue survived at the far north end and this was formed by an irregular course of bricks set above a foundation layer of poorly sorted stones and sand [058]. The construction at the north end of the flues

the north end may have been in order to create a stronger draft through the flue as well as possibly causing the heat to re-circulate through the flue instead of escaping out the end. Although much of the structure at the north end was truncated, it is thought that the heat and fumes would have been regulated by apparatus at this end of the flues before the fumes were carried through to a chimney. This chimney, as depicted on the early photographs (see Illus 3), seems to be located slightly further to the east beyond what is thought to be the second pan house. As the site is known to have had two chimneys, the second one being located to the east side of a central water capture tank, it is possible that another series of pans also existed on the east side of the salt pan works.

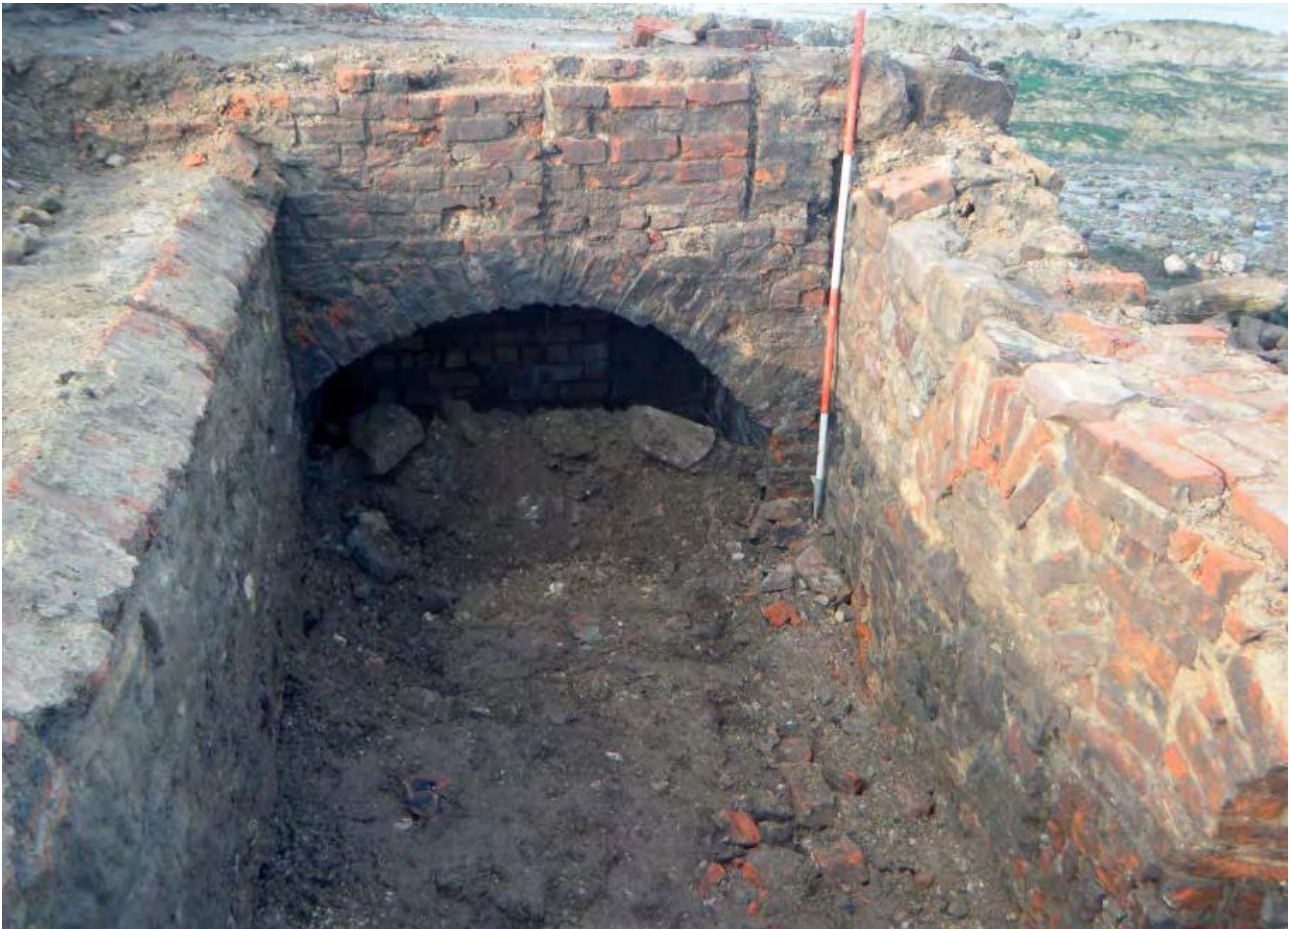
**Illus 12**

View of brick arch [021] facing W

The western ends of stone walls [019] and [020] were linked by a substantial brick arch [021]. This formed a large opening 2.15m wide and over 3m high at the west end of the channel created by walls [019] and [020]. This arch [021] had subsequently been brick-blocked with a large concrete slab placed over the top of the arch to support the construction of the modern sea wall.

The brick arch [021] at the west end of the stone walls ([019] & [020]) was clearly a later phase feature than the walls themselves and was probably associated with the phase that included the insertion of the arches and flues. The opening led through to the beach and may have been used as an entrance for the delivery of locally sourced coal which was known to exist in seams along the beach. The angled bricks capping on top of wall [019] suggested the whole channel would originally have been covered with a brick arched roof, although this would have been set at a slightly higher level than the arch recorded at the west end.

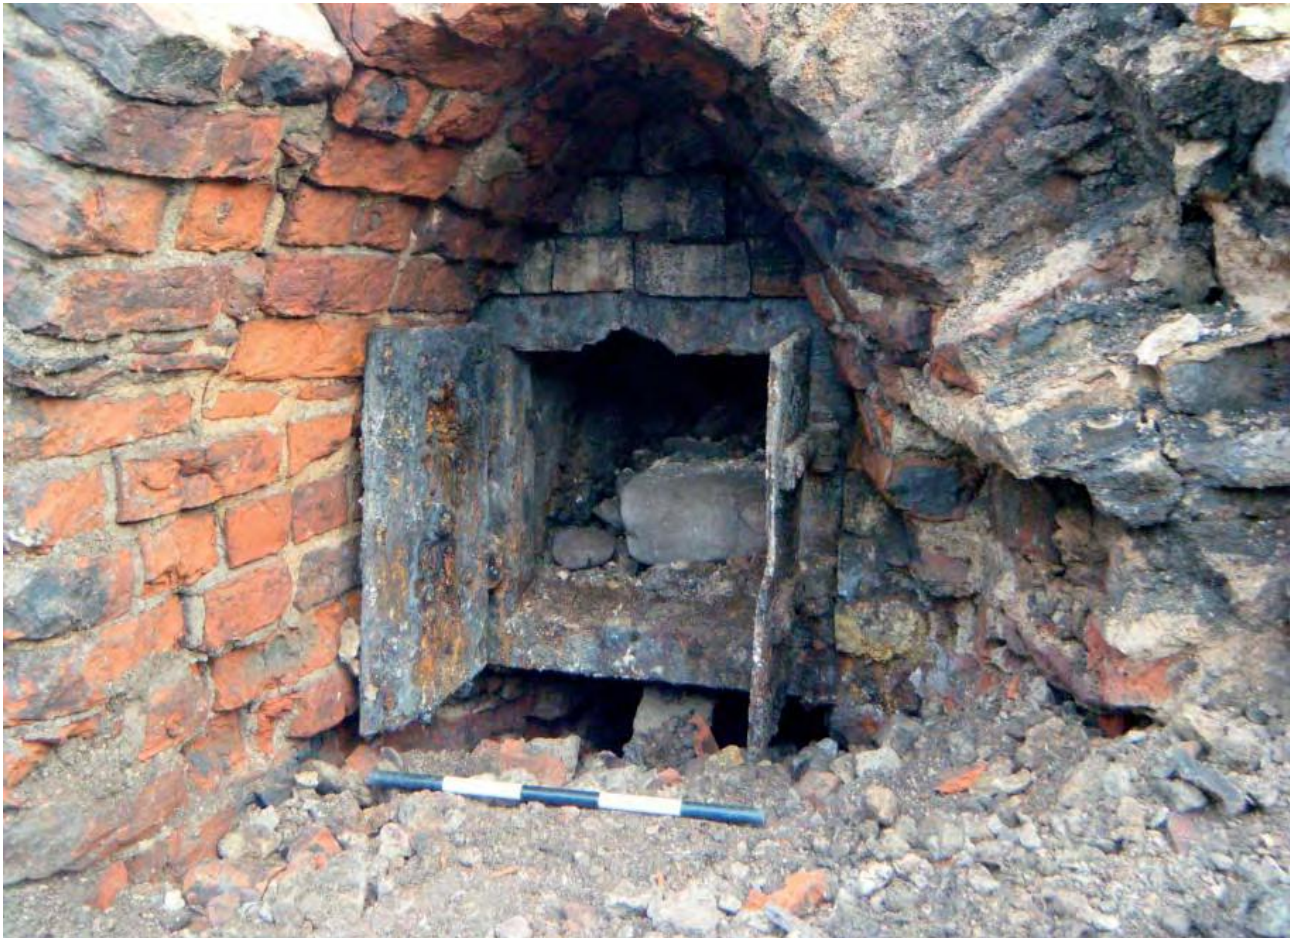
Illus 13

Detail of flue door [051] inserted in arch [023]

Once the pan flues had gone out of use Phase 3 saw a much smaller flue inserted in one of the existing arches. The metal doors inserted in the archway leading from the south side of wall [020] formed the opening for a small firebox or oven, suggesting that fuel was introduced from this side. The 'ETNA' fireclay bricks surrounding the firebox were made at Armadale in West Lothian and were produced from 1890–1947 (Douglas *et al.* 1985). The slabbed stone surface above the later flue may have been constructed for a small pump or similar piece of equipment that required more stability than a brick surface could provide. Although the later flue had been badly truncated by modern disturbance its smaller scale indicated that it was not being directly used in the production of salt and was more likely to have been a heating duct or utilised for some other purpose that involved the transfer of heat.

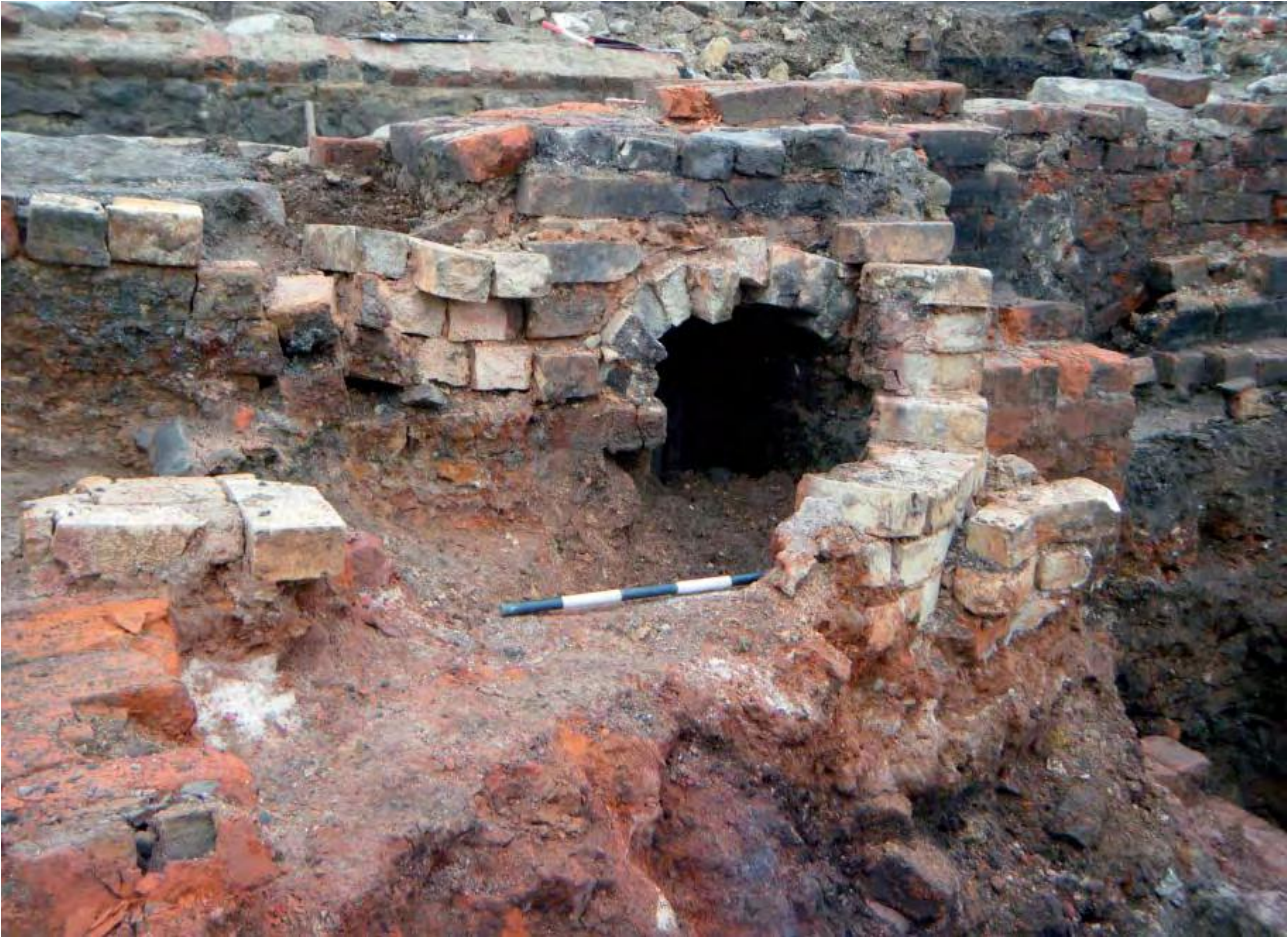
**Illus 14**

Detail of later phase flue [032] facing S

which the flue had been truncated by modern activity. The flue was approximately 1m above original flue [053] on a deep red sand foundation that had been discoloured due to heat.

A number of features associated with the later phase flue [035] were also recorded. These included a series of flat concrete slabs [030] forming a platform on top of wall [020]. To the west side of the flue a square brick structure [048] was recorded. This abutted the north elevation of wall [020] and also partially sat over flue [052]. This small structure (0.62m x 0.58m in plan and 0.84m high) included a small shelf, the side walls of which had evidence of burning or soot. It was unclear what the feature [048] represented and whether it was related to the later phase flue, although it was clear that it was a later phase than the main pan flues below.
