Project Code: EERR.09/002 Date of Report: December 2010 Client: Farrans and I. & H. Brown

A HISTORIC BUILDING RECORDING OF BARROWFIELD WEAVING MILL

Desk Based Assessment & Level 4 Historic Building Survey

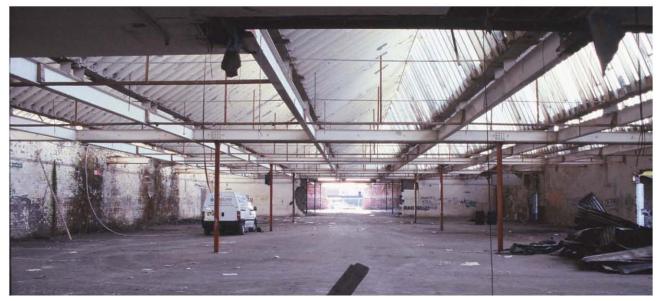
Illus 6 Room R2 & 3, looking west

Rooms R2 and R3 were originally one large hall 78m EW by 26m NS, later subdivided by a breeze block wall. It was lit by 6 large windows in the E wall (F13–15, 17–20), (and through the north lit glass roof). The shutter door F16 in the middle of the E wall appears to be a later modification of the original door.

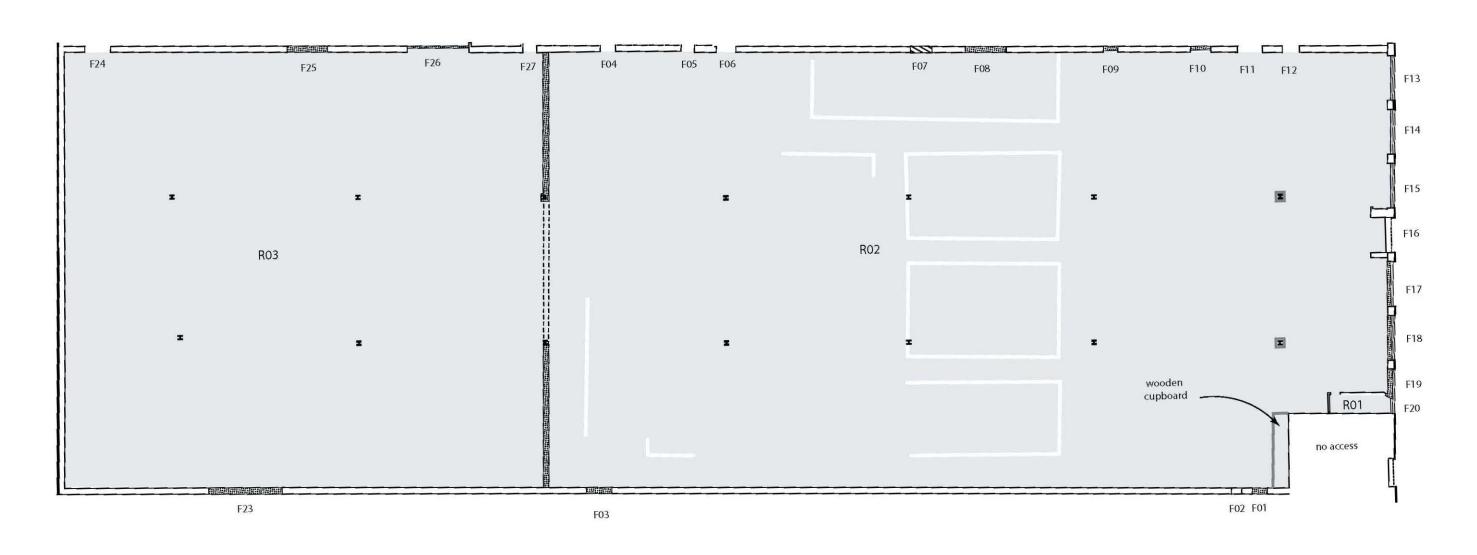
Illus 8
Detailed floor plan of southern shed, rooms R.1–3

Room R2/3 have wooden floor. In the north half (R2) were remains of painted lines on the floor defining rectangular bays/areas. Four of the best preserved areas were all in line to the east (Illus 8).

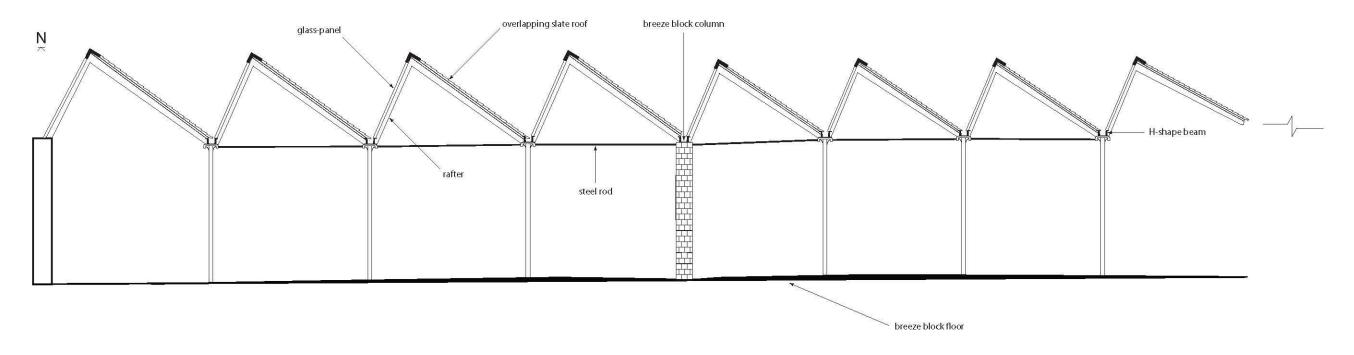
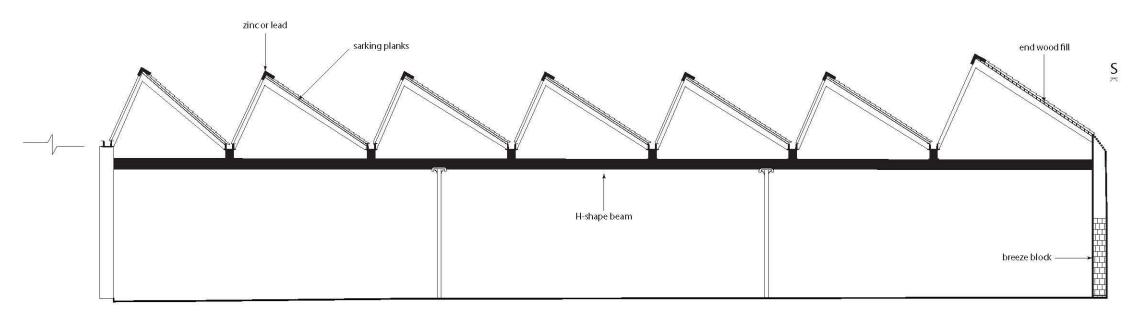
Illus 9
N-S cross section showing roof construction

The roof in room R2/3 was supported by steel H-beam columns arranged in two rows E to W 8.5m apart on either side of the middle of the room. The beams were 10 to 11m apart. The columns supported a grid of longitudinal and transverse steel H-beams that than provided support for the steel beams running E-W below and along the gullies of the 'zig-zag' roof. This construction seems to be a later modification of the original design seen in the rooms to the north. The purpose of the intermediate grid of longitudinal and transverse steel H-beams was to be able to widen the gap between the rows of roof supporting columns beyond the width of the individual 'zig-zags', thus making room for wider machinery.

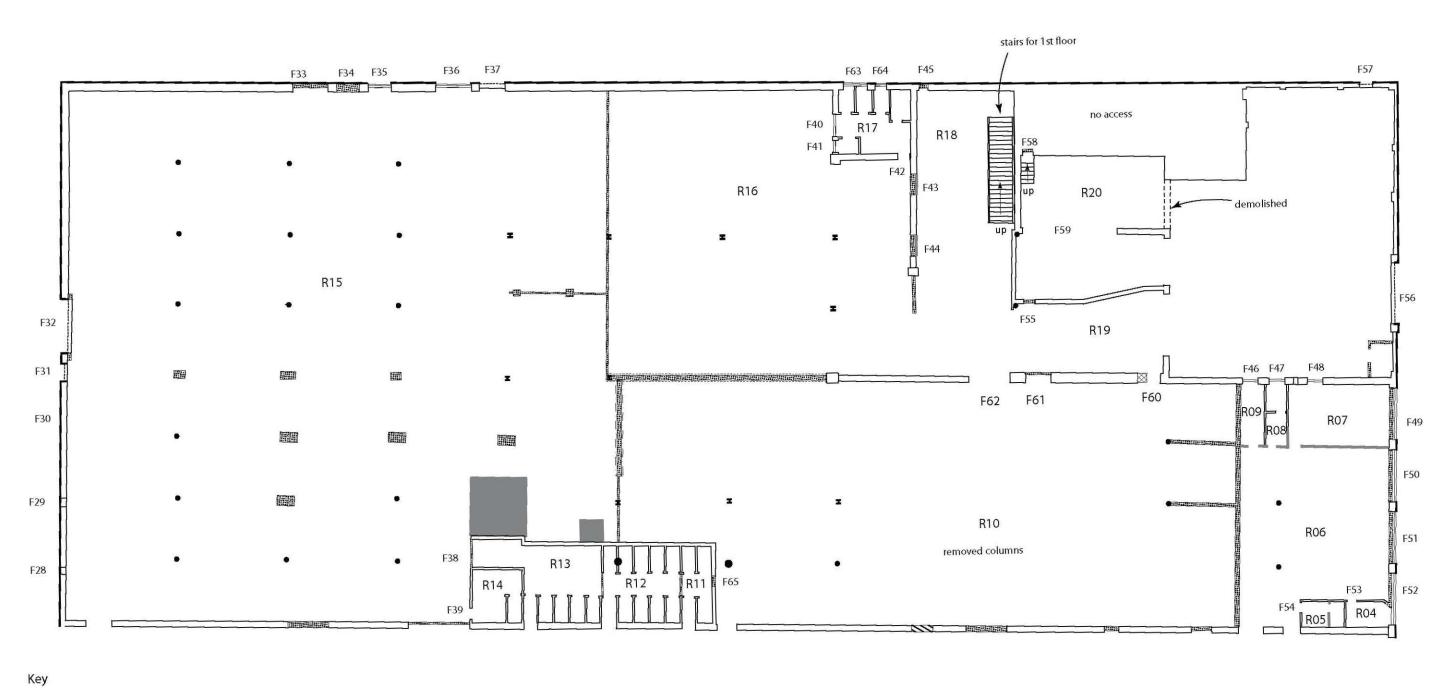
Illus 10Detailed floor plan of northern shed, rooms R4–20

Rooms R4–10 were located to the north of room R2. Originally all of these rooms (with the possible exception of rooms R8–9) formed a big hall 45.5m long EW and 14.5m wide. Large parts of the roof in room R10 had been demolished prior to the survey. This meant that only four roof support columns out of a likely total of 10 were located within this room. The wall at the NW corner of the room had a breeze block base some 1m high with brick fabric on top possibly indicating a later insertion. A breeze block filling of a 4m wide gap in the west wall against the toilet block indicates a former passage through to room R15.

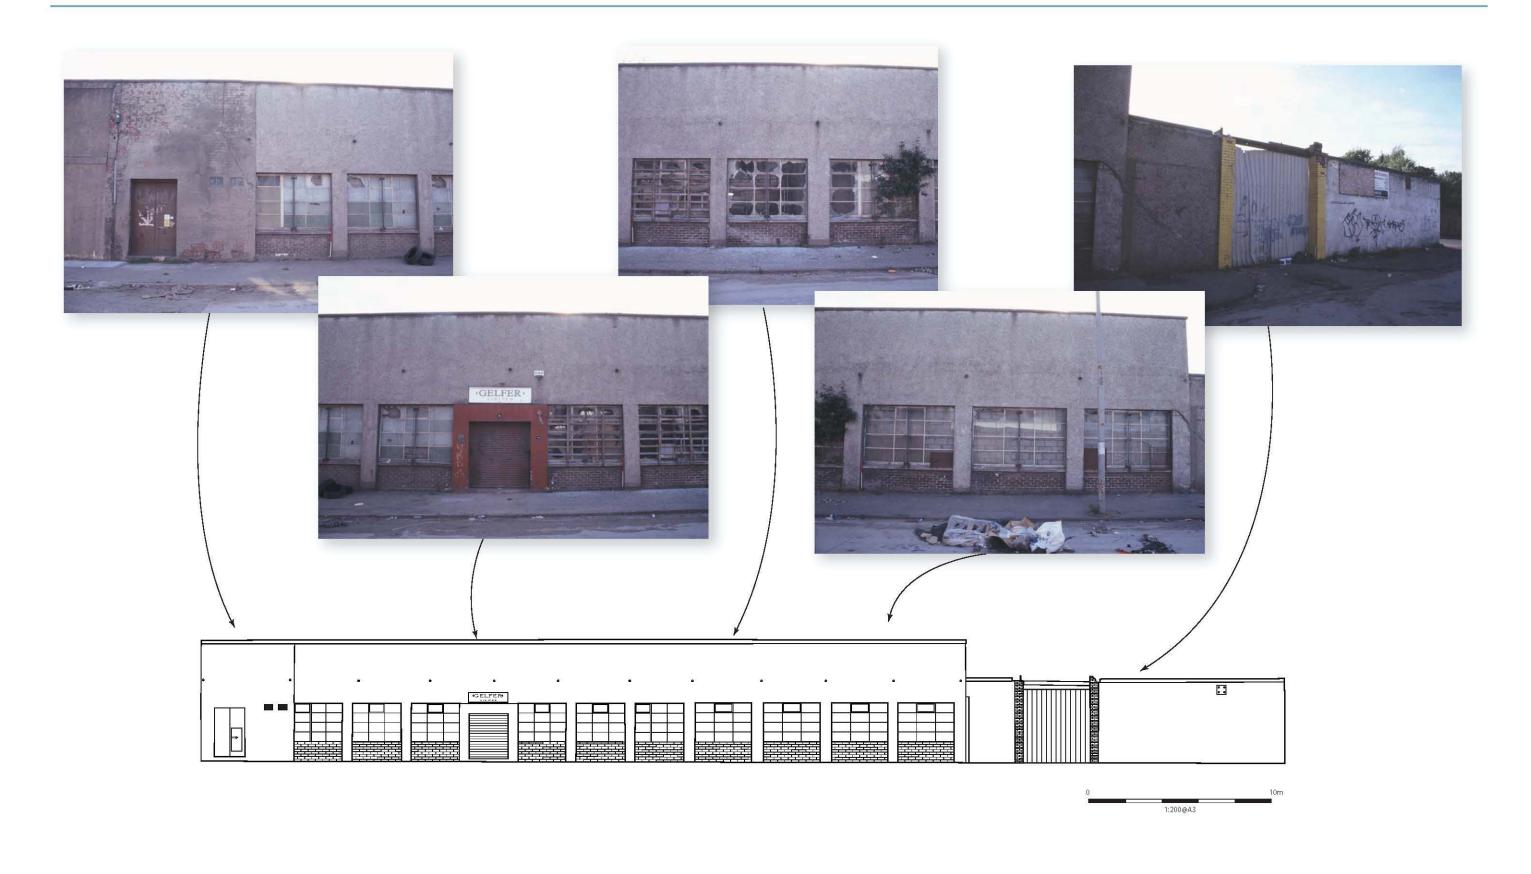
Illus 12East elevation of weaving sheds

This elevation (Illus 1) is a single storey 10 windowed section of the structure (approx. 59m), fronting onto Dora Street. The section examined in this survey contained one main shuttered door, one fire exit and at the northern end of the elevation the large gates/goods entrance mentioned above. The original brick work had been rendered in rough concrete, apart from below the window bays.

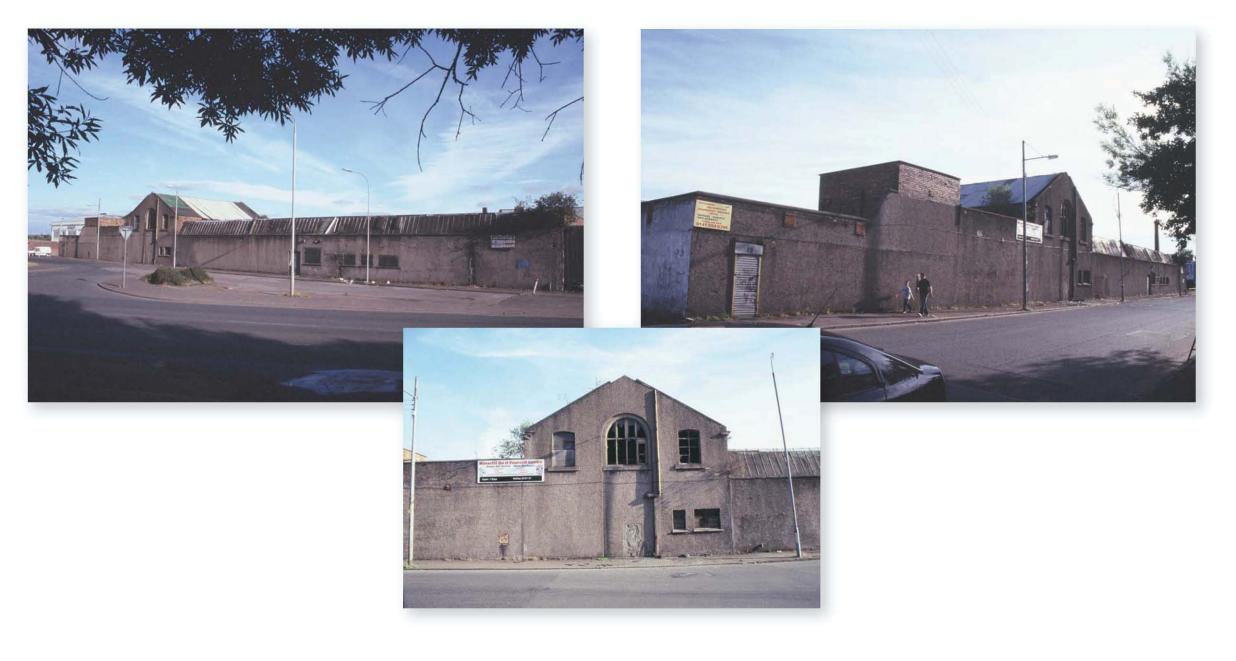
Illus 13
North elevation of weaving sheds

The northern elevation (Illus 12) is the only section of the structure where you can clearly see a second storey in the building. The elevation extends approx 88m and is orientated E-W fronting on onto Poplin Street; all of which has been rendered in rough concrete. The east section of this consists of the brick walled courtyard area which contains one roller shutter door. Directly west is the two storey structure, which contains 1 blocked doorway at centre, directly west two small ground floor windows currently boarded up. First floor centre contains a large arched window with two smaller 8 pane windows on either side (the east of which is blocked). The western section of this elevation consists of the weaving sheds with one roller shutter door and 4 windows. The north lit roof can be seen quite clearly from the front, with several repairs/later modifications along it.

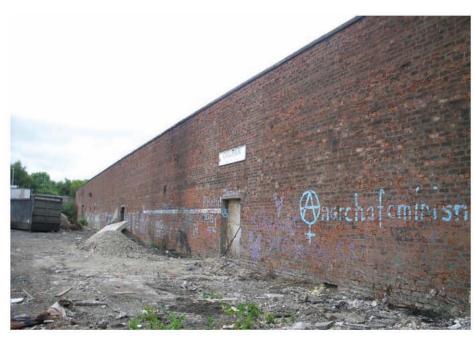
Illus 14
Photo of western elevation of weaving sheds

The western elevation was surveyed before any of the main works as it was demolished to provide access into the weaving sheds. A Level 1 Photographic Survey was undertaken of this side of the building to allow the sheds to be cleared out and made safe prior to internal survey. The elevation is the only one surveyed that had not been rendered and therefore showed the original brickwork of one header and four stretcher bricks.

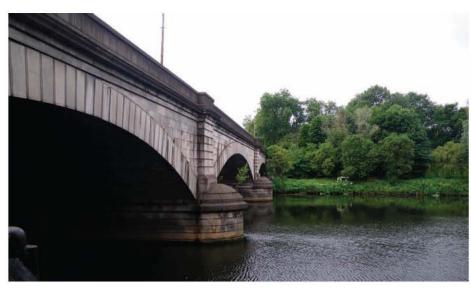
Illus 15 Photo of bridge section

Three span segmental arched bridge, faced in grey granite. The structure has two central pier supports (boat-shaped) and two terminal piers, constructed from granite with ashlar. Central arch may be slightly larger in width. Built in 1896 (Hume, 1974) by Crough and Hogg (GCC, 2010a) this structure replaced an old five span masonry bridge and was built to allow for the use of the crossing by two lanes of trams (Scran, 2010a).

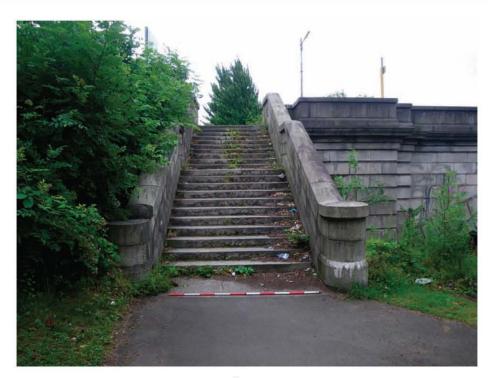
Illus 16 Photo of stairs

The superstructure of the bridge has a plain parapet, no balustrade or any detail. The deck is currently used as a 4 lane tarmac road with pavements on both sides. One set of original stairs down to riverside from the deck exists on the western side (Illus 16). This was likely to have been mirrored on the eastern elevation but no longer exists. This has been replaced with later ramped access down to the riverside, which is constructed as a roughly hewn sandstone wall, and abutts the bridge at the NE.

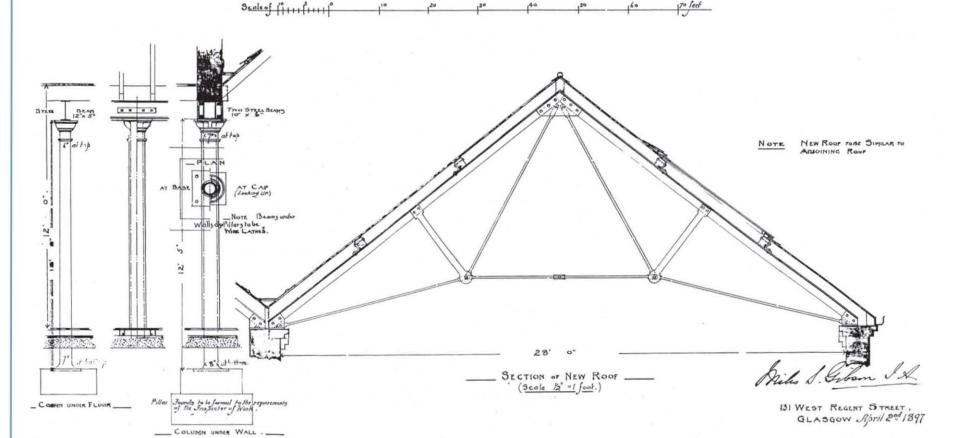
The sourced architectural drawings of the building (Appendix 2) add extra information to the original build of the structures. Plan 1 & 2 show the pitched roof construction of a second storey at the south of the complex (not in study area). This is similar in design to that recorded in the HBR focus area at the north, with two iron struts and several iron braces. This continues the theme of simple and cost effective design, easily constructed.

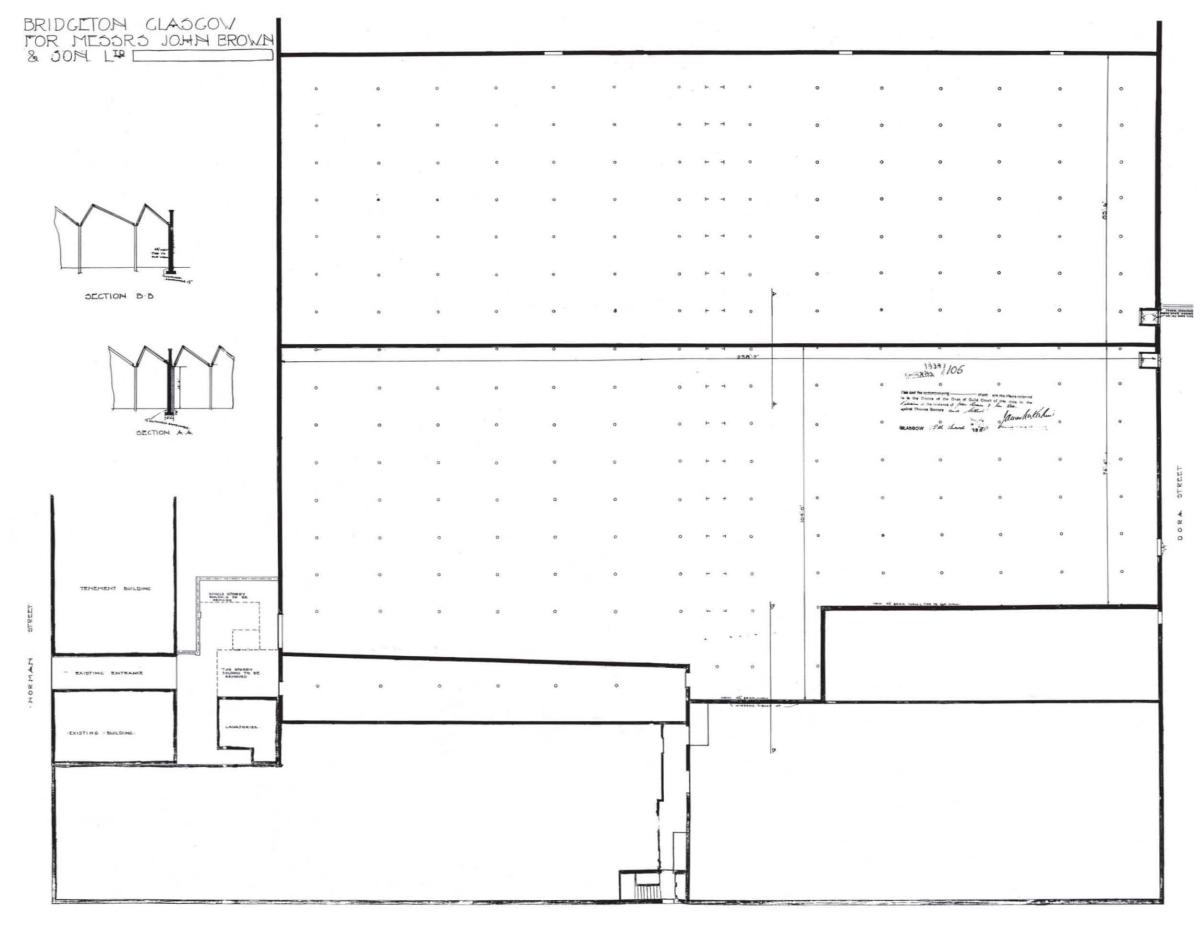
Plans 3 and 4 are ground floor plans of the weaving sheds, showing the original spacing of circular cast iron columns and cross sections through the structure. Plan 3 also denotes the building fronting Norrman Street as a tenement building. These continued north up the street, with the gardens fronting the west perimeter wall of the weaving sheds, as can be seen on Plan 5.

Proposed divisional walls at factory, dated 9 Mar 1935, passed Dean of Guild

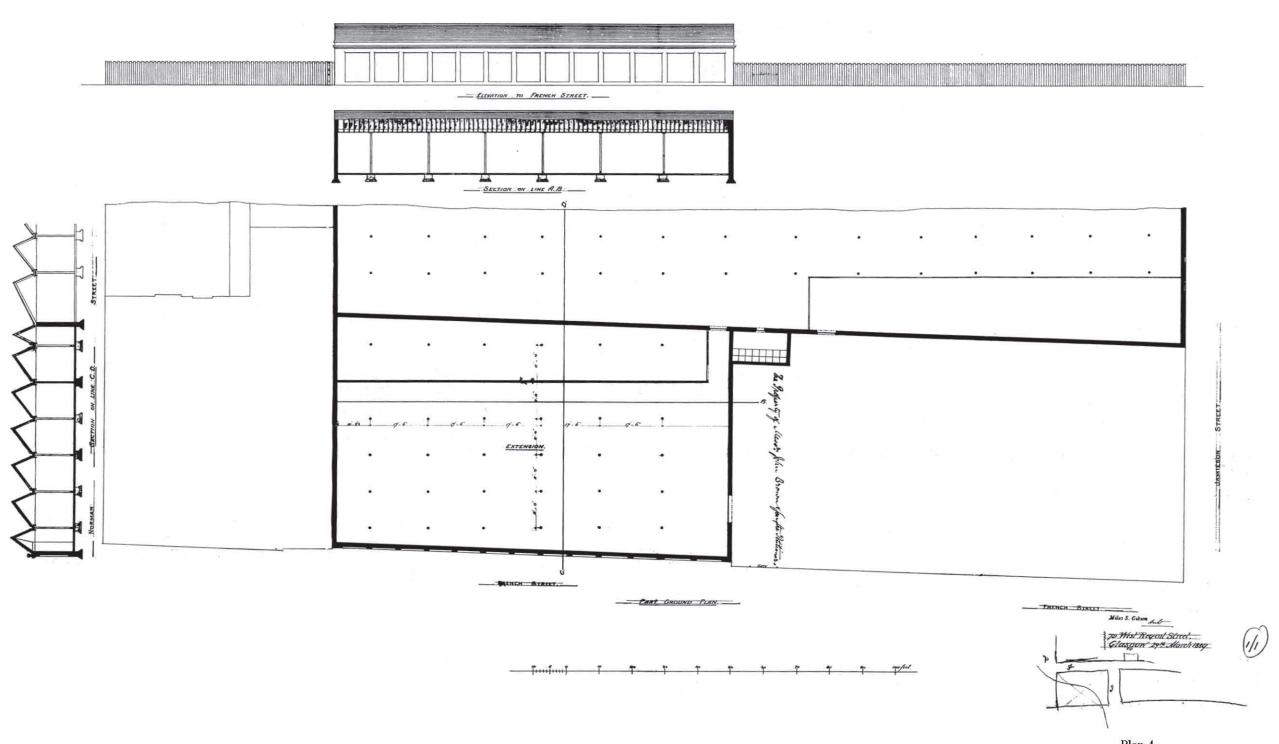
Proposed extension to weaving shed, signed M. S. Gibson, 79 West Regent St., 29 March, 1889
