Project Code: EERR09/003
Date of Report: December 2010
Client: Farrans and I. & H. Brown

RESULTS OF AN ARCHAEOLOGICAL EXCAVATION AT RUTHERGLENBRIDGE COTTON MILL, BRIDGETON, GLASGOW

PROJECT SUMMARY SHEET

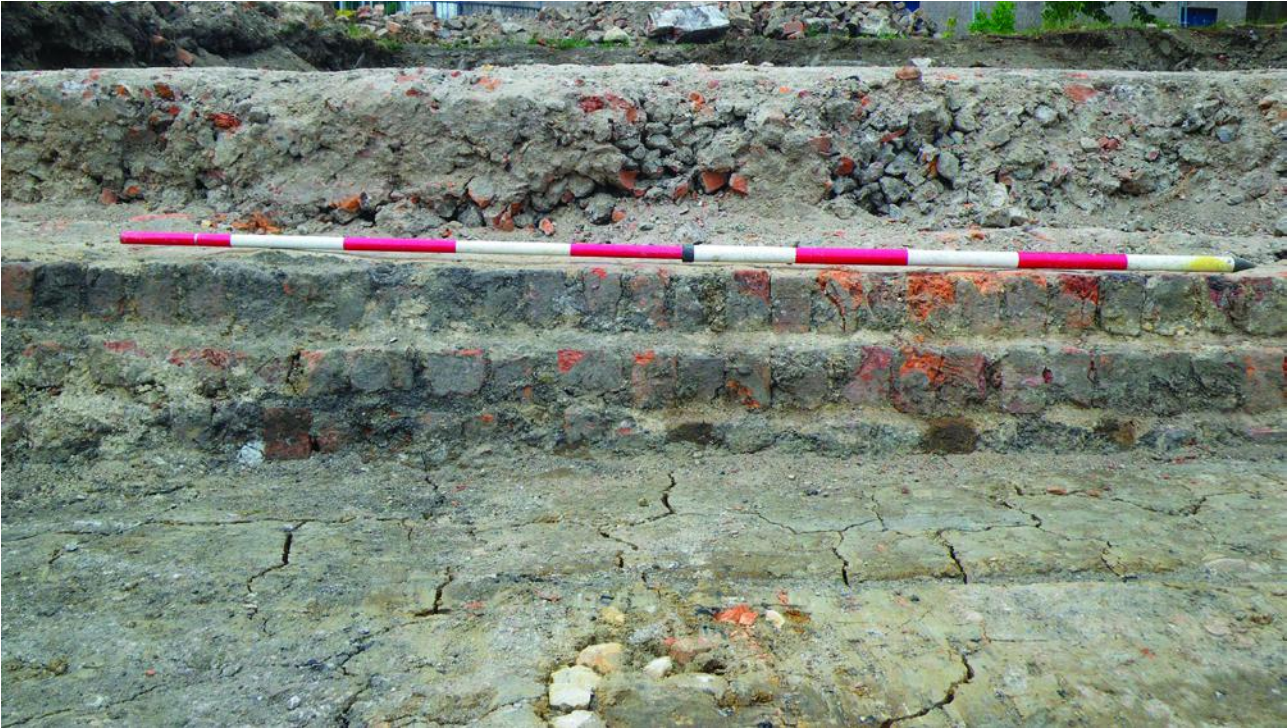
Illus 4

Tenement concrete foundations

Building 1 includes the L-shaped structure seen on Illus 3 and any structure remnants at its west. Excavation of this area revealed a section of northwest wall of Building 1 – [116], which was constructed from header bonded red brick with stepped foundation. This wall abutted Building 2 wall [142] which continued north at the east of chimney [109]. Possibly an interior feature/inner structure related to [116] was a U-shaped section of wall [118]. This feature was constructed of similar unmarked red brick and had been reduced to a maximum of four courses as the concrete tenement foundation can be seen truncating this feature at its northern and eastern limits. (Illus 4)

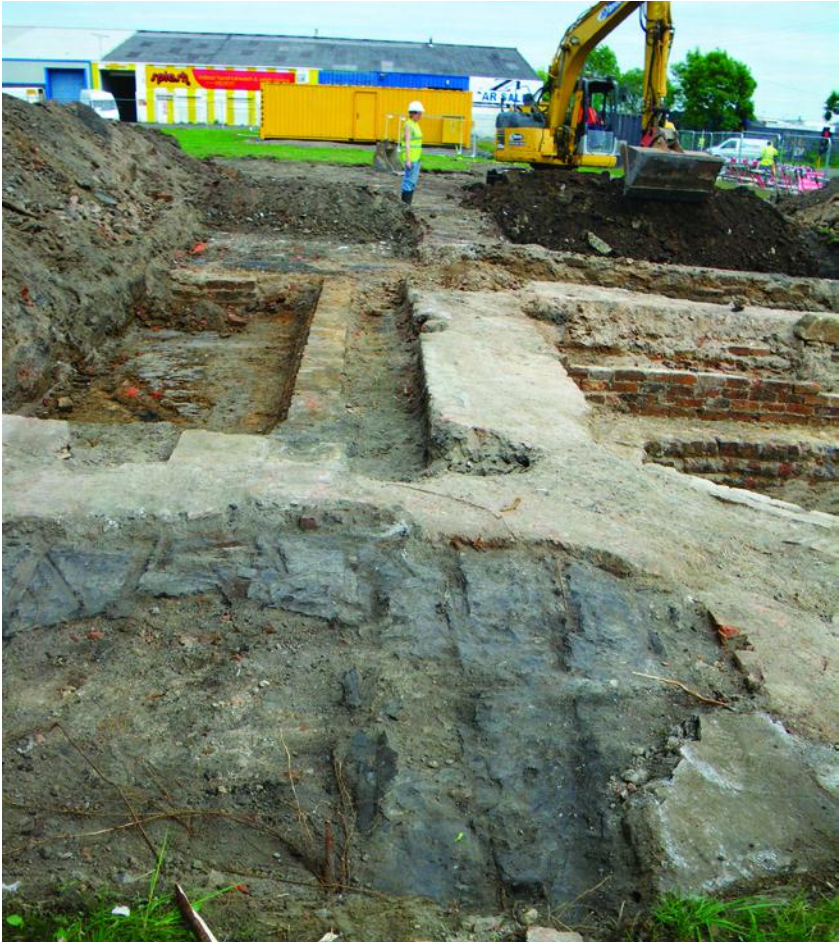
Illus 5
Tar floor [104] in mill

After the construction of the main walls the void areas were in-filled with a series of make-up deposits, including rubble material and re-deposited sand. Fragments of a rough tar floor were found above this at the east end of the structure, interpreted as a working surface at this end of the building. In addition to the main machine base a linear row of metal pegs [117] were excavated, rooted into the make-up deposits just east of the western perimeter wall [136].

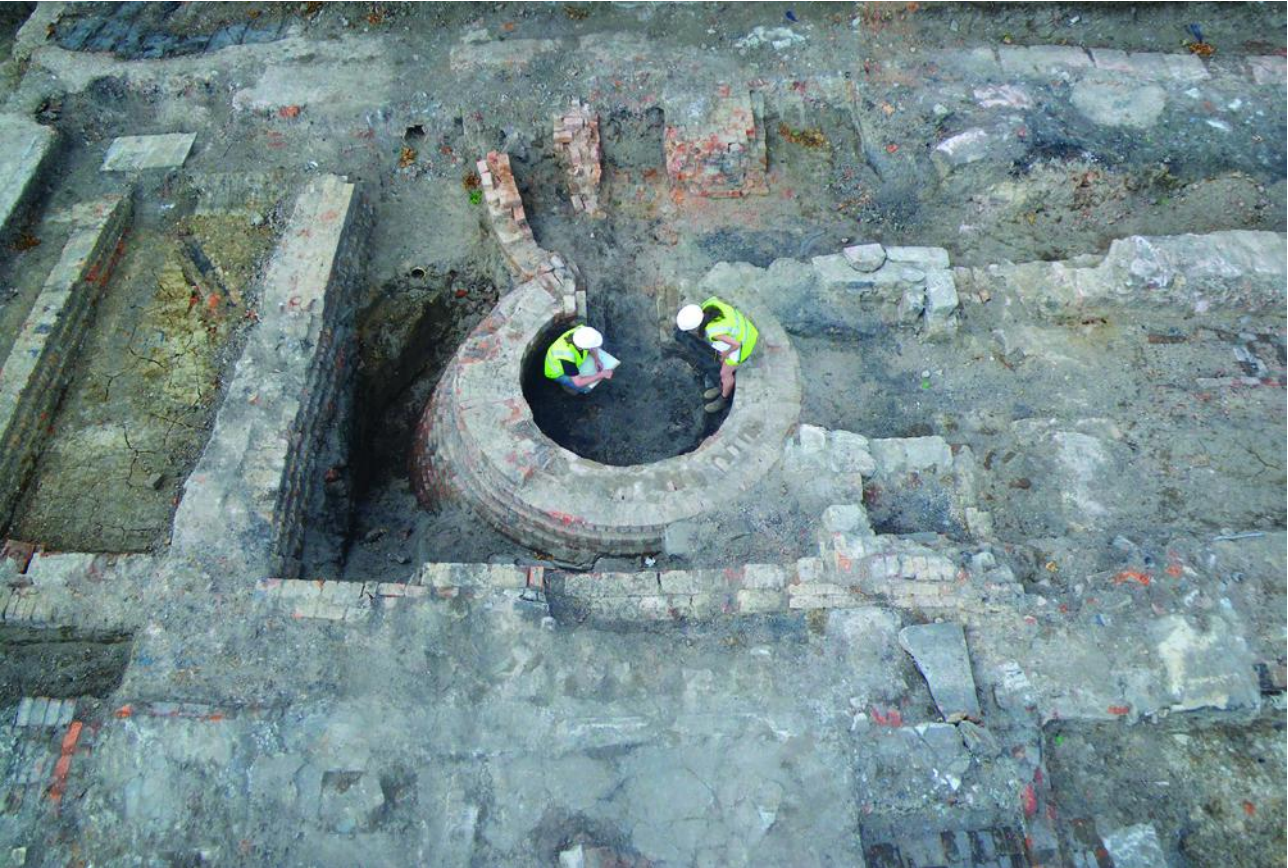
Illus 6
Aerial view of chimney

The circular feature, similar in size as [121] next to Building 1 was revealed and immediately interpreted as a chimney. The chimney base was located 1.5m north of wall [116] and had associated flues [109], [112], [113], [114]

running west. These appeared to divert into two separate channels, perhaps indicating two separate destinations/ associated buildings. The feature is mainly constructed from red brick, some of which are marked with 'Patent Williamson Glasgow'. The chimney structure has been lined with white firebrick, as have the flues in order to withstand the extreme temperatures. Unfortunately due to the limits of excavation the area to the west was not fully exposed, therefore its direct relationship to any Engine House/other structure is unknown.

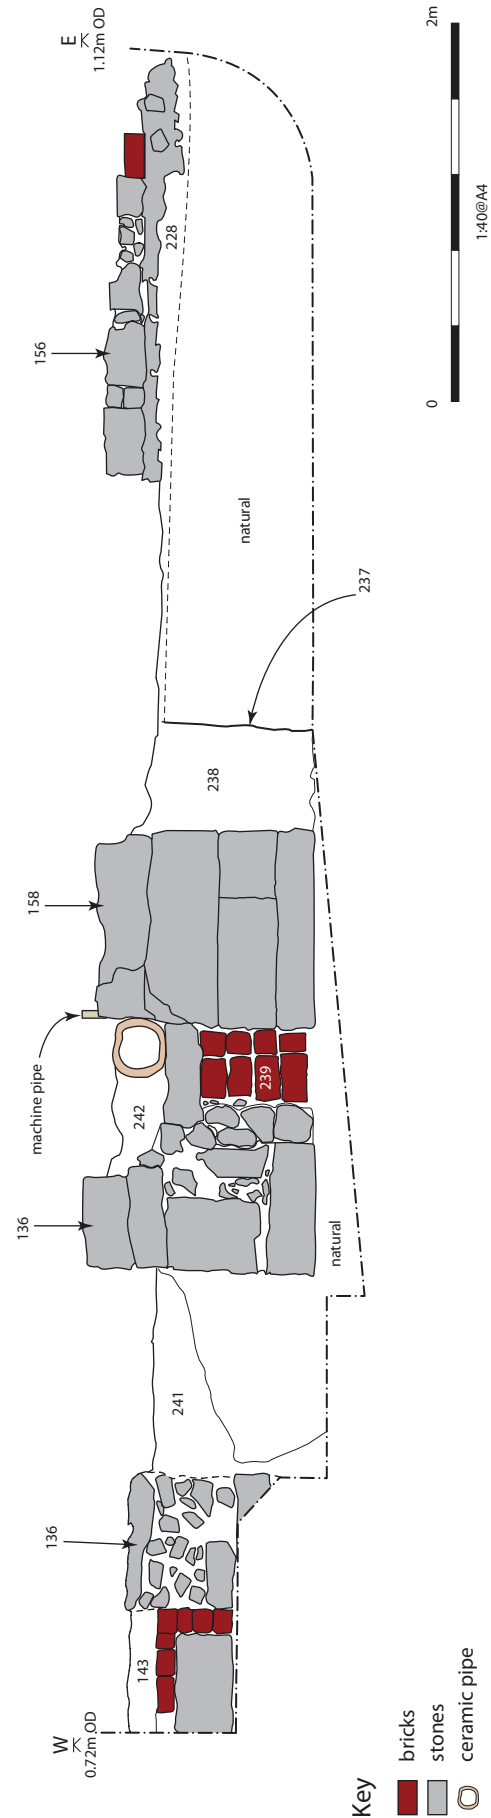
Illus 8
South facing section through [156] & [158]

Some evidence pertaining to the back garden walls/bin houses were discovered. Feature [156] was the best preserved, showing the individual compartments for each flat’s bin. Constructed of grey sandstone and orientated approx N-S this structure extended approx. 10m. A continuation of this feature ([174] & [205]) continued north up site, but was less well preserved.

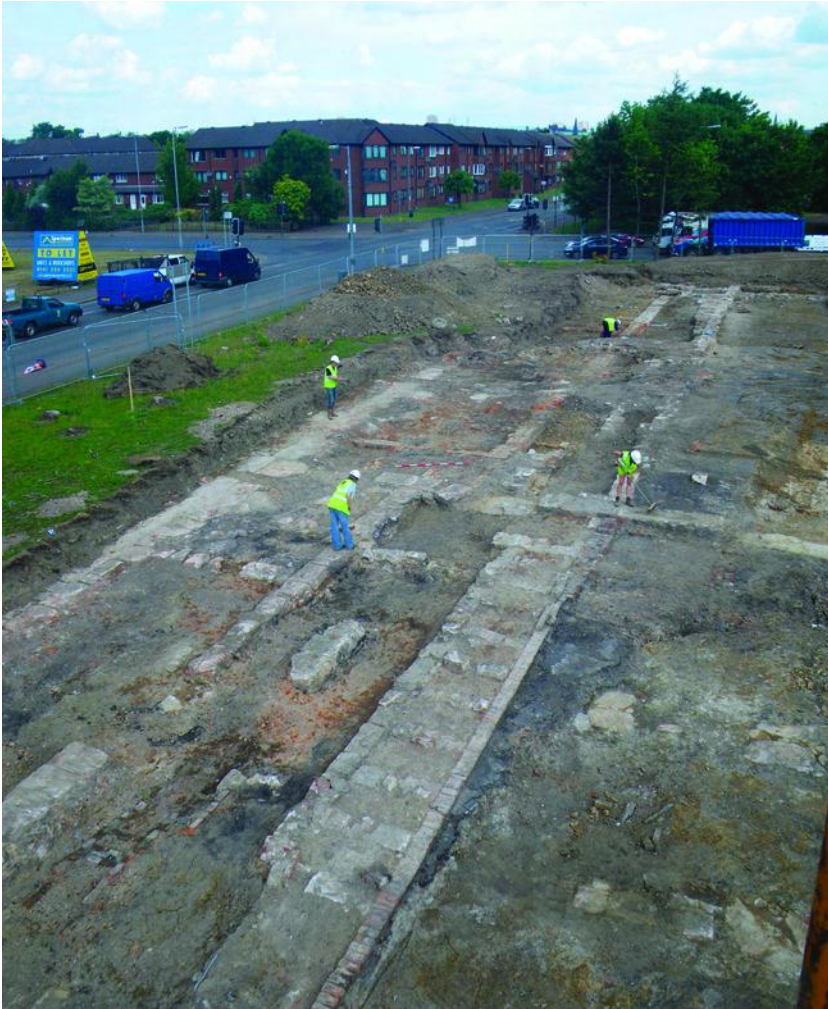
Illus 11
General view of Building 3 & 4

Building 3 comprises one of the main mill buildings uncovered on site, located directly north of Building 2. It was revealed as substantial yellow sandstone foundations, located at both west ([136]), north ([198]) and south ([196]) of the building. In order to fully record the construction within this structure two trenches were excavated by machine, one orientated N-S, the other E-W. The building was built using large roughly hewn sandstone blocks (1.4m by 0.9m approx.) laid long side by side, stepped out (0.4m) from the main wall elevation. The wall elevations were constructed in one sandstone block width laid head to head, with some sections made up of two separate blocks. The internal sub floor space contained 3 support walls ([197], [203] & [240]) each running parallel with exterior walls at north and south. These were constructed from pink sandstone but were built in an identical fashion to the exterior. No floor remains were discovered within this section of the building.

When looking at the First Edition OS Building 4 is the long narrow structure, located at the north west of site, orientated approx N-S. The archaeological remains in this area comprised of two brick thick red brick walls, running parallel. Several small sections of internal walls (contexts [166], [167] & [168]) were identified that are likely to be contemporary with this building phase, perhaps as floor supports. On the east side of Building 4 a small rectangular base [211] was uncovered which

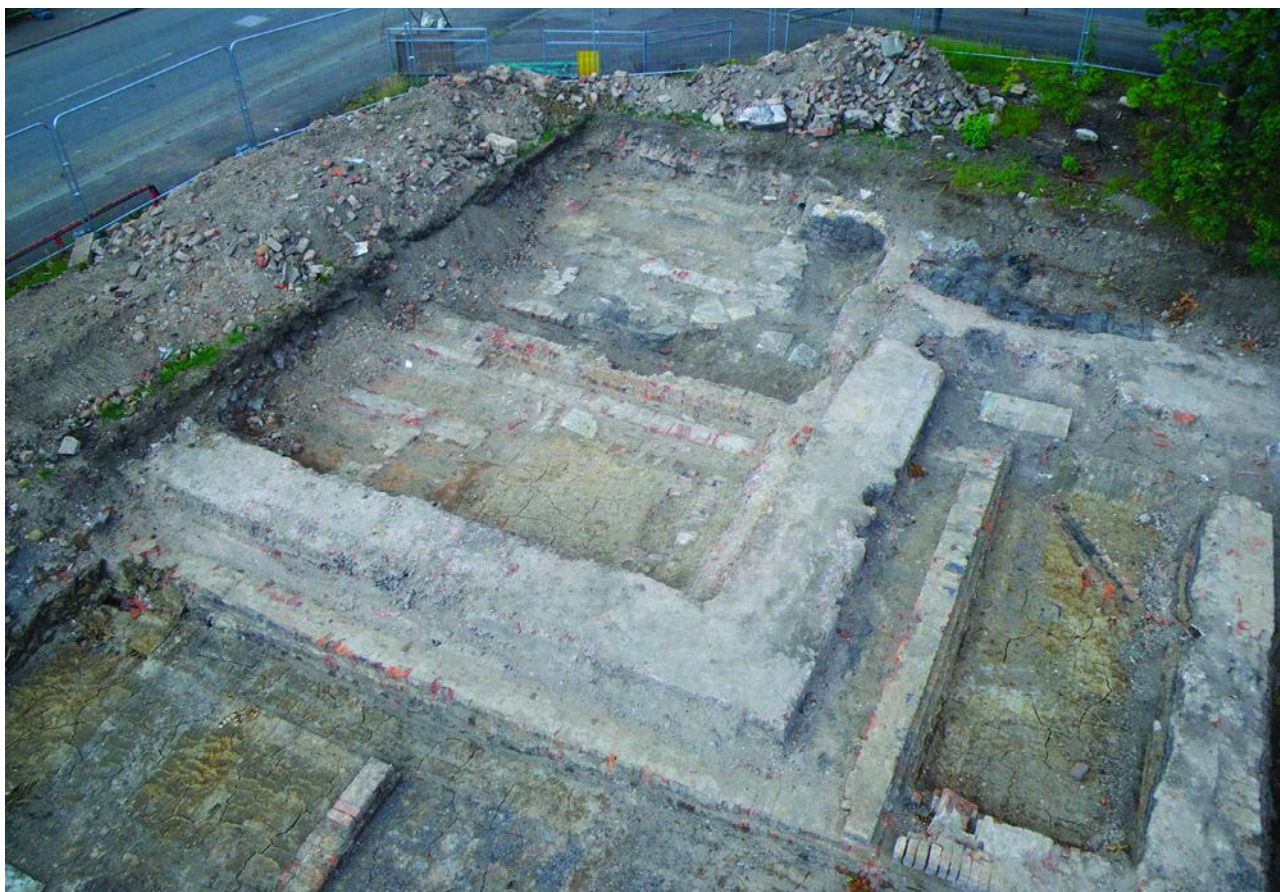
Illus 12

Southwest tenement foundations – [102]

Two main well preserved tenement buildings were encountered on the site, the first of which [101] was located at the southwest corner of site, fronting onto French Street. This comprised of an L-shaped rough concrete foundation [102], with a series internal red brick walls forming the subfloor structure of the building. The second [195], located at the southeast, was more completely exposed, with a full concrete grid. It is interesting that a lot of these walls clearly respect the mill walls and may have been shuttered against them during construction.

strength to the tenement build. For example, on the west wall of structure 3, the concrete foundation for the tenement abuts and runs the length of mill wall [136]. This respect of the earlier builds footprint is seen in several places across site, where tenement and mill meet. Due to the size and weight of the materials used to construct the mill it is no surprise that a large proportion of it remains *in situ*.
