# THE ABBEY CHURCH, PERSHORE

*Archaeological Evaluation*

*for Robert Kilgour Architects Ltd*

*July 2011*

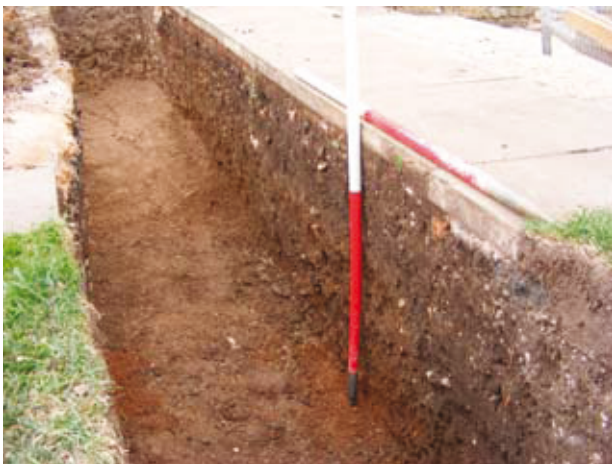
**Illus 3**

Trench 1 – West facing section

Beneath the make-up for the concrete slab path surface, Trench 1 contained a silty clay deposit [103], containing occasional small pieces of disarticulated human bone. Beneath this a loose deposit of rubble was present containing fragments of medieval floor tile alongside pottery dated to the 18th century (Appendix 2).
