## CASTLE HOUSE HOTEL, HEREFORD

*Archaeological Watching Brief*

*DCCE2008/0919/F*

*August 2011*

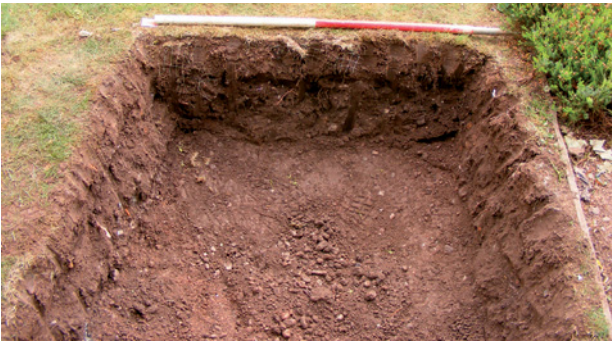
**Illus 2**

View of excavated footing pad 2, facing west

<b>Footing pad no.</b>	<b>Context no.</b>	<b>Description</b>	<b>Dimensions</b>	<b>Deposit depth</b>
2	2001	Blue grey, modern pea grit surface	1.2 x 1.2m (max)	0.02m
	2002	Yellow angular stone bedding plane		0.1m
	2003	Angular grey scalping layer forming levelling layer of modern lower terrace	0.15m	
	2004	Mixed topsoil and previous turf line, possibly redeposited, containing brick and rubble fragments	0.3m	
	2005	Modern garden wall, brick and stone clad, built in late 1990s (running north south)	–

Summary of excavation: the sequence in this footing pad was the same as in FP1, reflecting their location on the lower terrace of the hotel garden.

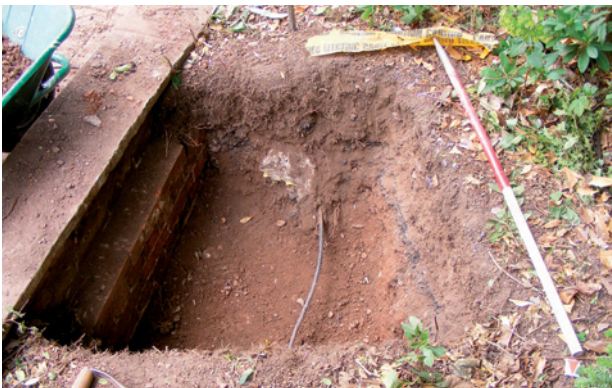
**Illus 3**

View of excavated footing pad 4, facing south

<b>Footing pad no.</b>	<b>Context no.</b>	<b>Description</b>	<b>Dimensions</b>	<b>Deposit depth</b>
4	4001	Reddish brown sandy clay subsoil, containing brick fragments and mixed modern debris (redeposited garden soil)	1.2 x 1.2m (max)	0.25m
	4002	Modern garden wall, brick and stone clad, built in late 1990s (running north south)		–
	4003	Modern tarmac layer, sloping towards moat; cut by modern electric cable [4005] and wall construction [4002]	0.08m	
	4004	Previous turf and subsoil horizon; sealed by tarmac; no finds present	0.2m	
	4005	Modern armoured electric cable associated with the lighting on the present garden	–

Summary of excavation: this area appears to have been built-up very recently, sealing an earlier modern surface.

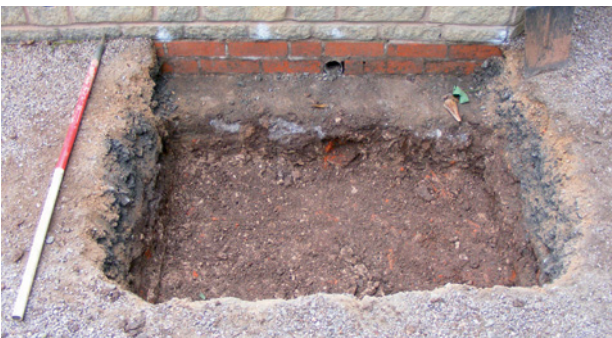
**Illus 4**

View of excavated footing pad 6, facing north

<b>Footing pad no.</b>	<b>Context no.</b>	<b>Description</b>	<b>Dimensions</b>	<b>Deposit depth</b>
6	6001	Blue grey, modern pea grit surface	1.2 x 1.2m (max)	0.03m
	6002	Yellow angular stone bedding plane		0.1m
	6003	Angular grey scalping layer forming levelling layer of modern lower terrace		0.1m
	6004	Mixed topsoil and previous turf line, possibly redeposited, contained brick and rubble fragments		0.3m
	6005	Modern garden wall, brick and stone clad, built in late 1990s (running east west)		-

Summary of excavation: only modern landscaping deposits were encountered.

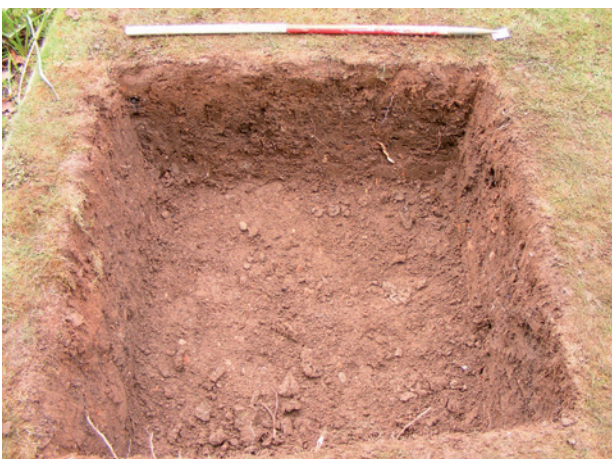
**Illus 5**

View of excavated footing pad 8, facing west

<b>Footing pad no.</b>	<b>Context no.</b>	<b>Description</b>	<b>Dimensions</b>	<b>Deposit depth</b>
8	8001	Turf line (present day surface)	1.2 x 1.2m (max)	0.1m
	8002	Reddish brown sandy clay subsoil, containing brick fragments and mixed modern debris (redeposited garden soil)		0.35m

Summary of excavation: only modern landscaping deposits encountered.
